NEOPRENE PREMOLDED JOINT SEAL INSTALLATION
Project F 34-15 - M-66

Highway Research Project 36 G-4(3h)
Progress Report No. 3

Research Laboratory
Testing and Research Division
Report No. 196
September 15, 1953

Installation - Project F34-15, C4: F-412(4)

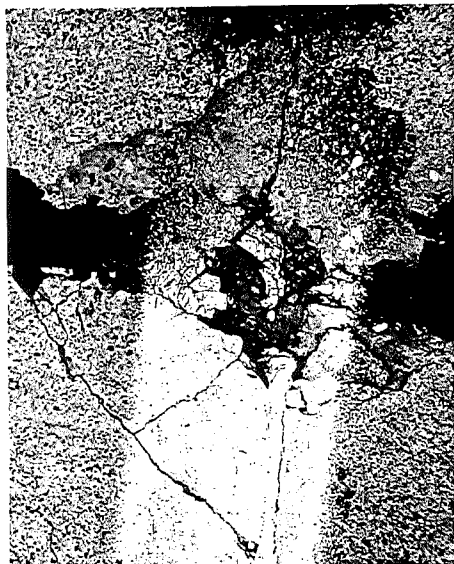
Of the 14 regular or standard highway joints installed in connection with this test installation only one, an expansion joint at station 102~~7~~32, has developed a fairly bad condition of D cracking at the center of the joint. This is shown by Figure No. 1.

FIGURE 1. D-CRACKING AT A REGULAR EXPANSION JOINT. STATION 102 + 32.

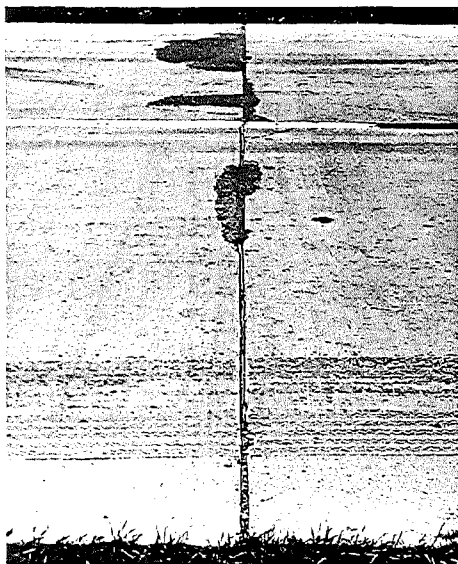
FIGURE 4. NEOPRENE JOINT SPALLING THAT STARTED BEFORE JUNE 7, 1951 AND HAS BEEN CONTINUING TO INCREASE TO THE PRESENT DATE STATION 104 + 30.

It is apparent that a heavy maintenance repair is necessary at this time to salvage the existing value of these joints.

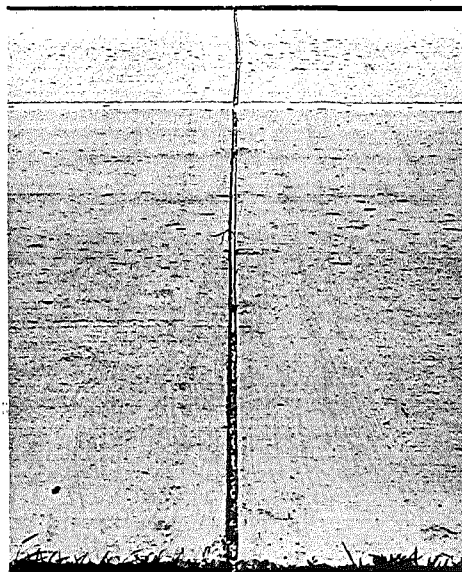
FIGURE 2. NEOPRENE JOINT IN PERFECT CONDITION. STATION 107 + 27.

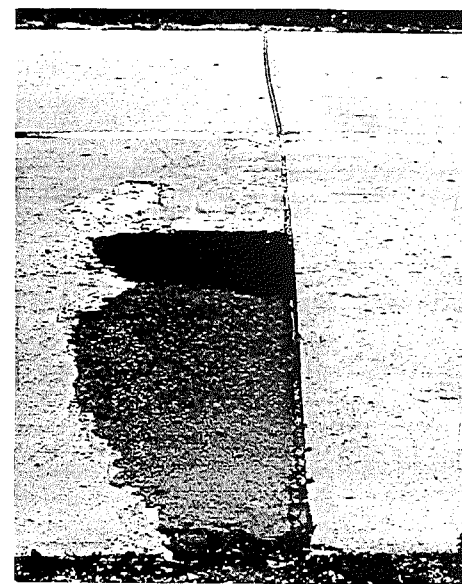
FIGURE 5. BAD DISINTEGRATION AT NEOPRENE JOINT WHICH DEVELOPED MOSTLY DURING LAST WINTER AND IS CONTINUING AT THE PRESENT TIME. STATION 131 + 29.

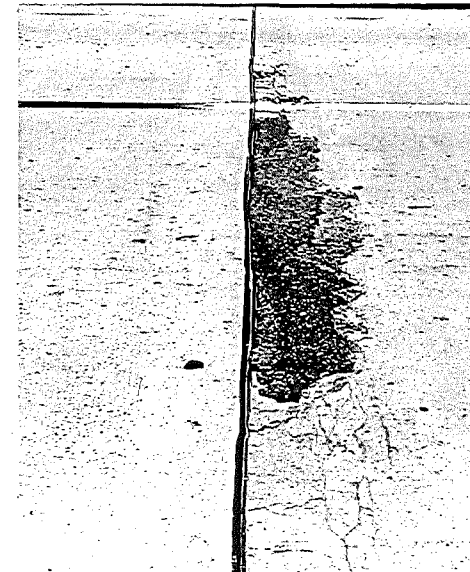
FIGURE 3. NEOPRENE JOINT SHOWING SCALING AND CRACKING WHICH DEVELOPED PROGRESSIVELY.

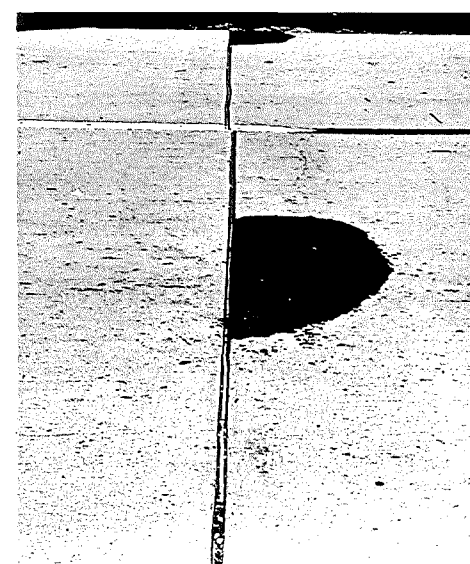
FIGURE 6. NEOPRENE JOINT SHOWING SPALLING AS OF AUGUST 3, 1953.
