**INVESTIGATING CAUSES AND DETERMINE REPAIR NEEDS TO
MITIGATE FALLING CONCRETE FROM BRIDGE DECKS**

Dr. Nabil Grace, Principal Investigator

**Department of Civil Engineering
Lawrence Technological University
Southfield, MI 48075-0134**

September 2012

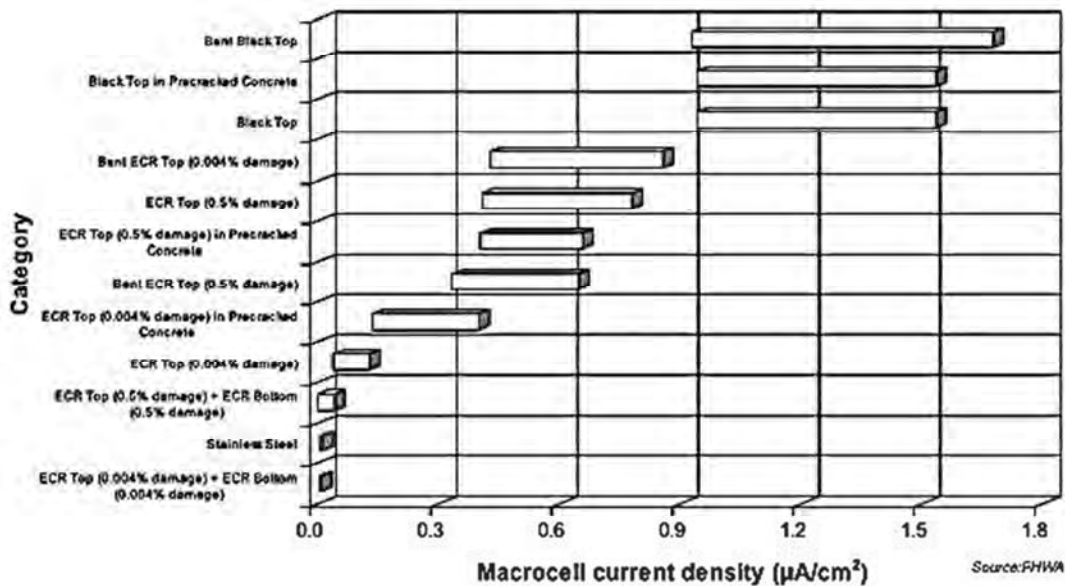
Figure 2-1 Resistance to corrosion of reinforced concrete with different reinforcement types and damage (FHWA)

Michigan DOT, in the early 1980's, directed that all reinforced concrete superstructures had to be constructed with epoxy coated reinforcement (Novak et al., 2000). For reinforced concrete deck slabs, epoxy coated reinforcement was to be used in both the top and bottom mats. The use of epoxy coating in both the top and bottom mat reinforcement has proven to be very efficient in providing corrosion resistant reinforcing solutions. Lee and Krauss (2004) found that the resistance to corrosion was about 15 to 20 times higher in epoxy coated reinforcement mats compared to that of uncoated steel mats. This conclusion is relative to the electrical current passed over a macrocell. The lower the current the higher is the resistance to corrosion (Figure 2-1).

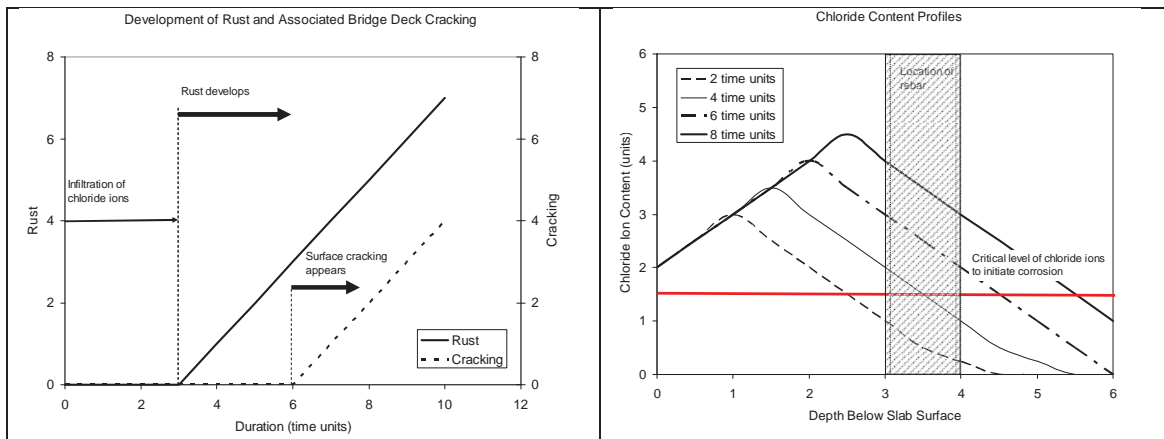
(a) Development of Rust and Cracking due to Corrosion

The inter relationship between the crack initiation, onset of rust development and chloride content is illustrated in Figure 2-2 (a) and (b). Additional deterioration, in terms of spalling and delamination, are controlled by both environmental and traffic load factors. For the sake of simplicity, the rates are shown as linear in the figures.

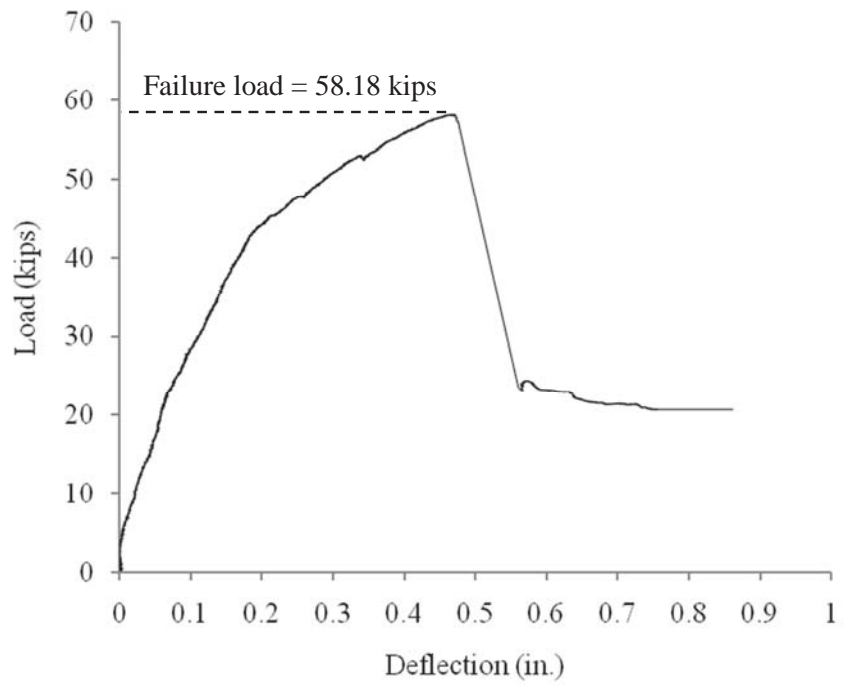
Figure 3-26 Typical load-deflection curve for ultimate load test

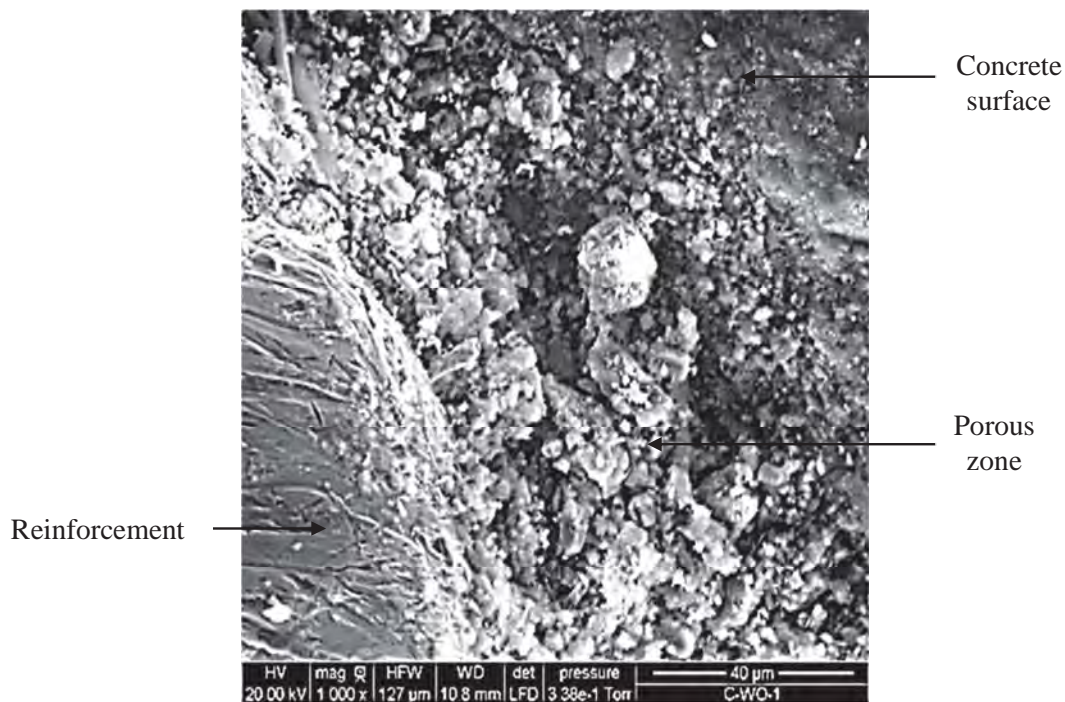
Figure 3-32 Porous zone of C-WO (1000x)

size of the corresponding sample. A representative image showing the porous zone for the specimen C-WO is presented in Figure 3-32.

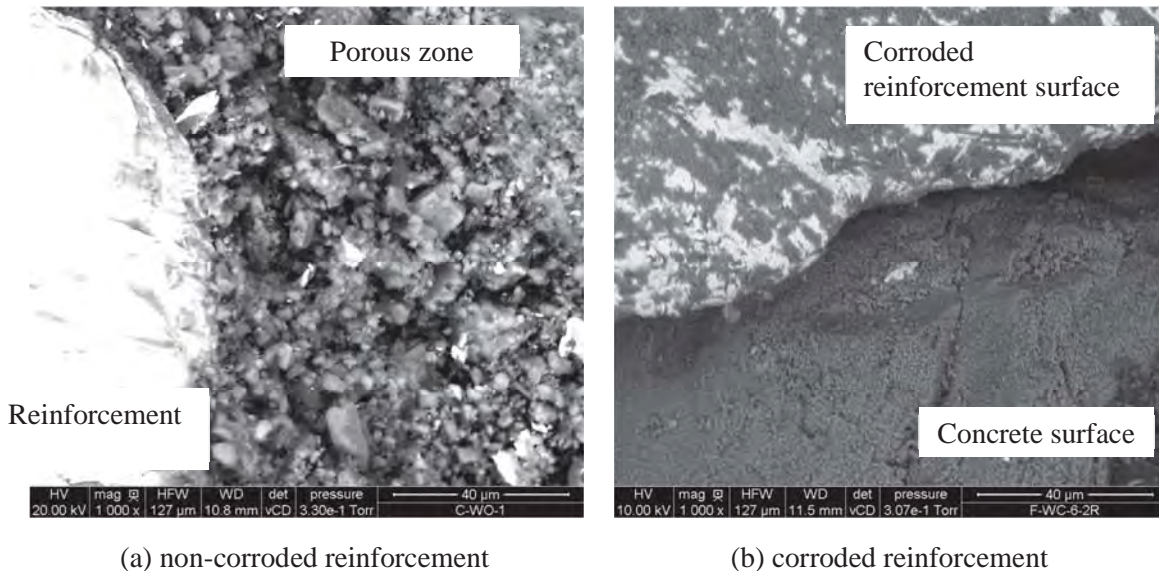
(a) non-corroded reinforcement

Figure 3-33 shows backscattered electron images of non-corroded and corroded reinforcement on representative specimens. It can be observed from the images that the non-corroded reinforcement appears brighter due to the higher atomic mass, and the corroded reinforcement appears darker due to the lesser atomic mass of the corrosion product. Corrosion product may be hydrated ferric oxide.

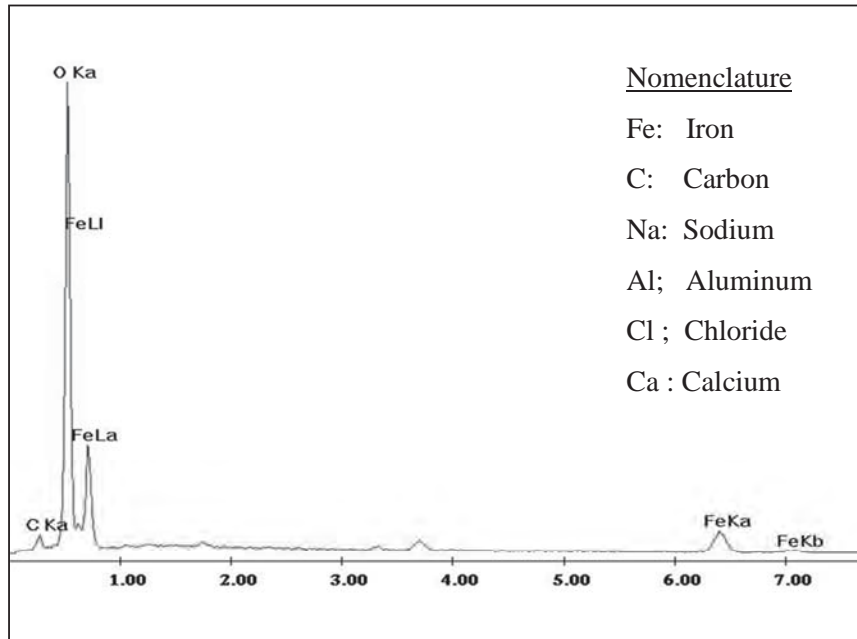
Figure 3-34 Typical plot showing the element composition analysis on reinforcement surface

In this manner, EDAX evaluation was performed for each sample and three spots were chosen, on the reinforcement, on the porous zone and on the concrete surface. Typical plots of element compositional analysis of the reinforcement, porous zone and concrete surface are presented in Figure 3-34 through Figure 3-36. Note the spike in oxygen present on the reinforcement surface and perimeter indicating presence of corrosion products.

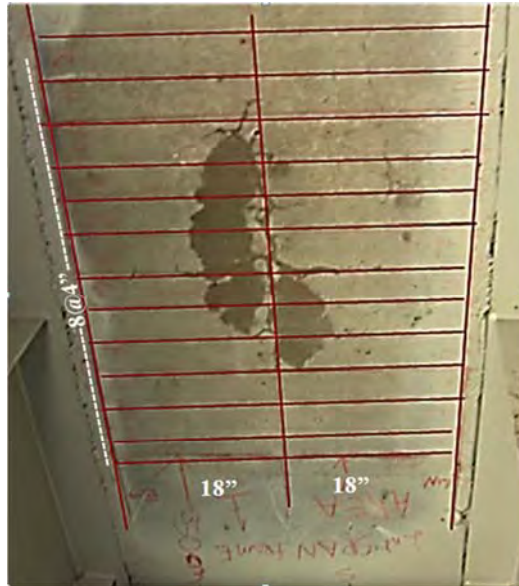
Figure 4-2 Grids used for NDT

Test grids of 4 in. x 18 in. were mapped on each area (Figure 4-2). The bottom steel reinforcement bars were located using the Profometer. The reinforcement was exposed by drilling a ½ in. diameter hole to complete the circuit for the half-cell potential measurements using the CANIN system. The surface, on areas marked out for potential measurements, were water saturated for improved conductivity. Moreover, in-situ hardness was measured by Silverschmidt. Chloride content and pH values were determined by taking concrete powder samples and cores from the bridges. The powder samples were taken from the bottom surface of the deck in a minimum of 6 random areas to a distance of 4 in. from the bottom deck surface. Mapped grids underneath the bridges and exposing reinforcement bar by drill bit are shown in Figure 4-2 and Figure 4-3, respectively.

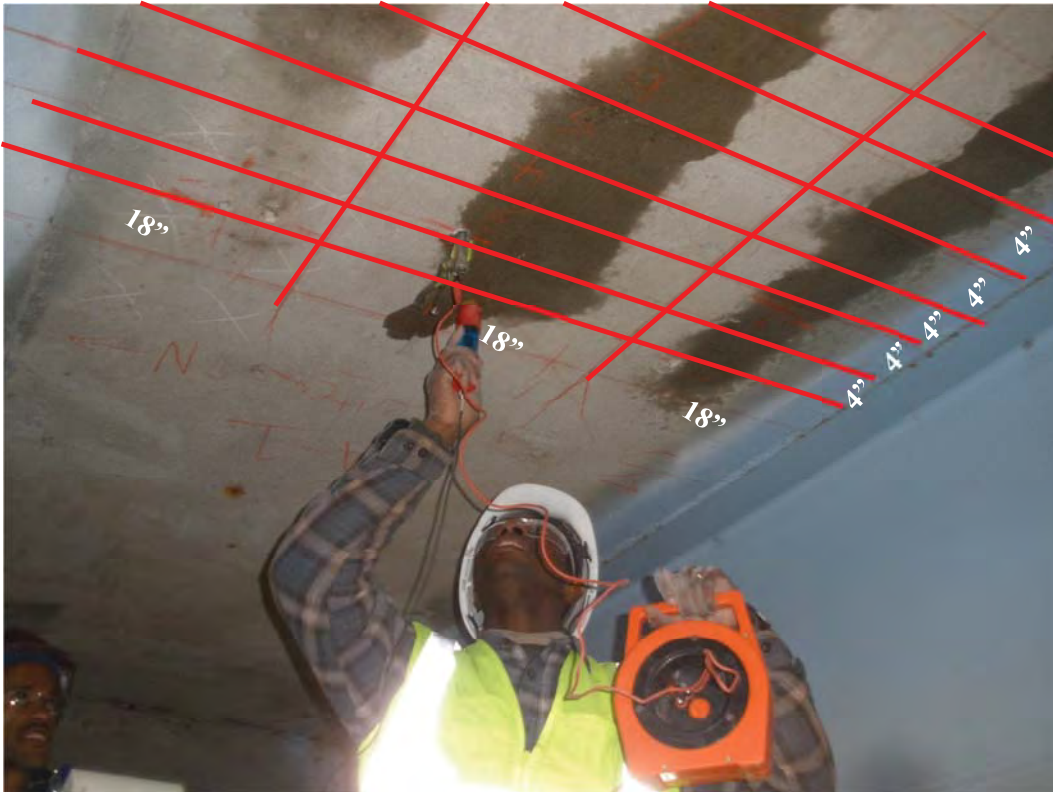
Figure 4-9 Measuring corrosion potential underneath bridge deck with CANIN

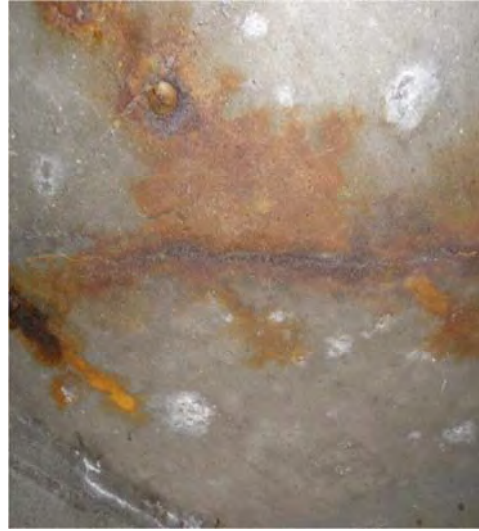
(b) Rust traces and cracks (tail span)

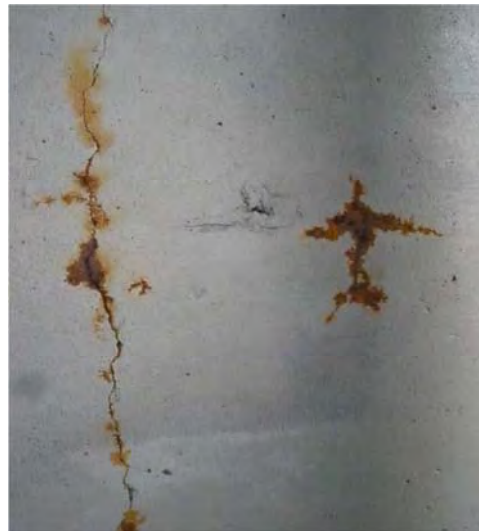
(d) Longitudinal bottom cracks and corrosion traces (Scale $\approx 1:20$) (tail span)

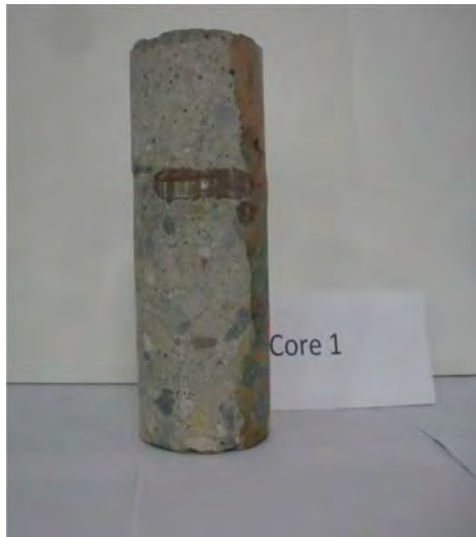
Core 1

- Height: 9 in.
- Diameter: 4 in.
- Reinforcement at a depth of 2 in. and 6 in. from bottom surface
- No major crack
- 3 in. overlay with different aggregate size
- No significant rust on the reinforcement

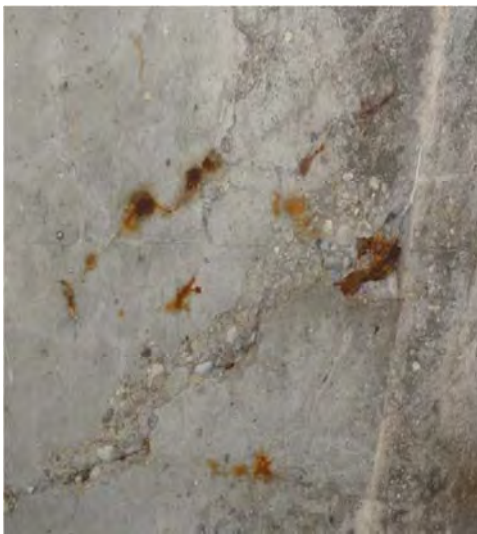
(c) Cracks and corrosion traces (tail span, WB)

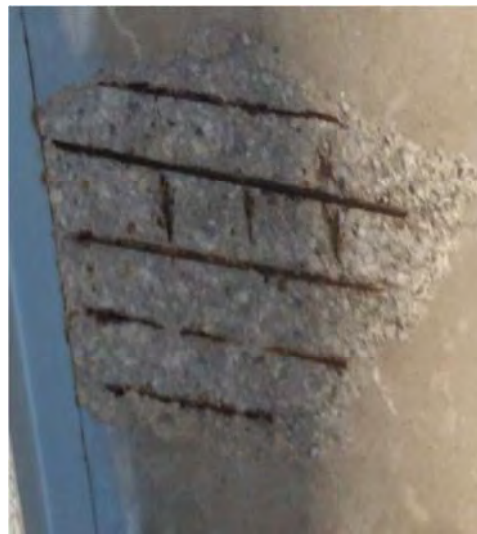
(d) Deteriorated concrete and exposed reinforcement bar (tail span, WB)

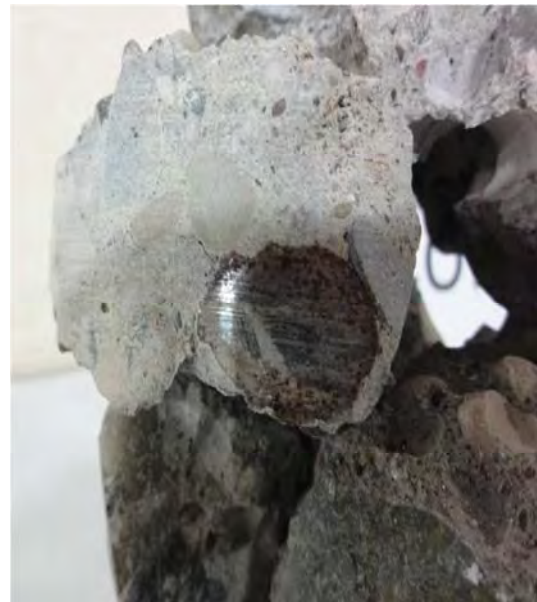
(b) Rust on the reinforcing bar

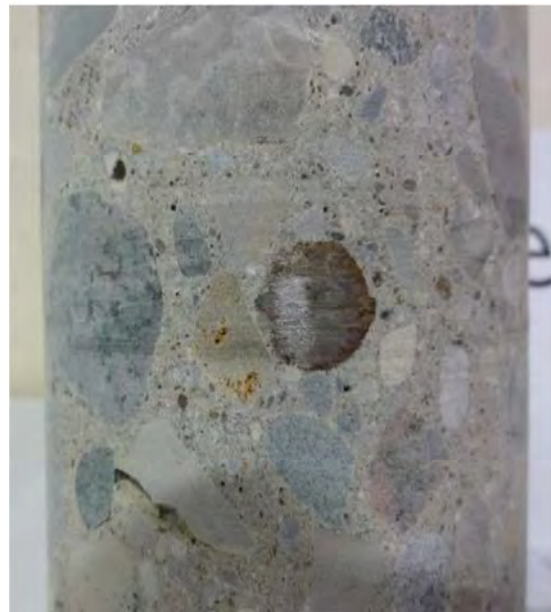
(b) Rust on the reinforcing steel

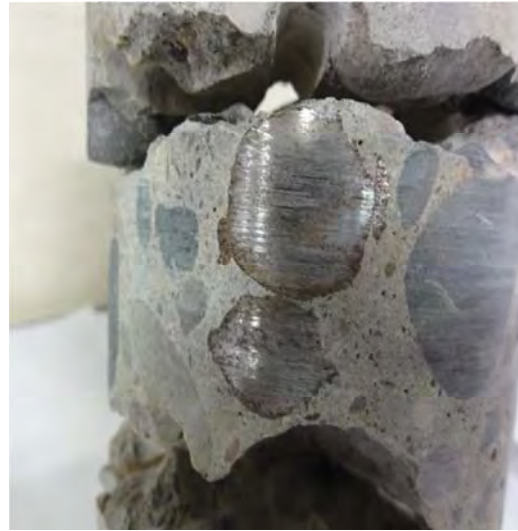
(b) Rust on the reinforcing steel

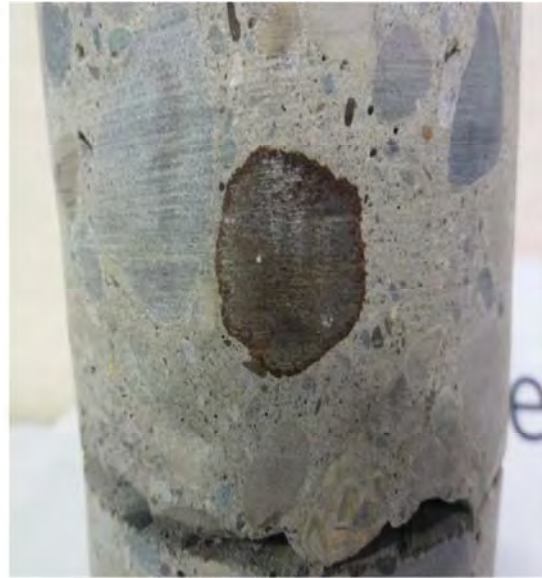
(b) Rust on the reinforcing steel

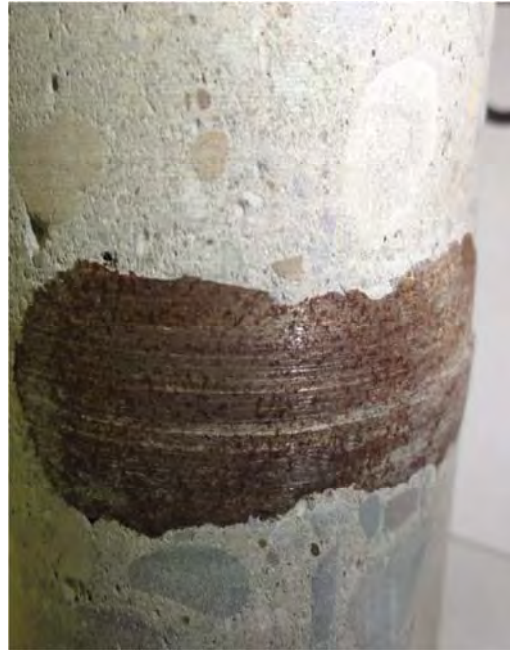
(b) Rust on the reinforcing steel

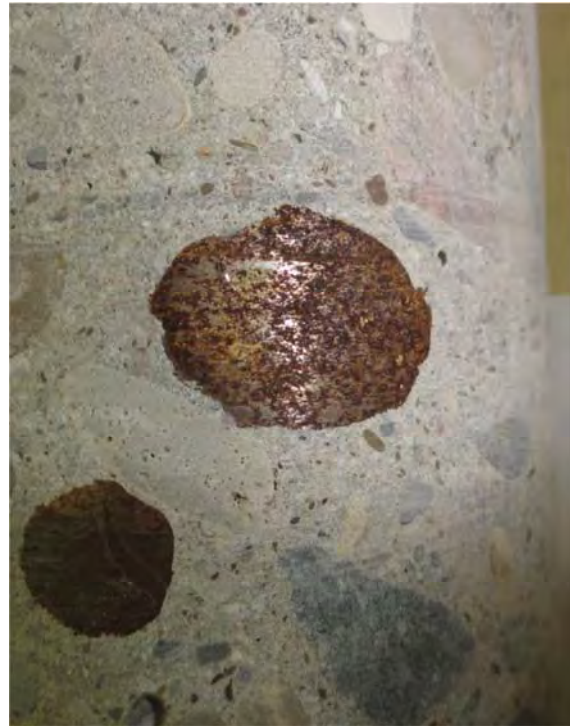
(b) Rust on the reinforcing steel

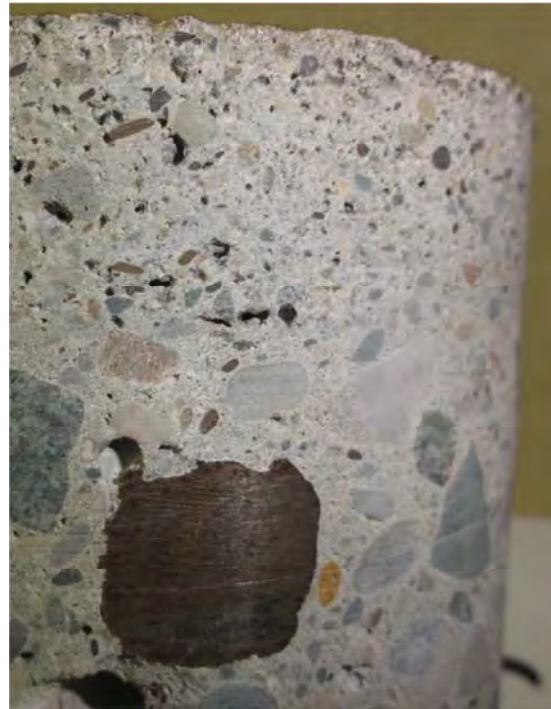
(b) Rust on the reinforcing steel

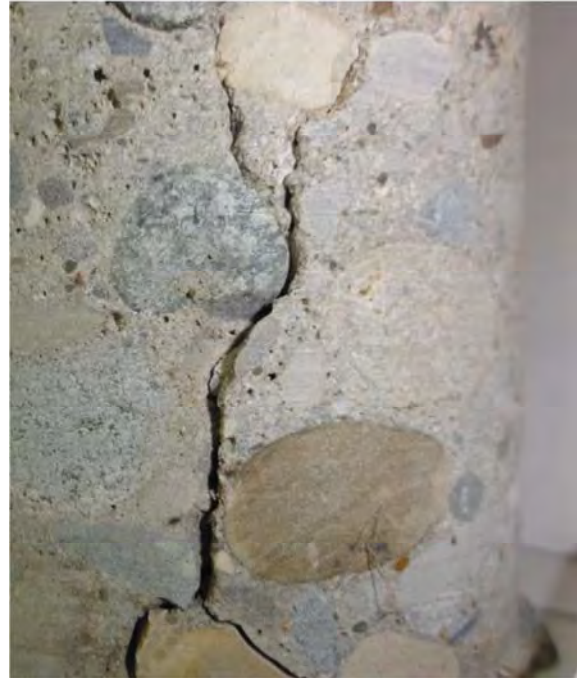
(b) Cracks on the core propagating from bottom surface to mid height

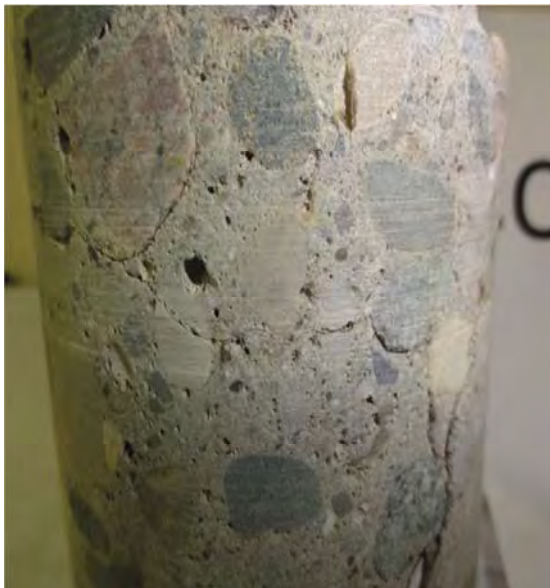
(c) Cracks on core propagating from bottom to mid height

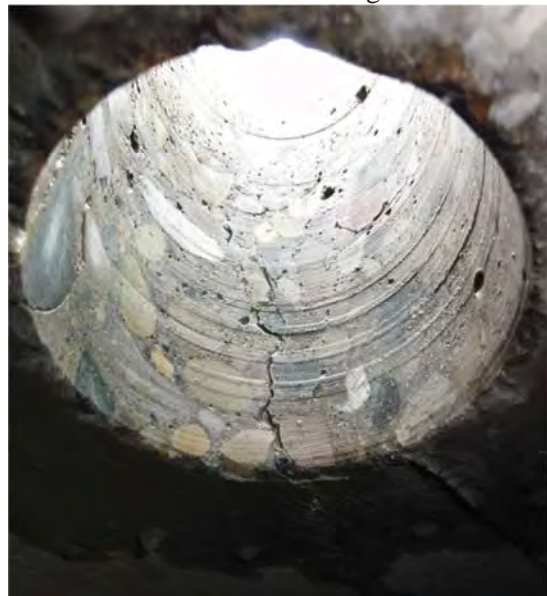
(d) Crack on deck propagating from bottom surface to mid depth

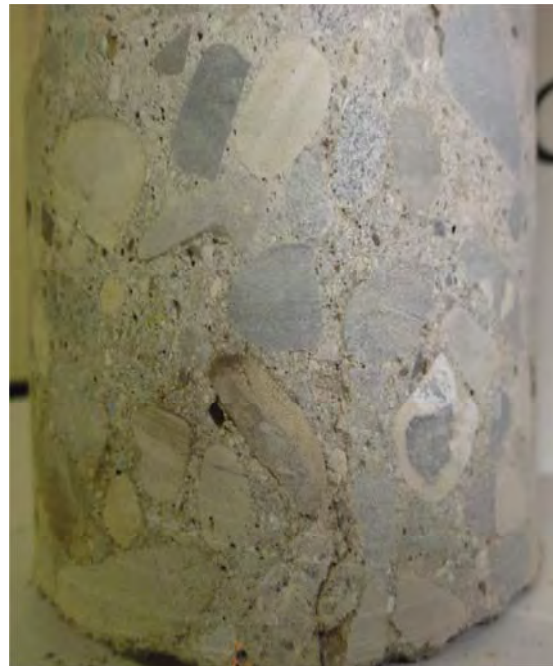
(b) Cracks on the core propagating from bottom surface

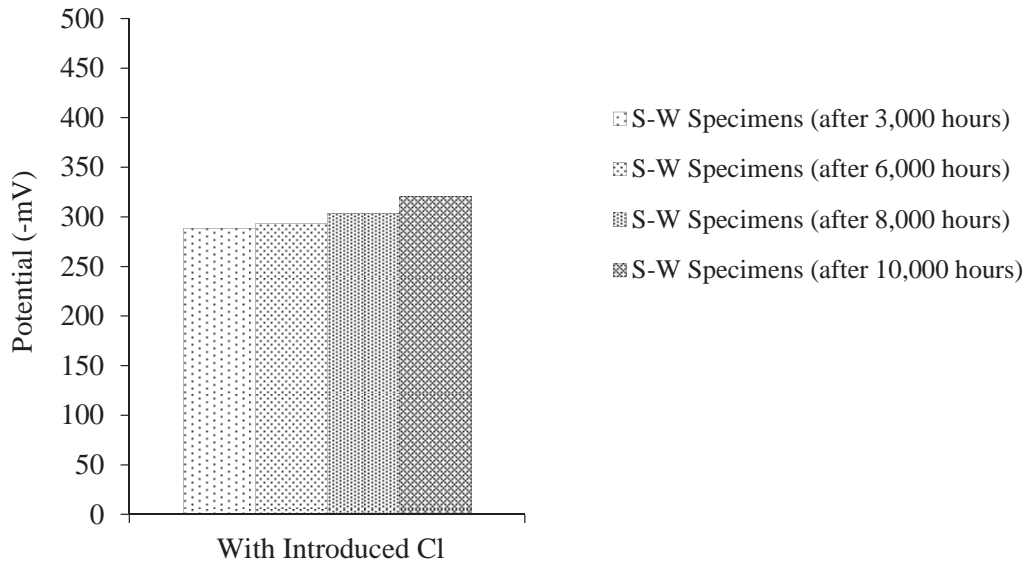
Figure 5-7 Half-cell potential values for saltwater exposed specimens

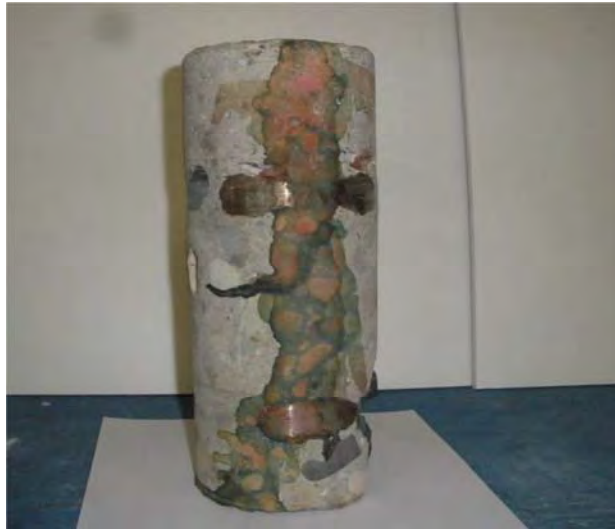
Figure 6-7 63174-S05-1 carrying I-75 NB over 14 Mile Road core exposed to Rainbow Indicator

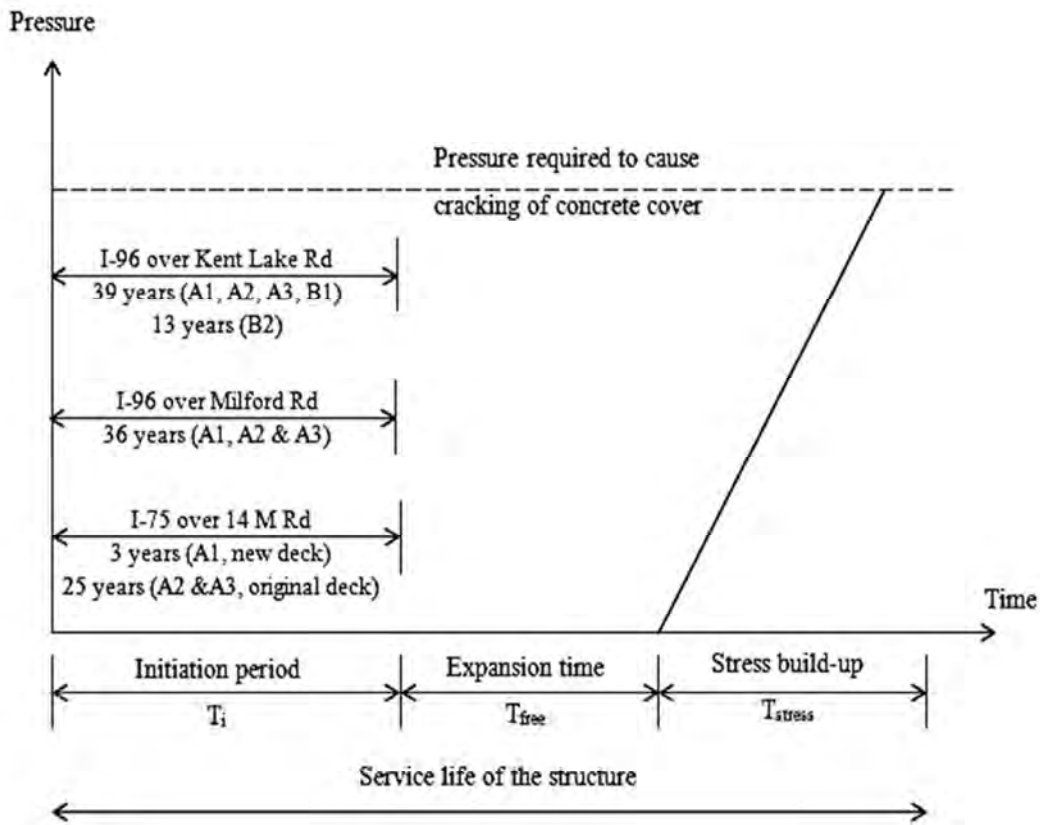
Figure 7-2 Summary of corrosion initiation time of the investigated bridges

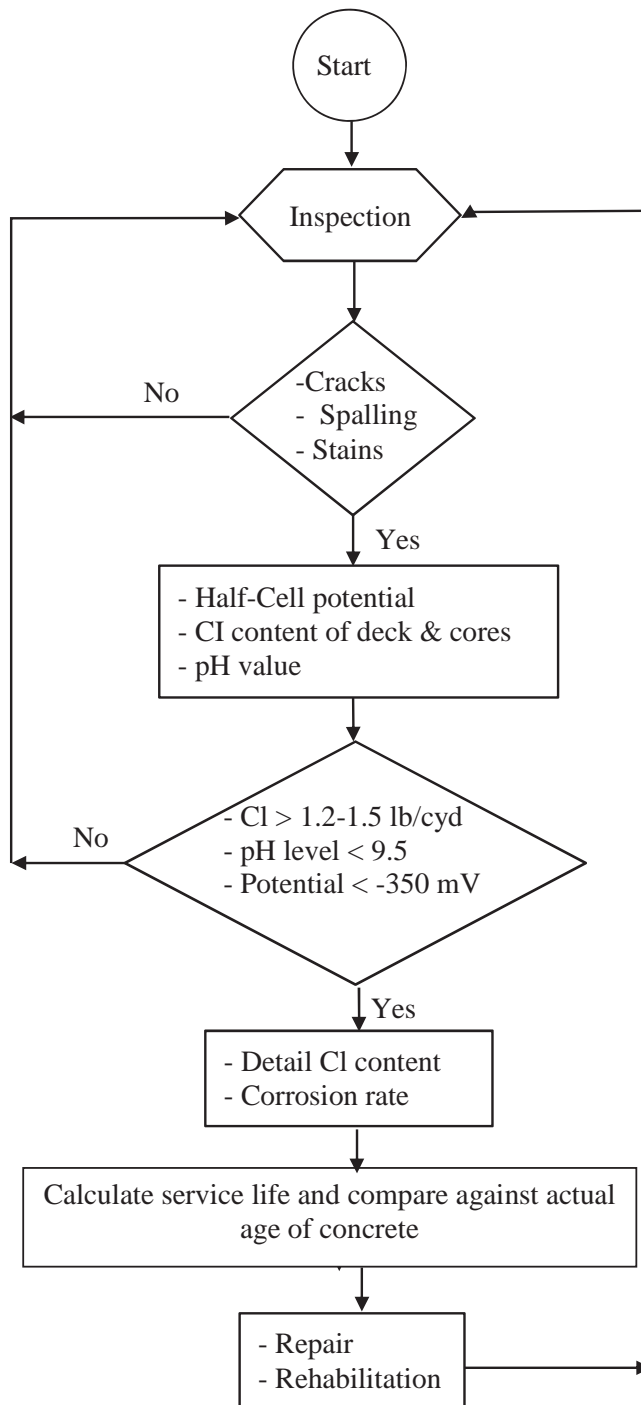
Figure 7-6 Flow chart of the recommended procedure
