MACHINE FINISHING OF BRIDGE B01 of 11016
I 94 over the St. Joseph River

Research Laboratory Division
Office of Testing and Research
Research Project 60 F-57
Report No. 373

Michigan State Highway Department
John C. Mackie, Commissioner
Lansing, March 1962

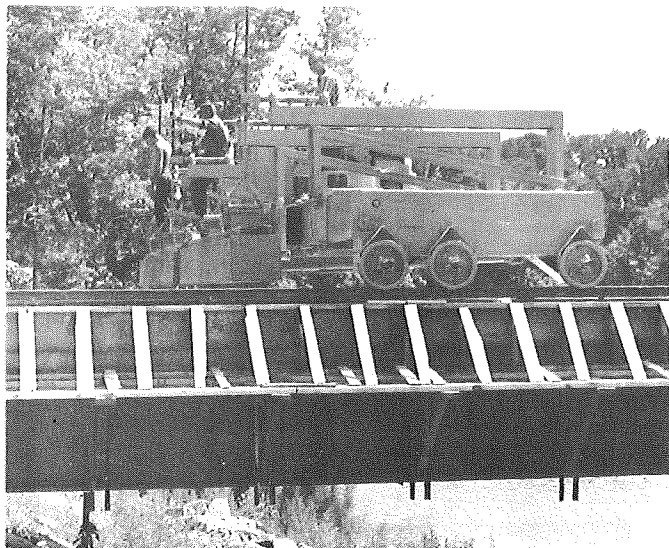
Bridge finishing machine (above).

Pipe sleeves welded to fascia stringer (right).

Threaded pipe and machine rail support.

Figure 4. Finishing machine and support rail.

The finishing machine used was manufactured by the construction machinery division of the Chain Belt Co. (Fig. 4). It weighs 18,000 lb and is supported at each side by three wheels spaced at 3 ft 7 in. and 1 ft 10 in. This machine has a variable width frame and a single oscillating screed 16 in. wide with a maximum lateral screed displacement of 5 in.

The rails on which the machine rode were supported every 4.5 ft on pipes threaded into sleeves welded to the top flanges of the two fascia stringers. These pipe posts were covered with bituminous wrapping paper to facilitate their removal and re-use after a pouring sequence was finished. The sleeves and completed rail support are also shown in Fig. 4. Stay-in-place corrugated steel forms were also used in construction, welded to the stringers and remaining as permanent parts of the structure. These forms and the deck reinforcement are shown prior to pouring in Fig. 5.

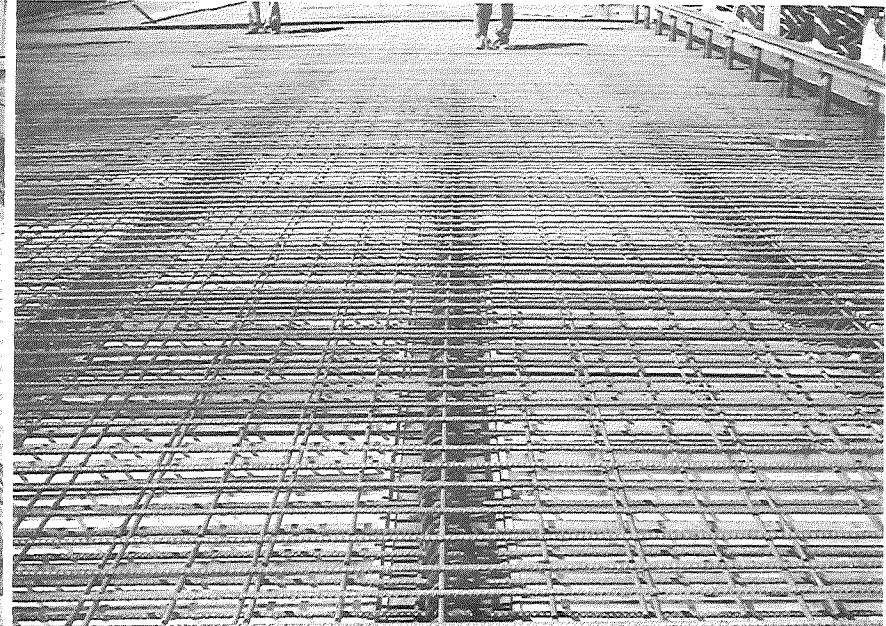
▲ Figure 5. Stay-in-place corrugated metal forms (top left) and deck reinforcement with spiral shear developers (top right).

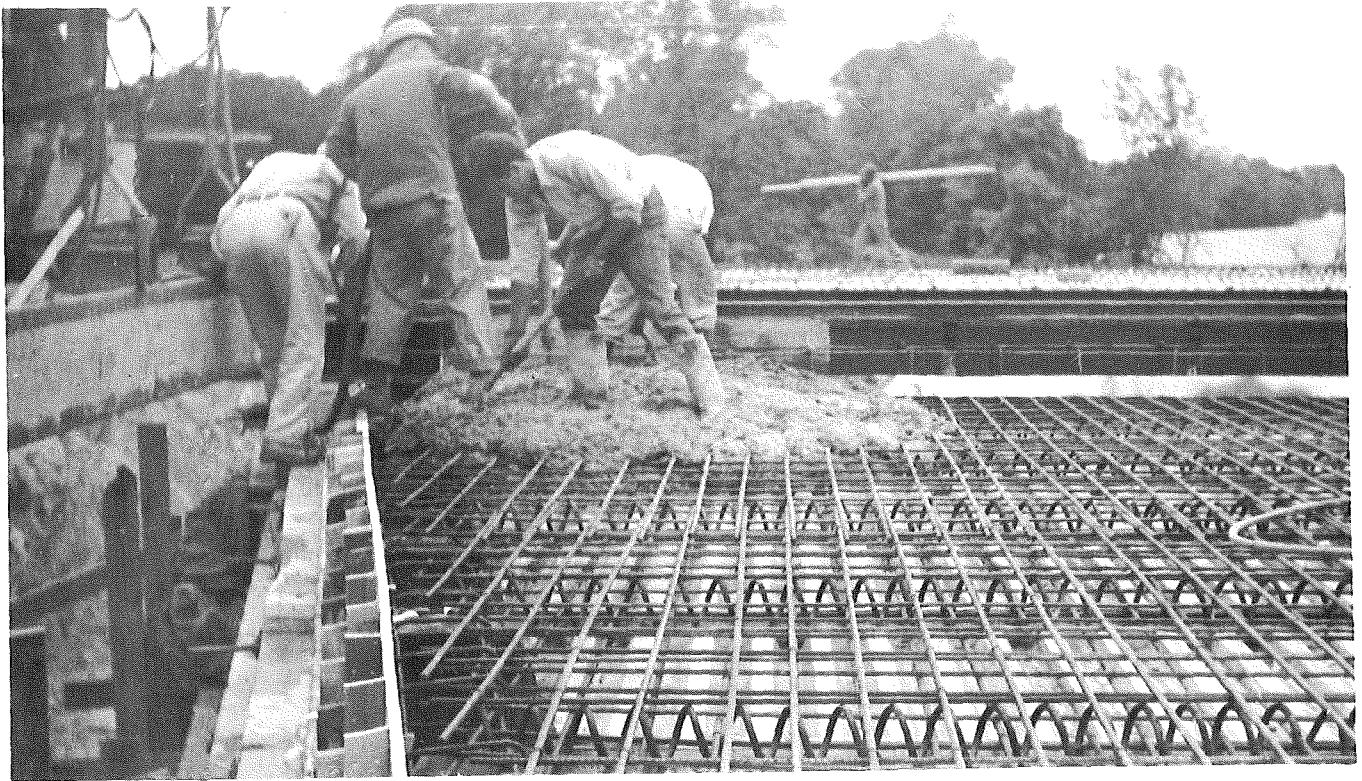
Figure 7. Placing concrete on Span 1.

The work crew required for the finishing operation consisted of a machine operator, two hand-finishers, two concrete muckers, and a vibrator man. The entire width of roadway was finished in one operation, utilizing the machine for the center 30 ft of the deck, and hand-finishing for the slab portions under the sidewalks. Placing and finishing operations are shown in Figs. 7, 8, and 9. This type of construction, of course, eliminated the longitudinal centerline bulkhead and construction joint which would ordinarily have been required. The average rate of pour was about 30 cu yd per hr, corresponding to approximately 30 lin ft per hr. The longest continuous pouring sequence was 168 ft, and the shortest was 64 ft.

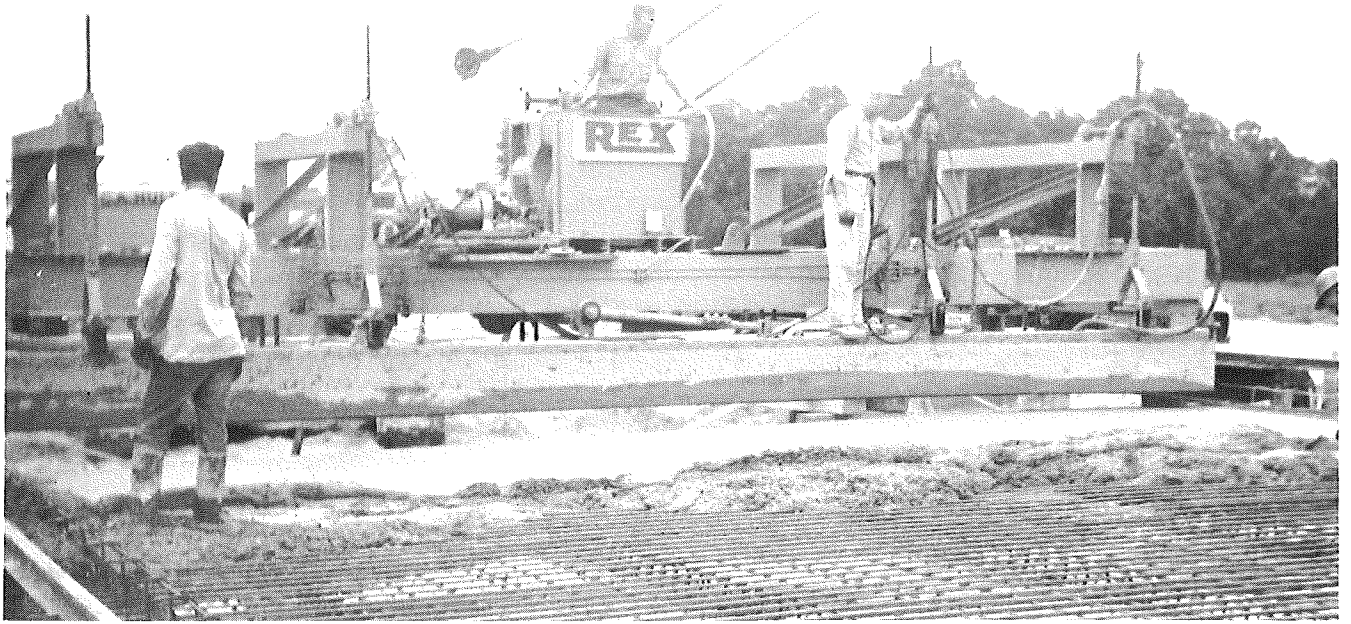
Figure 8. Finishing machine in operation on Span 1.

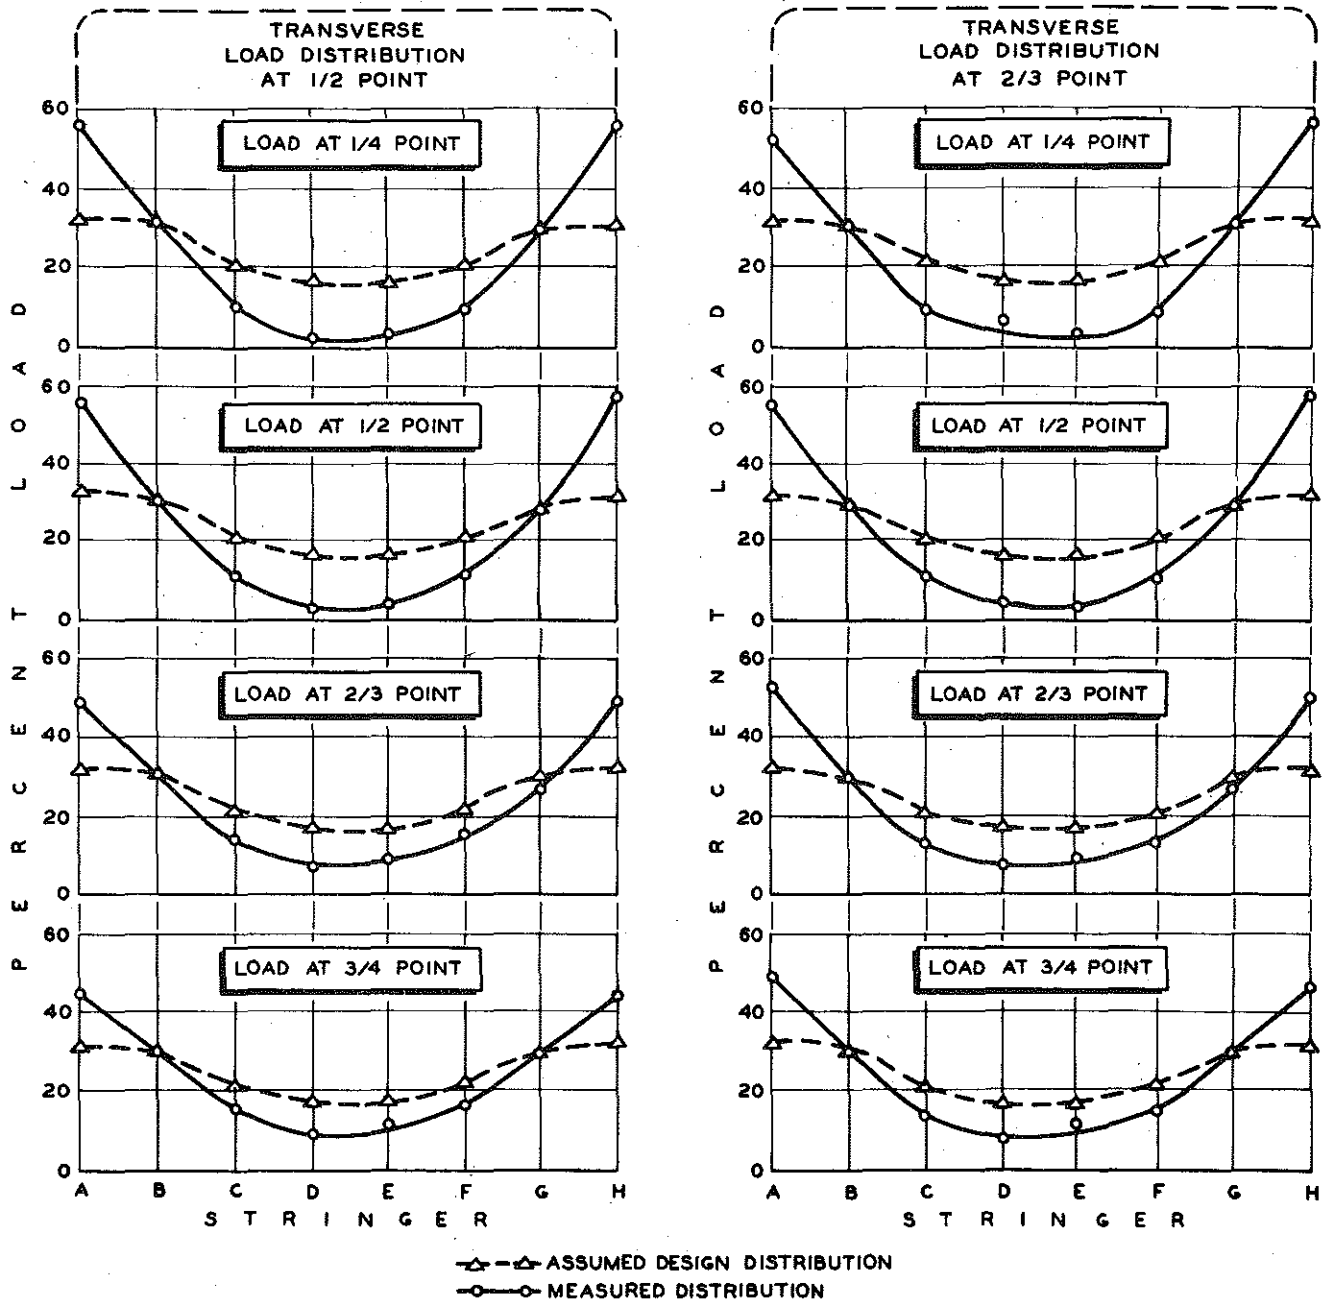
Figure 11. Assumed and measured transverse load distributions for four machine positions on Span 8.

The percent load distributions of the finishing machine on Span 8, at the center and two-thirds points, are plotted in Fig. 11. The diaphragm connections between stringers were at the one-third points of this span. The same graphs also show the analytical load distributions, for the different machine load positions, as determined by the bridge consultants. Average measured stringer load distribution with the machine at each of the four points on each fascia stringer was as follows: 53 percent to the fascia stringer, 29 percent to the next adjacent stringer, 12 percent to the next, and 6 percent to the center, where the design distributions as presumed by the bridge consultants were 32, 30, 21, and 17 percent, respectively. Average maximum fascia stringer deflection was found to be 0.26 in.

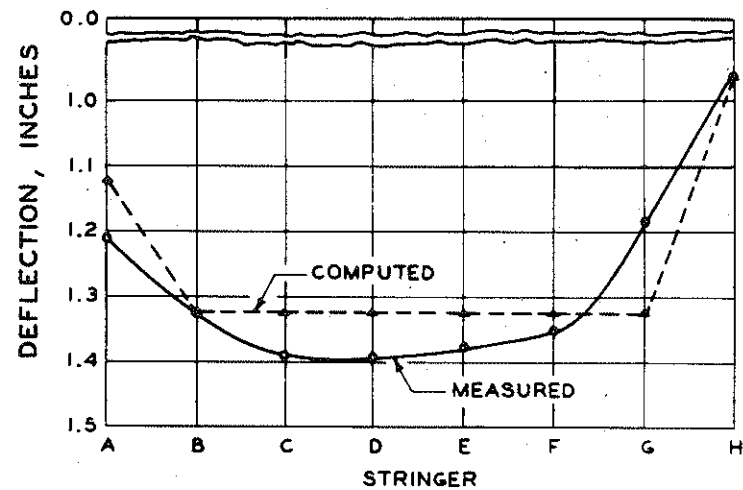
Figure 17. Computed and measured dead load deflection at half-point of Span 2, with deck completed on both Spans 2 and 3.
