MICHIGAN TEST ON ROLLED BEAM BRIDGE  
USING H20-S16 LOADING

G. M. Foster, Chief Deputy Commissioner

Highway Research Project 47 F-14

Research Laboratory  
Testing and Research Division  
Report No. 166  
December, 1951

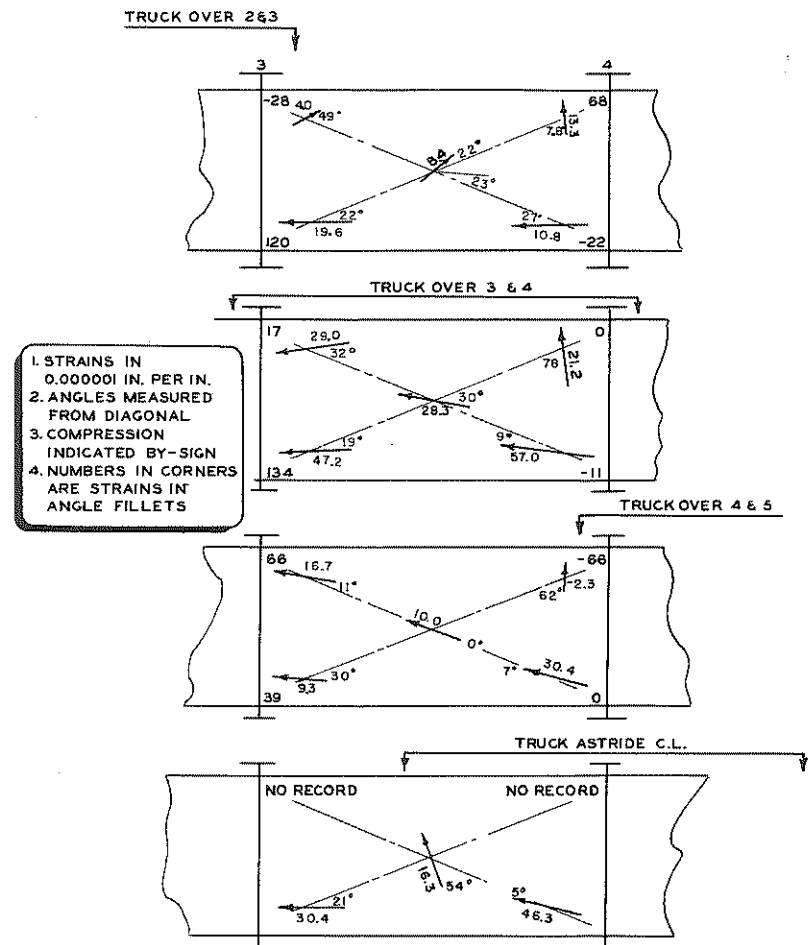
FIGURE 24  
STRAINS IN DIAPHRAGM 4

GAGE LAYOUT FOR DIAPHRAGM 4

Computations of principal strain magnitudes and directions from the readings of the rosette gages gave the results which are shown schematically in Figures 23 and 24. Most of the values on the diaphragm webs are small, although in the case of the diaphragm connecting Beams 3 and 4, a resulting strain of 86 micro-inches per inch was found. In Figure 24, the largest value shown is 57 micro-inches per inch. In terms of steel with a modulus of elasticity of 30 million psi., these strains indicate stresses of 2580 psi. and 1710 psi. respectively.
