REPORT ON TEN-YEAR SERVICE OF EXPERIMENTAL  
CONTINUOUSLY REINFORCED CONCRETE PAVEMENT  
IN MICHIGAN

J. E. Simonsen  
G. R. Cudney

Research Laboratory Section  
Testing and Research Division  
Research Project 57 F-46  
Research Report No. R-771

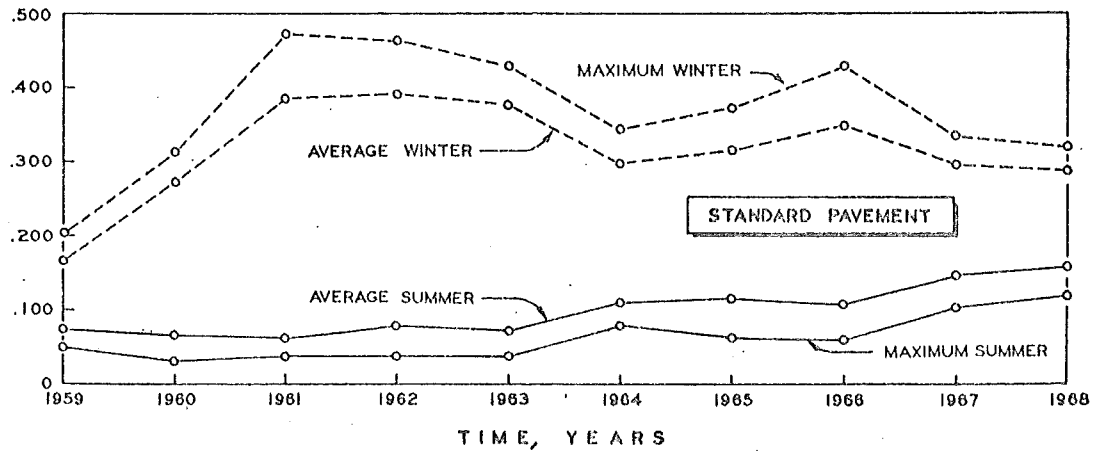
Figure 15. Contraction joint width variation data (standard pavement).

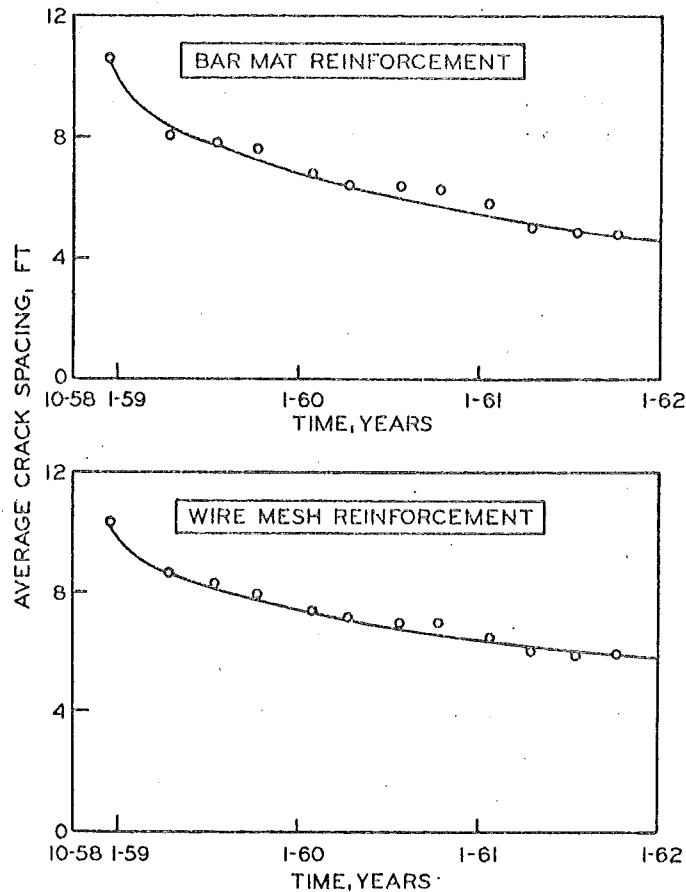
Figure 16. Average crack spacing in bar mat and wire mesh reinforced sections.

From the time of construction in 1958 through 1961, quarterly surveys of crack spacing for the full-width pavement were conducted in six daily pour sections reinforced with bar mat and in seven daily pour sections of wire mesh reinforcement. Since the crack spacing at an unrestrained end of a continuously reinforced pavement does not represent the spacing in restrained pavements a 300-ft length of pavement at these ends was deleted from the survey in all pour ends adjacent to a relief section. The results of these surveys, shown in Figure 16, illustrate the relationship between average crack spacing and pavement age for both types of reinforcement. During this time interval the average crack spacings for both sections decreased slowly with time with a consistently shorter interval in the bar mat

reinforced sections. In the fall of 1958 the average crack spacing in the bar mat reinforced sections was 10.5 ft and in late 1961, 4.8 ft. In the mesh reinforced sections, the average crack spacing interval for the same dates was 10.3 and 5.9 ft, respectively. It is evident from Table 3 and Figure 16 that the average crack spacing decreases rapidly during the first few months and then proceeds to decrease at a much slower rate from then on.

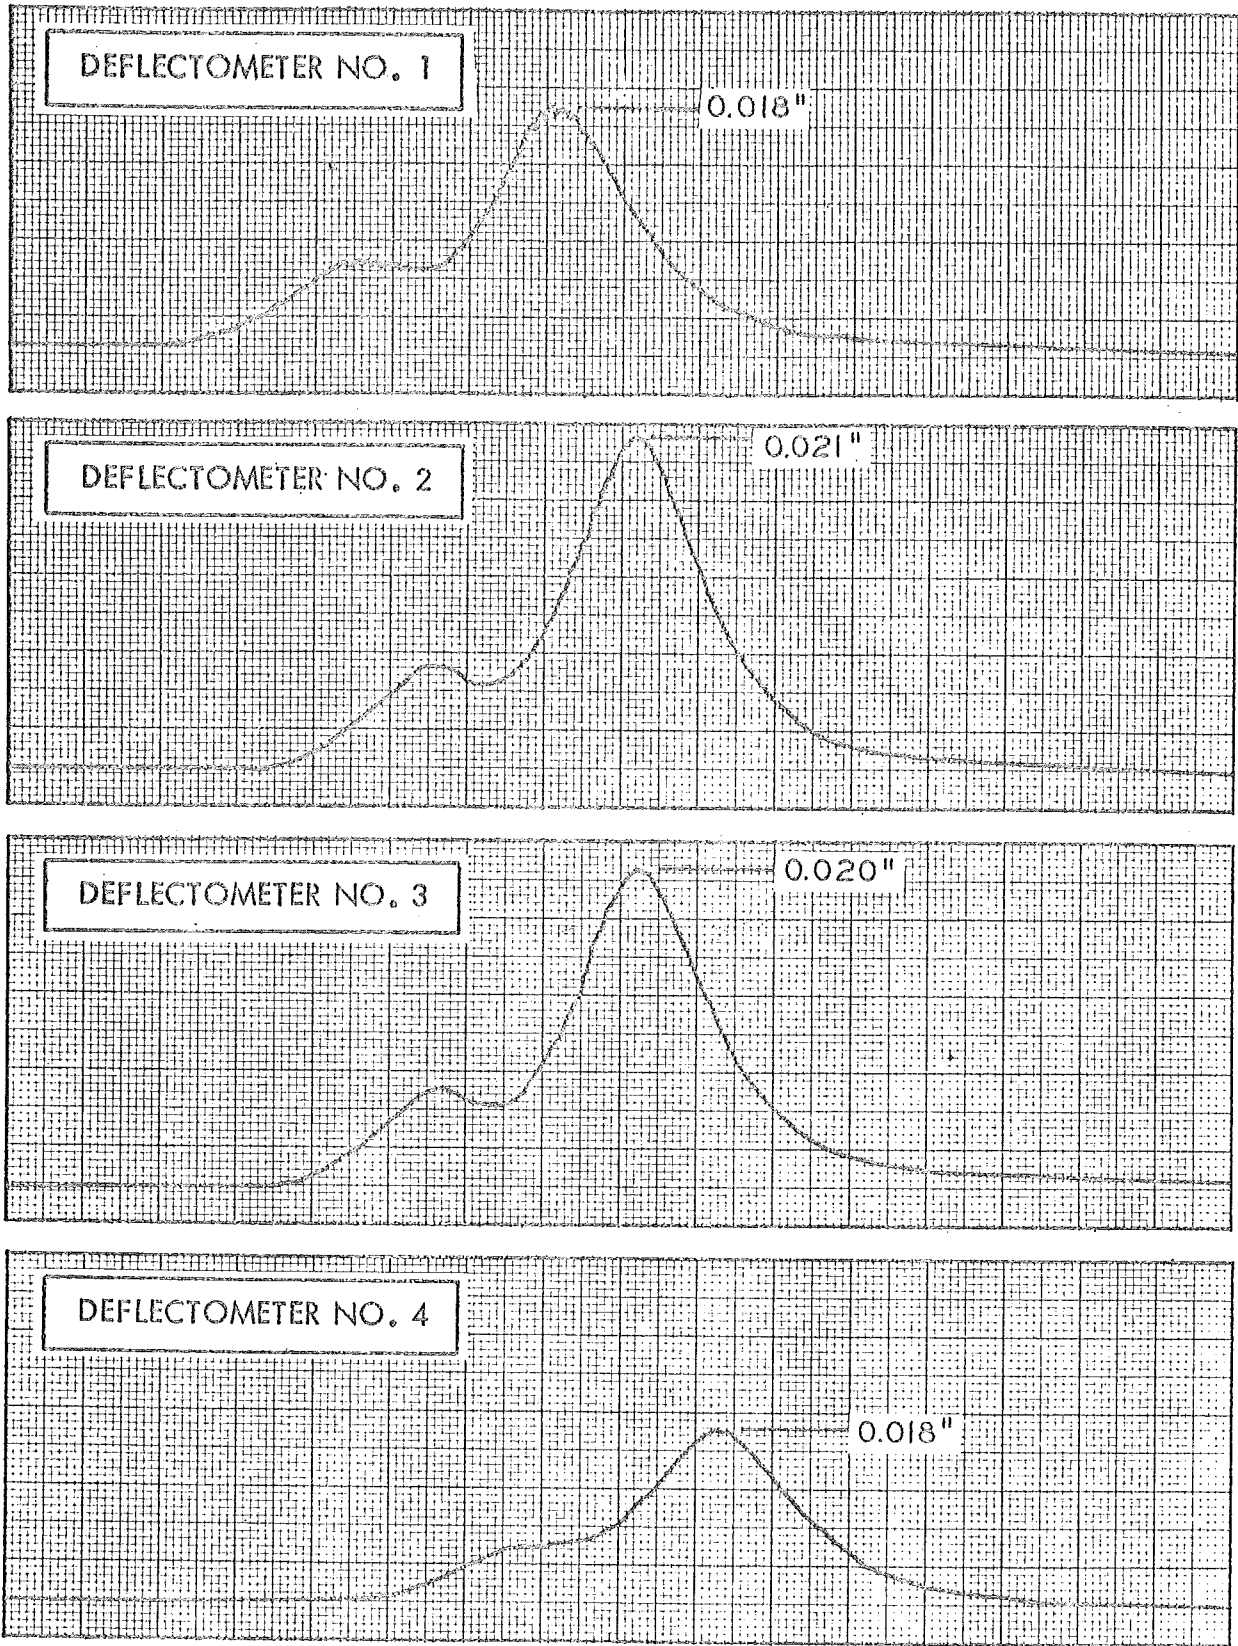
Figure 44. Deflection Test No. 2, Test Area No. 3.
