**CAUSES & CURES FOR CRACKING OF
CONCRETE BARRIERS**

August 2004

Center for Structural Durability
Michigan DOT Center of Excellence

1. Report No. Research Report RC-1448	2. Government Accession No.	3. MDOT Project Manager John F. Staton, P.E.	
4. Title and Subtitle Causes and cures for cracking of concrete barriers		5. Report Date August 2004

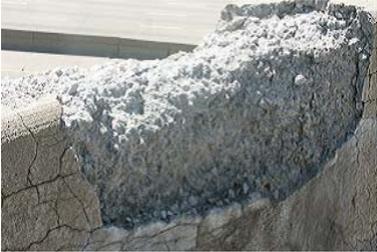
Distress Type	Description	
Spall or Disintegration	A fragment, usually in the shape of a flake, detached from a larger mass; a small spall shape is roughly circular or oval or in some cases elongated, is more than 0.8 in. in depth and 6 in. in greatest dimension.

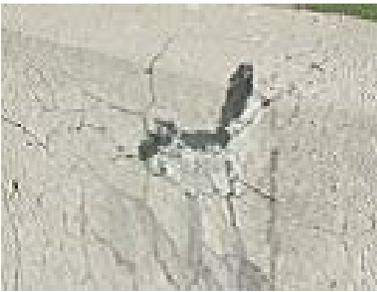
Delamination	A separation along a plane parallel to a surface.

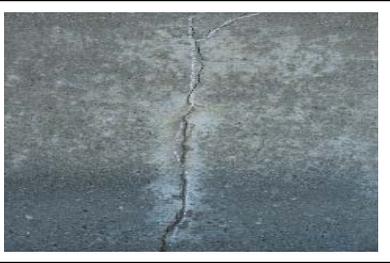
Efflorescence	A deposit of salts, usually white, formed on a surface, the substance having emerged in solution from within concrete and subsequently been precipitated by evaporation.

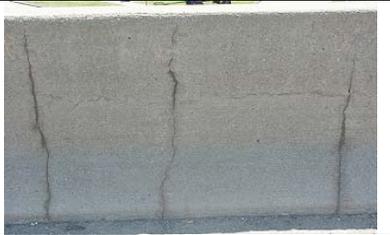
Vertical Cracking	Cracks that develop at right angles to the longitudinal direction of the member. Also referred to as transverse cracking.

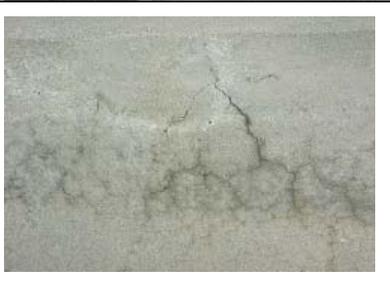
Map Cracking	Intersecting cracks that are near the concrete surface.

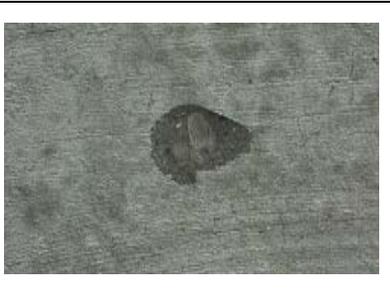
Popouts	The breaking away of small portions of a concrete surface which leaves a shallow, typically conical, depression; small popouts leave holes up to 0.4 in. in diameter, medium popouts leave holes 0.4 to 2 in. in diameter, large popouts leave holes greater than 2 in. in diameter.

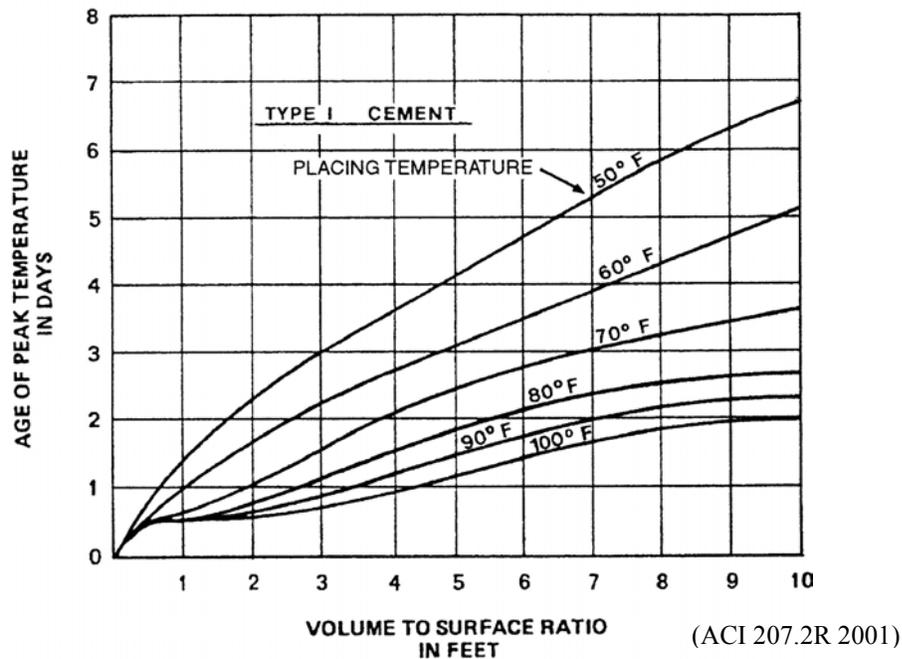
Figure 2-1. Effect of concrete placing temperature and volume to surface (exposed to environment) ratio on age at peak temperature for Type 1 cement

forming the barrier and the ambient air. After determining the peak temperature from Figure 2-1, Figure 2-2 can be used to compute the percent absorbed or dissipated heat between placing and ambient temperature.

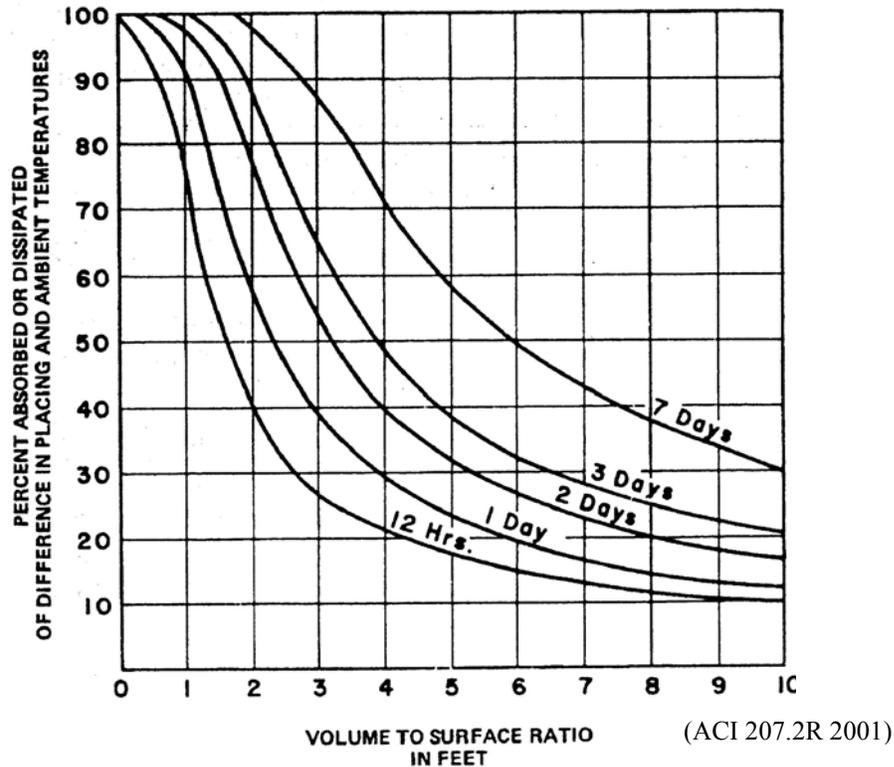
Figure 2-2. The effect of volume to surface ratio and age at peak temperature on percent absorbed or dissipated of difference in placing and ambient temperature

New Jersey bridge barrier geometry gives a volume to exposed-surface ratio (V/S) of 0.42 feet. Consequently, from Figure 2-2 the rate of heat absorbed or dissipated approaches 100%. Thus, the effective concrete temperature during placement approaches ambient temperature. Concrete temperature during placement is also a parameter for adiabatic temperature rise (Figure 2-3). The temperature rise within the concrete barrier also depends on the exposed barrier surface condition. As depicted in Figure 2-4, if the exposed concrete surface is kept wet, the temperature rise decreases significantly.

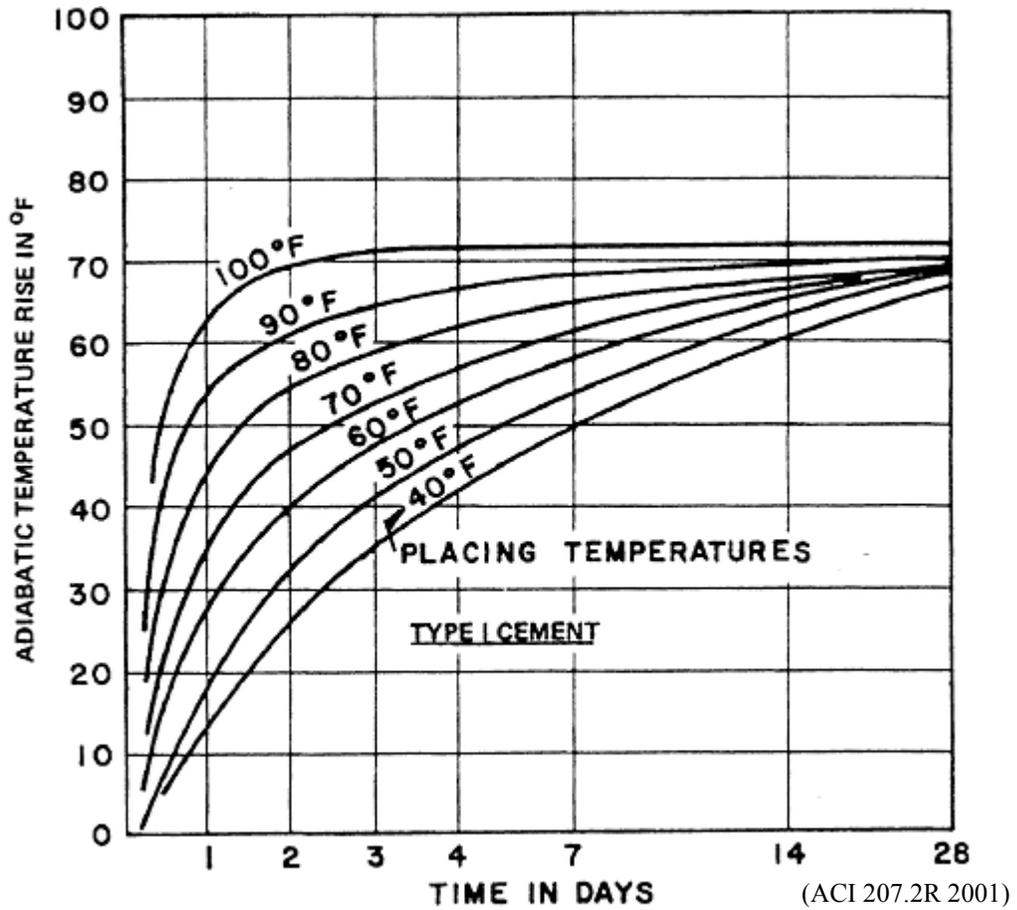
Figure 2-3. Effects of placement temperature on adiabatic temperature rise

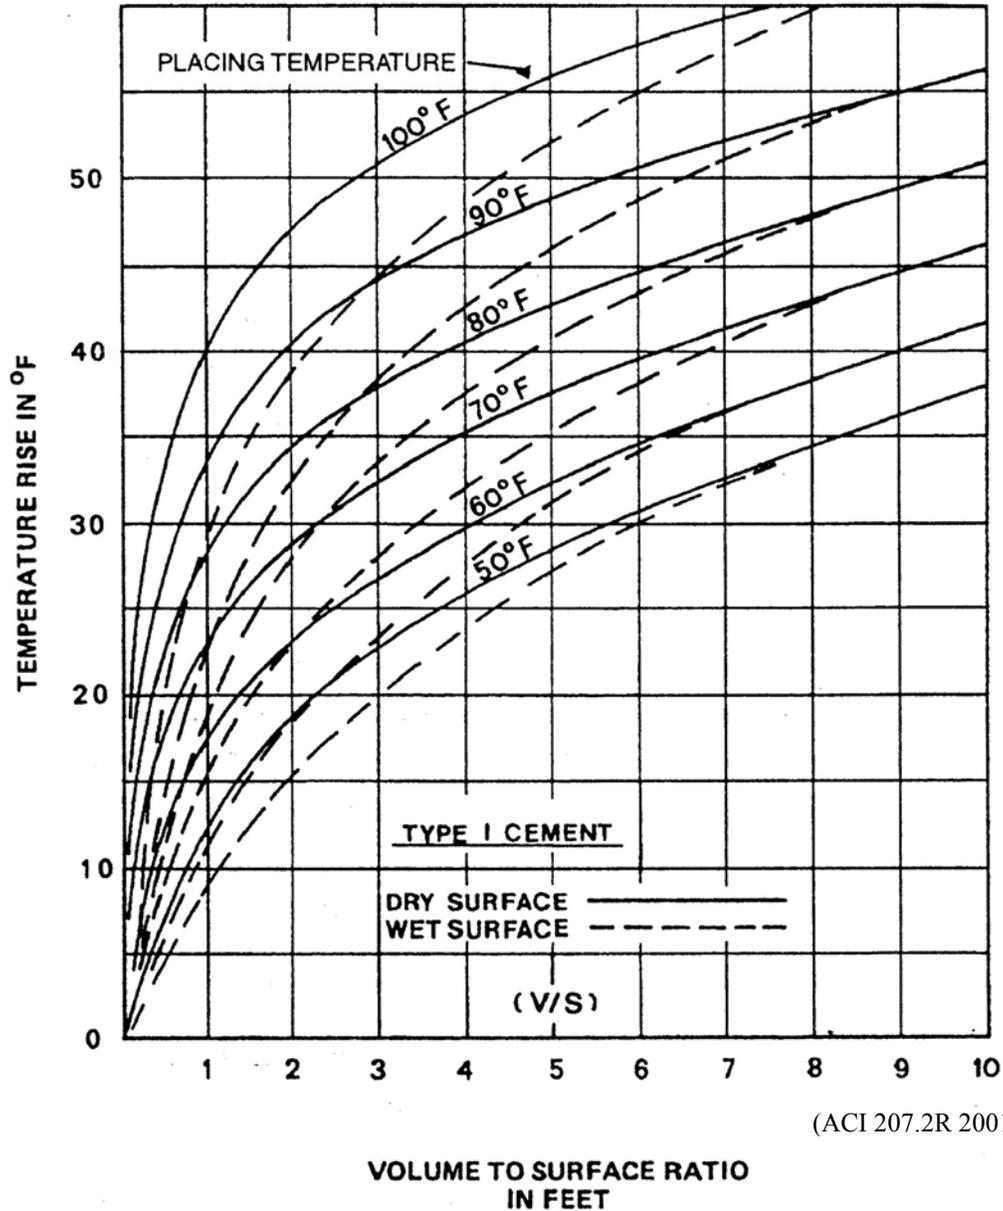
Figure 2-4. The effect of volume to surface ratio and exposed surface condition on temperature rise of concrete members (376 lb/yd³)

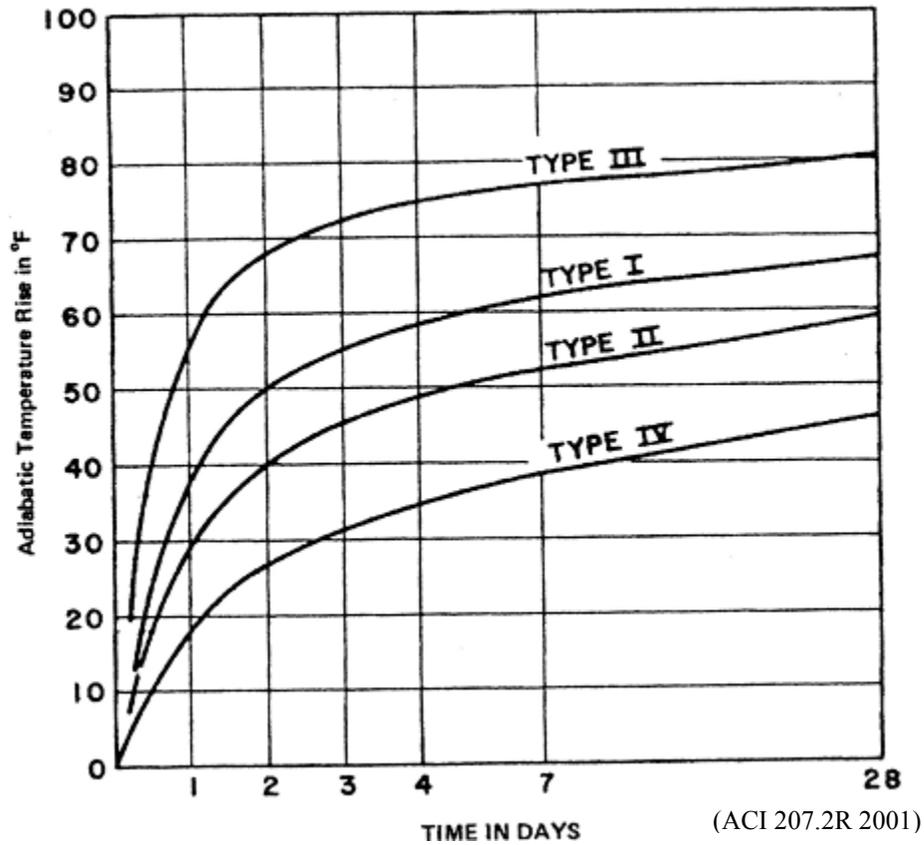
Figure 2-5. Variation of adiabatic temperature rise with age of concrete for different types of cements

Cement type, content, and its fineness affect the adiabatic temperature rise in a concrete component. Figure 2-5 shows the adiabatic temperature rise for different cement types. In developing Figure 2-5, cement types and the respective average fineness given in Table 2-9 were used. For cements with different finenesses, Figure 2-6 can be used to calculate the correction factors. In summary, the maximum amount of heat generated in concrete is directly proportional to the amount of cement in the concrete mix.

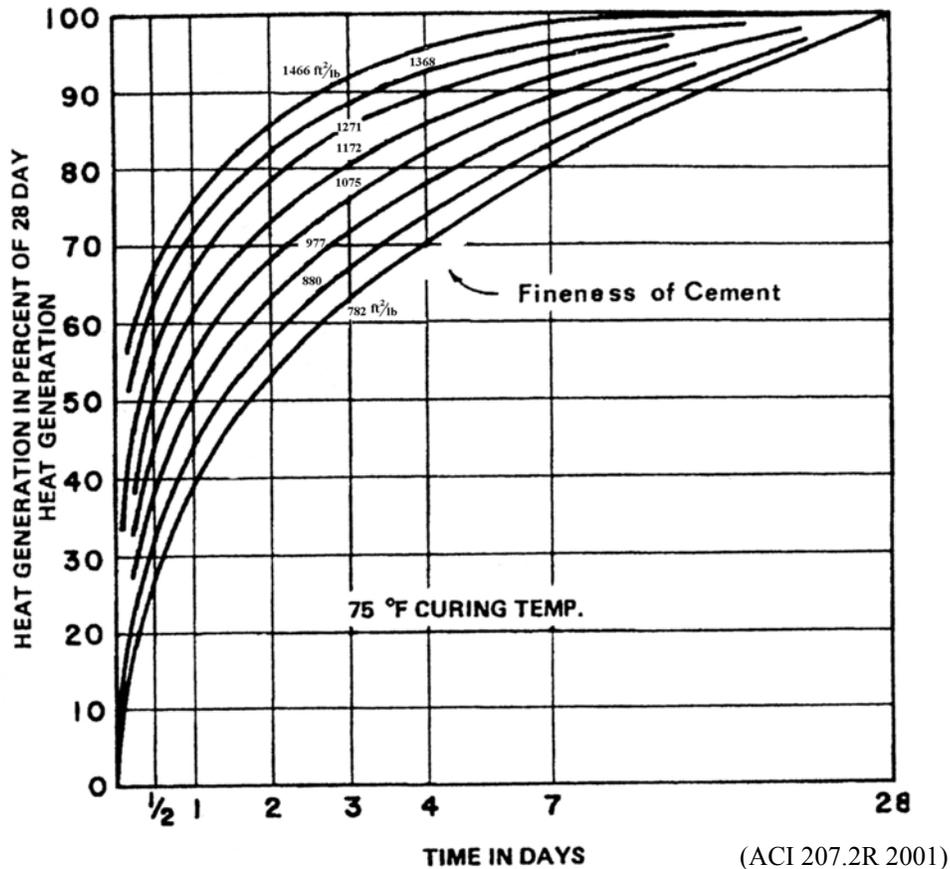
Figure 2-6. Effects of cement fineness on heat generation

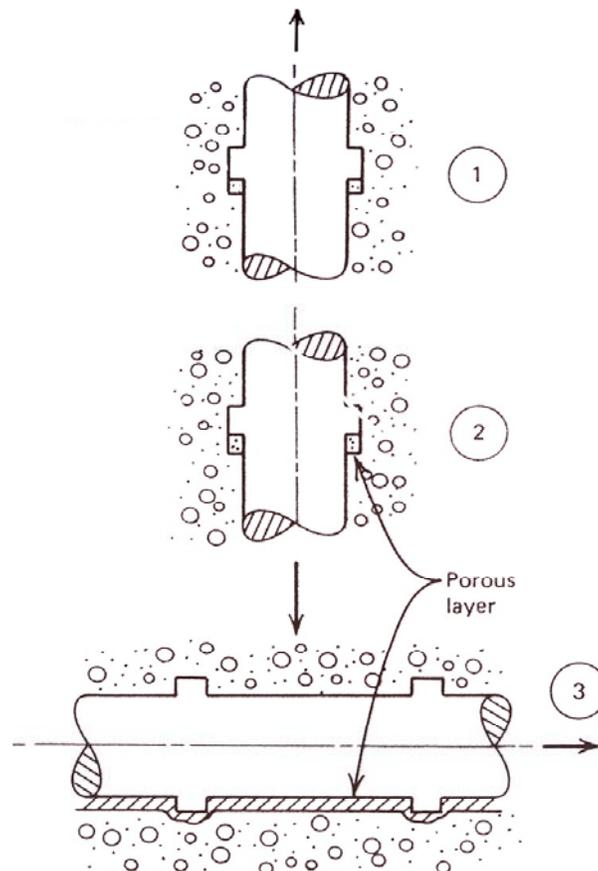
Figure 2-7. The porous layer under the ribs and the rebar upon concrete placement

In addition to shrinkage and thermal cracking of extruded concrete during first few days, bleeding of mix water during the first two or three hours after placement causes plastic shrinkage of newly placed concrete, leading to premature cracking if constrained. For barriers, the plastic shrinkage may be quite large. These cracks may exhibit some regular pattern (RILEM-42-CEA 1981).

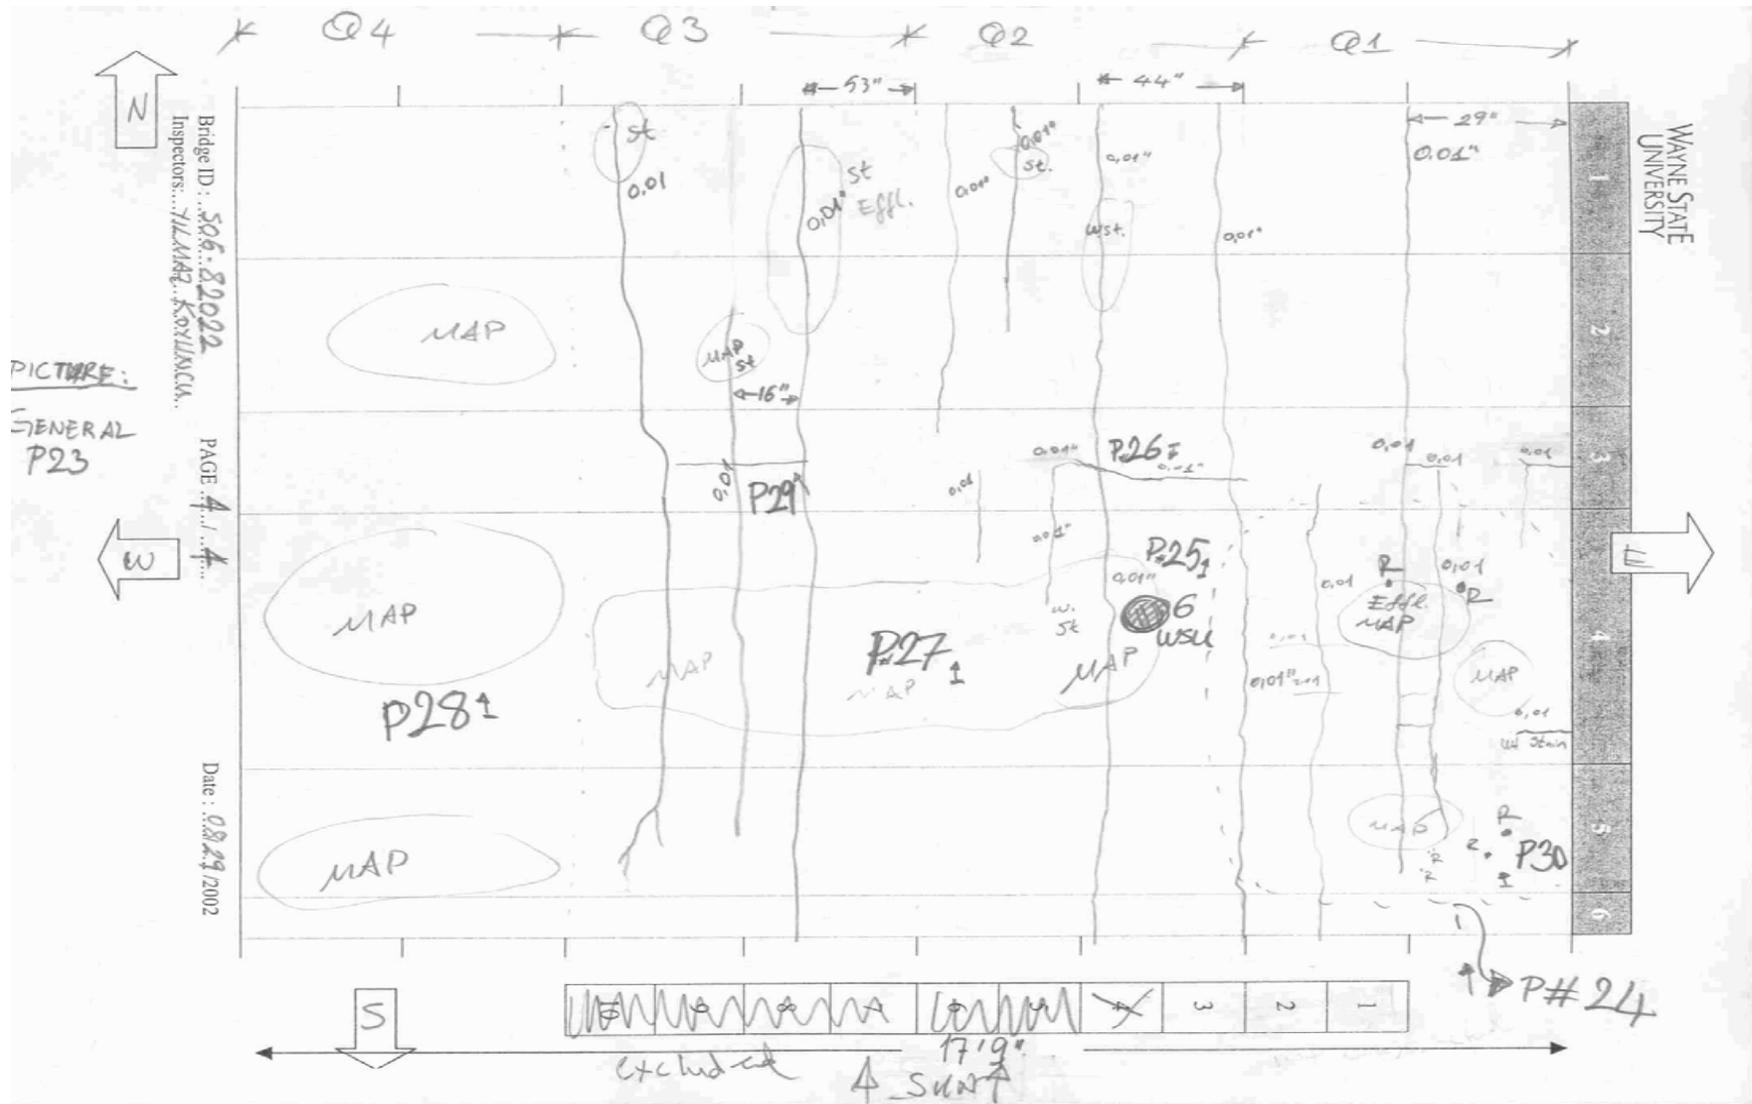
Figure 4-1. Barrier inspection template (S06-82022)

Bridges with New Jersey barriers and shoulders wider than 12 feet were selected for inspection. This provided the inspection crew with a safe and workable area without any need for lane closure. Topology of segments and all visible distresses were recorded with regard to their location, width, and dimensions. A general bridge view and data was also collected for each bridge.

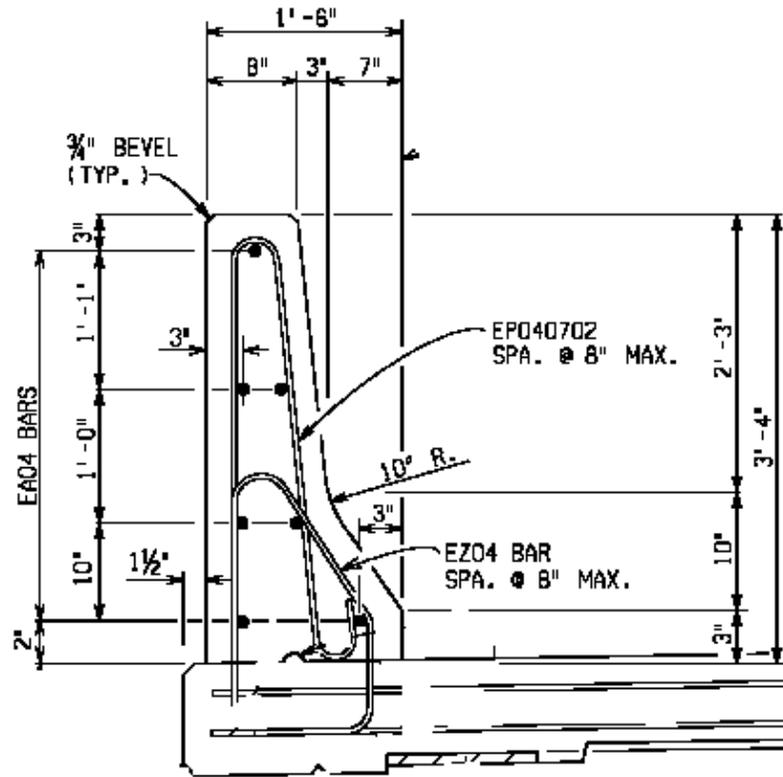
Figure 5-1. Cross-section of New Jersey Type 4 bridge barrier railing

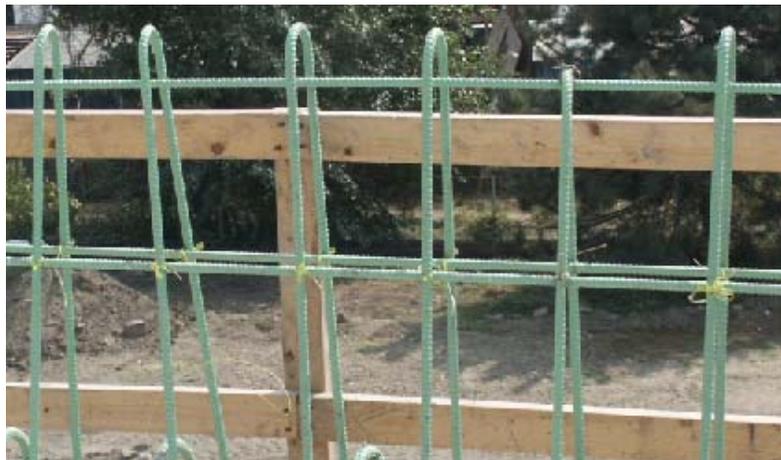
Photo 5-1. Reinforcement ties missing at some rebar intersections (bridge S06-82194)

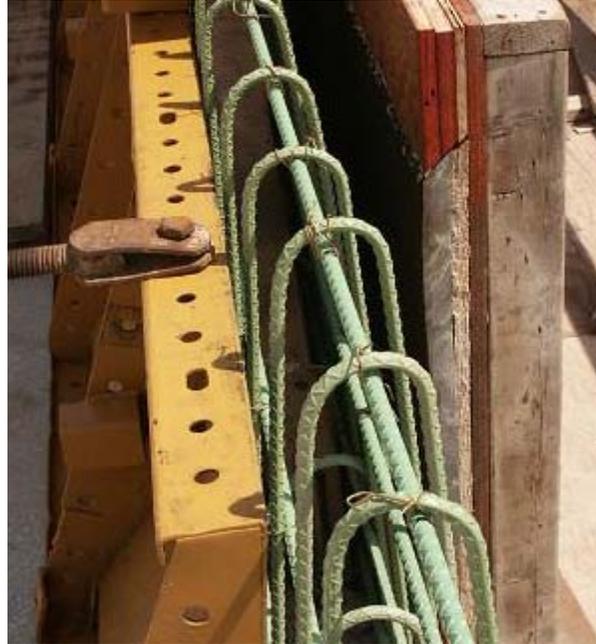
Photo 5-2. Formwork of barriers of bridge S05–82191

The day before the concrete placement, sites were visited to check the formwork and reinforcement. Removable forms (steel forms on traffic bearing side and wooden forms on the other side) were used in form-cast barrier construction. Figure 5-1 shows the barrier and reinforcement geometry and the specified reinforcement cover for New Jersey Type 4 barriers. Observations show that the reinforcements were not tied at all intersections as required by the specifications (Photo 5-1). In general, fabrication of reinforcement appeared satisfactory, yet some problems with inconsistent cover for the transverse reinforcement were observed (Photo 5-2).

Molds were placed aligned with the deck edges and spacing equipment was not used. Rebar cover was less than 1 inch at some locations (Photo 5-2). The form interiors were not clean and contained some sawdust, wood chips, and other debris (Photo 5-3). The outer surface of the barrier mold was textured wood and the traffic side was steel (Photo 5-2 and Photo 5-4). Concrete was placed either using a bucket or directly from the mix-truck chute (Photo 5-5 and Photo 5-6). Concrete placement was continuous with no disruptions during placement. A mechanical internal vibrator was used to consolidate concrete (Photo 5-7). Steel bracing fixtures were used for supporting the barrier forms (Photo 5-8). The bracings were cut during form removal, and the braces remained in the hardened concrete.

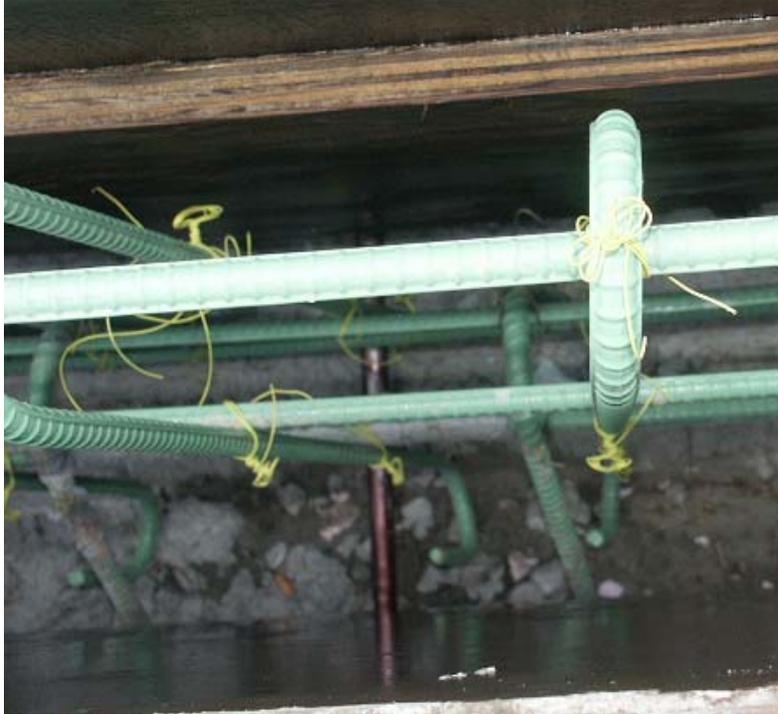
Photo 5-3. Debris inside the forms (S05-82191)

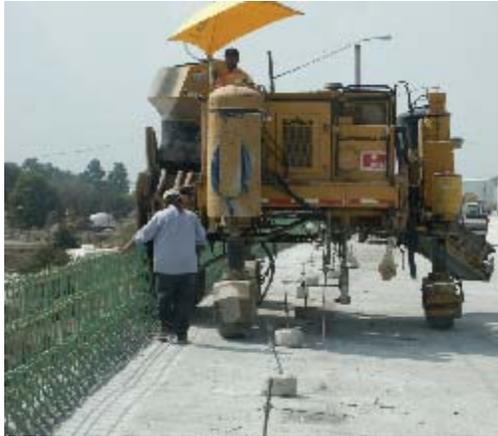
Photo 5-9. Test run of the paver (S06-82194)

Prior to concrete placement, a test run was performed with the paver to adjust the finishing position and to check the reinforcement alignment (Photo 5-9). However, the crew dealt only with the reinforcements that were interfering with the paver path. The reinforcements were realigned by hammering into proper positions (Photo 5-10). After hammering, the potential damage to the epoxy coating were not inspected and repaired. Placement was at a relatively rapid pace considering the low workability of concrete. Vibration was applied externally. The vibration was not sufficient in duration and intensity to consolidate the low slump concrete. Inadequate consolidation observed as rock pockets and cavities and some plastic flow from the molded cross-section were observed. In addition, the surface of the freshly placed concrete was fairly rough and required extensive floating. The required cross-section was achieved by striking as allowed by the Specifications. Final surface finishing was performed with wooden and/or metal floats (Photo 5-11).

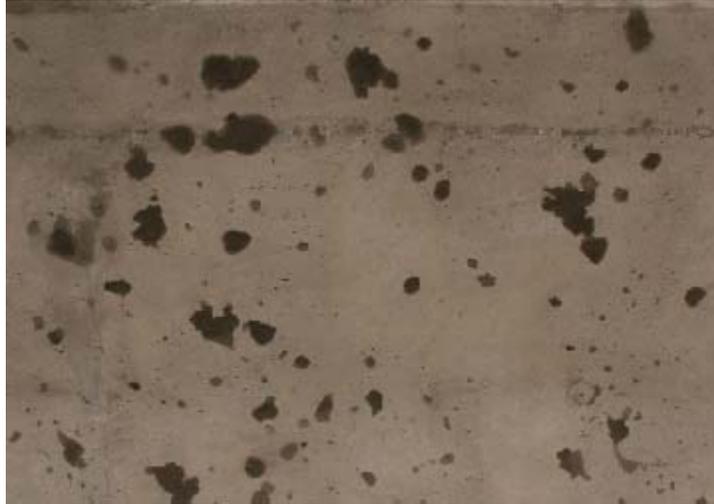
Photo 5-12. Repaired surface voids of form-cast barrier surface (S05-82191)

Forms were removed approximately 18 hours upon concrete placement, even for the late season placement. The surface defects were repaired with a mortar (Photo 5-12). Repair was only performed on the traffic side surface of barrier in order to satisfy MDOT exposed surface regulations. Close inspection of the barrier did not show any vertical, horizontal, map or local cracking upon form removal. The control joints were saw-cut on the traffic side of the barrier (Photo 5-13). Curing compound was not applied anytime during the day after the form removal (Photo 5-14); at that time concrete was exposed to very hot summer temperatures.

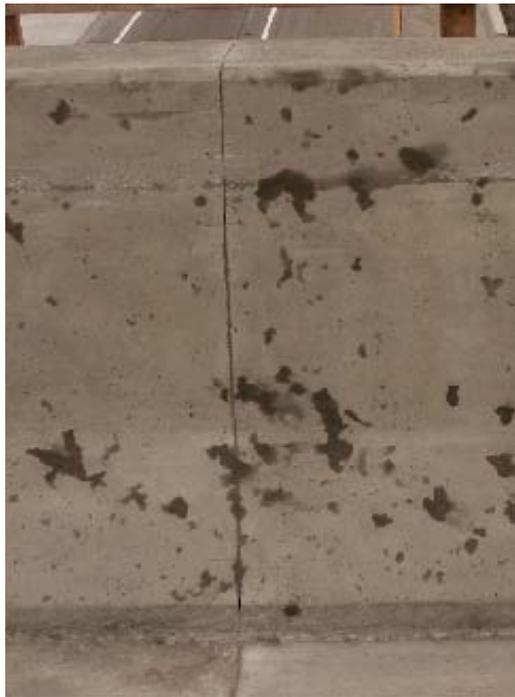
Photo 5-13. Saw-cut joint of a form-cast barrier (S05-82191)

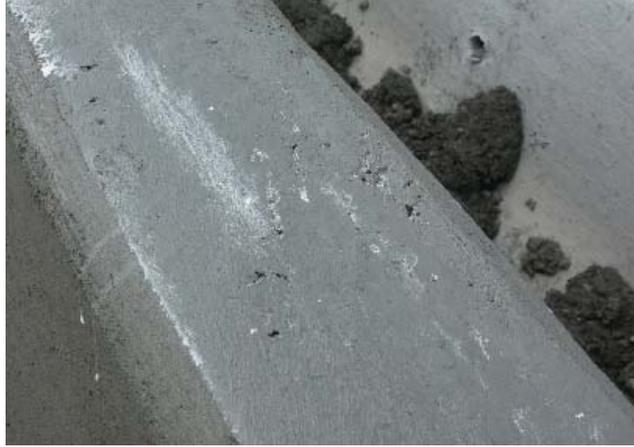
Photo 5-15. Visible surface defects after extrusion in slipformed barriers (S06-82194)

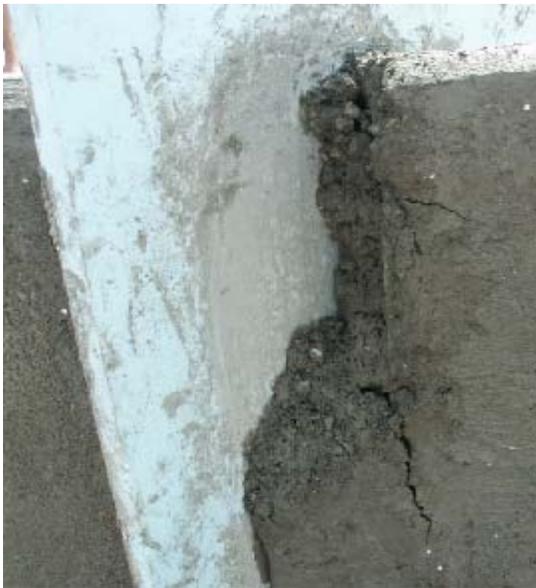
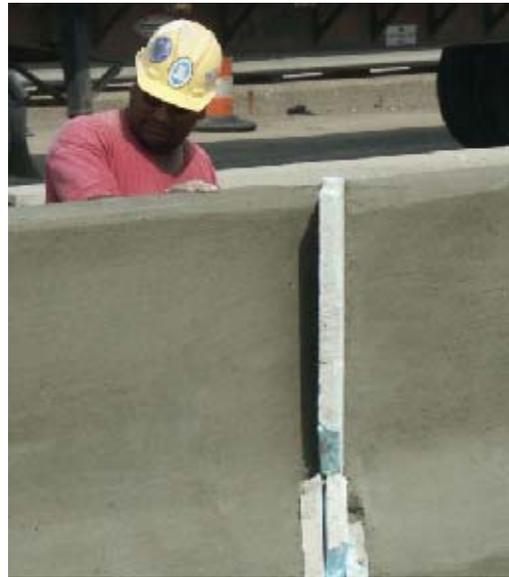
Photo 5-16. Portions of plastic concrete near the construction joint of slipformed barrier broke away and later hand repaired (S06-82194)

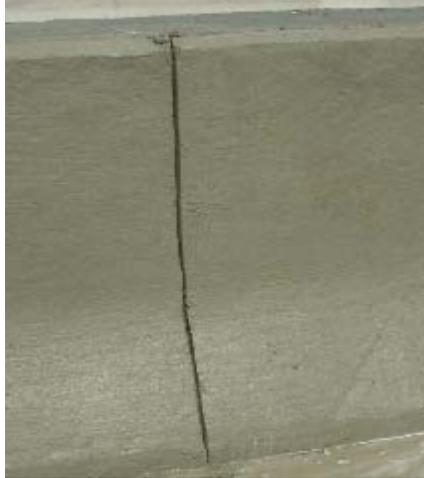
Photo 5-17. Hand finish joint of a slipformed barrier (S06-82194)

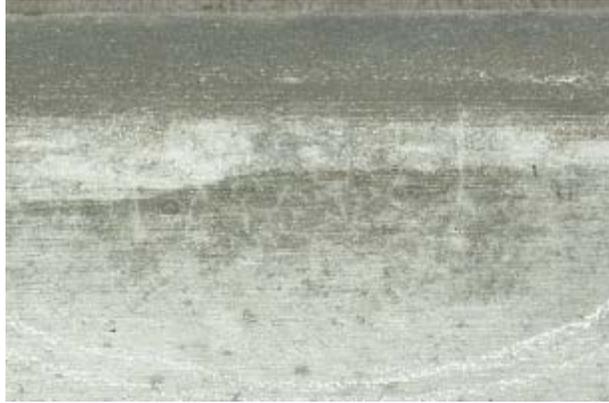
Photo 5-20. Map cracking of barrier surface observed 48 hours after slipforming (S06-82194)
(Note: absence of curing compound)

A site inspection visit was made two days after placement. Map cracking and vertical cracking on all barrier segments were revealed (Photo 5-20 and Photo 5-21). All control joints had formed full-length vertical cracks. Additional vertical cracks were observed on the barrier segments. It should also be noted that the traffic flow next to the newly cast barrier created significant vibrations (Photo 5-22).

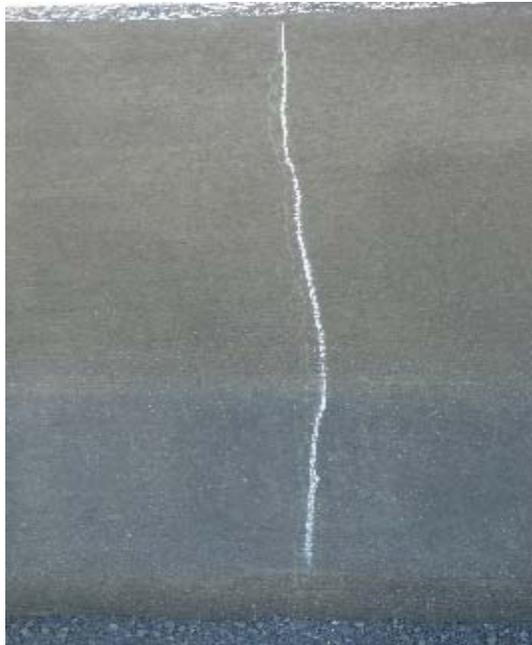
Photo 5-21. Full-length vertical crack on the barrier observed 48 hours after slipforming (S06-82194)
(Note: the lack of curing compound on barrier surface)

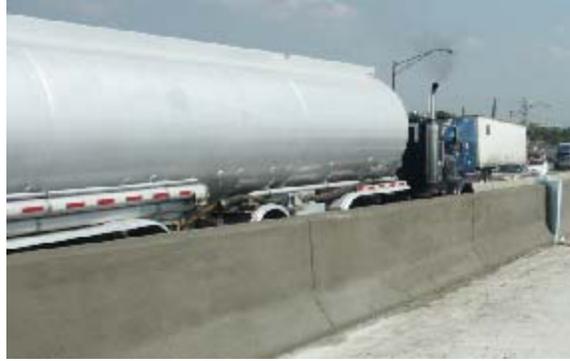
Photo 5-22. Traffic generating vibrations while slipforming of barriers (S06-82194)

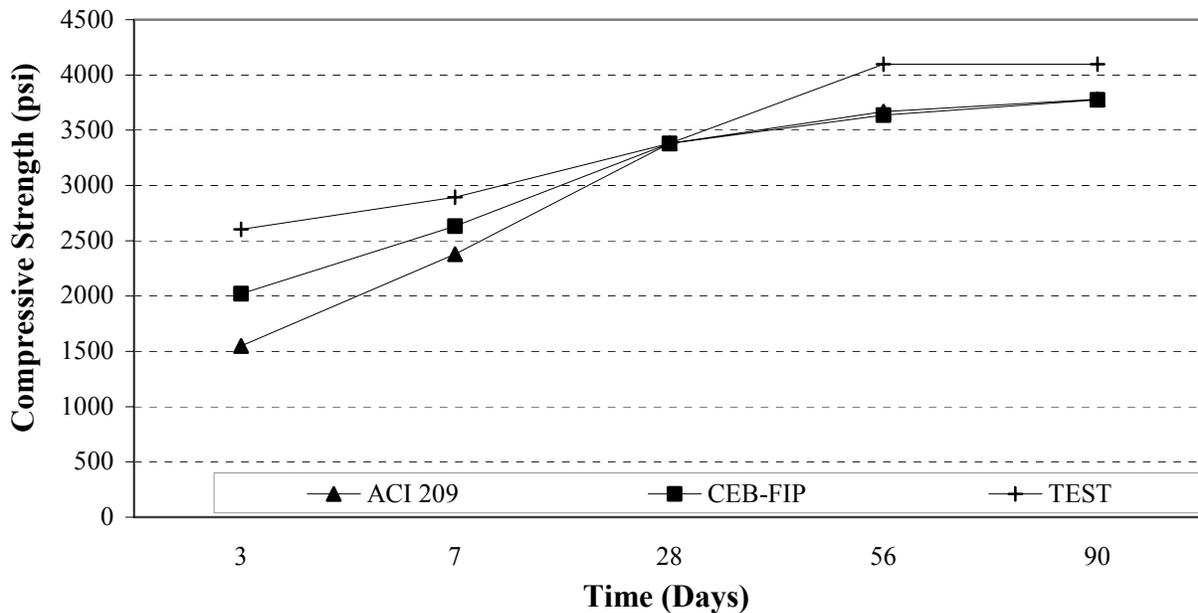
Figure 7-1. Comparison of compressive strength prediction models

Both models require 28-day concrete strength for the formulation of compressive strength variation against time. A complete set of compressive strength test data is available only for S06 of 82194 bridge barrier replacement project (see Chapter 6). CEB-FIP and ACI 209 predictions are compared with the test data of barrier concrete of bridge S06 of 82194. Test data shows high early-age concrete strength. In that case, CEB-FIP Models Code (1990) requires using $s = 0.2$ in Eq. 7-2. From the comparison of the model predictors with the experimental data given in Figure 7-1 within the time span of test data, CEB-FIP model gives the best fit. This model will be used for estimating very early-age concrete strength.

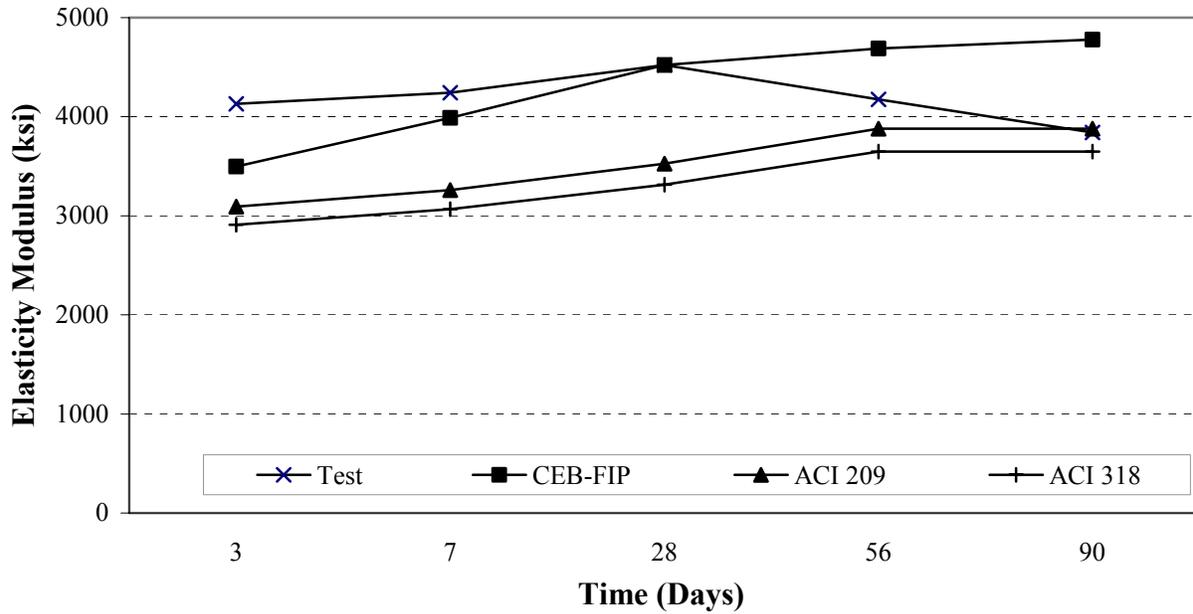
Figure 7-2. Comparison of elasticity modulus prediction models

Based on these comparisons, the CEB-FIP model, which closely predicts the early-age elasticity modulus generated in this study, is used for estimating the elasticity modulus.

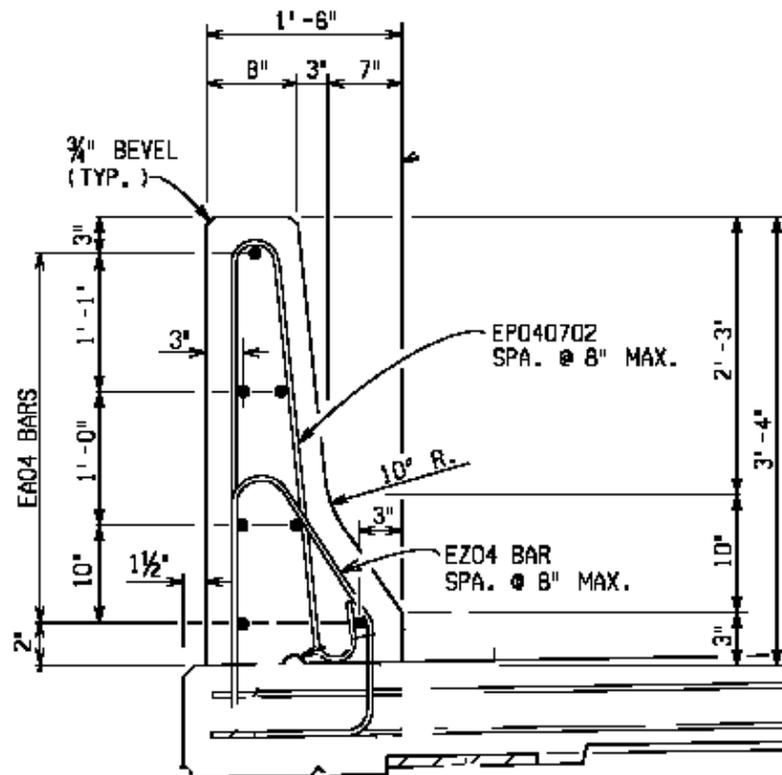
Figure 7-3. Geometry of the barrier

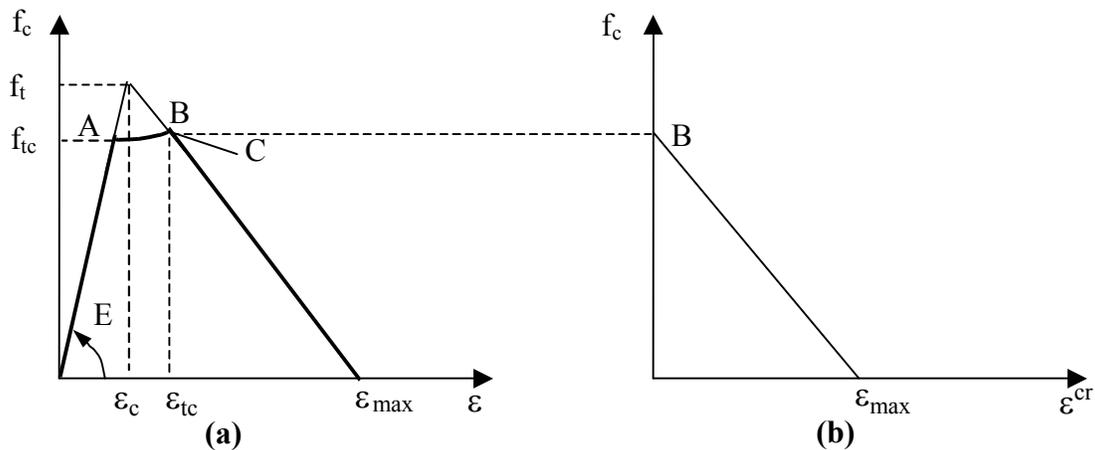
Figure 7-4. (a) Stress-strain envelope for cracking of concrete and (b) stress- strain normal to cracking plane after crack initiation (assuming linear-elastic behavior)

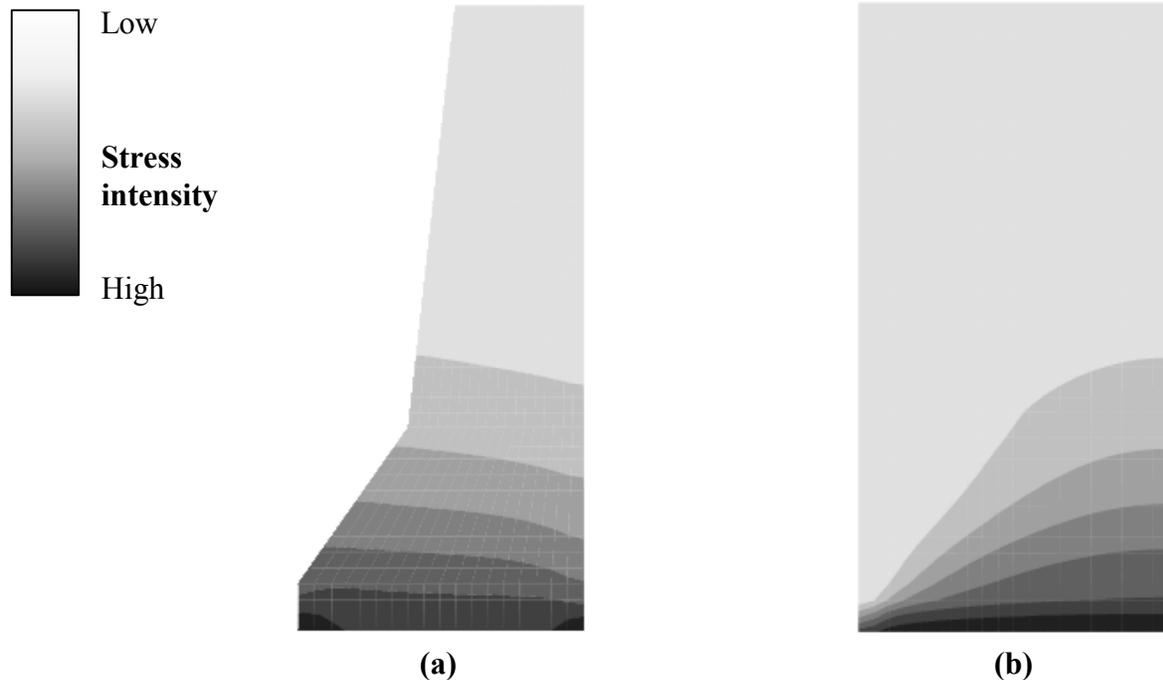
Figure 7-6. Longitudinal stress distribution along the barrier (a) height and (b) length for $L/H=1$

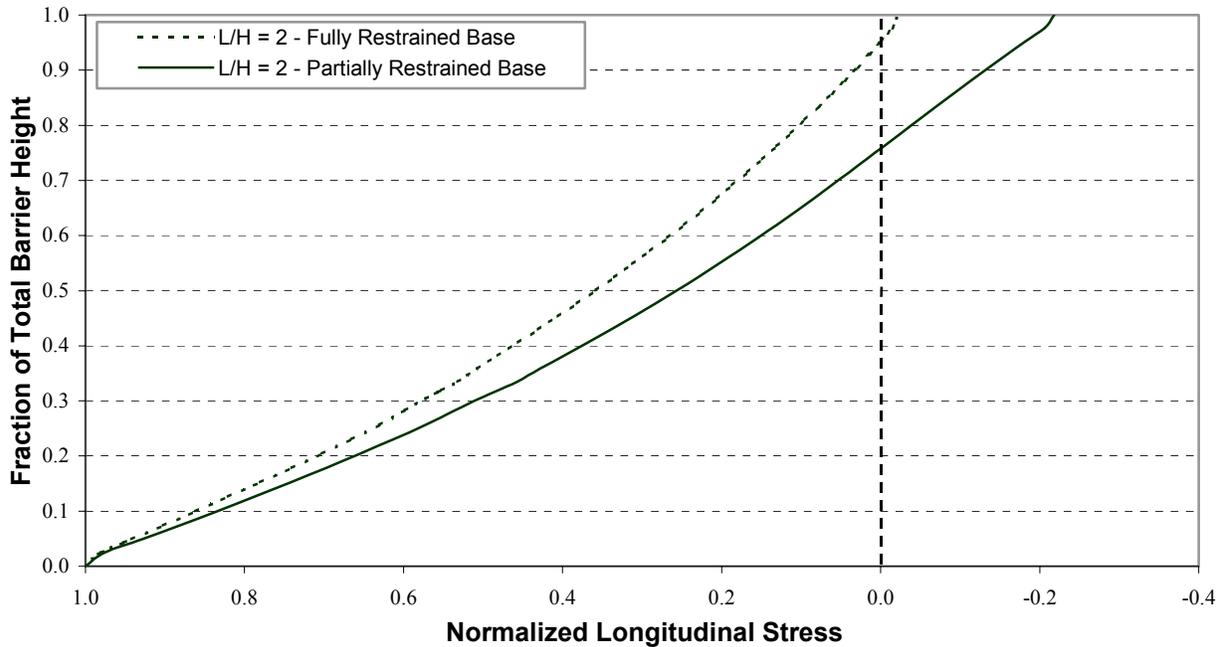
Figure 7-9. Longitudinal stress distribution along barrier height at mid section for $L/H = 2$
