THE PRESERVING AND RECONDITIONING  
OF  
CONCRETE BRIDGES

Progress Report No. 1  
of  
Research Project 46 B-18

Research Laboratory  
Testing and Research Division  
Report R-47  
September 30, 1948

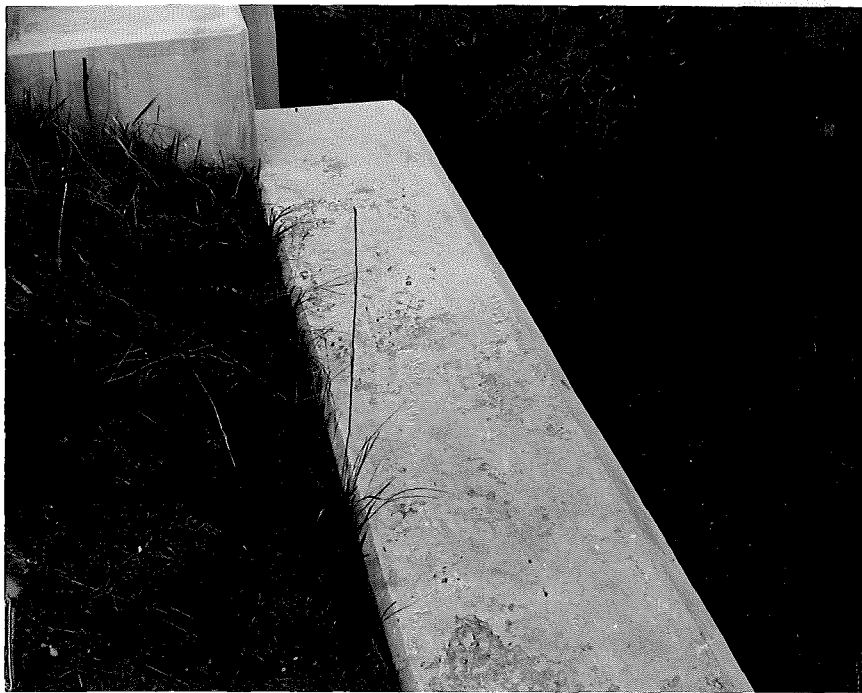
Survey of Experimentally Painted Structures: As mentioned earlier, a survey of structures painted experimentally in 1944 and 1945 has just been completed. Pertinent data concerning these jobs are given in Table I. Two of the structures, one an overpass on US 16 near the airport west of Lansing, the other a culvert on M 78 near Charlotte, were painted in 1944 with a coat of oil paint pigmented with portland cement and finished with a coat of transparent seal. The oil type paint coat on the guard rail posts of the culvert at Charlotte had cracked and flaked so badly at the end of one year that they were repainted over the old paint with Peerless portland cement paint in 1945. The failure of the original oil paint was characteristic of this type of material when used on exterior concrete and, of course, repainting with portland cement paint has not remedied the situation. Lack of adhesion of the original oil paint coat will ultimately cause scaling of subsequent paint coats. An example of oil paint scaling is shown in Figure 1.

Figure 1. Top of culver wall at Charlotte painted with oil paint in 1944. Note extensive flaking of original coating.

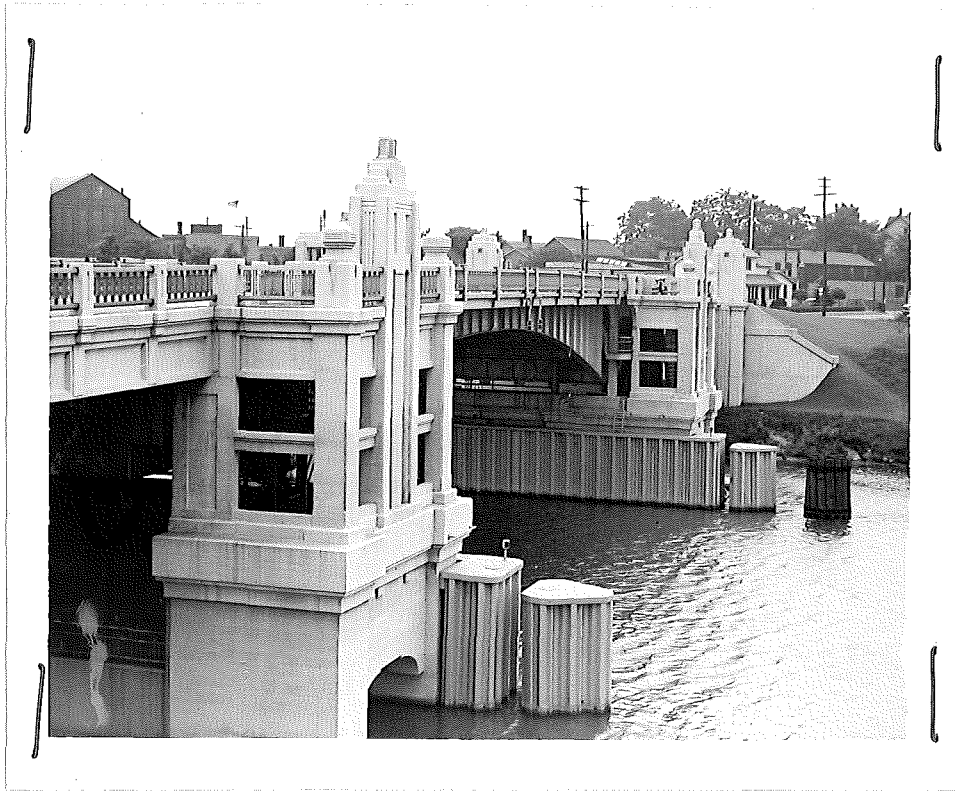
Figure 3. General view of bridge at Manistee.  
Painted in 1945 with Peerless portland cement paint.

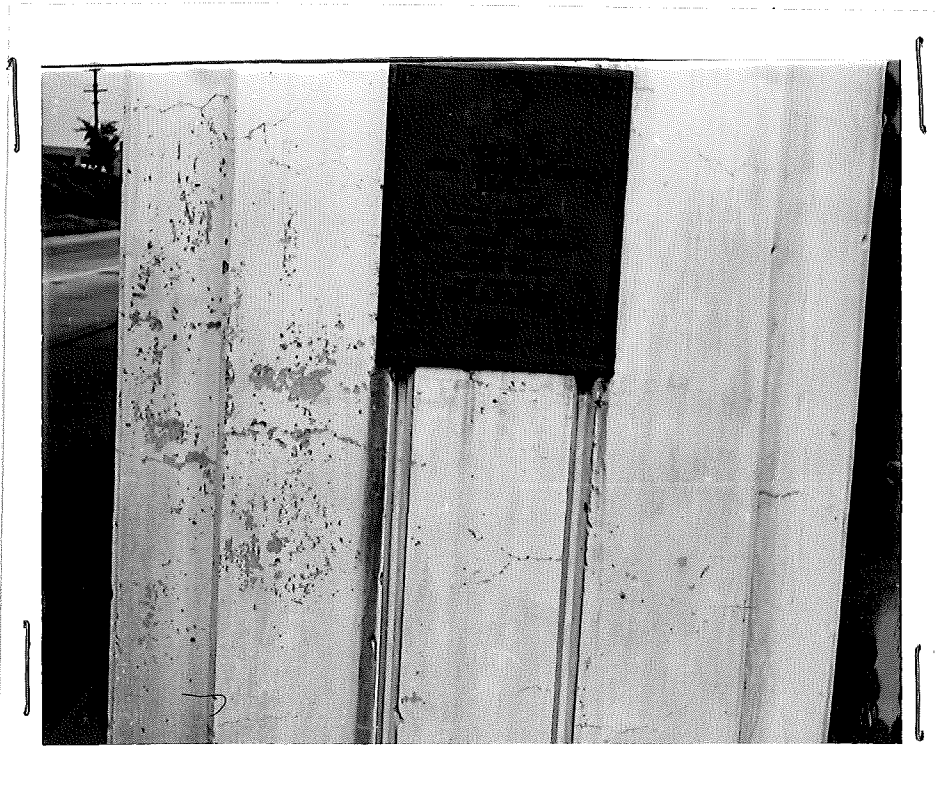
At Howell, in addition to the effects described above, there is also a tendency of the paint film to flake off on some areas, especially those adjacent to cracks in the concrete (Figures 5 and 6). This is an indication of poor adhesion which probably is due to inadequate preparation of the concrete surface prior to painting. Smooth, dense surfaces should be acid washed, lightly sand-blasted or dry rubbed with coarse abrasive stones before painting in order to provide "tooth" for the paint. The present (1942) bridge specifications of the Department call for a rubbed finish on new structures to be obtained by the use of a medium coarse carborundum stone with portland cement mortar followed by a fine carborundum stone with water, leaving the paste thus forced in the surface voids of the concrete. Such a surface will not hold a

Figure 5. Chipping and sealing of portland cement paint film on underpass east of Howell on US 16. Painted in 1944.

paint film as well as one which has only been cleared of projections and rubbed with a dry coarse stone after pointing the cavities with mortar. Proper preparation of the concrete surface of existing structures to receive a paint coating necessarily requires roughening by one of the methods mentioned above to secure adequate bond and a durable finish.

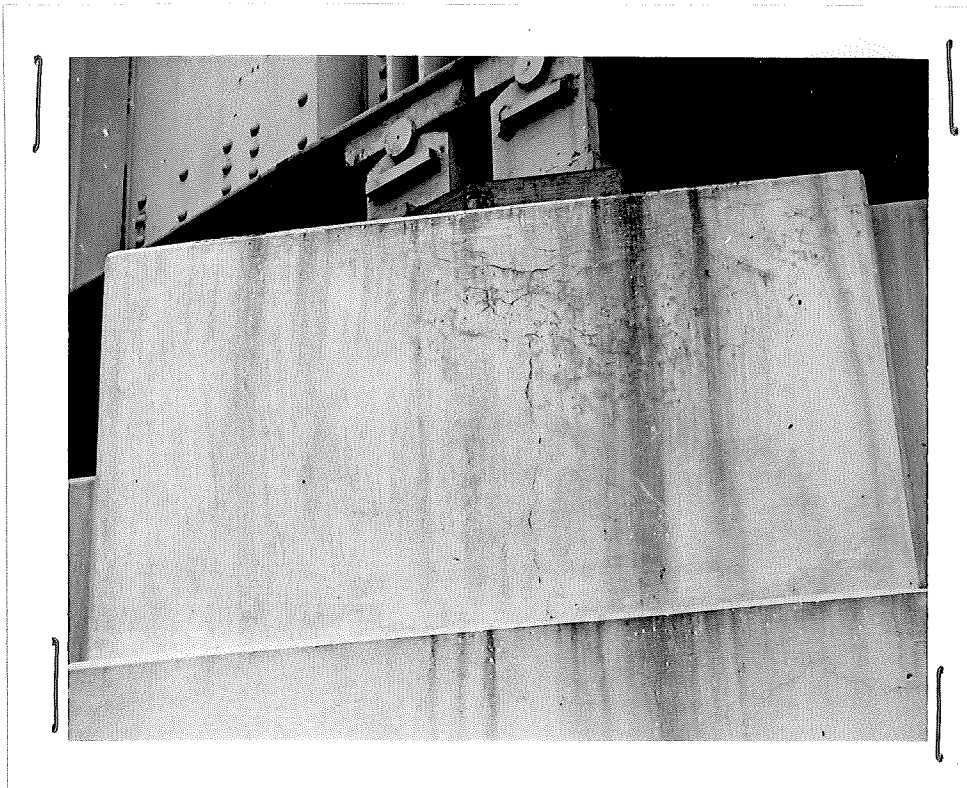
It is apparent from even this limited survey that greater emphasis should be placed on certain related construction factors in order to increase the durability of bridge concrete. Figures 2 and 7, which are photographs taken at the Lansing airport and Howell structures respectively, illustrate the accelerated weathering by freezing and thawing which occurs as a result of water dripping on the wall from above, which is probably aggravated by intermittent application of loads and vibration and which may also be partly due to the fact that the quality of standard concrete at top of abutment walls is sometimes questionable due to segregation and water gain. In each case the water stains are clearly visible in the cracked areas.

Figure 7. Another example of accelerated weathering of concrete indicated by network of cracks near the top of the wall, US 16 east of Howell.

The use of an air-entraining agent in the concrete of the structure to reduce its permeability should prevent or at least greatly delay this type of deterioration.

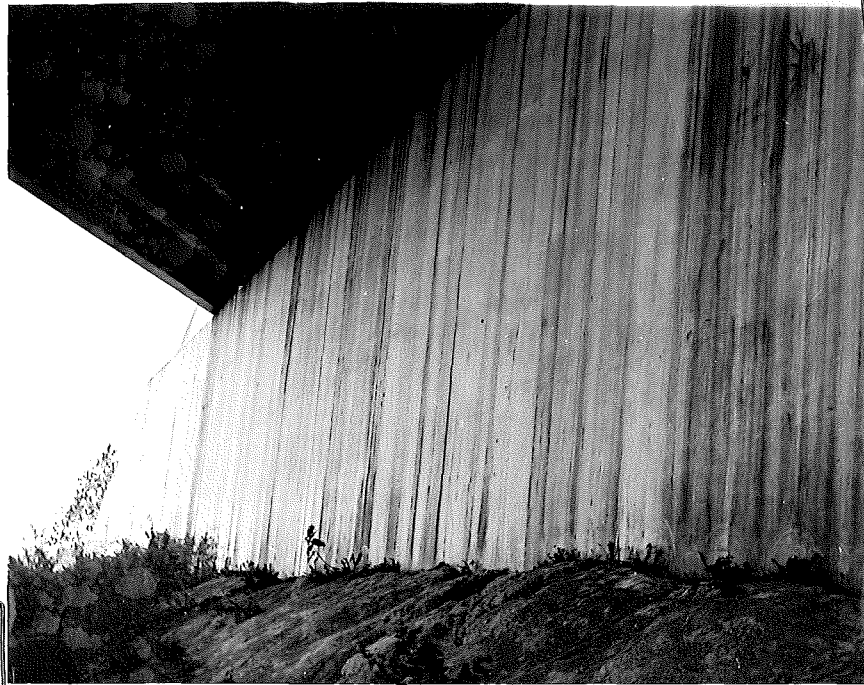
Figure 9. Staining of paint due to surface water.  
Landing airport overpass.

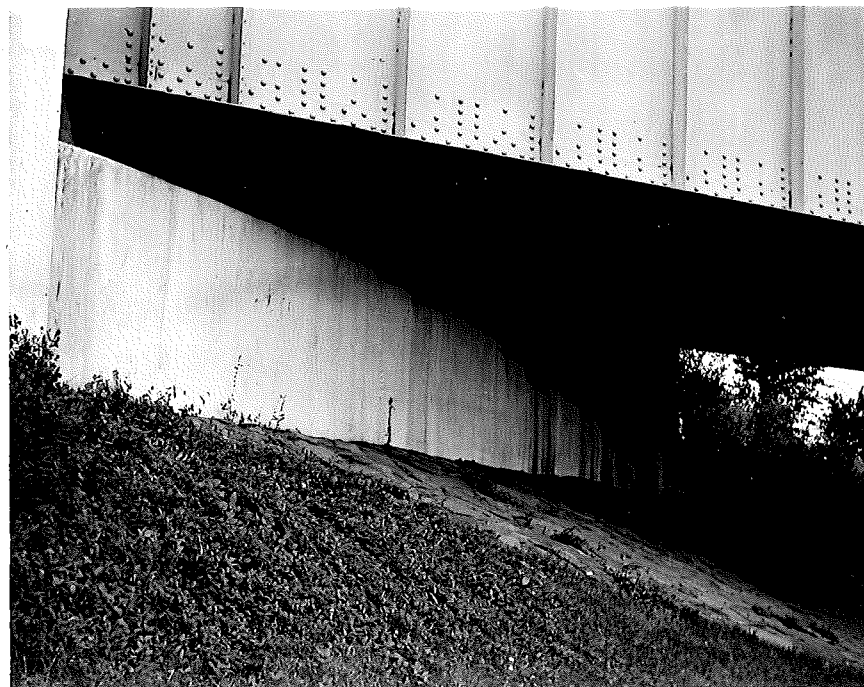
Figure 10. Staining due to surface water.  
Howell underpass.
