DISCOLORATION PHENOMENON IN
BEADED REFLECTORIZED HIGHWAY
SIGN MATERIALS

Research Project 42 G-19 (2)

Research Laboratory
Testing and Research Division
Report No. 42
January 10, 1943

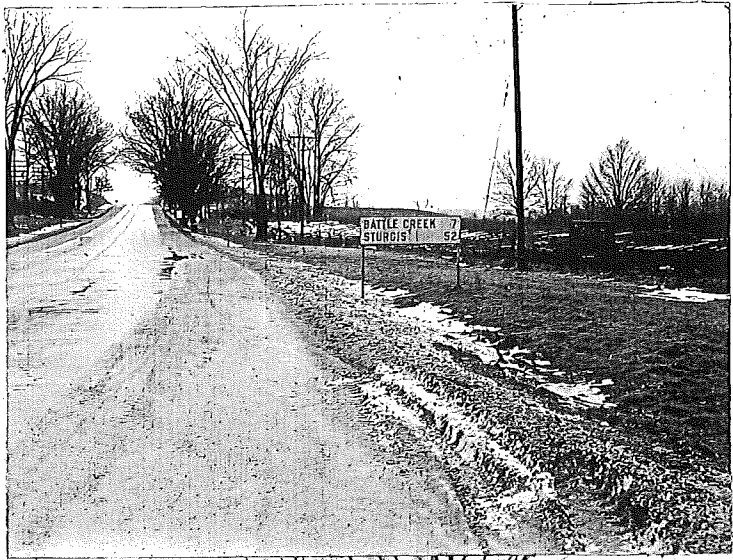
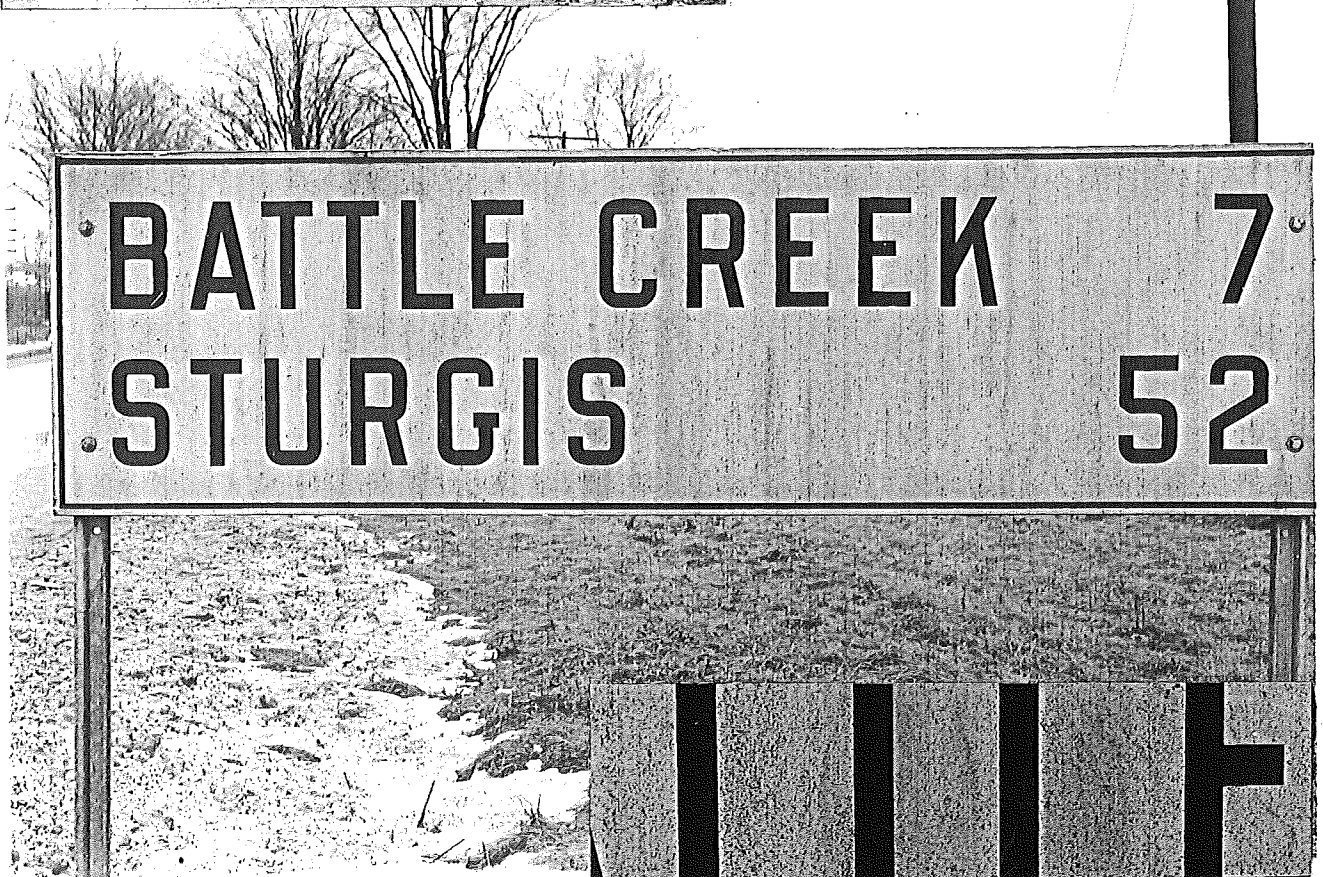
FIGURE 1

A recent survey conducted in November 1942 has revealed that, almost without exception, the Scotchlite signs in this area have developed dark spots over their entire surface. See Figure 1. The spots, illustrated more closely in Figure 2 part A, and microscopically in parts B and C, are roughly circular in shape, and about 1/16 to 3/16 inches in diameter. The edges of the spots are not sharply defined but shade off gradually from the center. The surface between the spots has also taken on a dark and dirty appearance.
