# OFFICE MEMORANDUM

MICHIGAN  
DEPARTMENT OF STATE HIGHWAYS

**Subject:** Protection of Substructure Concrete from A588 Steel Staining by Use of an Aluminum-Pigmented Coating. Research Project 67 G-158. Research Report No. R-716.

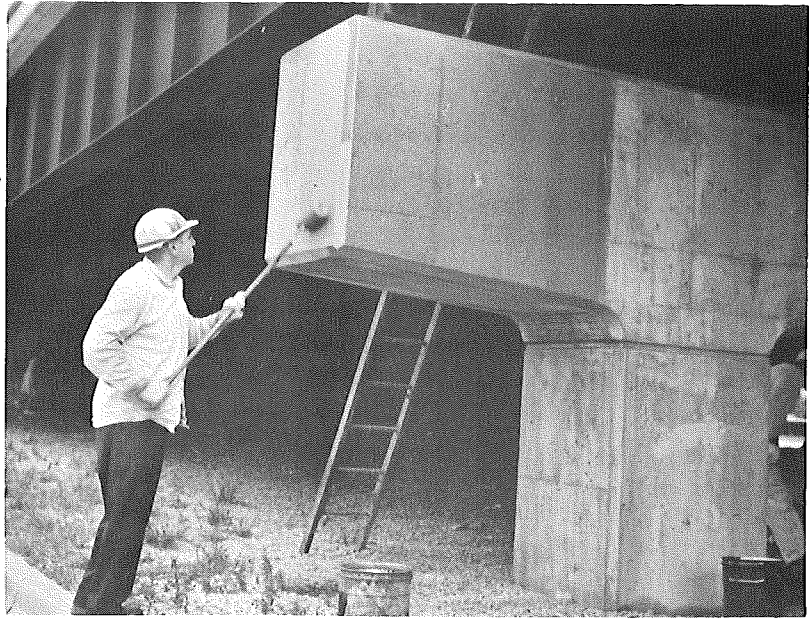
Figure 2. Application of the coating by roller after gross staining was removed by wire brush. Application is on S corner of first pier on W end of M 102 structure. Coating was extended over pier cap under fascia since it was previously uncoated.

A. J. Permoda reports that almost 15 gallons of the test coating were applied on areas of the low piers at either end of the structure, as indicated in Figure 1. The coating was applied mostly by roller (Fig. 2) and some by brush where necessary. The test application showed the coating was slightly too viscous and too fast drying for best application, with a tendency to cobweb as a result. This was partially corrected in the field by thinning and can subsequently be corrected in formulation. The coating gave a good appearance after application (Fig. 3). It dried within the specified 1/2 hour and gave a coverage estimated at 250 sq ft per gallon of coating. As a supplementary remark on application; surface voids on the concrete present something of a problem in coating, since a roller will not coat most of them while the shallow ones receive too much paint, which subsequently runs out. A second pass of a semi-dry roller corrected the latter, but the deeper ones were not coated in subject tests and present a freckle appearance on careful observation.

The subject test coating was applied on stained concrete, after wire brushing. Surprisingly, wire-brushing removed almost all of the accumulated staining on this structure that was previously chemically de-stained during construction. It is assumed that power wire-brushing would have been even more effective.

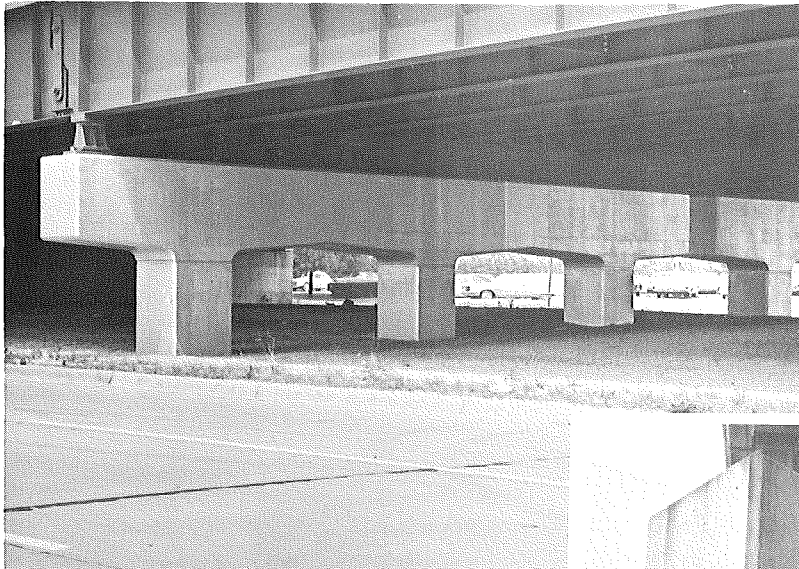
Figure 3. Good appearance of pier concrete after coating application. Left portion coated; right-yet uncoated (same pier as above).

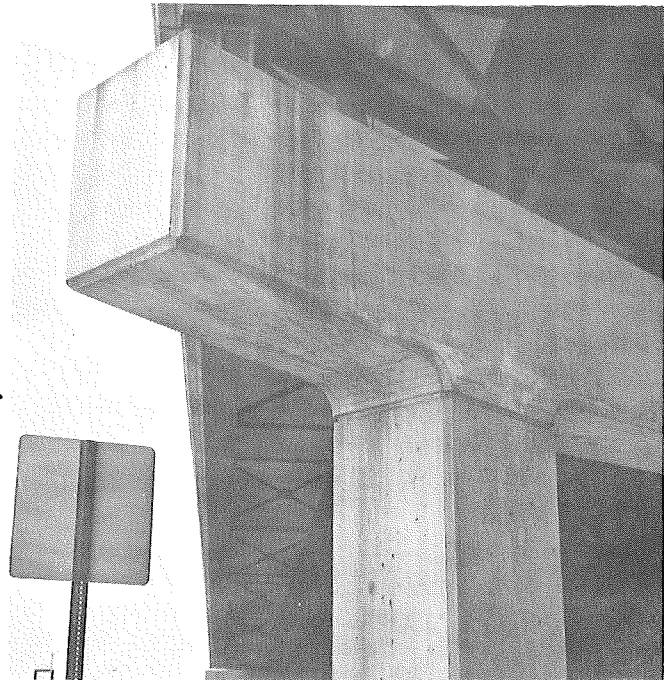
Figure 4. Appearance of pier concrete stain before removal by brush-off sandblasting. This was left uncoated. See Fig. 1 for exact location on W section of structure.

Wayne County Road Commission personnel who performed the work under agreement with District 10 personnel, expressed preference for a brush-off sandblasting method from their experience in removing pornography and other unwanted stainings. This was also tried on some stained concrete and was not overcoated (Figs. 1 and 4). It proved very effective, and probably economical, in removing the stain.

It is now believed that both power wire-brushing and brush-off sandblasting, without overcoating, have potential in dealing with the staining problem.
