DEPARTMENT OF STATE HIGHWAYS

October 4, 1972

Subject: The Effects of Pavement Drainage Gratings on Bicycle Control for Narrow-Tired Bicycles. Research Project 72 TI-101, Research Report No. R-834.

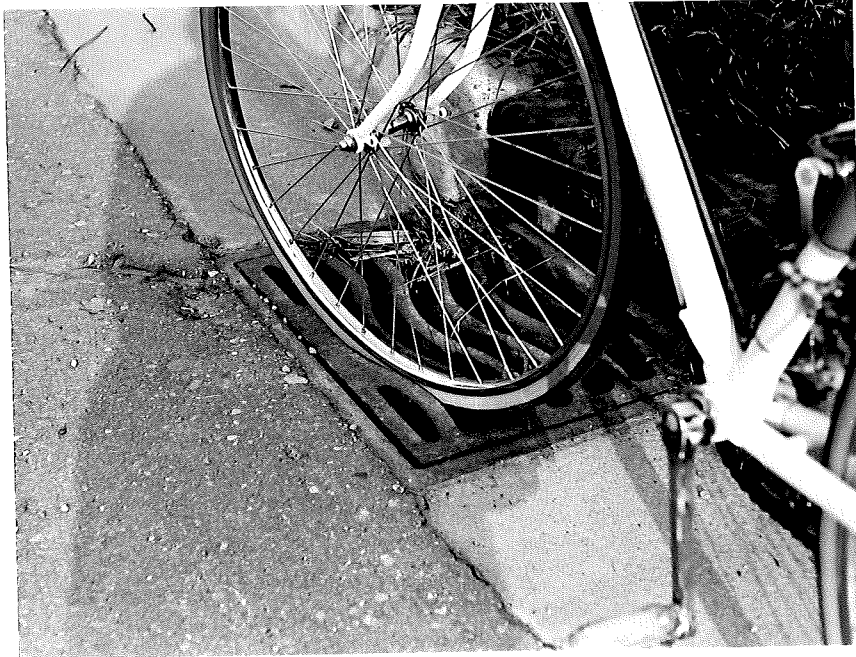
Figure 1. Racing bicycle tire penetrating opening in sinusoidal type grating.

Discussion with local bicycle shops and bicycle riders confirm that very narrow tires are now being produced. Three nominal dimensions for these tires are 26 by 1-3/8 in., 27 by 1-1/4 in., and 27 by 1 in. Currently the narrowest tire measures about 1 in. Preliminary testing was done with a Raleigh racing-type bicycle with nominal 27 by 1-1/4 in. tires. An exact measurement indicated that these tires when properly inflated measured 1.128 in. in width. The opening of the sinusoidal grating is given on the Standard Plans as 1-1/2 in. As shown in Figure 1, a tire of this width when aligned at a certain angle of about 15 degrees will penetrate the sinusoidal type grating but does not penetrate the rectangular grating as illustrated by Figure 2. The rectangular grating has a greater width of opening, 2-1/8 in., but with transverse supports at 4-in. intervals no bicycle tire penetration results.

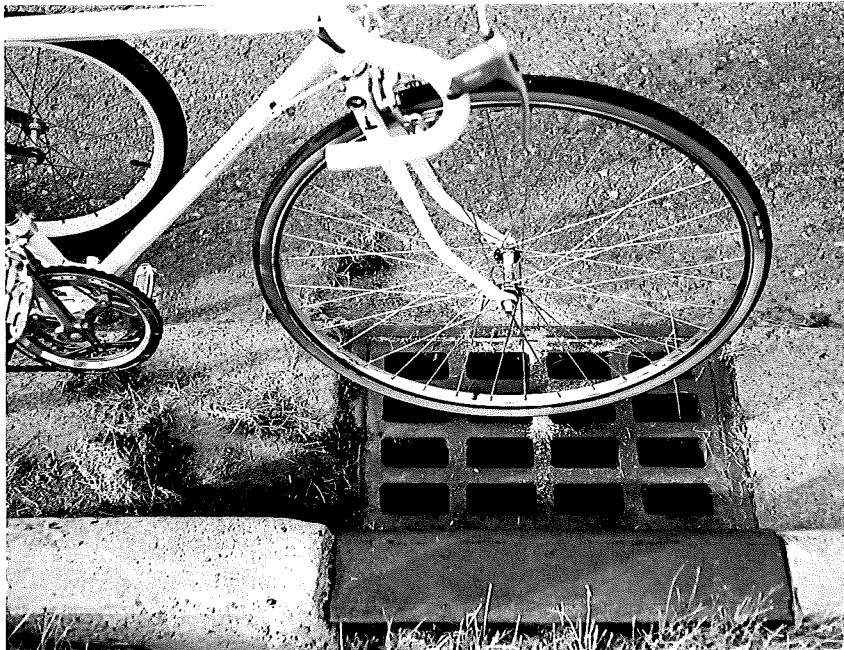
Figure 2. Same bicycle tire on rectangular grating.

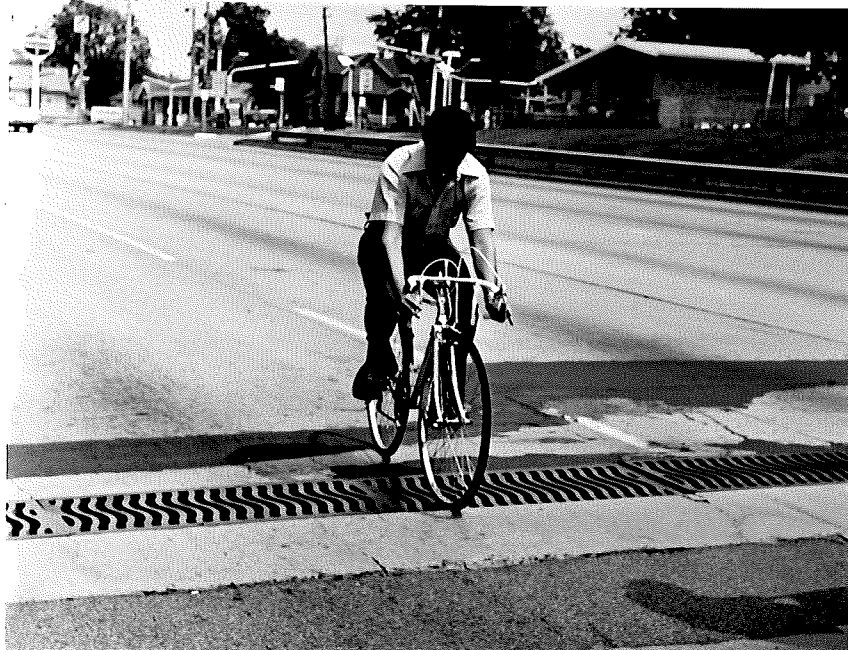
Figure 4. Bicycle test runs at various speeds and angles over sinusoidal grating.

On July 20, a series of tests with the same Raleigh bicycle were conducted over the sinusoidal grating on East Saginaw St. near Pennsylvania Ave. in order to determine the effect this grating might have on bicycle control. As shown in Figure 3, it was possible to place the front wheel of the bicycle at such an angle that the tire penetrated the grating under a static condition. However, a large number of passes of the bicycle over the grating at a variety of angles (Fig. 4) did not result in any significant effect on bicycle steering or control. Bicycle speeds were also varied in these runs from slow to the maximum attainable under the situation. At times during these runs there was a penetration of the bicycle tire into the grating but the bicycle momentum in every case carried the tire over the grating with only a very slight or noticeable ride effect and no significant steering correction was required. Even with a very relaxed condition of the bicycle rider's hands on the handle bars no steering correction was required. The higher speed runs resulted in less effect than the slower speeds probably due to the increased momentum resulting in less grating penetration. No attempt was made to go over the grating without hands on the handle bars although the tests conducted would indicate that this would not be a problem. It has also been mentioned that the bicycle grating problem might be more serious under wet conditions. In order to check this the grating was wetted and a number of tests conducted under this condition. These tests indicated that there was no difference between wet and dry conditions and that under either condition there was no appreciable effect on bicycle steering or control. As a result of this series of tests no damage resulted to the tire or the rim of the bicycle, although there were a number of black marks on the tire sidewall resulting from the contact with the sides of the grating bars.
