*PERFORMANCE OF
MICHIGAN'S CONCRETE BARRIERS*

Performance of Michigan's Concrete Barriers

**Materials Section
Construction and Technology Division
Research Report R-1498**

**Michigan Transportation Commission
Ted B. Wahby, Chairman
Linda Miller Atkinson, Vice Chairwoman
Vincent J. Brennan, Maureen Miller Brosnan
James R. Rosendall, James S. Scalici
Kirk T. Steudle, Director
Lansing, Michigan
August 2007**

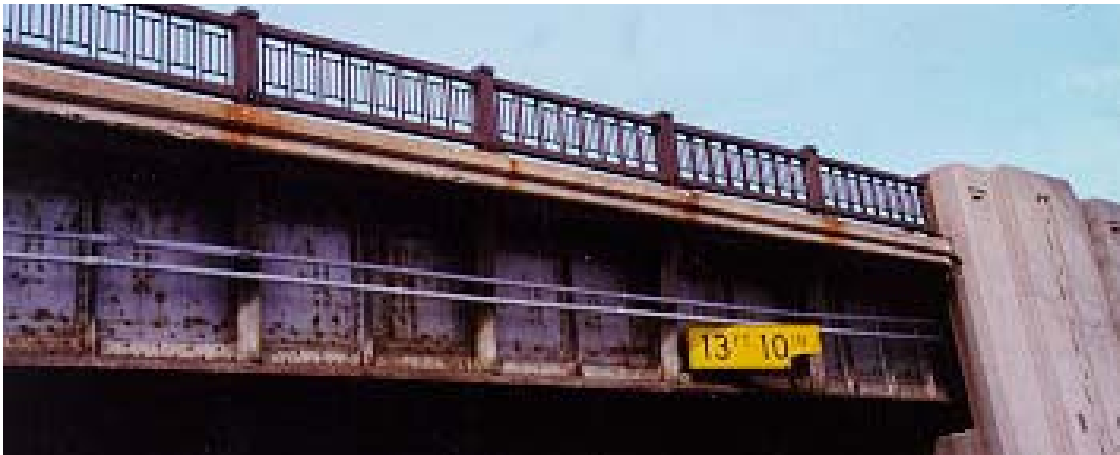
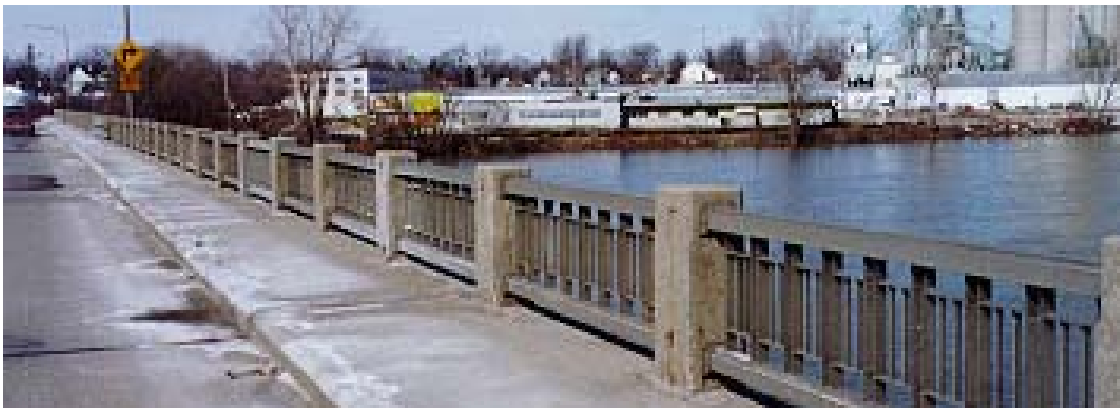
Figure 1A and 1B: Typical R-4 or R-5 standard bridge railing design prior to 1960.

Prior to the 1960's, the standard bridge railing types used in Michigan were the Types R-4 and R-5. These railings were constructed of either concrete (R-4) or steel (R-5) posts with metal lattice between posts. Illustrations of these two railing types are shown in Figures 1A and 1B. Depending on the specific application and location, some of these railings, or modifications to them, are still in service today. In addition to the Types R-4 and R-5 railings, other typical railing construction details incorporated extensive use of cast-in-place architectural concrete, and various renditions of rolled and tubular steel designs.

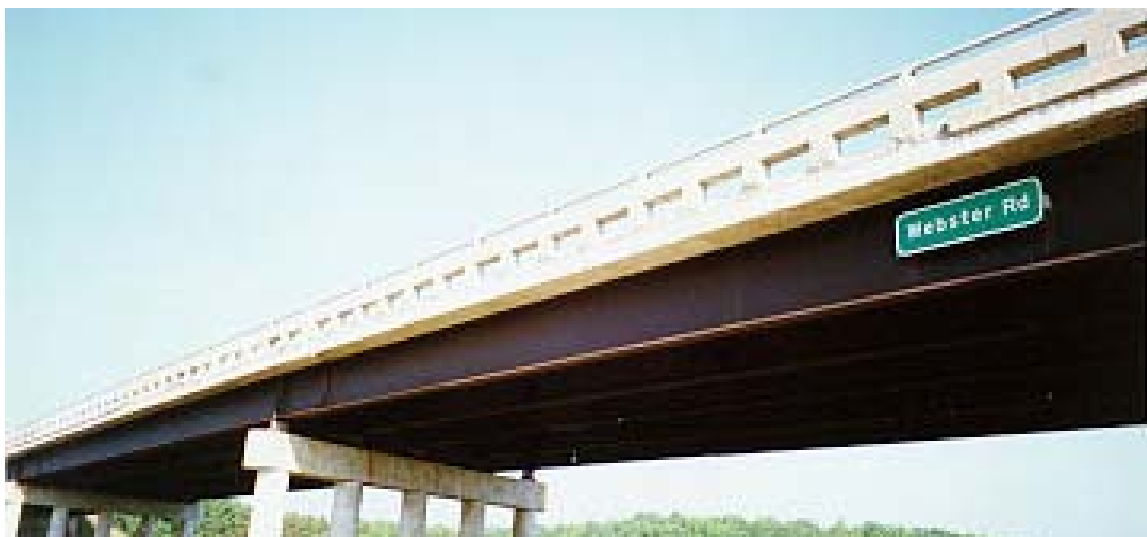
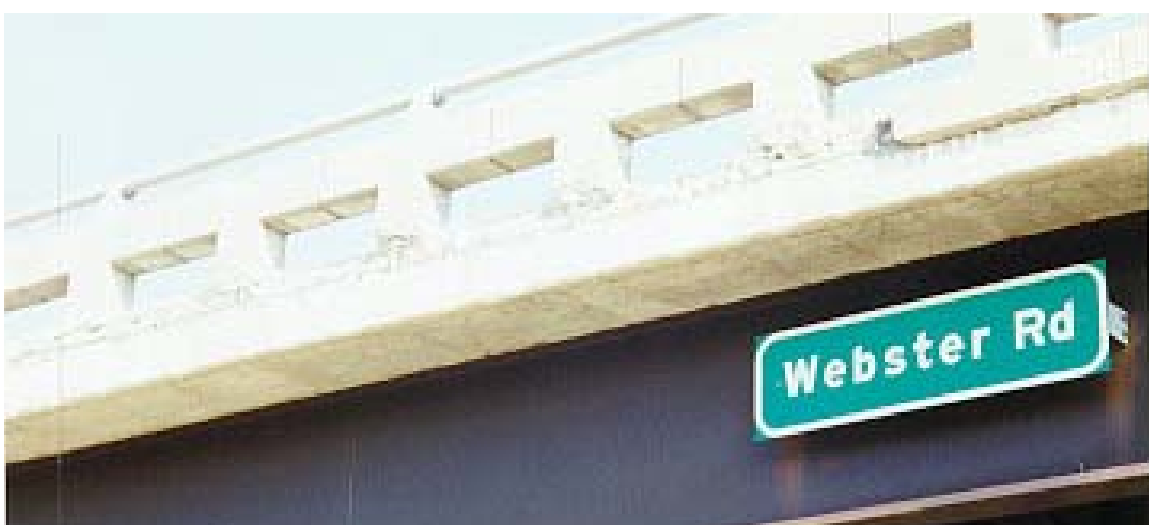
Figure 2A and 2B: Concrete railing typical of the standard R-11 or R-12 adopted in 1961.

The open parapet concrete railing with aluminum or steel tube (Types R-11 or R-12) was adopted as the standard railing detail in 1961. These railings were used throughout the 1960's and 1970's. Illustrations of a typical open parapet railing with aluminum railing on a structure constructed in 1974 are shown in Figures 2A and 2B. In 1967, the G.M. (Type 1) concrete barrier was approved as the standard barrier detail for trunkline applications. The general shape of this barrier is similar to modern standard details, with exception of the G.M.'s optional tube railing and dimensional modifications. Figure 3 illustrates a typical G.M. (Type 1) detail configuration. The G.M. (Type 1) barrier was shorter in overall height and narrower in cross-sectional width than today's standard design; only 2'-8" high, 6" wide at the top, and 1'-4" wide at the base. According to field inspections, some G.M. barriers are still in service today; many were still observed to be in excellent condition. In 1976, the "New Jersey" (Type 2) concrete barrier design was adopted for use in Michigan.

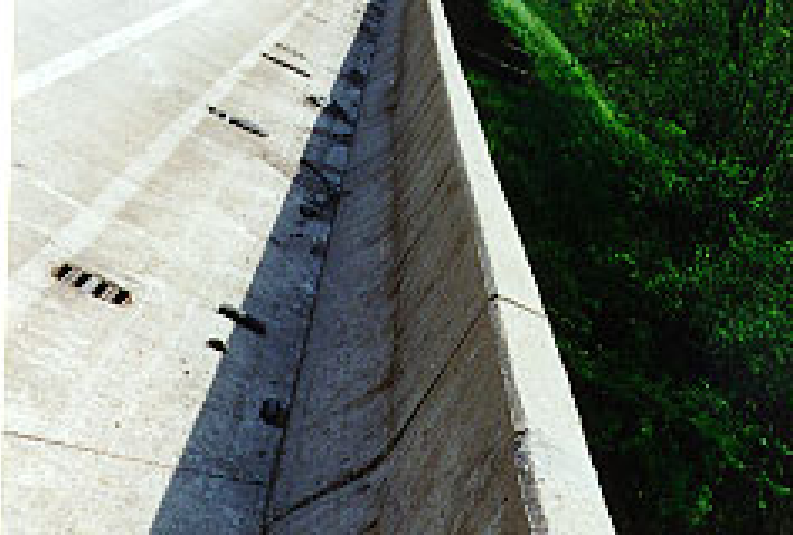
Figure 3: Typical G.M. (Type 1) concrete barrier adopted in 1967.

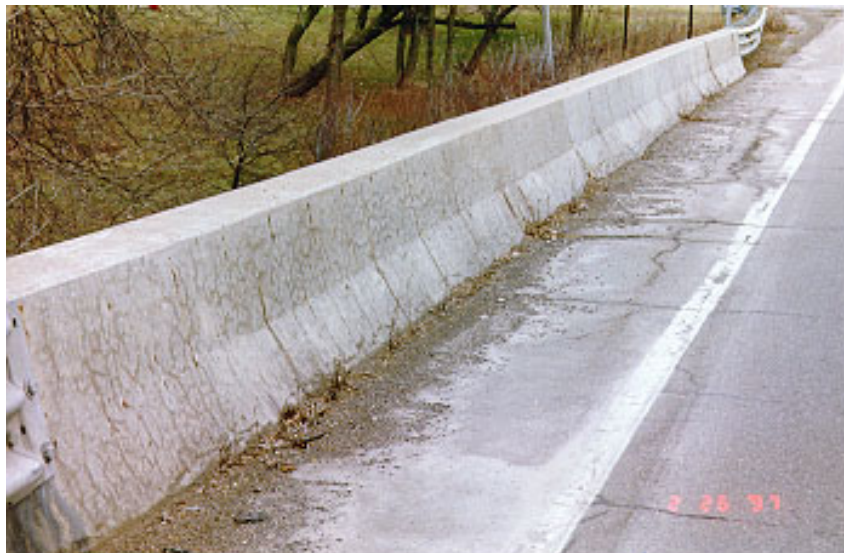
Figure 4: Typical New Jersey (Type 2) concrete barrier adopted in 1976.

Figure 4 illustrates a typical New Jersey (Type 2) detail configuration. Differences between the two standard design configurations (G.M. vs. New Jersey) are dimensional modifications to the toe and sloping face of the traffic bearing side. The cross-sectional widths at the top and bottom of the New Jersey (Type 2) barrier were also increased to 1'-0" and 1'-10", respectively. Several revisions to the standard design were adopted during the 1970's, including optional tube railings.

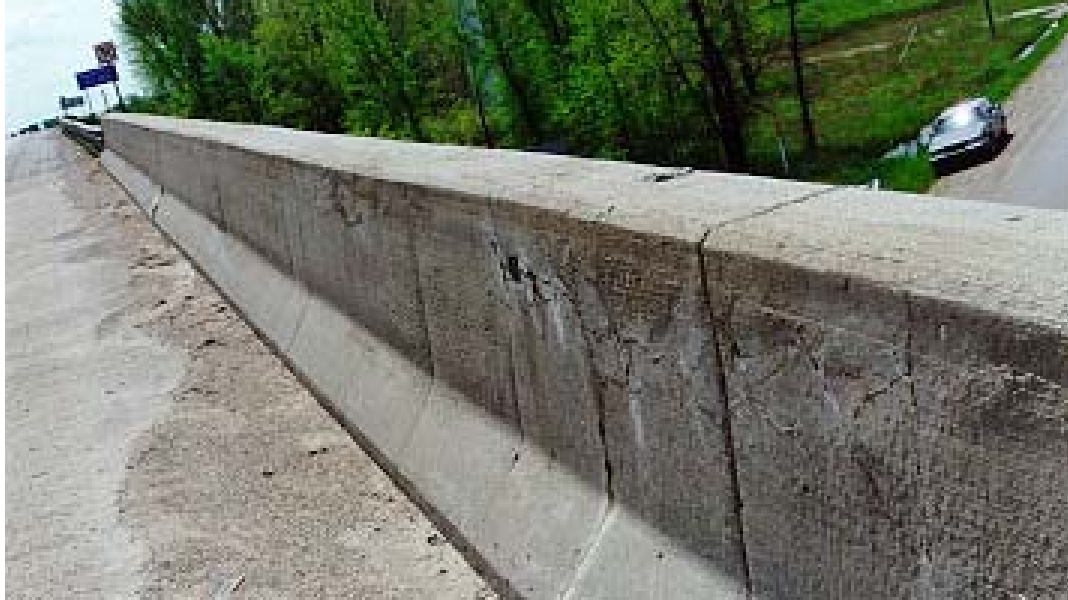
Figure 5: Typical New Jersey (Type 3) concrete barrier adopted in 1977.

In 1977, the New Jersey (Type 3) barrier was adopted. This standard design configuration specified an overall concrete barrier height of 3'-4" with no additional tube railing. Figure 5 illustrates a typical New Jersey (Type 3) detail configuration.

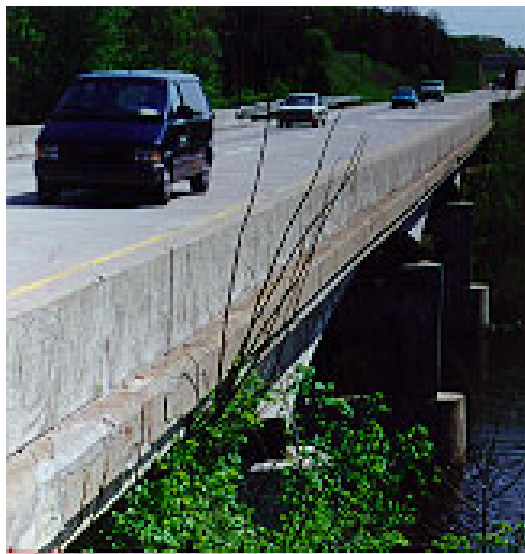
Figure 6: Typical New Jersey (Type 4) concrete barrier adopted in 1982.

On October 14, 1982, the MDOT Engineering Operations Committee (EOC) requested the standard design details for the New Jersey design be further modified. This was based on concerns raised by the Federal Highway Administration (FHWA) that MDOT's current Types 2 and 3 barriers were over-designed. Based on these concerns, the cross-sectional widths were reduced and reinforcement details were modified. Hence, the New Jersey (Types 4 and 5) concrete barriers were developed. These new standard design configurations (Types 4 and 5) resembled the previous standard designs (Types 2 and 3), respectively. However, the detail (Types 4 and 5) modifications reduced the cross-sectional widths to 8" at the top and 1'-6" at the base. Illustrations of these standard barriers types are shown in Figures 6 and 7.

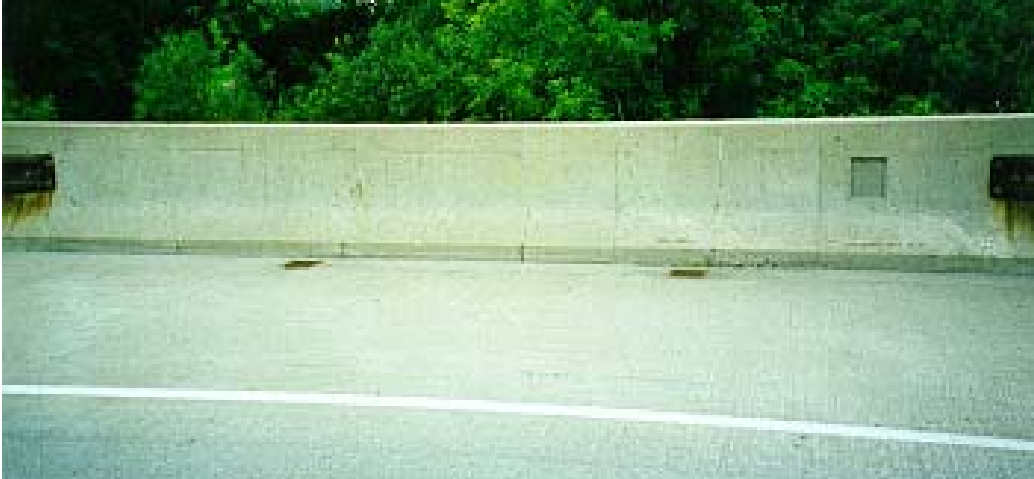
Figure 7: Typical New Jersey (Type 5) concrete barrier adopted in 1982.

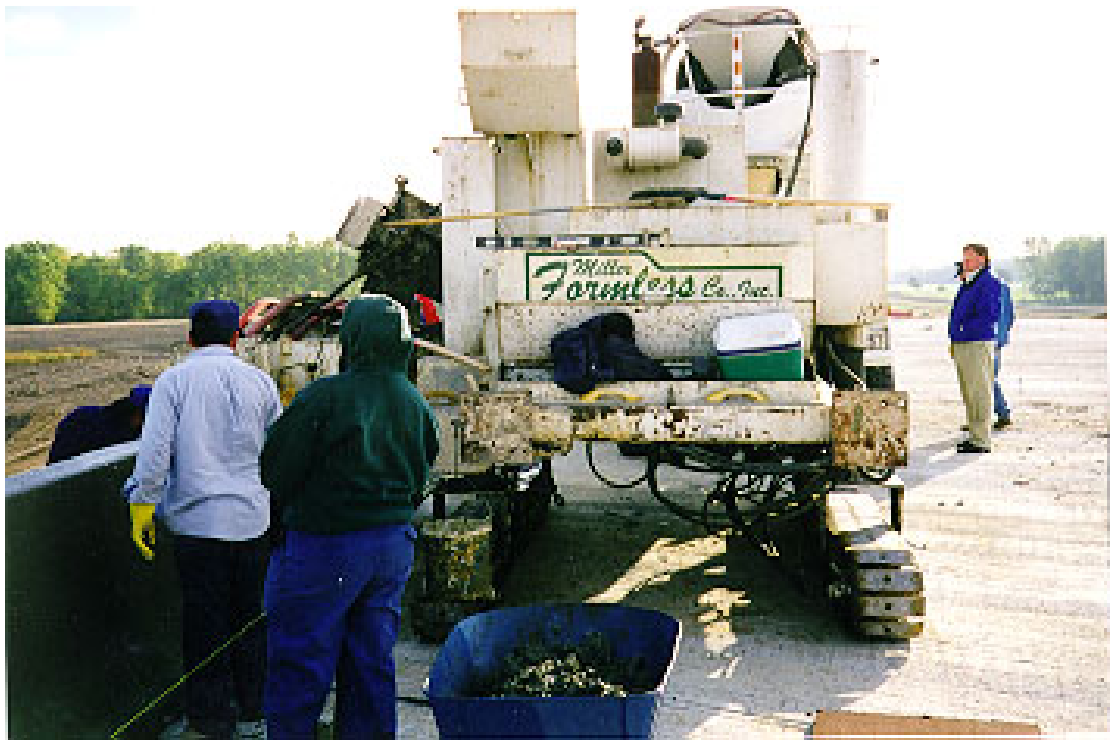
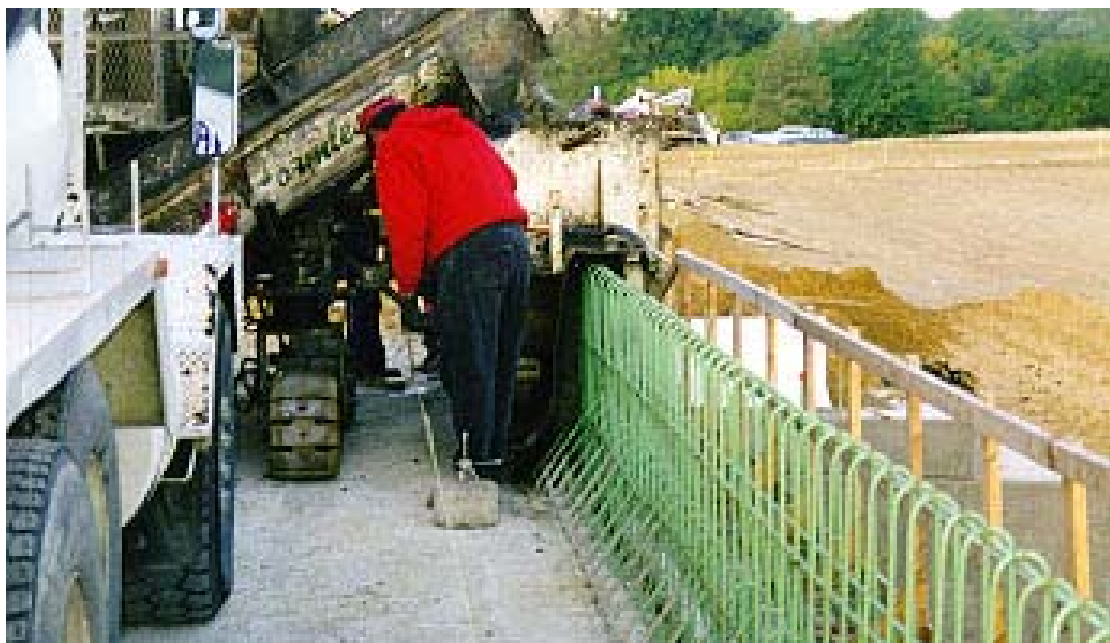
Figures 8A and 8B: Typical "slipform" concrete barrier operation.

In October 1972, the EOC approved the use of “slipform” paving technology for construction of Portland cement concrete barriers for bridge and freeway median applications. This construction technique consists of extruding very low slump (0 to 1-1/2 inch) concrete through a paving machine (commonly known as a “mule”) around the steel reinforcement. The standard design shape is generated by saddling the reinforcement with a moving form, templating the plan cross-sectional shape of the barrier. This method was particularly attractive to industry because of its time- and labor-saving characteristics. Unlike cast-in-place concrete technology (which requires assembly and disassembly of stationary forms for each day’s production), slipform is a continuously moving operation. The mule straddles the reinforcement cage and travels along the bridge deck surface, continually maintaining vertical grade control by means of a survey string-line. The low-slump Portland cement concrete is then charged into the moving form through a discharge hopper. High-frequency external vibrators are used to consolidate the low-slump plastic concrete. As the mule progresses along the bridge, the freshly extruded concrete is hand-floated, broomed, and finally coated with curing compound. A major concern when casting slipform concrete barrier is to maintain a uniform consolidation of the concrete in efforts to minimize voids and “rock pockets” without causing slumping or excessive disfiguration of the extruded concrete mass. This is a particular concern when extruding low-slump concrete around internal obstructions, such as utility conduits, bridge joint end treatments, and joint filler materials. Figures 8A, 8B, and 9 show a typical slipform barrier construction operation.

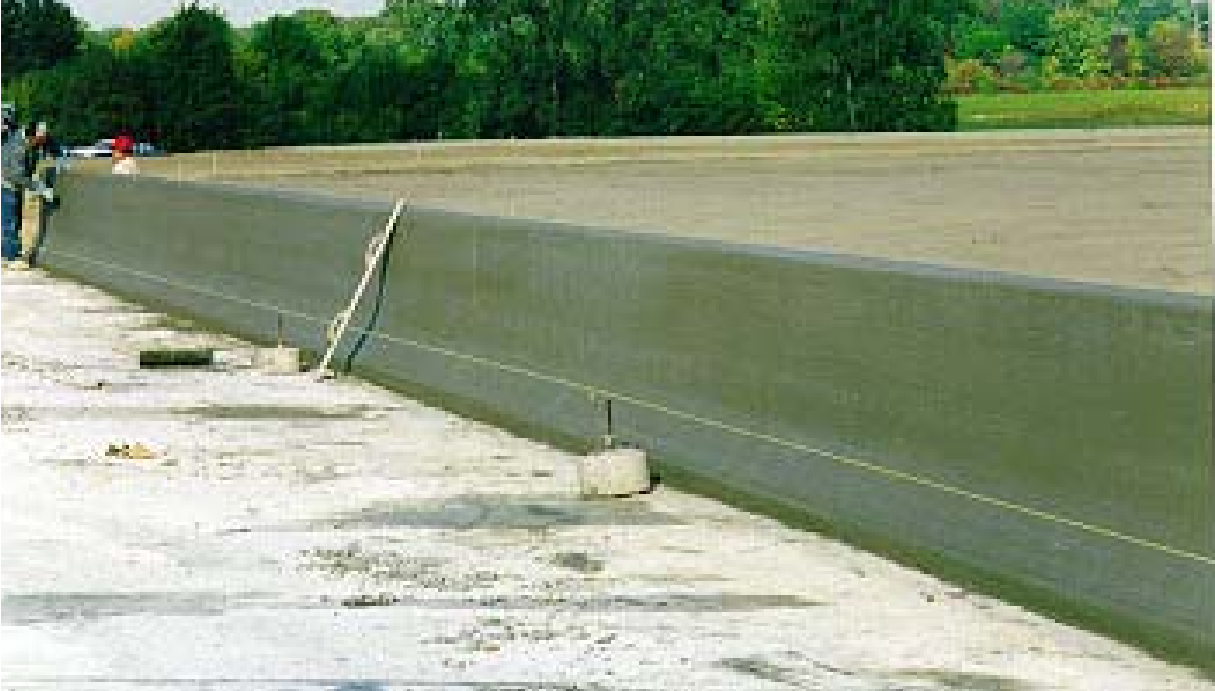
Figure 9: Typical “slipform” concrete barrier operation.

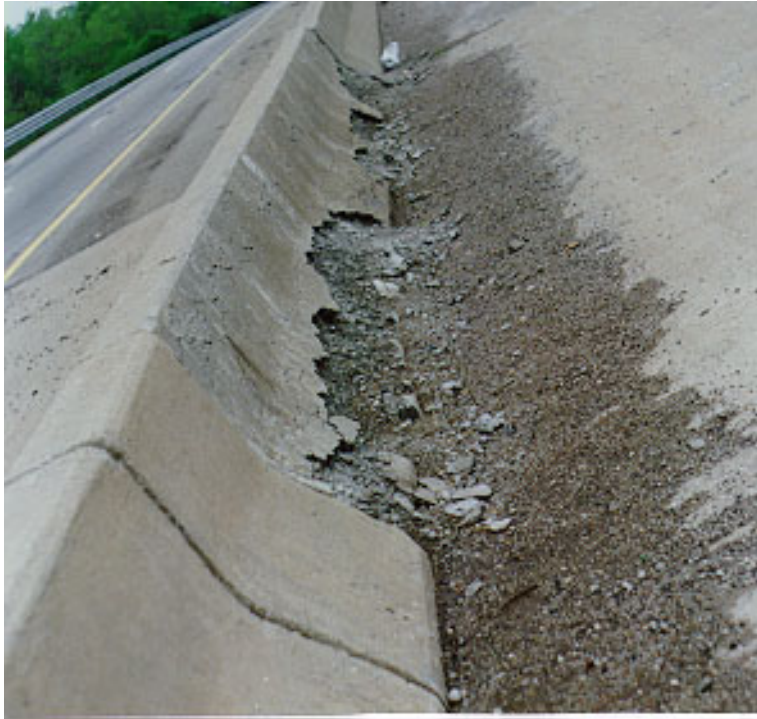
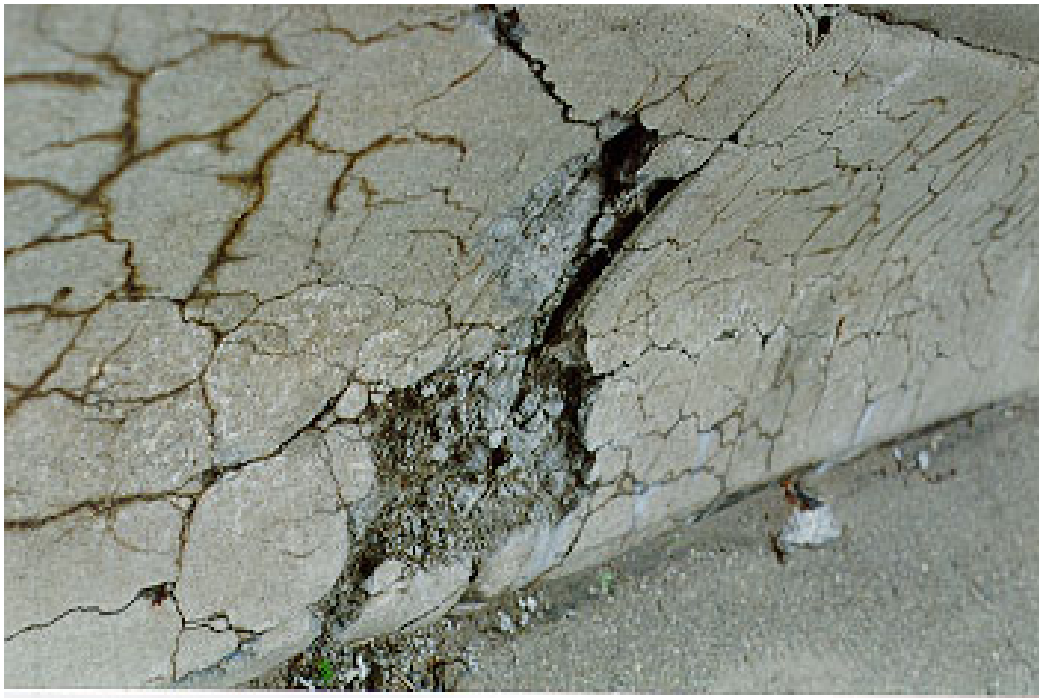
Deicers - Perhaps the most destructive assault on Portland cement concretes exposed to harsh Michigan freeze thaw environments occurs as a result of heavy applications of deicers. The osmotic and hydraulic pore pressures developed during internal expansions and movements of freezing liquids throughout the hardened concrete matrix induce localized tensile stresses ultimately causing micro-fracturing of the concrete paste. These micro-cracks eventually conglomerate to form macro-cracks which then provide wider avenues for further deicing chemicals and moisture intrusion. Osmotic pressures generated within the pore structure of concrete from water/deicer solutions are estimated to be approximately twice the magnitude of those generated by deicer-free pore waters. In addition, since the freezing point of deicer latent water is lower than that of water, the number of freeze thaw cycles experienced by the concrete over a given period of time may be greatly increased. In other words, the cyclic transformation of the pore fluids from a liquid state to a frozen state could compress the deterioration time-frame from decades to years. This, in turn, results in accelerated deterioration of the concrete structure. Further, as the concrete interior matrix is progressively eroded and exposed, carbonation and other complex chemical reactions manifest leaching of soluble calcium hydroxide from the concrete paste, and deposition of harmful mineral compound precipitate into the entrained air voids. This, in turn, reduces the concrete's resistance to future freeze thaw and chemical attack. Figures 10A and 10B show the accelerated deterioration of a concrete barrier caused by aggressive freezing and thawing.

Figures 10A and 10B: Typical deterioration caused by freeze thaw attack.

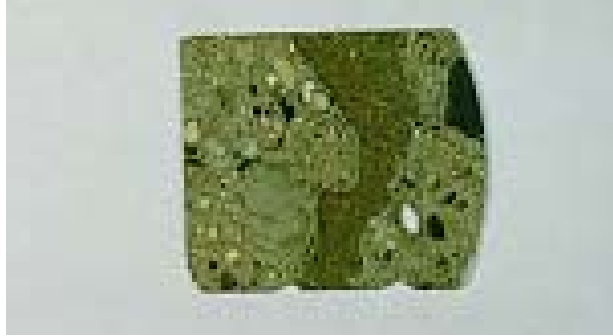
According to laboratory inspection of concrete specimens extracted from both slipform and cast-in-place concrete barriers, the rapid-chloride permeability (ASTM C 1202 Standard Test Method for Electrical Indication of Concrete's Ability to Resist Chloride Ion Penetration) for the two concretes are quite low, relative to normal quality concrete. However, an interesting observation was that the surface of the slipform specimen, to a depth of approximately 1/8-inch, was very porous and of very low quality. Sand streaks and a very porous matrix were noted within this thin cover layer. Visual evidence indicates that potential causes could likely be the result of improper mixing, handling, finishing and/or curing during construction. Figure 15 shows the lens of sand detected in the outer 1/8-inch of the slipform barrier traffic-bearing surface. In any case, the laboratory sample was taken at random and considered to be representative of normal slipform barrier concrete. Petrographic evaluation of concrete slices representing the surface of the cast-in-place concrete barrier was consistent and homogeneous in appearance with interior.

Figure 15: Lens of sand detected in concrete core specimen sampled from slipform barrier. The lens was observed to be located within approximately 6 mm from the traffic-bearing surface.

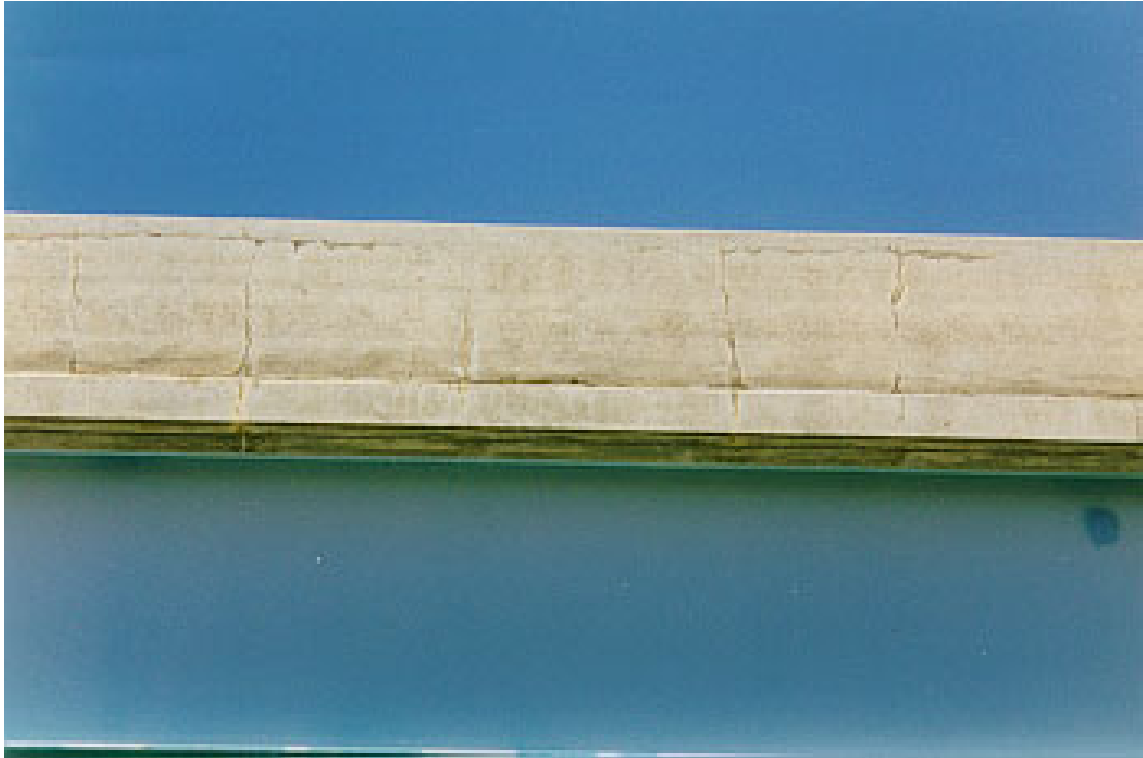
Spalling of these barrier tops was reported during a distinct warming period in late spring. Another barrier located on westbound I-496 over the Red Cedar River in Lansing, as seen in Figure 20, shows longitudinal cracking within three years after construction. Laboratory technical staff was on-site during construction in 1995 to observe slipform barrier construction. As observed, the ambient weather conditions were hot and windy. This contributed to excessive loss of moisture from the fresh concrete surface due to the typical time that the fresh concrete was exposed to the environment prior to application of curing compound. The result was an unwarranted need for excessive hand-finishing after concrete placement of the concrete barrier surfaces in attempts to restore its visual appearance. Many concrete barriers visually noted but not documented in this study exhibit similar premature deterioration characteristics.

Figure 20: Typical horizontal crack deterioration noted within three years after barrier construction (WB I-496 over the Red Cedar River in Lansing). These tensile stress cracks in slipform barriers are a result of early-age stresses developed from slumping plastic concrete.

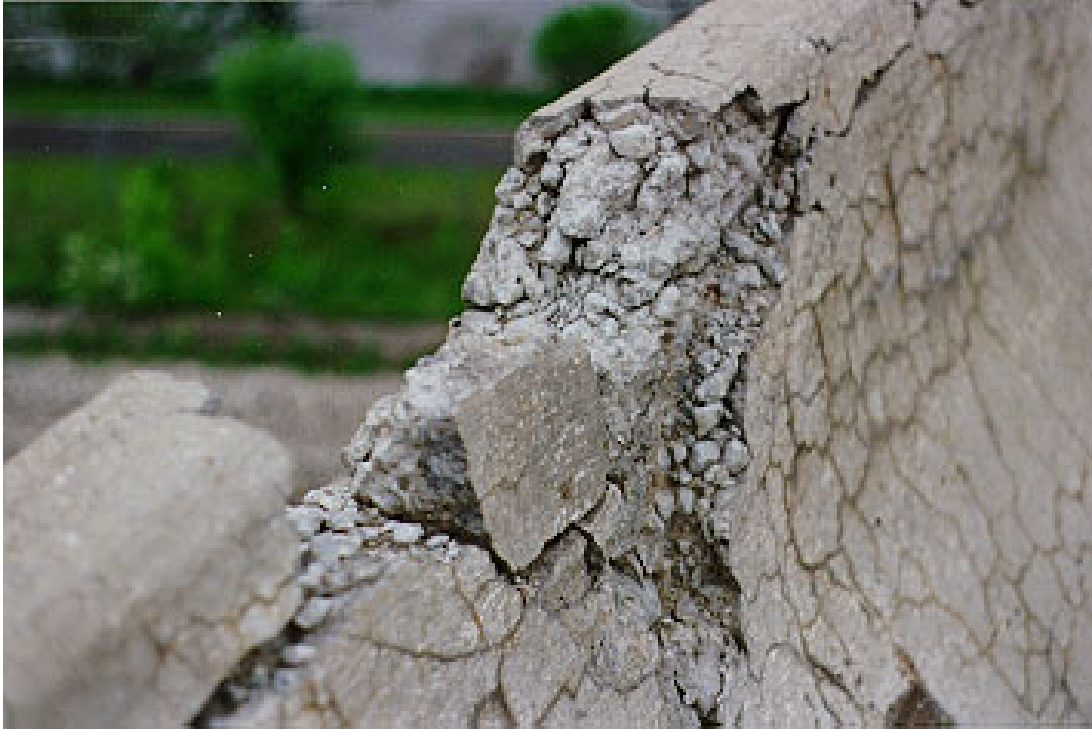
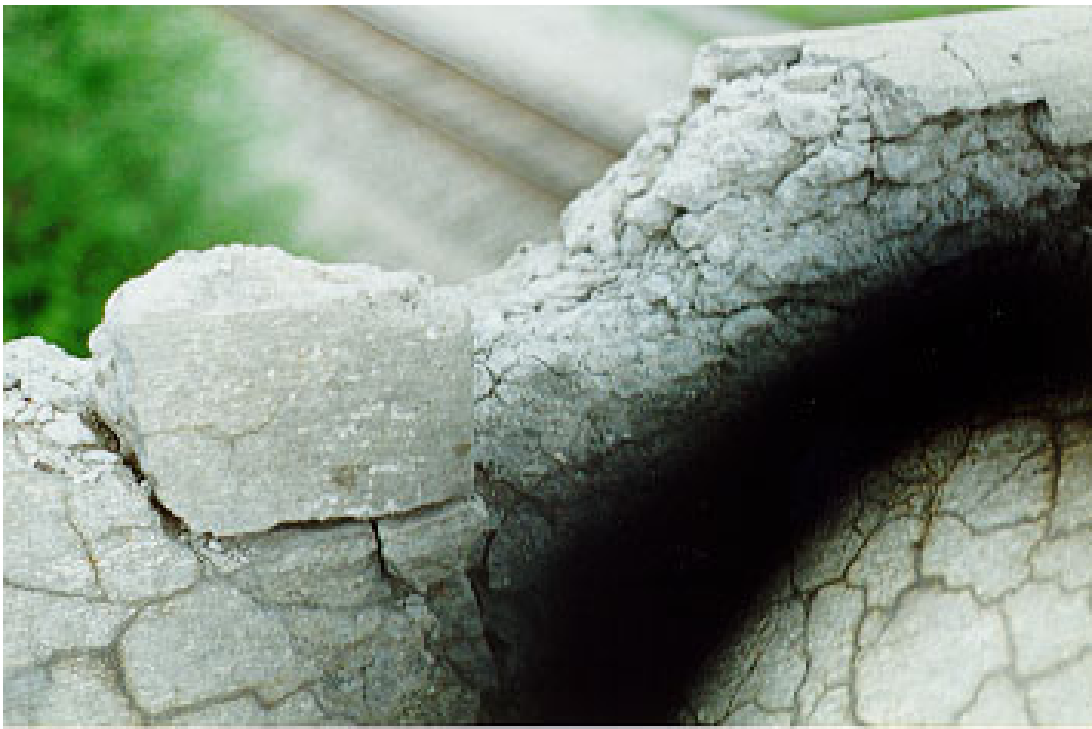
Regardless of the method of construction, concrete barriers constructed using blast-furnace slag coarse aggregate show significantly higher levels of premature decay than barriers constructed with higher quality quarried or natural gravel coarse aggregates. A characteristic indicator of a barrier constructed using blast-furnace slag coarse aggregate is one possessing a massive amount of surface drying shrinkage cracks. Many are clustered representing a “turtle shell” pattern initially noticeable only shortly after rainfall when the surface has dried, but moisture is still observed weeping from these fine surface cracks. Eventually, the thin platelets encompassed by the turtle shell cracking patterns spall. The spalling then exposes the interior concrete to the harsh environment. One other characteristic indicative of barriers constructed using blast-furnace slag coarse aggregate is severe longitudinal deep cracks propagating along the top concrete surface. Over time, aggressive environmental stresses from moisture absorption widen and deepen the longitudinal cracks, eventually causing the barrier top to crumble and fall away. It is evident by field observations that slipform barriers constructed using blast-furnace slag coarse aggregate show the highest level of premature decay. Figures 22 through 24 show characteristic deterioration of the median barrier on I-94 west of State Street in Ann Arbor, and a fascia barrier on US-23 over the Huron River in Washtenaw County, both constructed using blast-furnace slag coarse aggregates.

Figure 23A and 23B: Barrier on SB US-23 over the Huron River in Washtenaw County constructed in 1988.

- Conduct thorough candidate surveys by region to assess barriers for programmed replacement.
- Discontinue the use of blast-furnace slag and other highly absorptive/low durability coarse aggregates in Portland cement concretes used for all barrier/railing applications.
- Discontinue the use of slipform construction method for barrier construction applications.

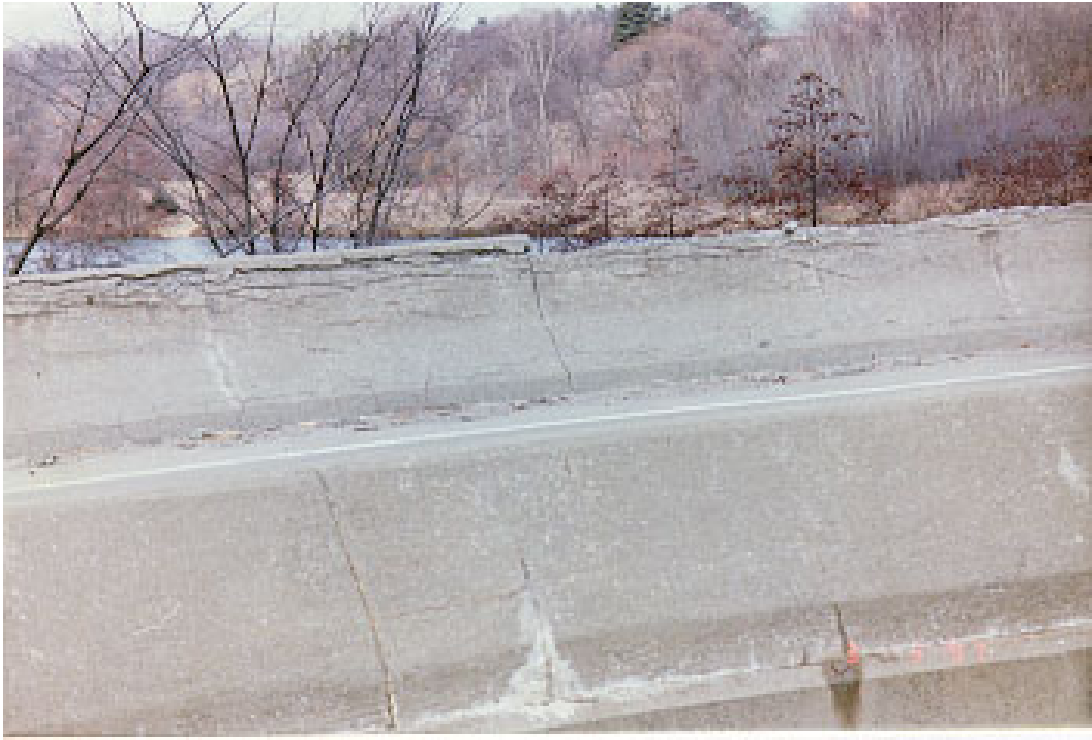
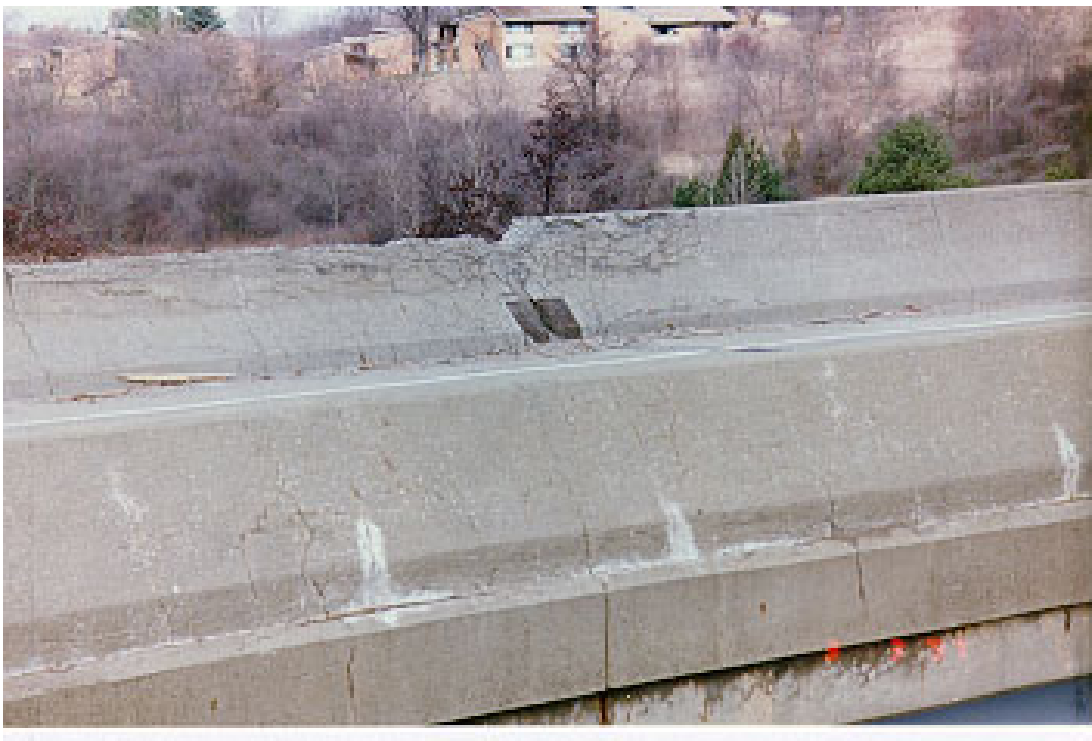
Figure 24A and 24B: Barrier on SB US-23 over the Huron River in Washtenaw County constructed in 1988.
