# *The* **MICHIGAN TEST ROAD**

**FINAL REPORT on the  
DESIGN  
PROJECT**

**FINAL REPORT - DESIGN PROJECT  
MICHIGAN TEST ROAD**

**Report No. 302  
Research Project 39 F-7 (2)**

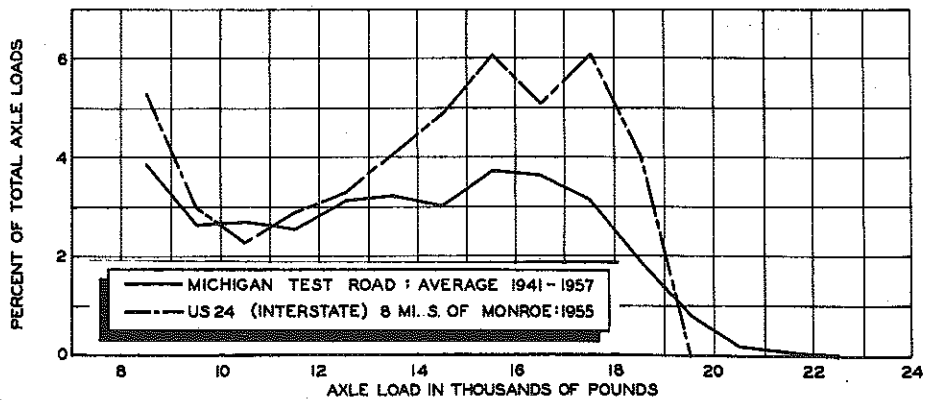
Figure 7. Axle Load Frequency

The axle load frequency on the Michigan Test Road, averaged for the 17 years, is presented graphically in Figure 7. For comparison, a similar axle load frequency curve is shown for 1955 commercial traffic on

heavily travelled Interstate route US 24, 8 mi south of Monroe, Mich. A further comparison is made in Figure 8, showing the percentage of total commercial axle loads in excess of any given weight--one quarter of the axle loads exceed 10,800 lb on the Michigan Test Road, while on US 24, one quarter exceed 14,200 lb.

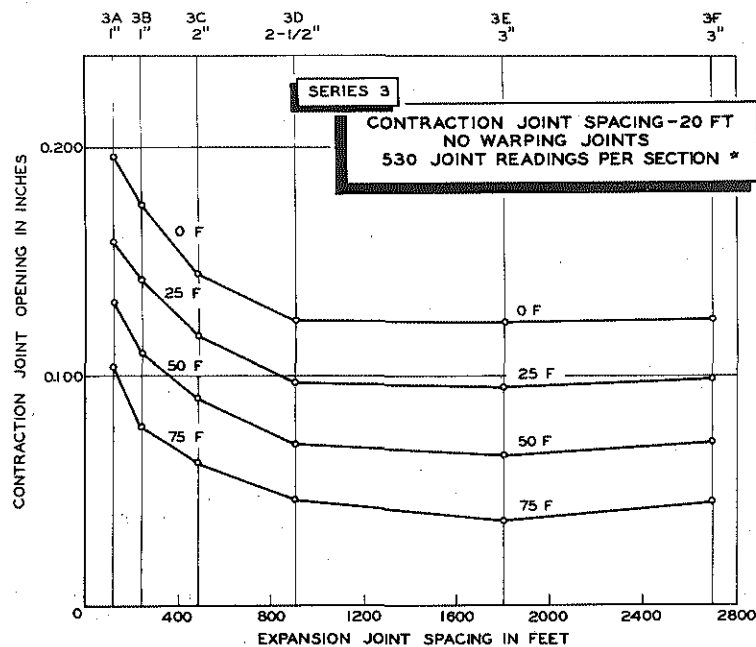
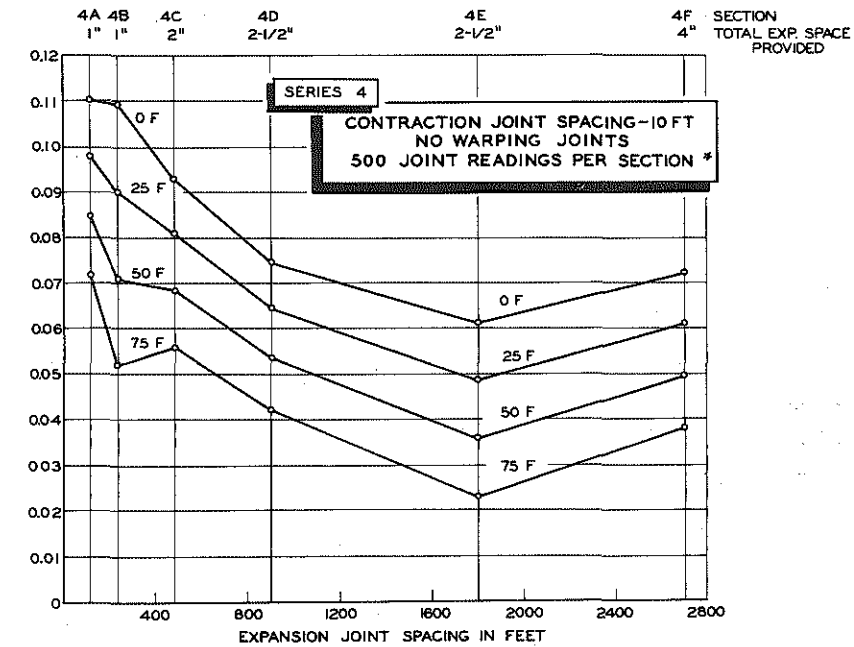
Figure 14. Effect of Expansion Joint Spacing on Contraction Joint Opening

Effect of Expansion Joints. By comparing data from Sections A through F of Series 1, 2, 3, and 4, it is possible to determine the effect of expansion joint spacing on contraction joint width openings for several slab lengths. In Figure 14, the data for various curves were obtained by averaging readings from all instrumented joints in each test section. There was some difference in the joint width movements near the end of a section (close to an expansion joint or relief section), and for the joints near the middle of a section. Joints near section ends had openings which averaged 2, 12, and 28 percent higher than joints in the middle of the section, for the 900-, 1,800-, and 2,700-ft expansion joint spacings, respectively. Points shown on these graphs for various temperatures were obtained from lines of regression based on statistical analysis of joint opening versus temperature. In every case, contraction joint opening decreased markedly as expansion joint spacing increased from 120 to 240 ft, and with one inch of total expansion space. Generally, the decrease in contraction joint opening continues to an expansion joint spacing of 900 ft (total expansion space of 2 1/2 in.), but then stays rather uniform for 900-, 1,800-, and 2,700-ft expansion joint spacings (total expansion space of 2 1/2, 3, and 3 in. respectively). An exception to this rule is Series 4, where the pattern is somewhat different, because total expansion space provided for 1,800- and 2,700-ft expansion joint spacings was 2 1/2 and 4 in. rather than 3 in. as in Series 1, 2, and 3.

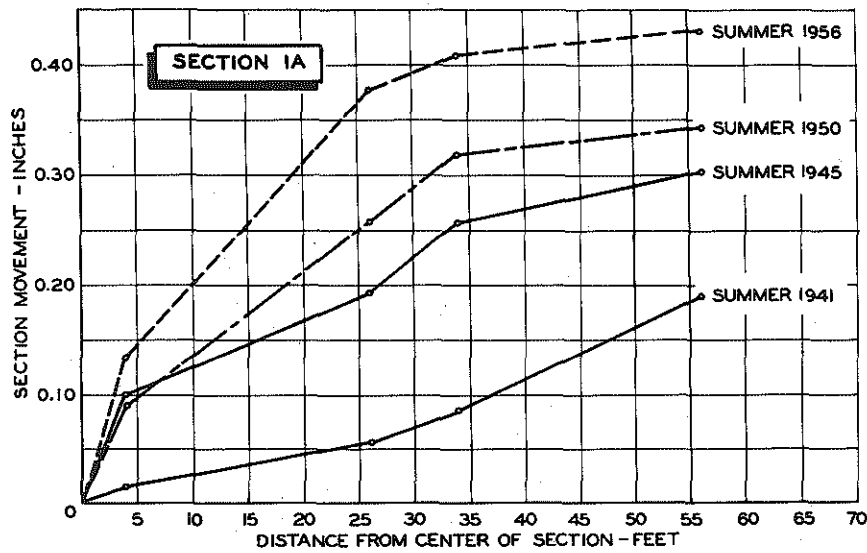
Figure 19. Relation Between Section Movement and Distance from Center of Section

In certain sections of Series 1, 2, 3, and 4, reference monuments were established to measure relative movement of different parts of the sections with respect to fixed points in the subgrade. Monuments were placed at the center, quarter points, and ends of Sections 1A, 1F, and 4F, and the ends and midpoints of Sections 3A, 4A, 1C, 4C, 1D, 3D, 2F, and 3F. Figure 19 shows the relationship between pavement movement and distance from the centers for Sections 1A, 1F, and 4F. Time's effect is illustrated by the progressive increase in amount of section movement from the first year to the last. Most of the sections were instrumented for measurement of pavement movement only at the center and ends. However, by comparing end movements of the various sections, it is possible to determine the effects of contraction, expansion, and intermediate warping joint spacing on the magnitude of this movement (Figure 20).

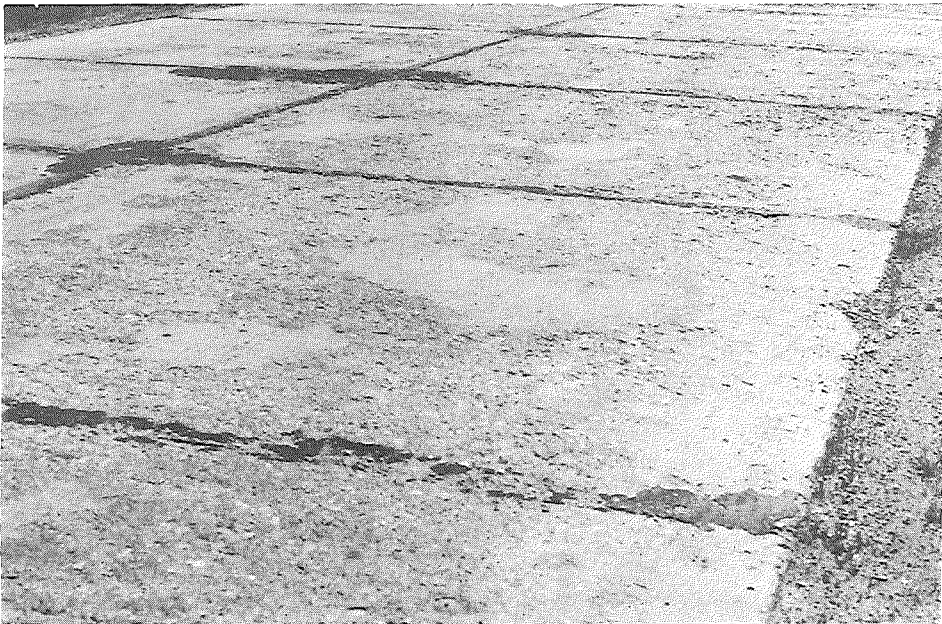
Variation in pavement condition in Series 1 through 4 is shown pictorially in Figures 22 through 25. The unscaled surface of part of Section 1C is shown in Figure 22, while Figure 23 illustrates light to medium scaling in Section 4C. More advanced scaling is illustrated in Figure 24, and typical scaling along a transverse joint in Figure 25.

Figure 24. Heavy Scale of Pavement Surface, Section 4E

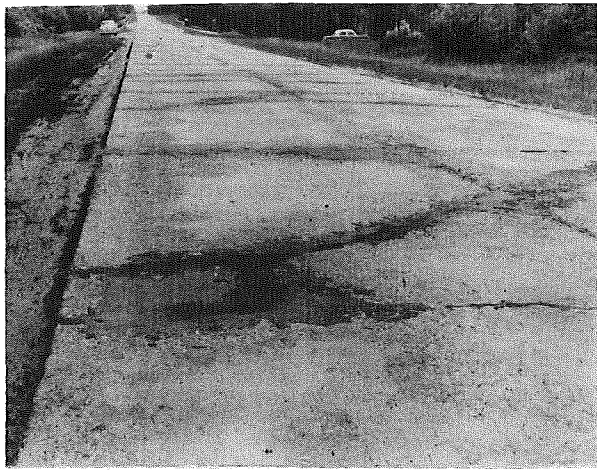
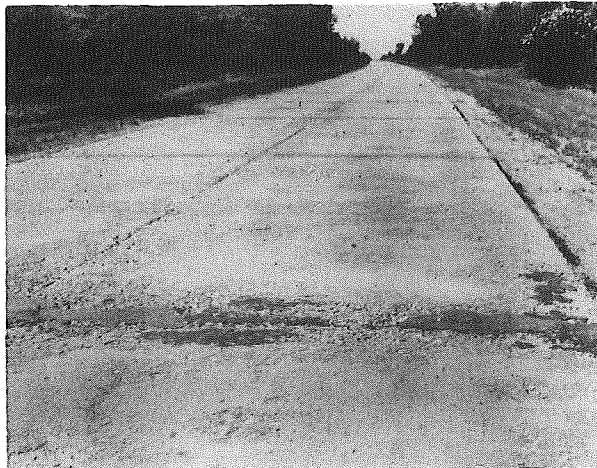
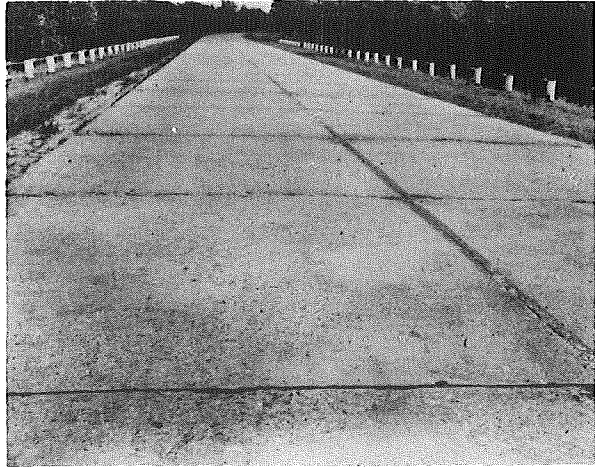
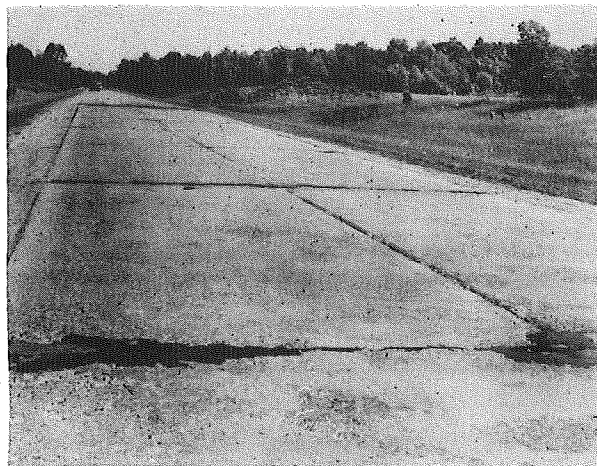
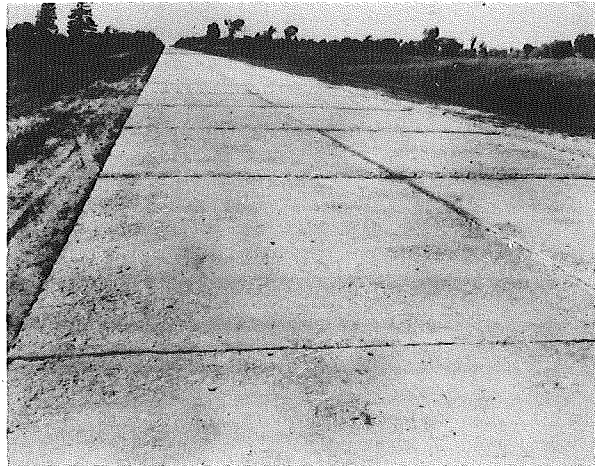
**Figure 32. General Views of Pavement Sections A and B of Series 6, 7 and 8**

The general physical condition of the pavement surface at time of re-surfacing for each section is shown in Figures 32 and 33.

**Section 6A**  
**Station 94+25 Looking South**  
**at Frost Heave Area**

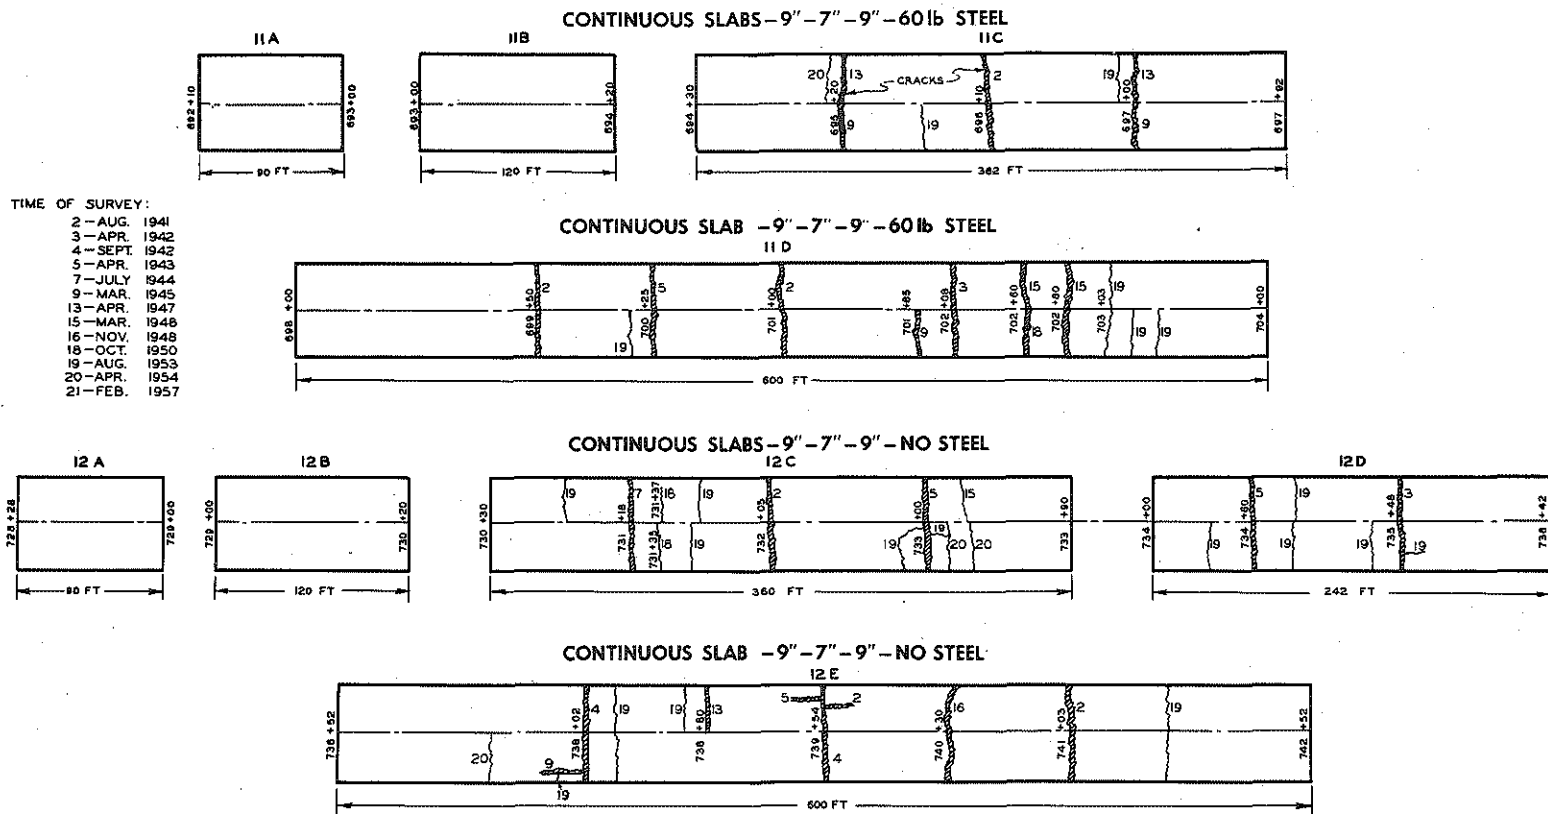
Figure 34. Pavement Condition: Series 11 and 12

series had numerous transverse cracks which opened appreciably (Figure 34). These cracks were instrumented and the openings measured twice a year. In Section 11C, these readings showed that the reinforcing steel had broken at Sta 696+10 as early as 1947, but at Sta 695+20 and 697+00 the steel apparently remained intact until 1949. A tabulation of pavement cracking is given in Table 12. The amount of transverse cracking was not significantly different in the two series. However, the reinforced pavement was in better general physical condition than the nonreinforced.
