| 4. Title and Subtitle Extending the Life of Asphalt Pavements (OR09-086A) | | 5. Report Date May 2011 | |
| 7. Author(s) Harold L. Von Quintus, P.E. and Rohan Perera, P.E. | | 8. Performing Org. Report No. 000510 – R5 | |
| 12. Sponsoring Agency Name and Address Michigan Department of Transportation Office of Research and Best Practices 425 West Ottawa Street Lansing, Michigan 48933 | | 13. Type of Report & Period Covered Research Report Oct. 07, 2009 to April 30, 2011 | |

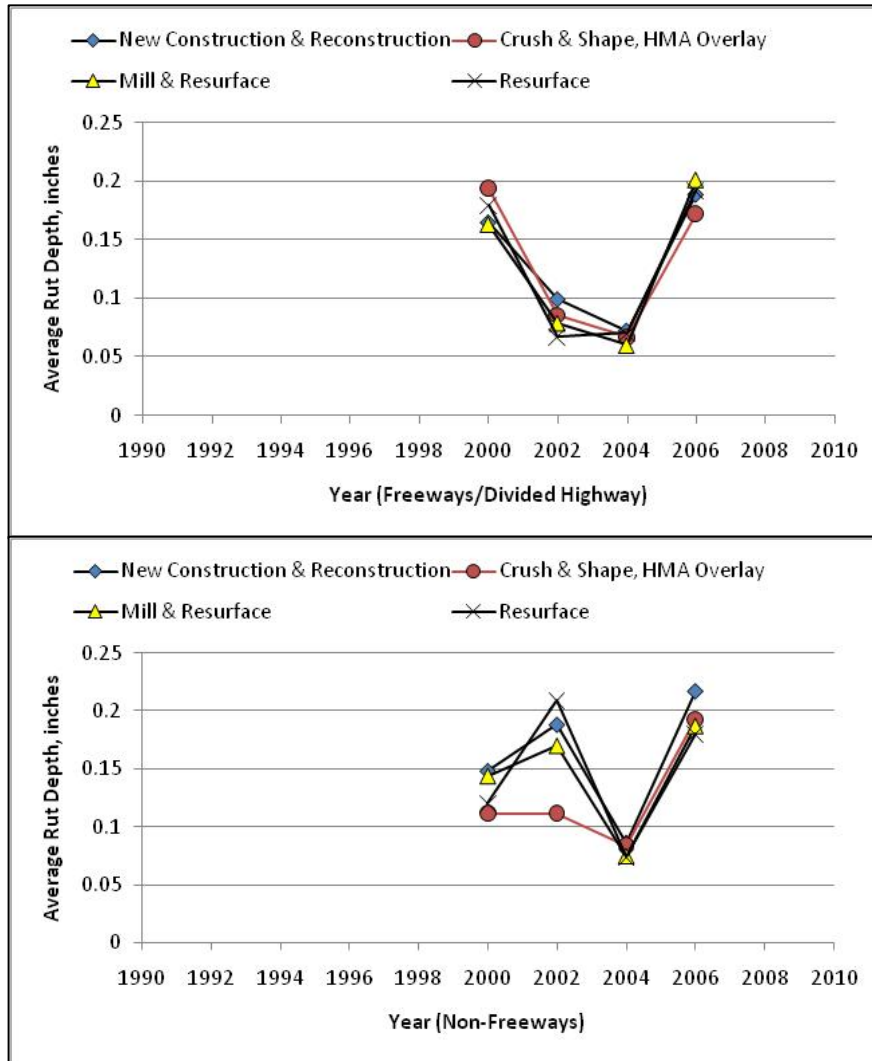
Figure 17. Change in Average Rut Depths Over Time for Different Pavement Structures

Possible explanations for the trend shown in Figure 17 include; abnormally cool summers over a couple of years, a change in the method or equipment used to measure rut depth, and/or implementation of specifications that result in stiffer HMA mixtures followed by abnormal hot summers over a couple of years. The other observation from this initial data review is that most rut depths are significantly less than the threshold or trigger values used by many agencies (0.35 to 0.50 inches).

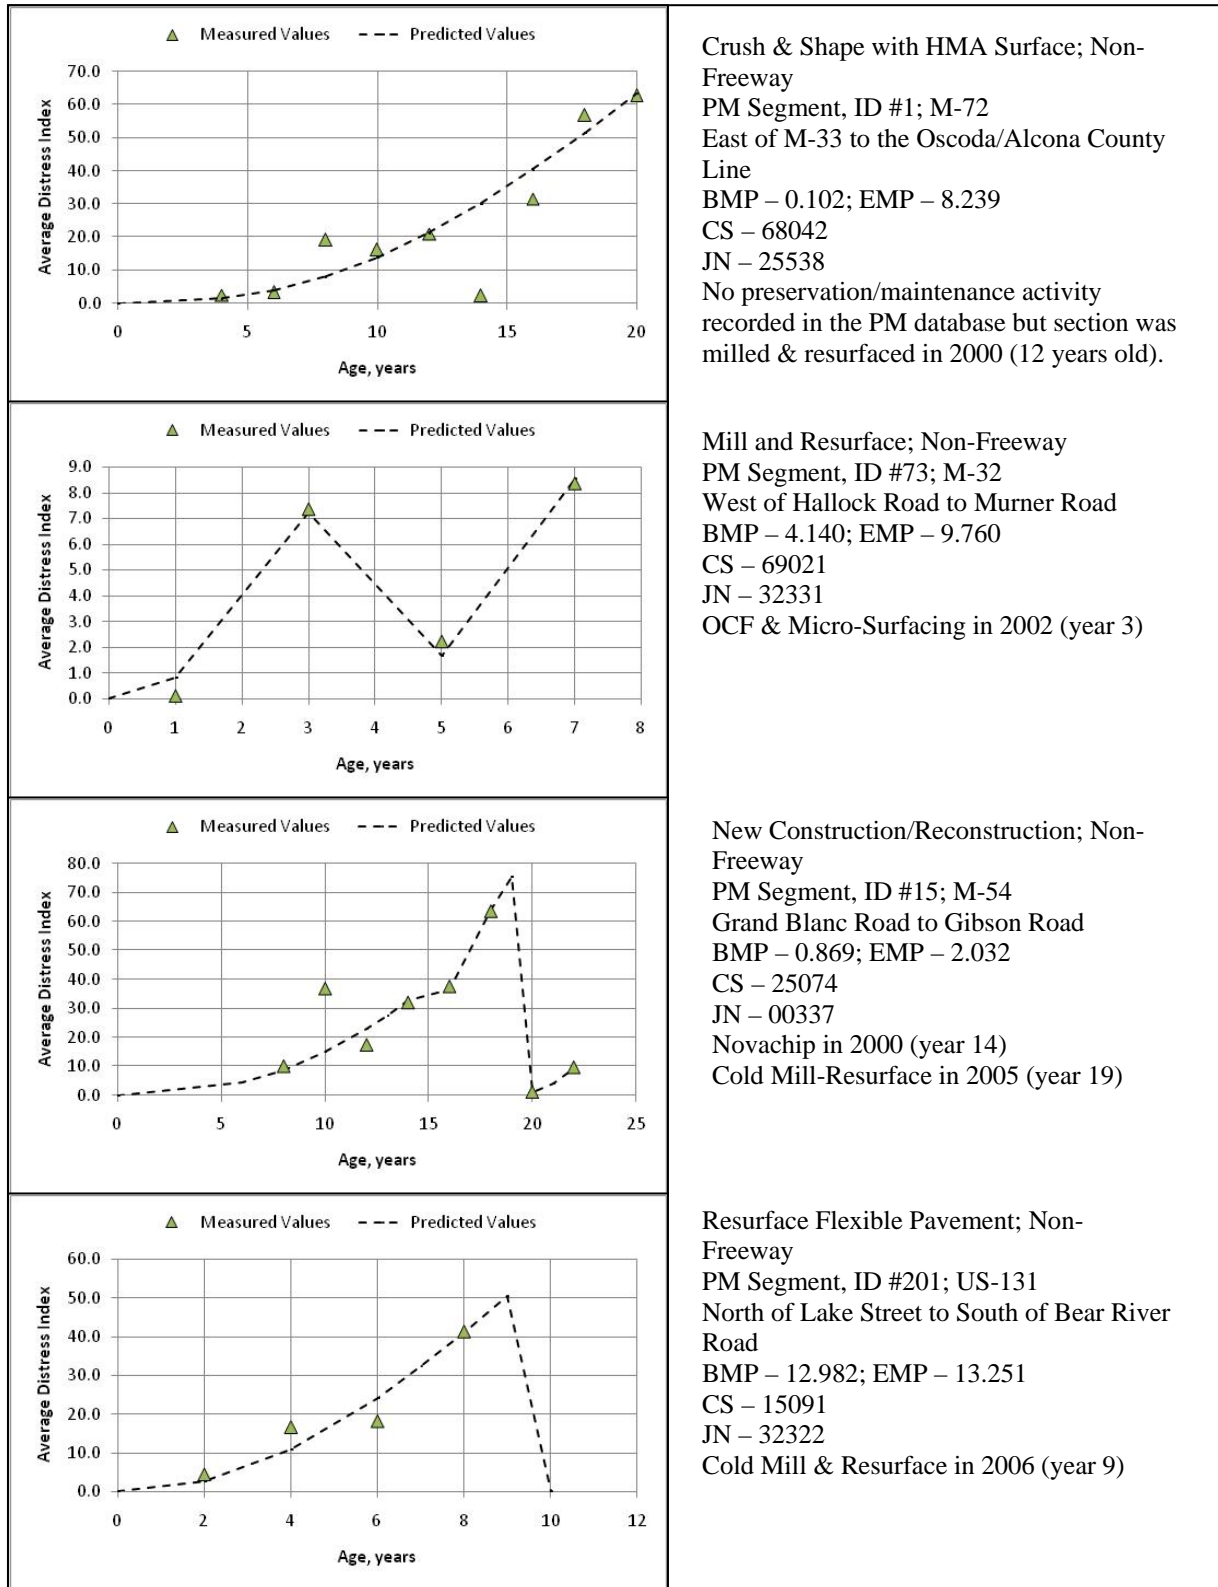
Crush & Shape with HMA Surface; Non-Freeway
 PM Segment, ID #1; M-72
 East of M-33 to the Oscoda/Alcona County Line
 BMP – 0.102; EMP – 8.239
 CS – 68042
 JN – 25538
 No preservation/maintenance activity recorded in the PM database but section was milled & resurfaced in 2000 (12 years old).

Figure 24. Predicted and Measured DI Values for Selected Non-Freeway PM Segments

Figures 24 and 25 compare the measured and predicted DI values for selected PM segments for which different preservation methods were placed at different times. As shown, equation 1 does a reasonable simulation of predicting the increase in DI values over time. Conversely, there are some PM segments for which equation 1 does not accurately simulate the change or increase in DI values measured over time. This difference between predicted and measured values is probably related to the measurement error, other maintenance activities not recorded in the PM database, and/or equation 1.

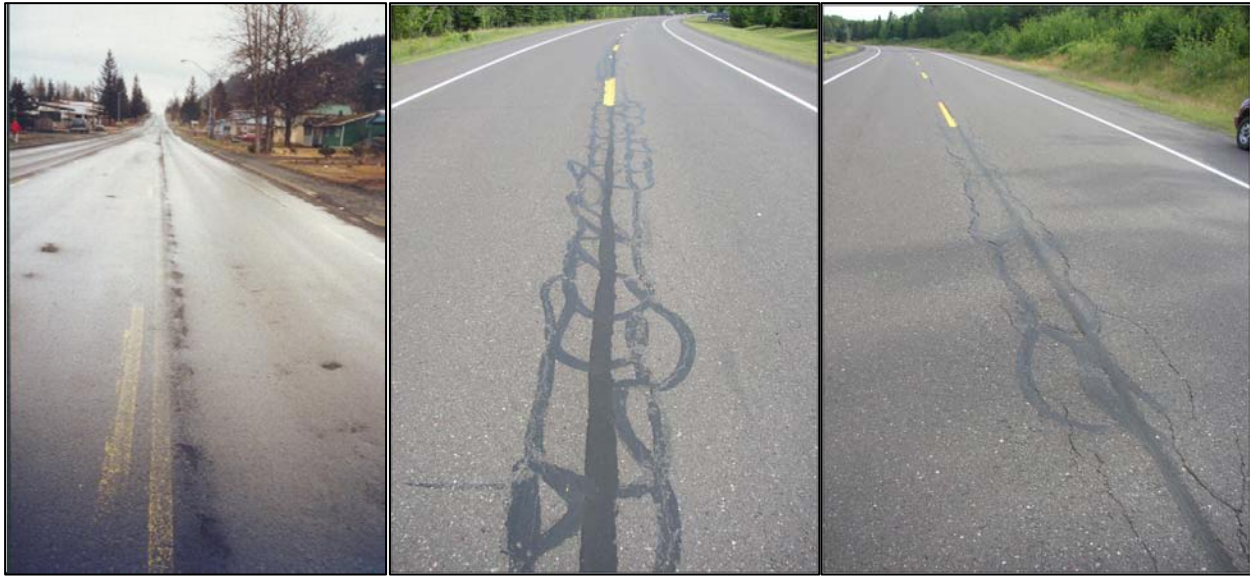
Figure 49. Cracking and Accelerated Deterioration Along Longitudinal Centerline Joints that were Inadequately Constructed

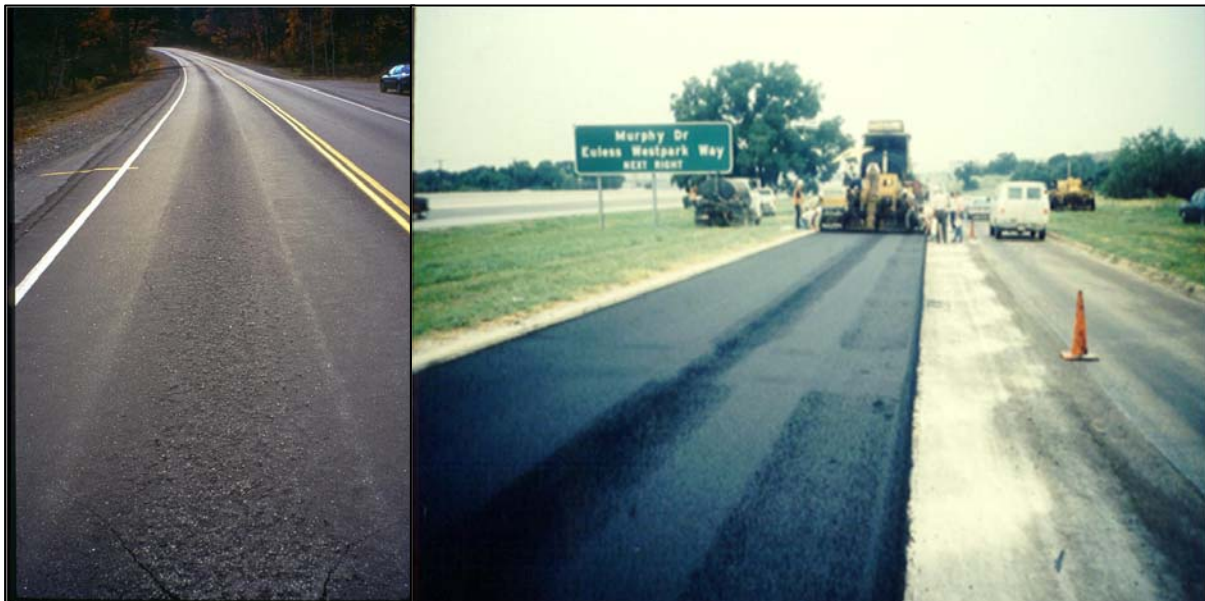
Figure 50. Cracking and Deterioration Along the Center of the Lane where the HMA was Improperly Placed

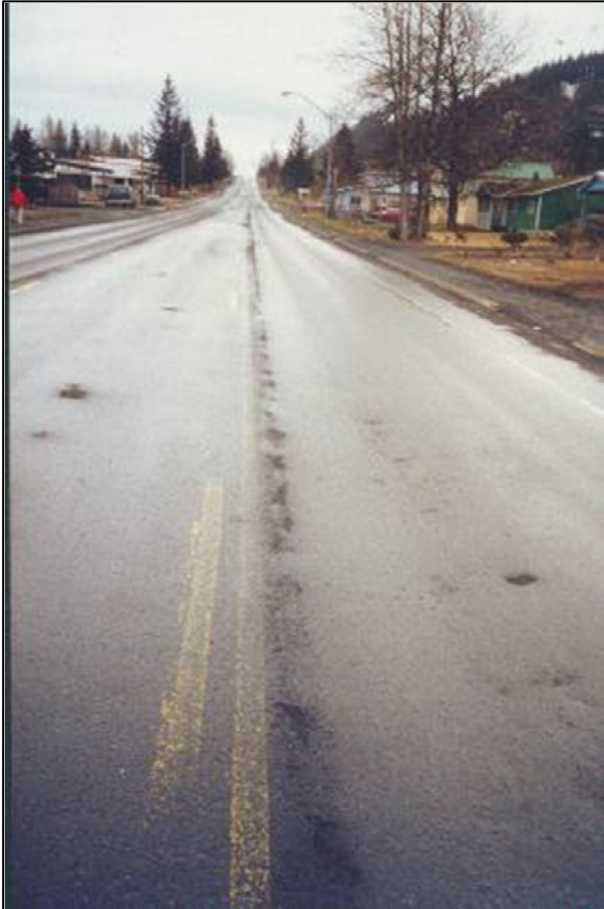
Figure 1. Photograph Showing an Example of Accelerated Deterioration Along a Longitudinal Centerline Joint that was Inadequately Constructed

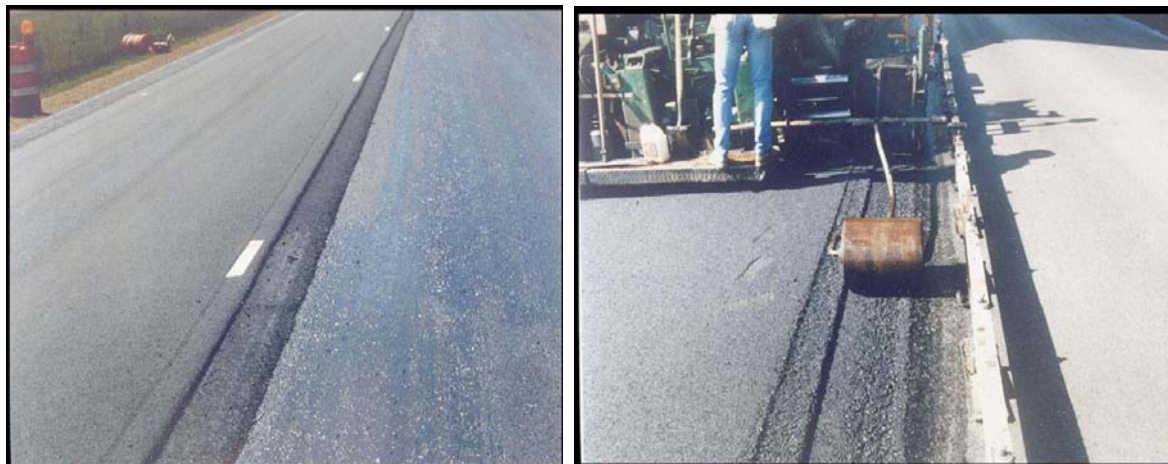
Figure 8. Notched Wedge Joint (a small steel drum is attached to paver to roll the wedge behind the paver)
