PERFORMANCE EVALUATION OF 'MIRAFI 140'
FABRIC AS OVERLAY REINFORCEMENT TO
CONTROL REFLECTION CRACKING

C. A. Zapata

Research Laboratory Section
Testing and Research Division
Research Project 77 TI-398
Research Report No. R-1125

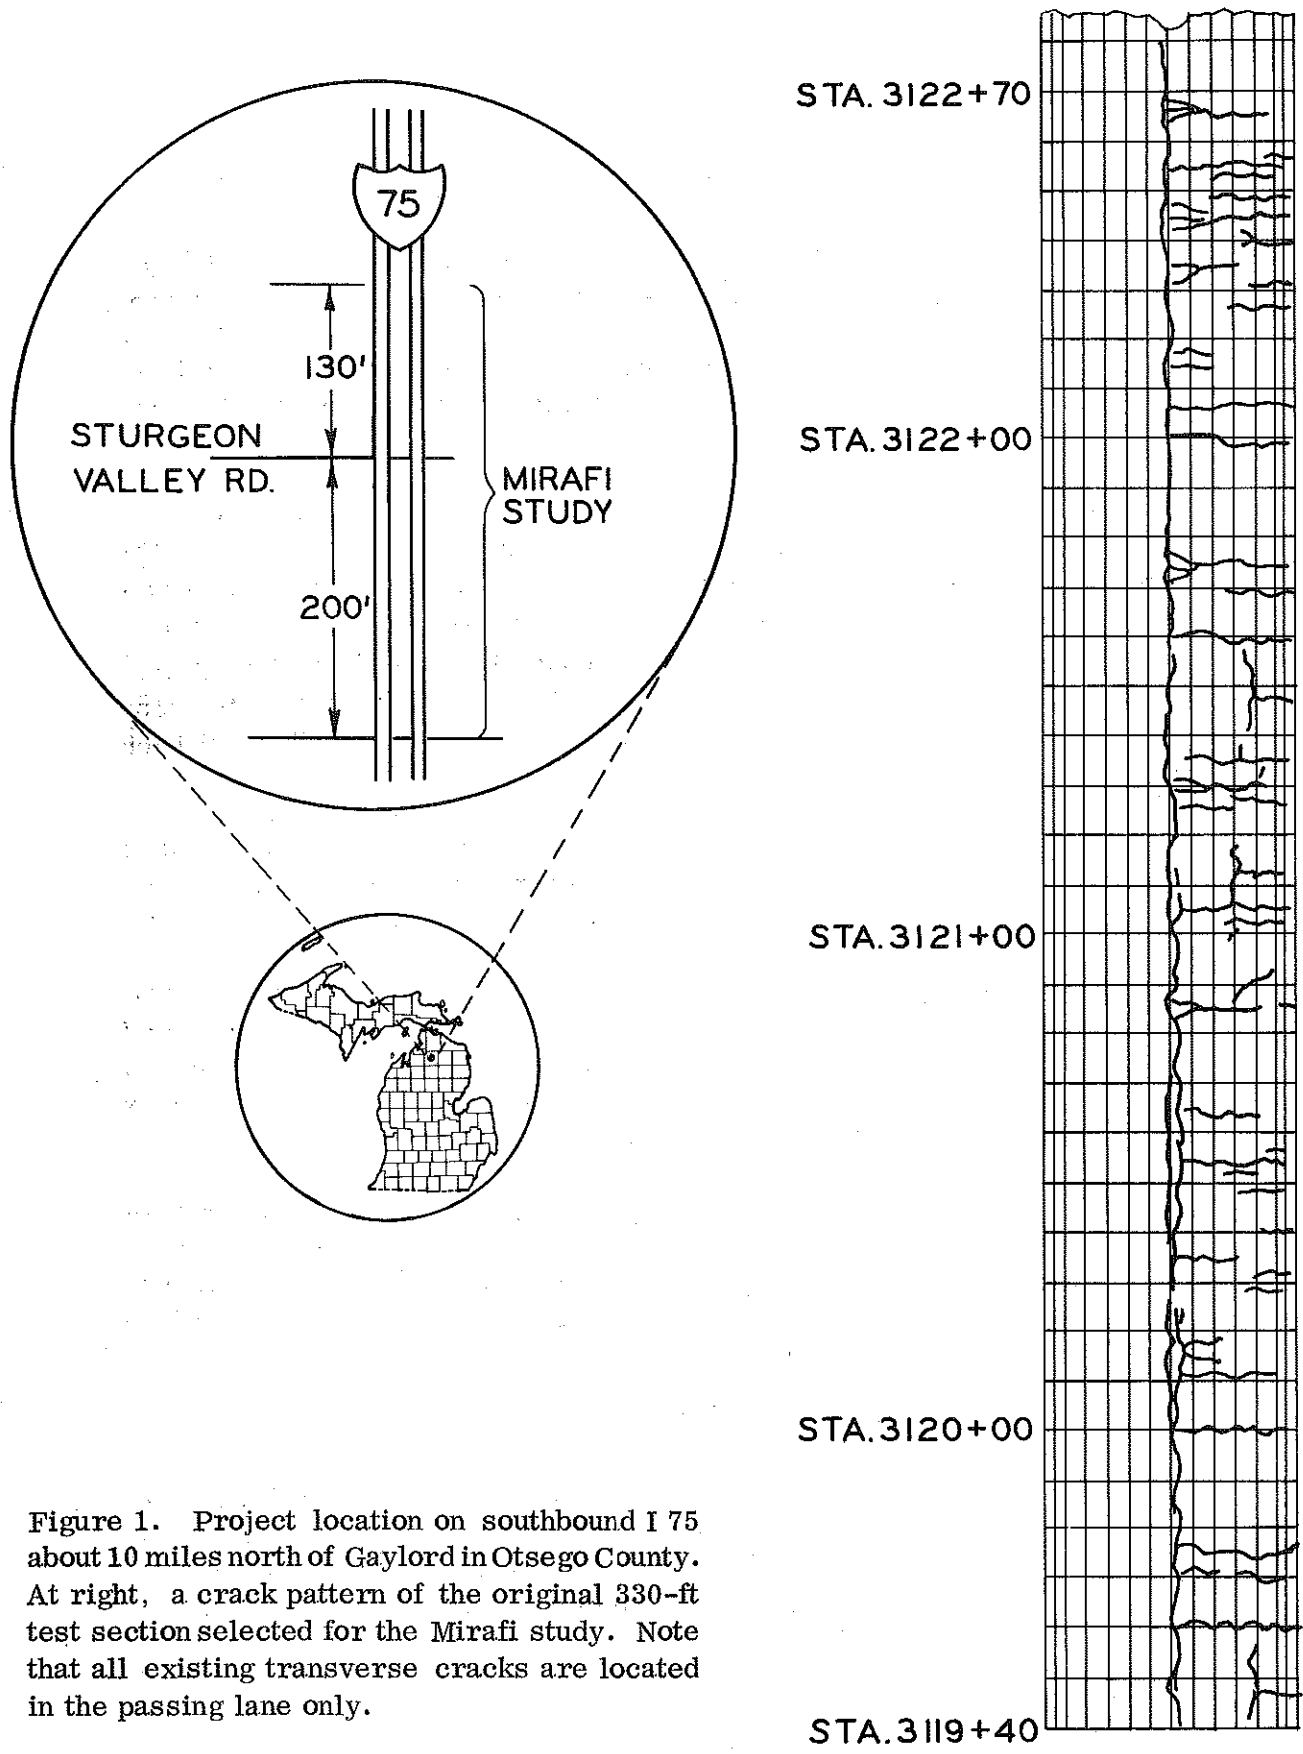
Figure 1. Project location on southbound I 75 about 10 miles north of Gaylord in Otsego County. At right, a crack pattern of the original 330-ft test section selected for the Mirafi study. Note that all existing transverse cracks are located in the passing lane only.

The test site is located on southbound I 75 of Project I 69014-09240A, from Sta. 3119+40 south to Sta. 3122+70 north of Sturgeon Valley Rd about 10 miles north of Gaylord in Otsego County (Fig. 1). The 15-year old test area, which carried an average daily traffic of 7,000 vehicles in 1977 was originally built as a three-course asphaltic concrete pavement. This area has not been resurfaced over a 15-year service period since construction.

Since a major objective of this study is to evaluate the crack-resistant property of the Mirafi fabric, condition surveys of the test area were conducted before the experimental resurfacing was applied. Existing surface cracks were counted and mapped in September 1977. Figure 1 shows the crack patterns of the original 330-ft test section selected for the Mirafi study. Figure 2 shows typical distress conditions of the original 15-year old flexible pavement. Note that this 330-ft test section of two-lane pavement developed both transverse and longitudinal cracks. All existing transverse cracks, visible from each side of the roadway, were located in the passing lane of the southbound roadway. Also, a longitudinal crack over 1/4 in. wide and over 400 ft long developed along the pavement centerline.

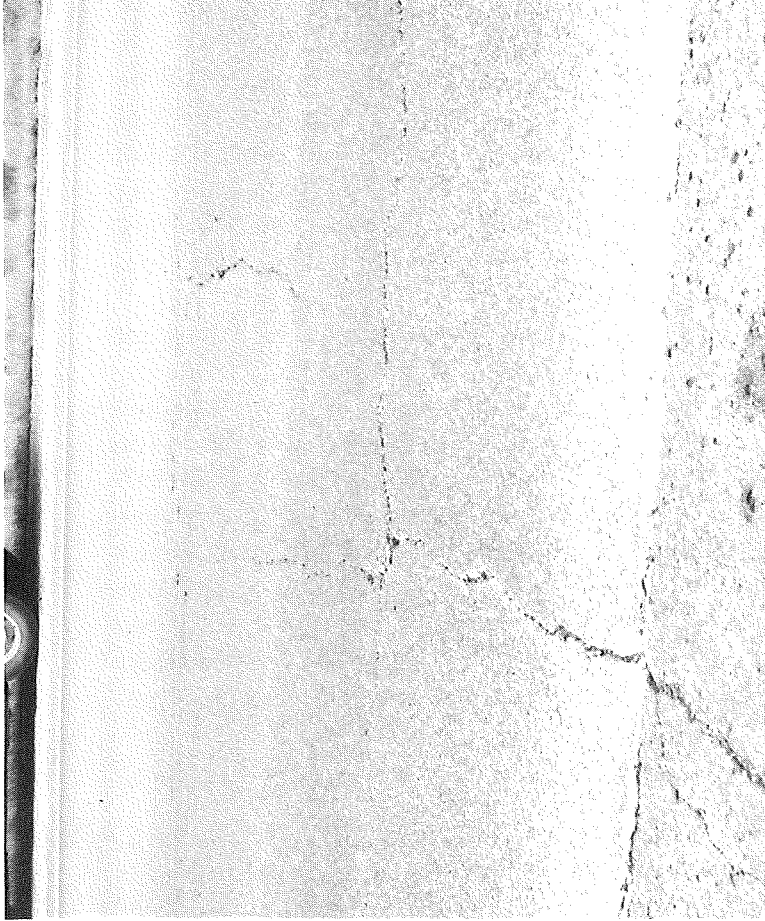
◀ Sta. 3121 looking west from the inside shoulder.

◀ Sta. 3121 looking south from the inside shoulder.

Figure 2. Typical distress conditions of the original 15-year old flexible pavement, construction Project I 69014-09240A on southbound I 75 about 10 miles north of Gaylord in Otsego County.

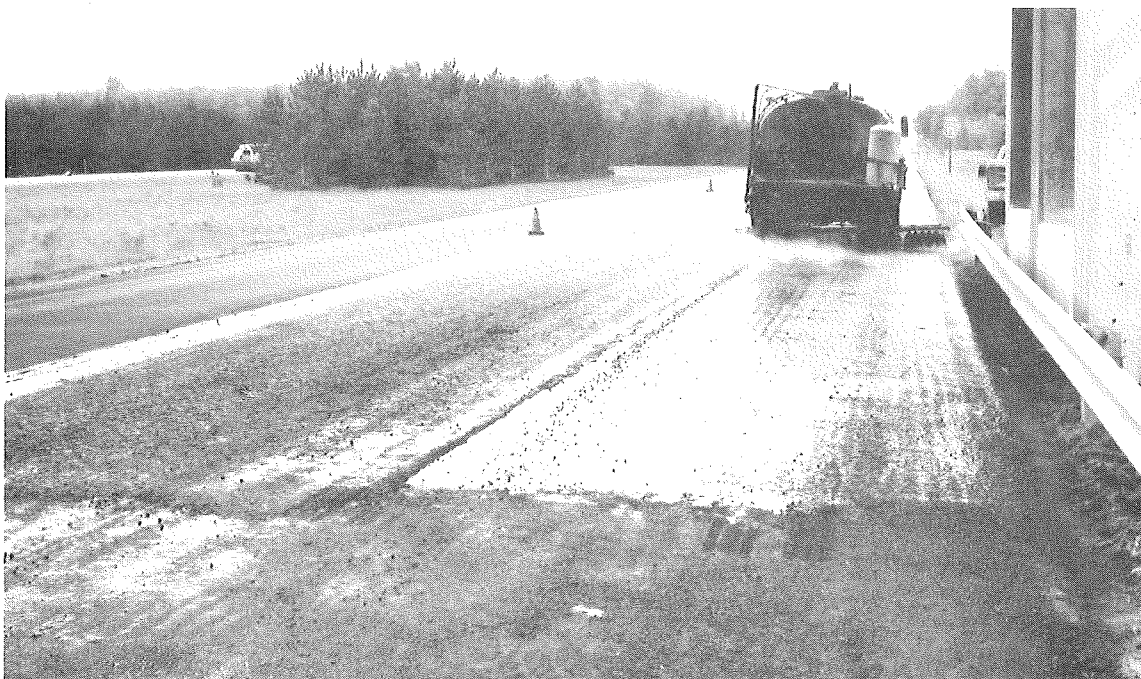
Figure 3. Spraying asphalt emulsion, SS-1h, over the 330-ft traffic lane of the test section. The emulsified asphalt was applied at temperatures over 300 F and at the rate of 0.15 to 0.20 gal/sq yd.

With extra care, the contractor's crew of five men spent more than an hour manually unrolling, laying down and bonding the first 330 ft of fabric, 14-3/4 ft wide. Installation problems such as tearing, wrinkling, and bubbling of the fabric were reasonably controlled during the project. Traffic continued to move along the open lane while the work was in progress. Figures 3 through 6 show field operations during the installation project.

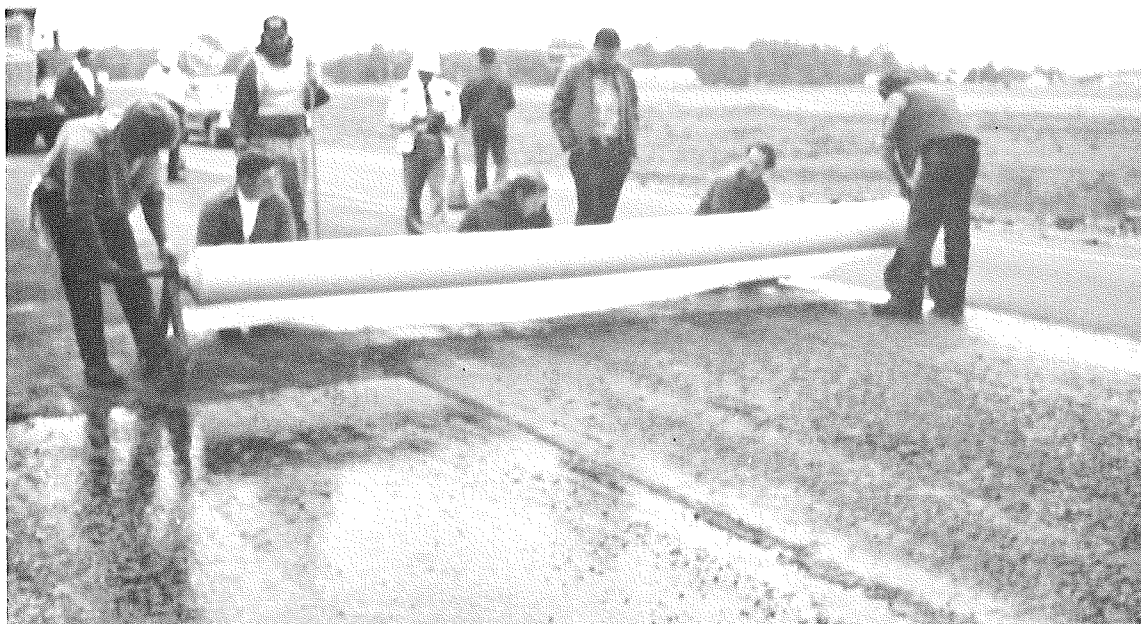
Figure 4. Unrolling, laying down and bonding the first 330-ft roll, 14-3/4 ft width, of Mirafi fabric, required five men and took more than an hour to place the fabric over the asphalt emulsion.

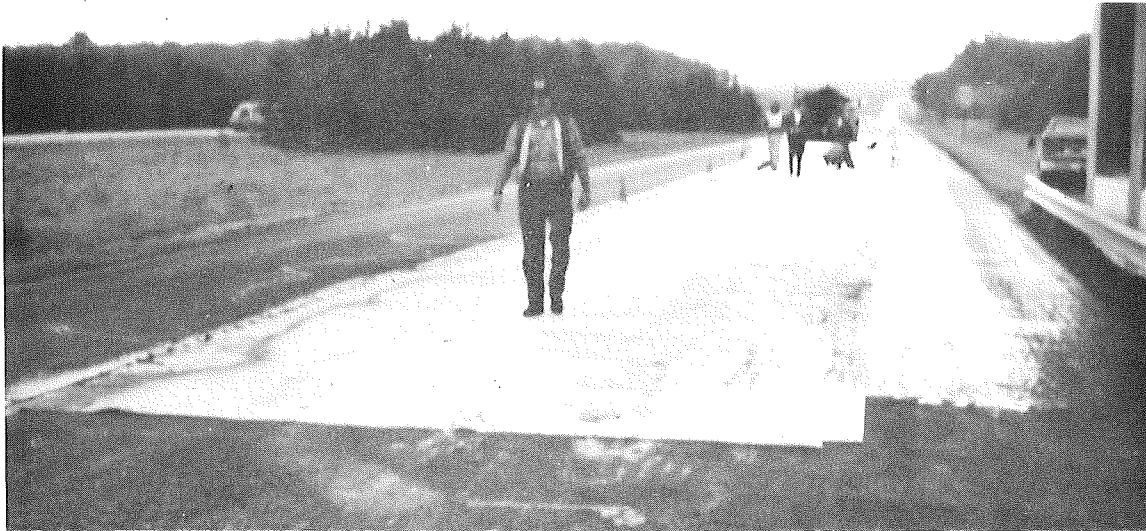
Figure 5. The uncovered Mirafi fabric was properly aligned, bonded and compacted along the straight 330-ft traffic lane of the test section. During the fabric laydown, the passing lane was opened to regular traffic.

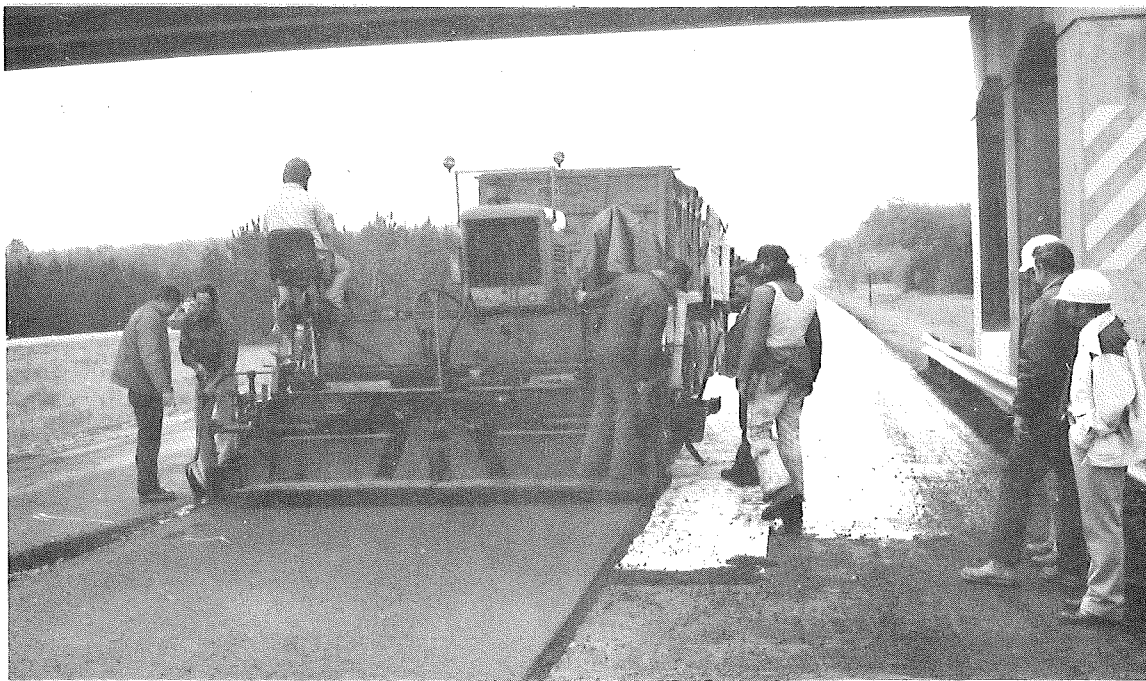
Figure 6. Applying asphaltic concrete overlay to the fabric at a rate of 250 lb/sq yd. The rolling sequence behind the paver required first a 2-ton steel-wheeled roller operating at 3 mph and then another 8 to 12-ton steel-wheeled roller operating also at 3 mph to complete the resurfacing job. Once this lane was compacted and finished, the other lane was ready for the fabric laydown. The two lanes were completed the same day according to plan.

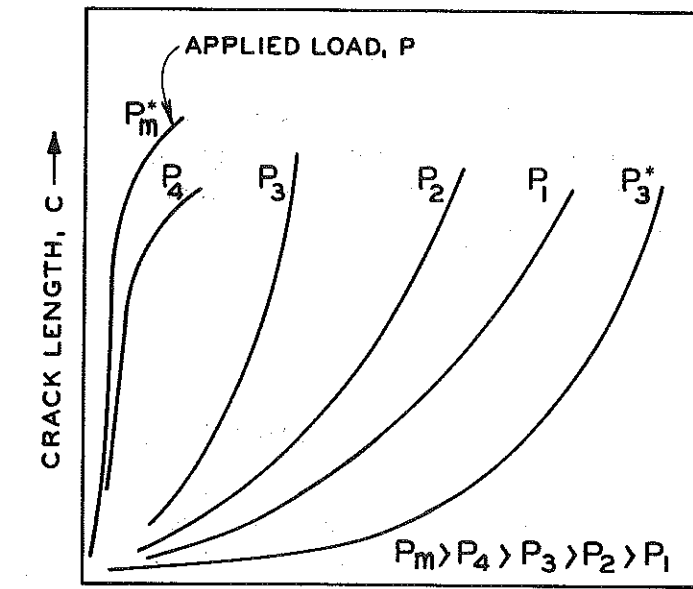
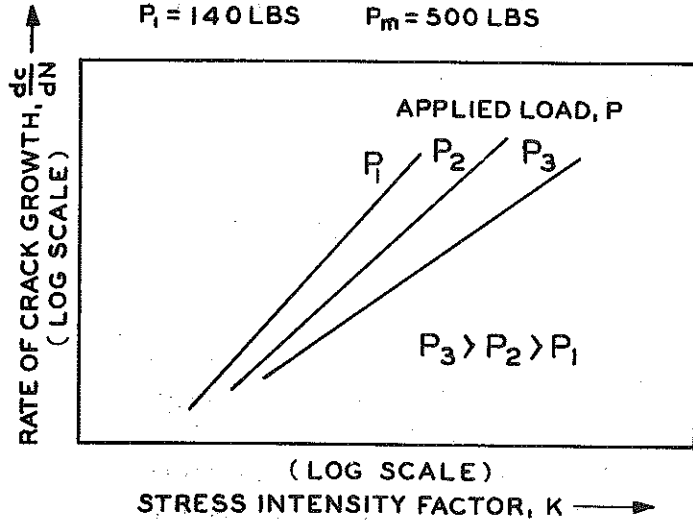
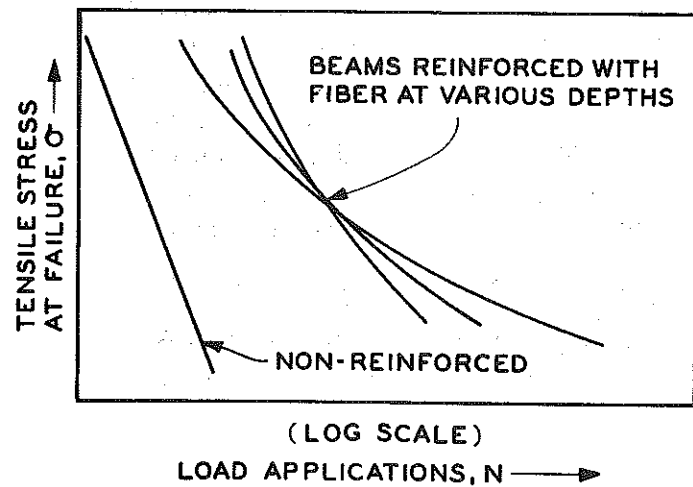
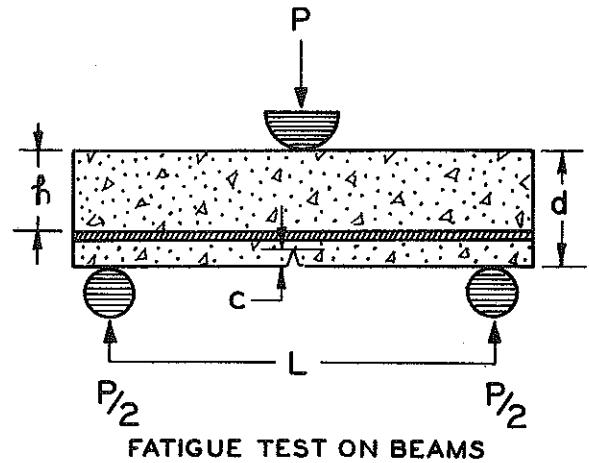
LOAD APPLICATIONS, N →
 *FABRIC-REINFORCED BEAMS
 $P_1 = 140 \text{ LBS}$ $P_m = 500 \text{ LBS}$

FATIGUE TEST ON BEAMS
 P = APPLIED LOAD
 d = BEAM DEPTH
 h = FABRIC-REINFORCED DEPTH
 L = BEAM SPAN
 C = CRACK DEPTH

Figure 1A. Laboratory fatigue results from recent study using fabric-reinforced and non-reinforced asphaltic concrete beams (8).

In an attempt to determine the effect of plastic fabric reinforcement on the fatigue strength of asphalt overlays, a simplified laboratory model (Fig. 1A) was tested in a recent study (8). Fracture and fatigue tests to simulate pavement response under actual field conditions were conducted using fabric-reinforced and non-reinforced asphaltic beams. The test loading ranged from 140 to 500 lb simulating field conditions under low and high stresses, respectively. Figure 1A includes three charts summarizing the laboratory results of this study. Figure 1Aa shows crack-growth trends associated with increased load applications N for fatigue loadings P ranging from 150 to 500 lb. It appears that fabric-reinforced as well as non-reinforced beams under high loadings ($P > 300$ lb) failed to stop or retard crack growth. However, fabric-reinforced beams under low stresses ($P < 200$ lb) showed better fatigue strength. Figure 1Ab seems to indicate that as the rate of fatigue cracking $\frac{dc}{dN}$ increases under various dynamic loadings P, the stress-intensity factor K also increases. Figure 1Ac shows the effect of fabric-reinforcement compared with non-reinforcement on

tensile stresses at the bottom of test beams. This indicates that as the applied tensile stress decreases, the number of loading cycles N increases and also that fabric-reinforcement seems to increase the fatigue strength of the test beams.
