MICHIGAN'S EXPERIENCE WITH DIFFERENT MATERIALS AND DESIGNS ON THE SKID RESISTANCE OF BITUMINOUS PAVEMENTS

Paul J. Serafin
Bituminous Engineer

Prepared for Presentation
The 49th Annual Meeting of the Highway Research Board
Washington, D.C., January 12-16, 1970

Testing Laboratory Section
Testing and Research Division
Project No. TB-21

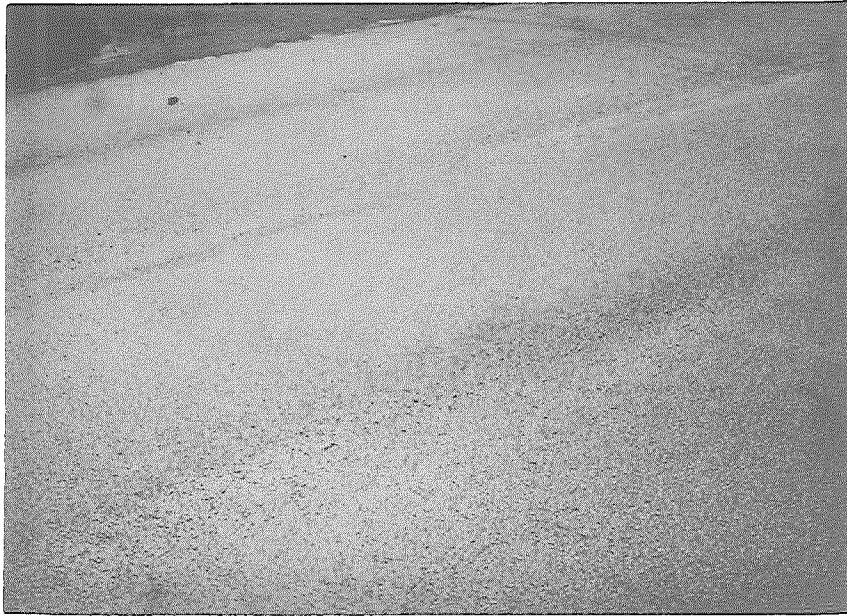
An example of a slippery pavement caused by polished coarse aggregate is shown in Figure 1. Note the reflection of light from the pavement surface which is a good indication that it may be slippery. A close-up of a sawed pavement core taken from this surface is shown in Figure 2. Note that the coarse aggregate particles have become oriented in such a way that their flat faces are exposed to the surface and subject to subsequent polishing by traffic. Turning this same specimen at an angle, as illustrated in Figure 3 shows the oily bitumen absorbed into the surface of the coarse aggregate particles which adds to the problem under wet condition.

Figure 1. Polished limestone-slippy pavement surface.

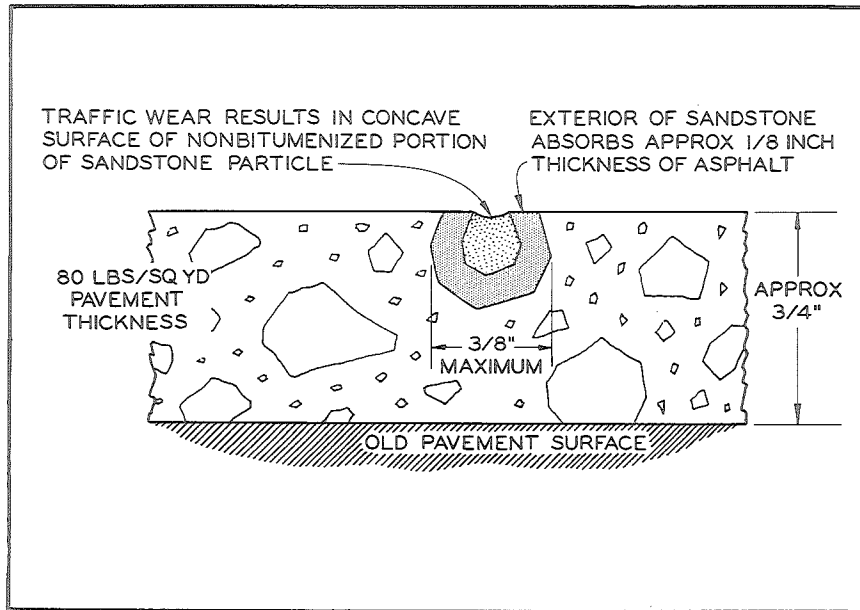
Figure 6. Result of traffic wear on larger particles of crushed sandstone.

Since the crusher-run material appeared to contain sufficient fines, no additional sand was added to the initial mix design. Several bitumen contents, varying from 8 to 10 percent, were tried but the resulting mixture was tough to handle and produced a non-uniform, open-textured mat. After some experimentation, the mix design was changed by adding one part fine sand to five parts crusher-run sandstone, and 9.5 percent 60-70 asphalt. Commercial mineral filler was not added to this mixture. This mixture produced a uniform textured, skid-resistant surface and was used on three intersections in the Bay City area. Normally, a gradation of this type would use about 6.5 percent asphalt; however, because of this material's high absorption (7.2 percent), it was necessary to raise the bitumen to about 9.5 percent in order to produce a serviceable pavement. Figure 4 shows a typical intersection after four years of service using this sandstone mixture and Figure 5 is a close-up showing the sandpaper surface texture. After several months of wear the larger sandstone particles began to show a dishing effect as illustrated in Figure 6. This has not detracted from the excellent service performance of this surface after four years of service under moderately heavy traffic, rather it is felt it has improved its skid resistance characteristics.

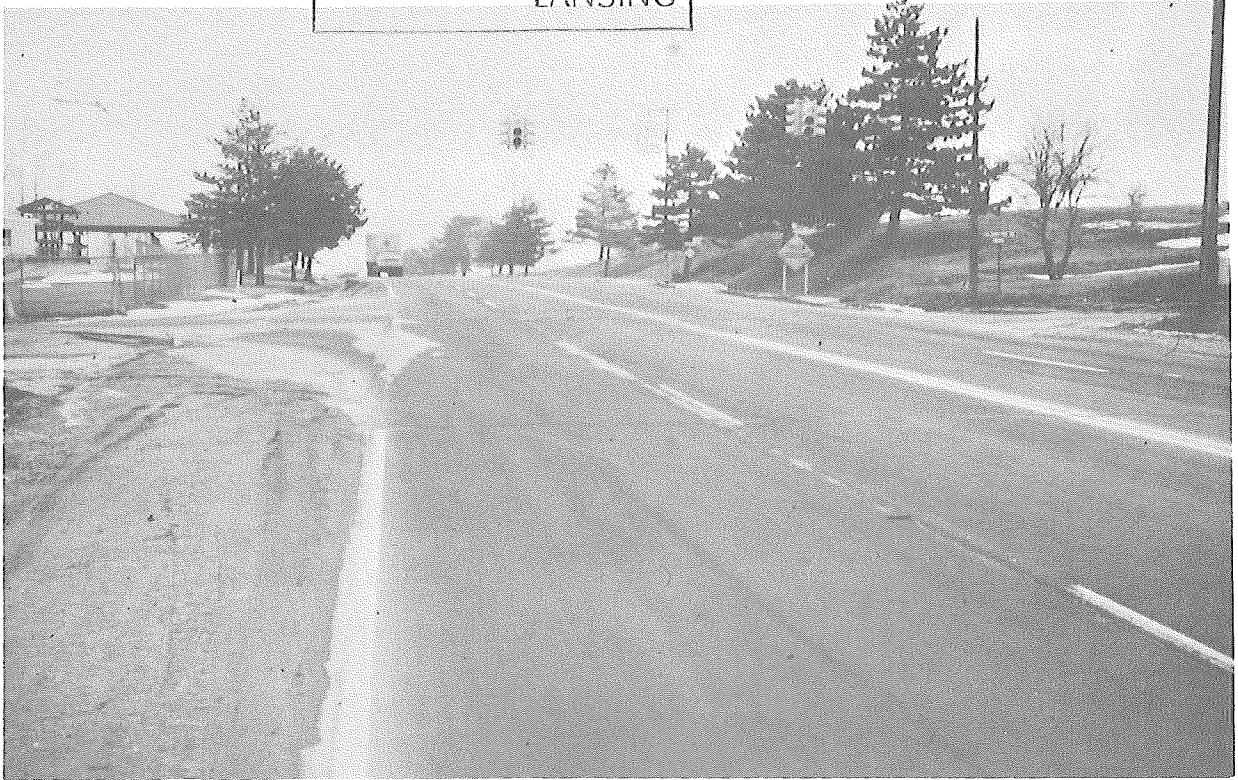
Figure 7. Crushed quartzite surface, 3 years after construction.

Based on laboratory-prepared Marshall specimens and the appearance of a trial pavement surface, the mix design for the major portion of the project was set at 6.5 percent 60-70 asphalt and 4.0 percent fly ash added as mineral filler to make up for the fines lost through washing, with the balance being the quartzite crushings. No other aggregate was added for this mix design. Figure 7 shows a typical surface after three years of service in the Flint area. Note that some loss was experienced where traffic entered from a side gravel road causing considerable localized abrasion, however the balance of the surface is in good condition. Figure 8 shows a close-up of this excellent skid resistant surface.

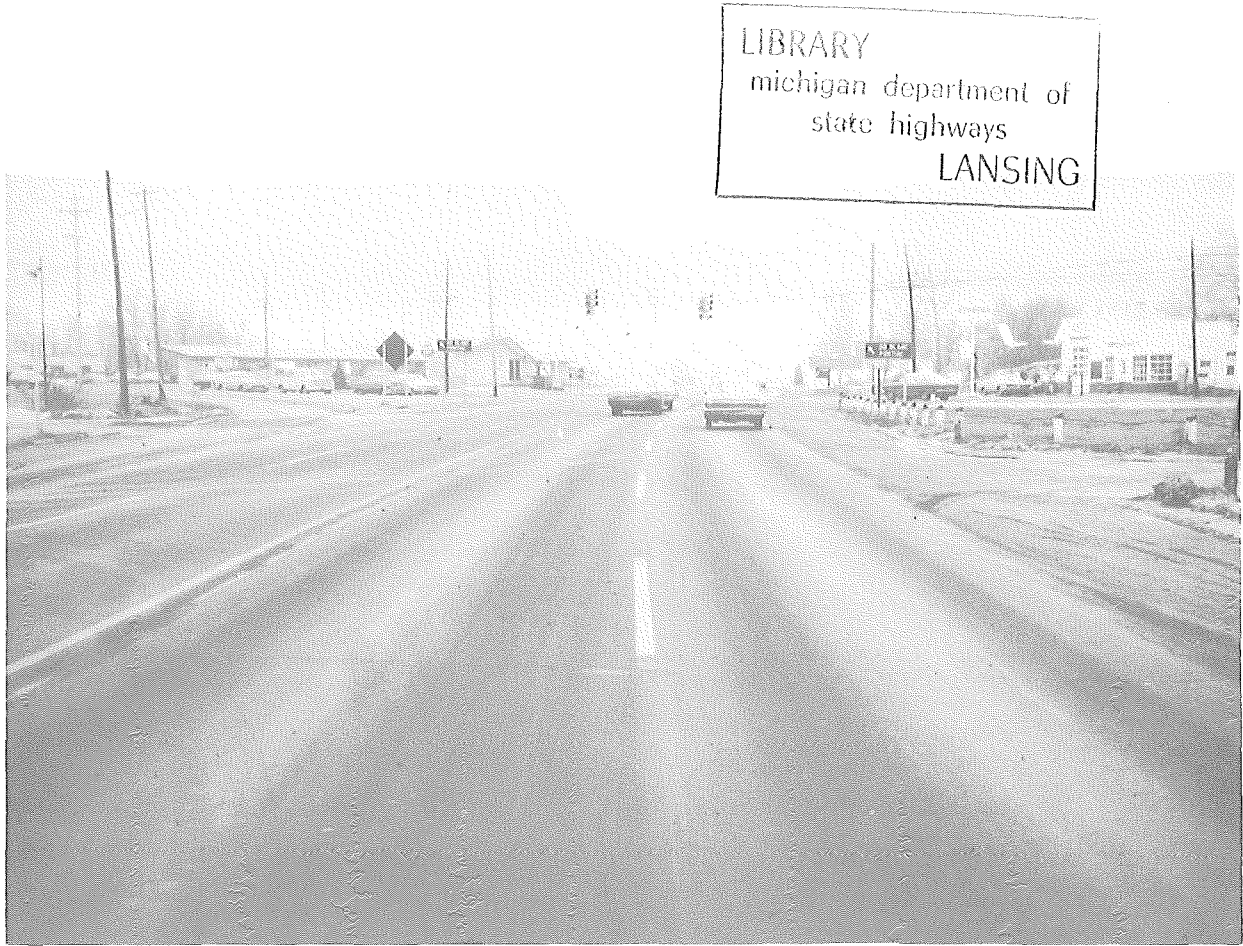
Figure 9. Crushed beach pebbles, 3 years after construction.

The mix design used was 5.7 percent 60-70 asphalt and 2.0 percent fly ash mineral filler, with the balance as crusher-run beach pebbles. No other aggregate was added to this mixture. Figure 9 shows a typical surface three years after construction at an intersection south of Flint. Figure 10 shows a close-up of the surface after four years of service. This surface is in fair condition; however, due to relocation of the roads in this area, part of this project was resurfaced last year.

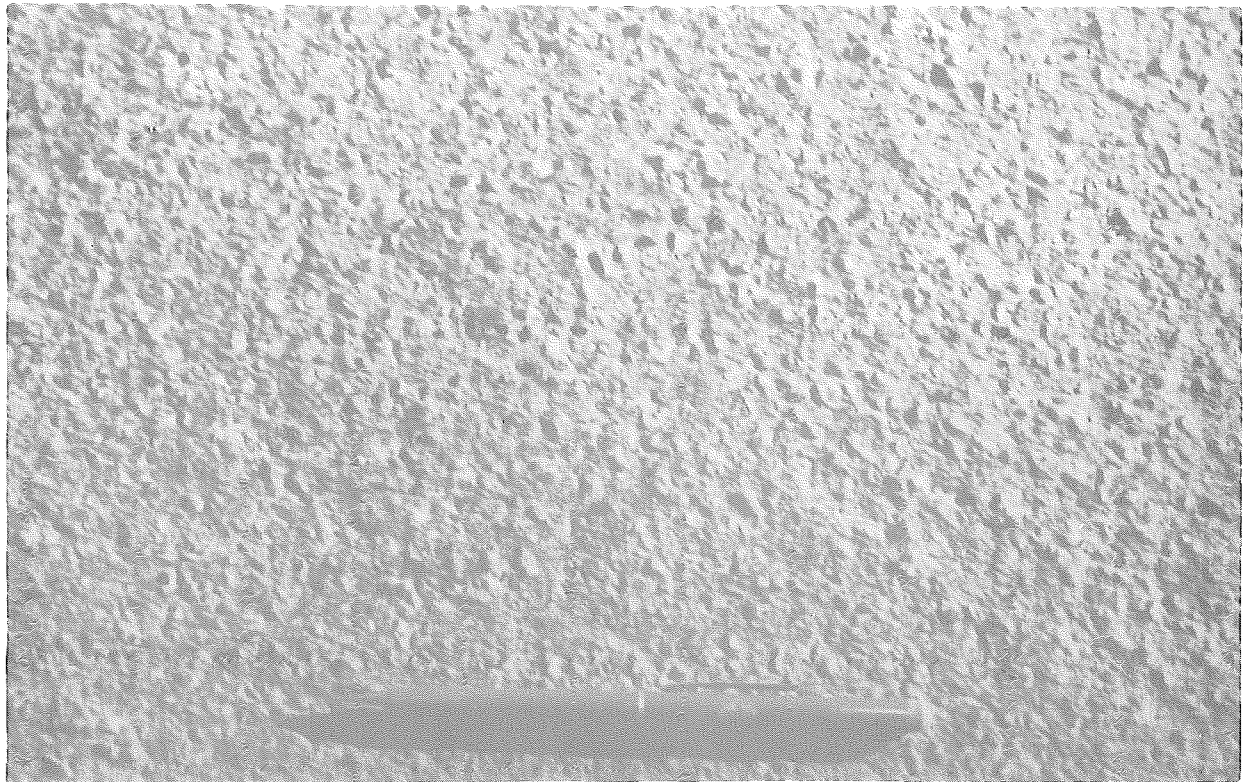
Figure 10. Close-up of beach pebble surface, 4 years after construction.

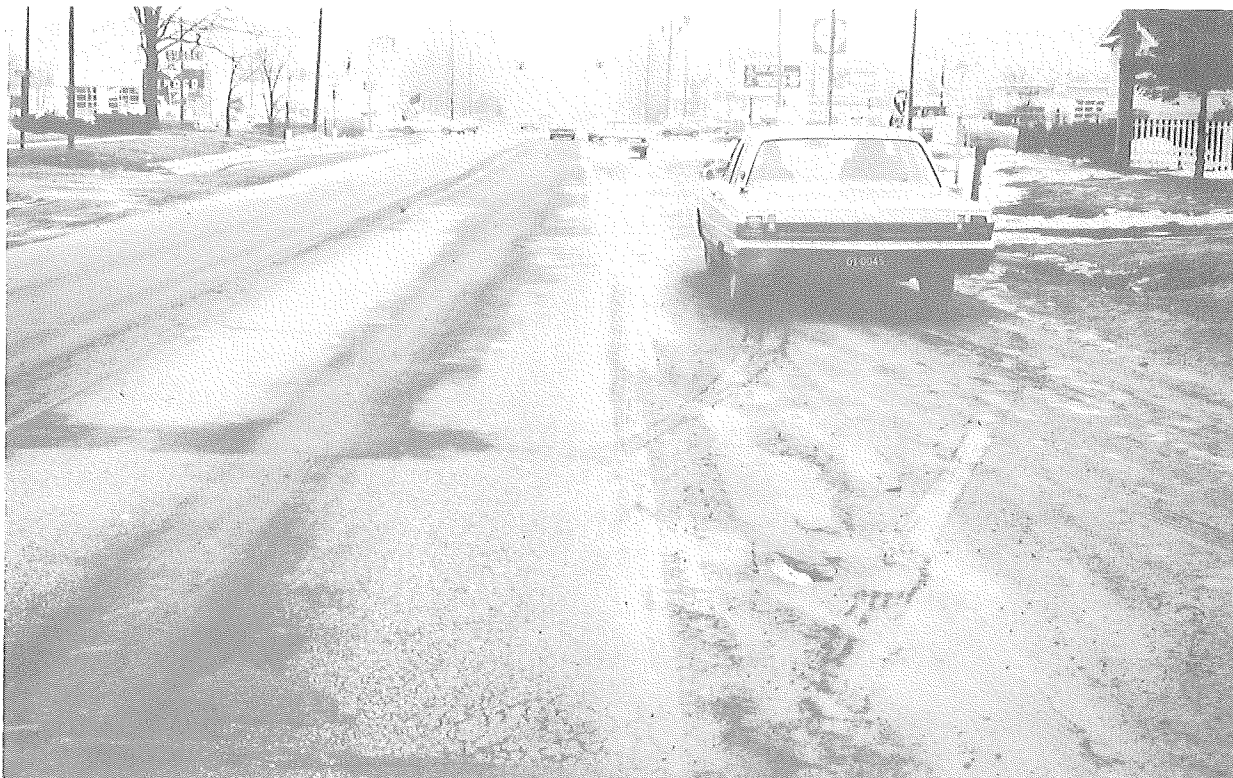
shows the surface after three years of service. Note that considerable areas of the surface were worn completely through to the old pavement. No detour provisions were made and heavy traffic was permitted to traverse the uncured, warm mat, resulting in premature wear that was evident within a few days after construction. I believe this mix would have proved more durable if traffic had not been permitted on the warm surface during construction.

Figure 11. Crushed trap rock, 3 years after construction.

The mix design called for 6.1 percent 60-70 asphalt plus 3.5-percent added fly ash mineral filler, with the balance being crushed trap rock. No other aggregate was added to this mixture, which was used at an intersection south of Flint. Figure 11

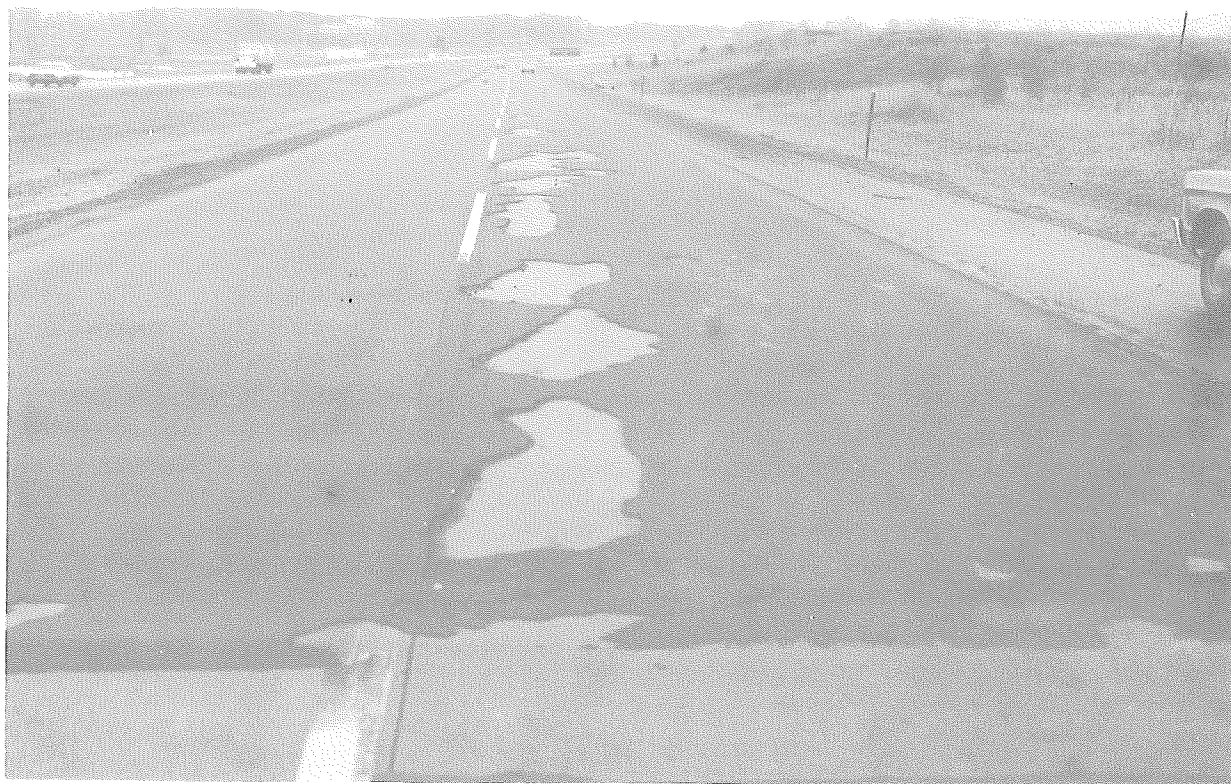
Figure 12. Synthetic bitumen and sand, 1 year after construction.

Previous experience indicated that when certain synthetic bitumens were mixed with sand, they exhibited promising skid resistance due to what appeared to be a noticeable rejuvenation of the sandpaper texture. This mixture was placed at a rate of 80 lb/sq yd on a section of I 96 about 50 miles west of Detroit. During the start of the first winter, sections of the pavement peeled off as noted in Figure 12. The balance of this surface was later bladed off. It was determined that considerable hardening of the bitumen occurred within a few months resulting in penetrations approaching zero. It is believed this contributed to the loss of adhesion between the thin bituminous mat and the underlying concrete pavement.

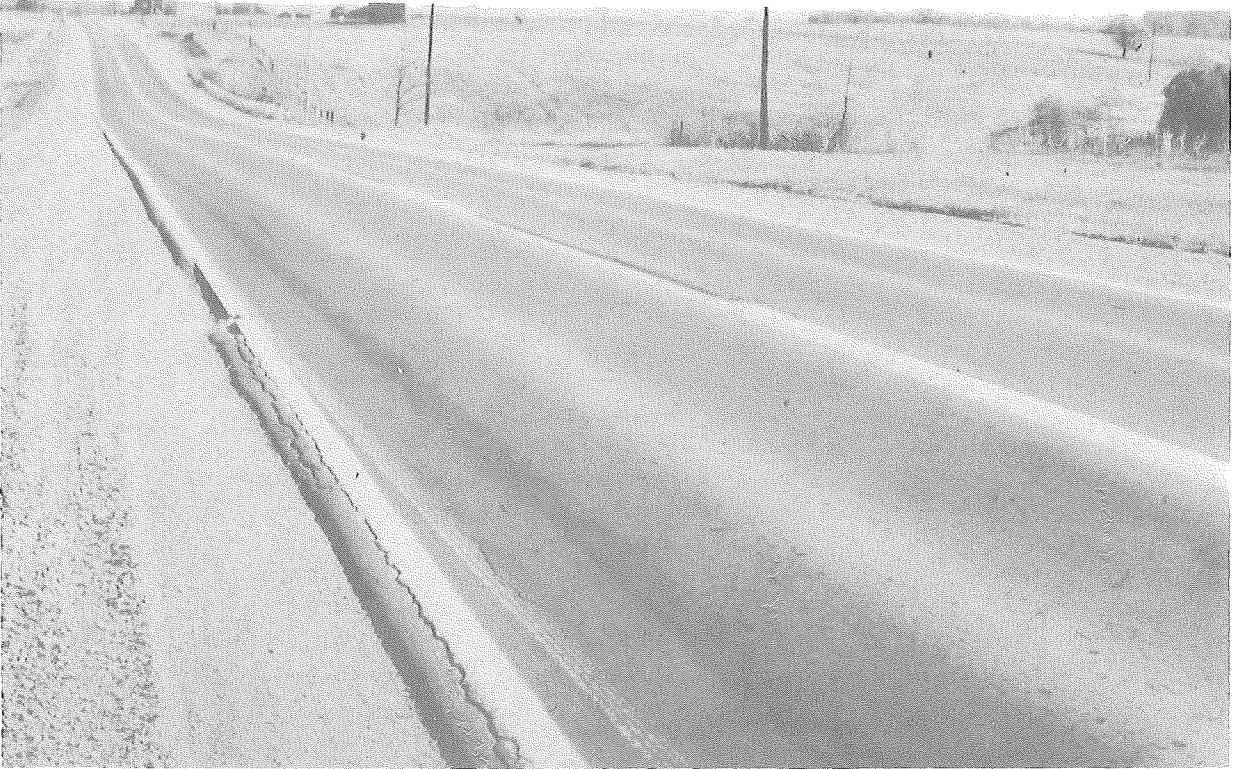
Figure 13. Sand-emulsion surface, 4 years after construction.

In recent years the Asphalt Emulsion Industry has promoted the use of hot emulsion sand mixtures for skid proofing purposes and other states have reported satisfactory service with these mixtures. A mixing grade emulsion was used for this purpose with the producer claiming that the bitumen residue has certain thixotropic characteristics, thus permitting higher bitumen contents to be used in the mixture without danger of flushing. A fine aggregate passing the No. 8 sieve was mixed with about 10.8 percent emulsion resulting in about 7.5 percent residue. The temperature of the mixture delivered to the street ranged between 245 and 270 F. Figure 13 shows a typical pavement section after four years of service while Figure 14 shows a close-up of the fine sandpaper texture. This road is in good condition and offers a skid resistant surface.

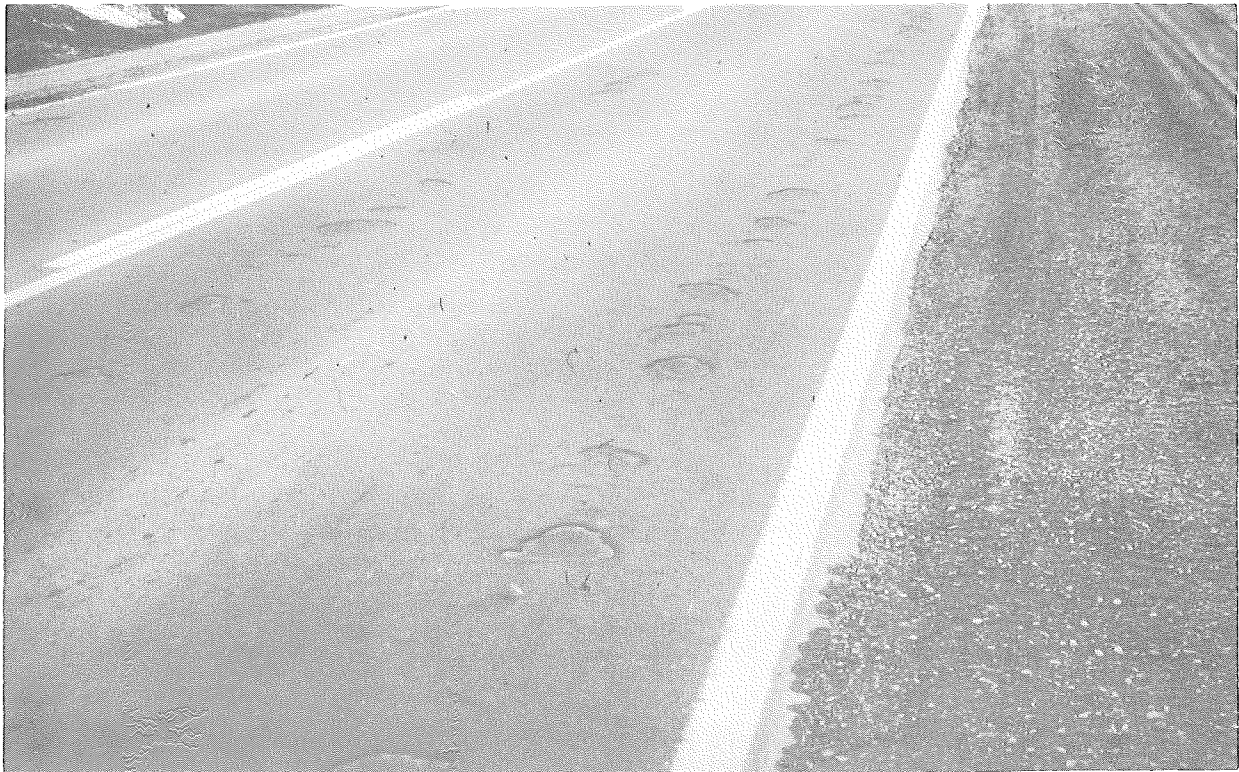
At the beginning of the first winter season, some sand-asphalt surfaces showed delamination in the wheel tracks. That is, about 1/8-inch layers would separate from the balance of the mat. Figure 15 shows a typical example of such a road and Figure 16 illustrates a detail of this phenomenon.

Figure 15. Sand-asphalt surface, 1 year after construction showing delamination.

Although some theories have been proposed as to the cause of this, the writer has reservations about these explanations. Of more importance is the fact that solutions have been found to reduce this type of failures. After several years of observation it was noted that bituminous mixtures with sands which are predominantly one size "belly type" often exhibit this delamination while uniformly graded sands very seldom show any delamination.

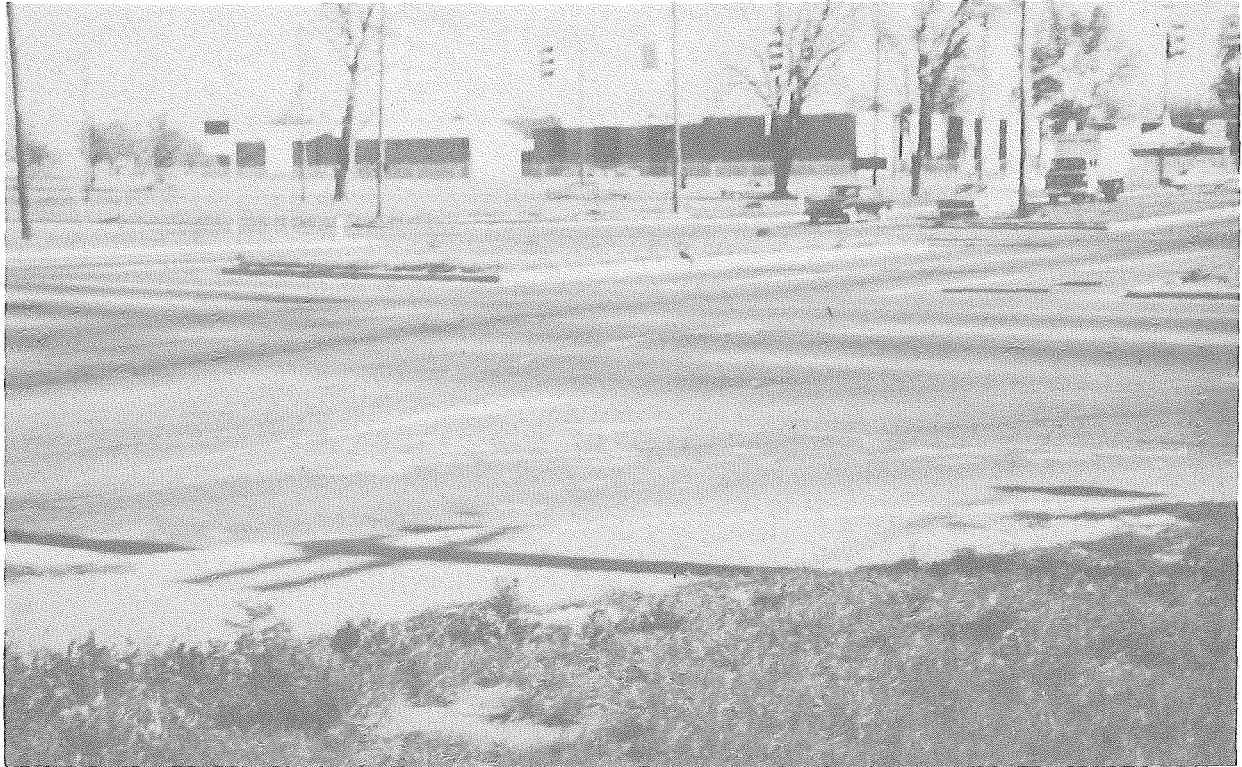
Figure 20 shows a typical area in Detroit after four years of service. It is generally in good condition except for the fillet areas which were manually placed and cooled before they were properly compacted resulting in some raveling. Figure 21 is a close up of the sand asbestos asphalt surface texture which exhibits satisfactory skid resistance.

Figure 20. Sand-asbestos surface, 4 years after construction showing raveled fillets.

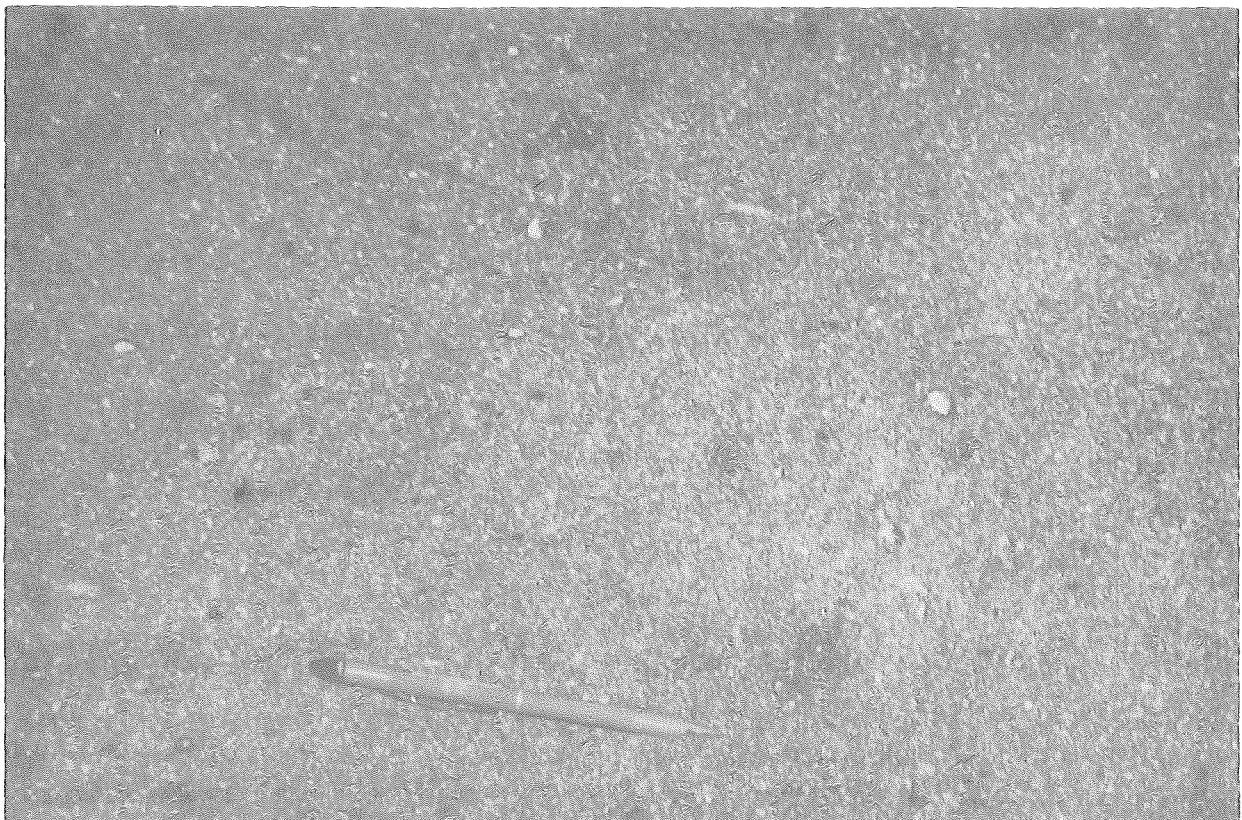
Figure 21. Close-up of sand-asbestos surface, 4 years after construction.

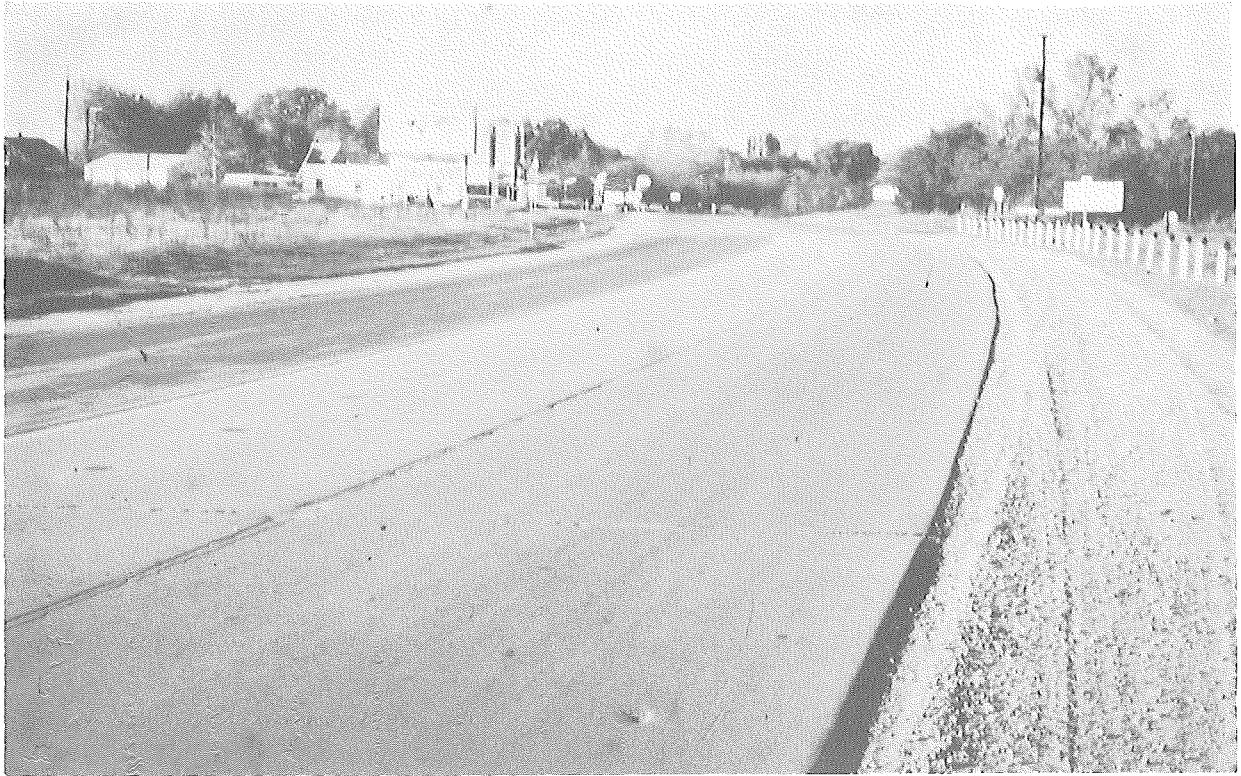
Figure 22 shows this surface after four years of service. The lighter colored areas shown in the right two lanes have the Synopal added while the darker areas in the left two lanes are mixtures of sand asphalt without Synopal. Figure 23 is a close up of the Synopal surface, note the white particles of Synopal exposed at the surface. This surface, in general, is in good condition and exhibits good skid resistance.

Figure 22. Synopal-sand surface, 4 years after construction.

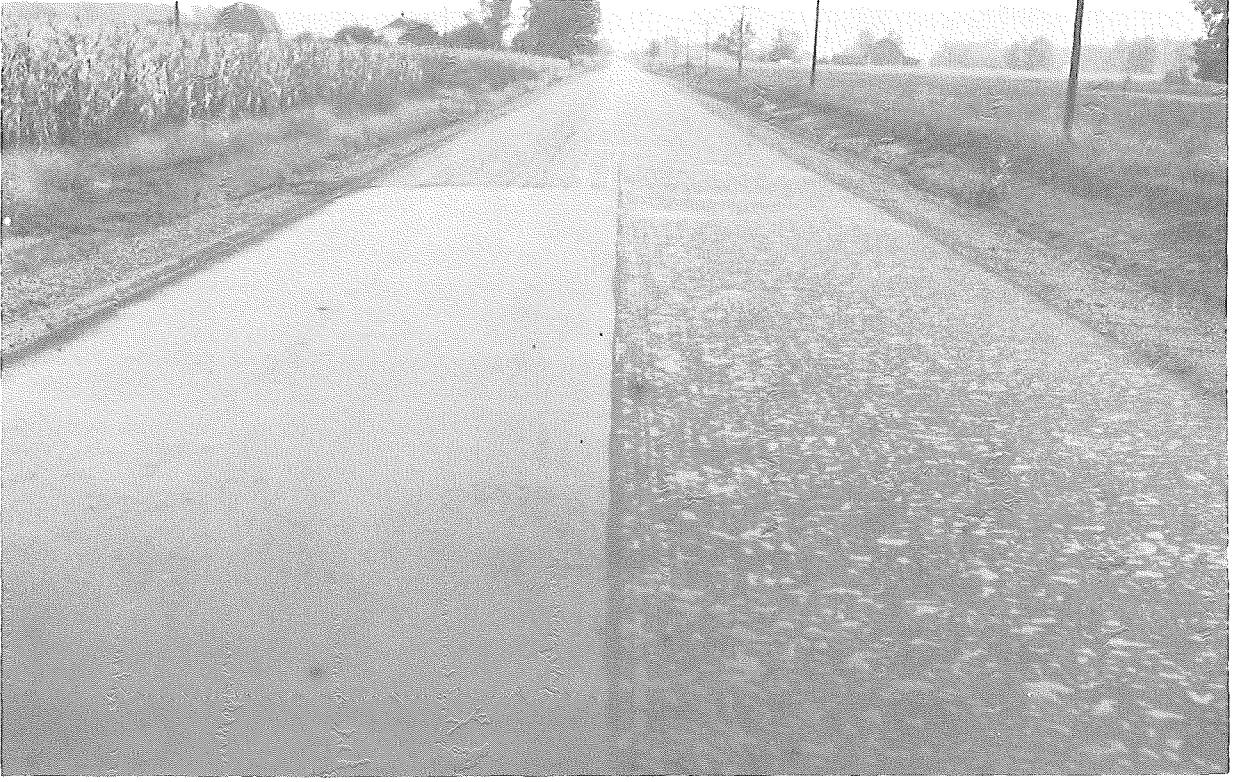
Motorists are sometimes warned of freshly laid bituminous surfaces with a sign indicating "Slippery When Wet". Figure 24 shows a freshly laid bituminous mat constructed with MC-3000 liquid asphalt. The left foreground surface was laid the day before while the balance of the surface which appears spotted has just been completed when it was rained on. After one day of curing and weathering, water wets the pavement. However, as indicated on Figure 25, a close-up of the fresh surface shows water globules formed on the mat. This non-wetting phenomenon of a fresh bituminous surface may contribute to slippery pavements when wet.

Figure 24. Freshly laid bituminous surface after rain.

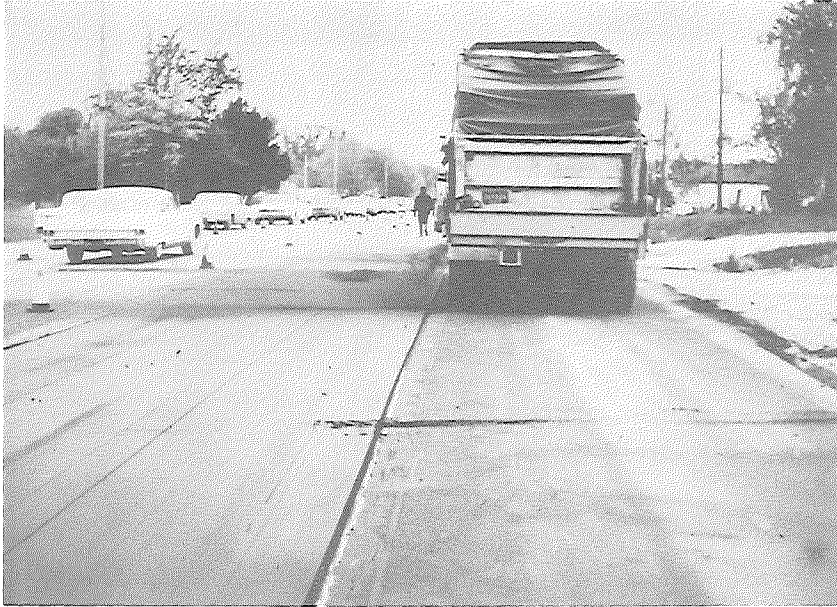
Figure 26. Spreading precoated sand on unrolled bituminous mat.

Figures 26 through 30 show some typical equipment used in this technique. Note that the spreader in Figure 27 is not equipped with a deflector, thus allowing about 2/3 of the precoated sand to be wasted on the shoulder. Using a seeder, as in Figure 28, sometimes leaves ridges that subsequently mark the pavement.

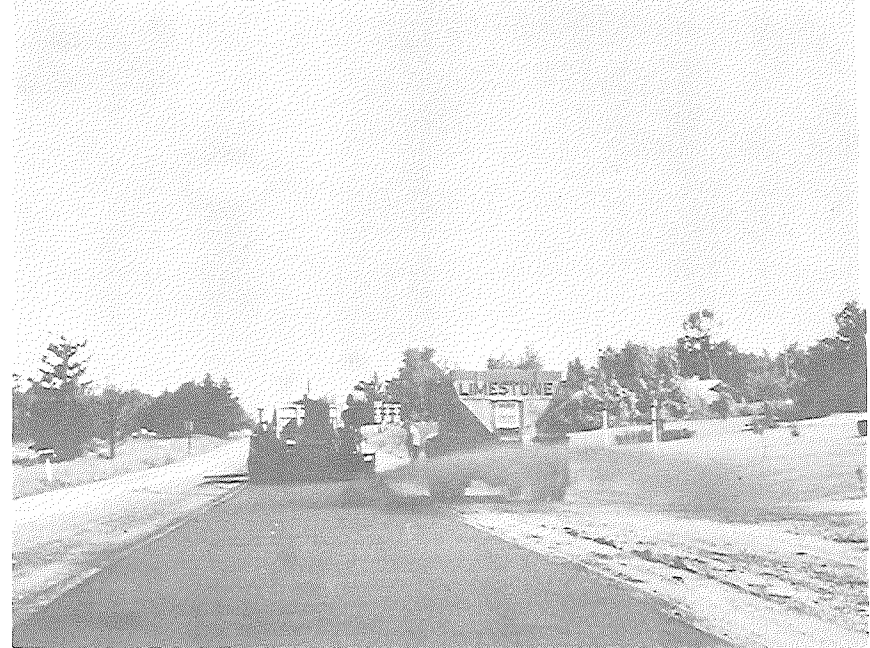
Figure 28. Seeder being used for spreading precoated sand.

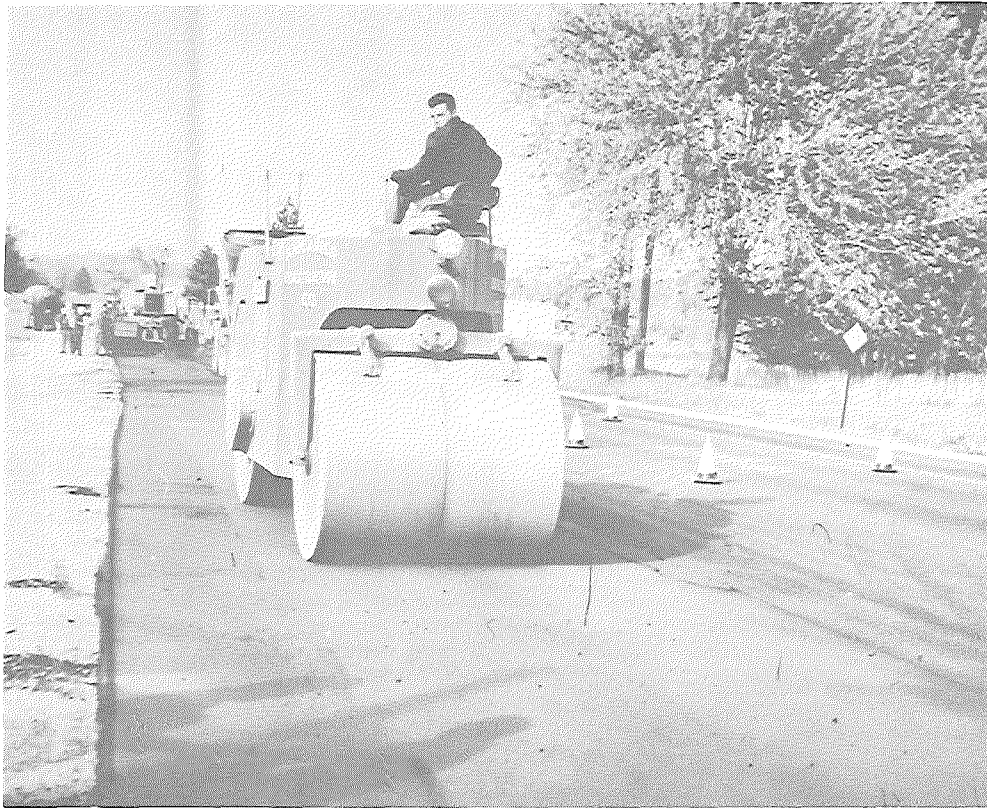
▲ Figure 29. Rolling pavement after sand application.

Figure 30. Partly rolled surface showing precoated sand on mat. ▶

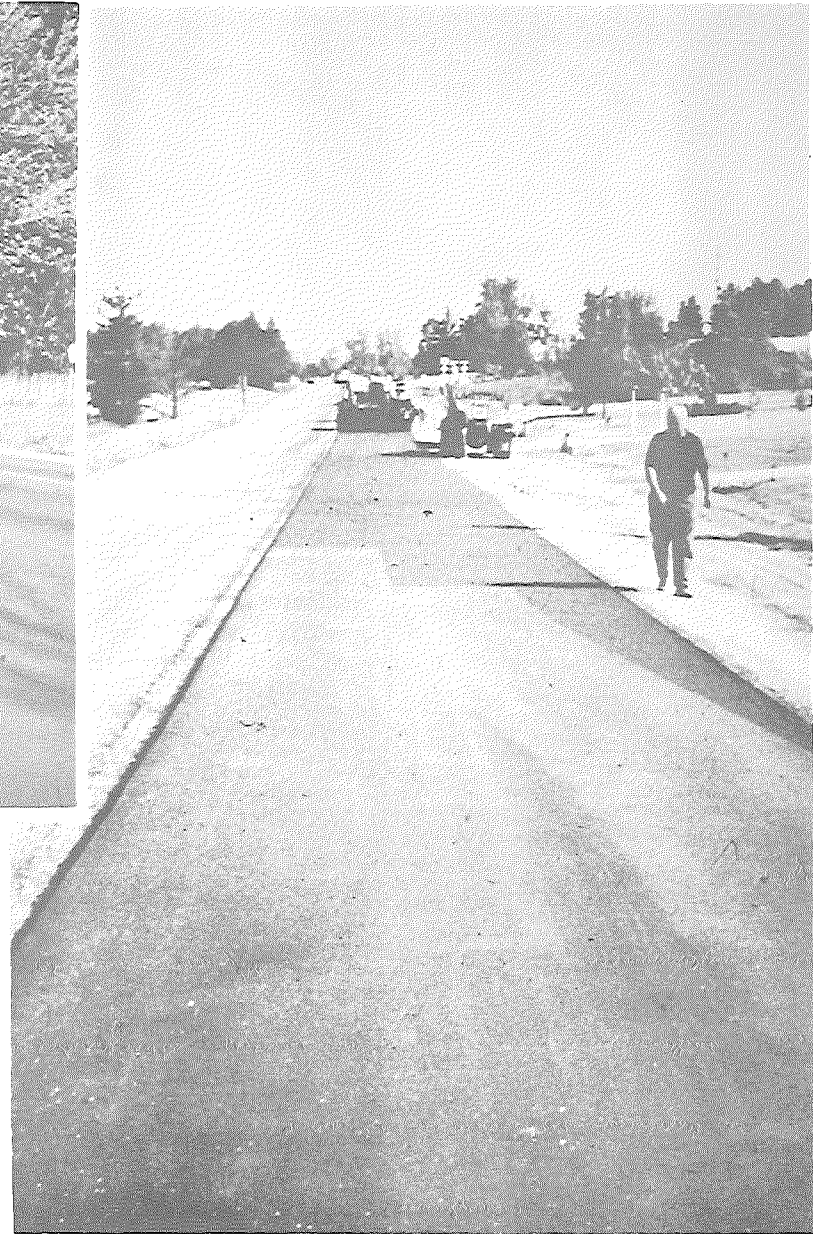
Figure 31. Tabulation of pavement skid-resistance coefficients of different materials vs. years of service.

0	1/2	1	2	3	4
	1965	1966		1967	1968	1969
		SPRING	FALL			
QUARTZITE	71	52	50	57	54	58
SANDSTONE	74	54	48	53	57	57
SAND-EMULSION	59	48	46	54	54	56
CRUSHED BEACH PEBBLES	63	47	46	44	47	52
SYNOPAL-SAND	47	41	39	54	47	49
STONE-FILLED SAND	52	41	37	45	45	48
ASBESTOS-SAND	62	39	36	43	44	46
SAND-ASPHALT	47	41	41	52	47	50

All the experimental surfaces start out with an initial average skid resistance coefficient of friction of over .45. The sandstone surface had an initial coefficient of .74 followed by the quartzite surface of .71, crushed beach pebbles .63, etc. There is a dip in all the curves after one year of service followed by an increase and leveling off of the coefficients. After four years of service again the sandstone and quartzite surfaces with coefficient of .57 and .58 are higher than the rest of the materials used in this study.

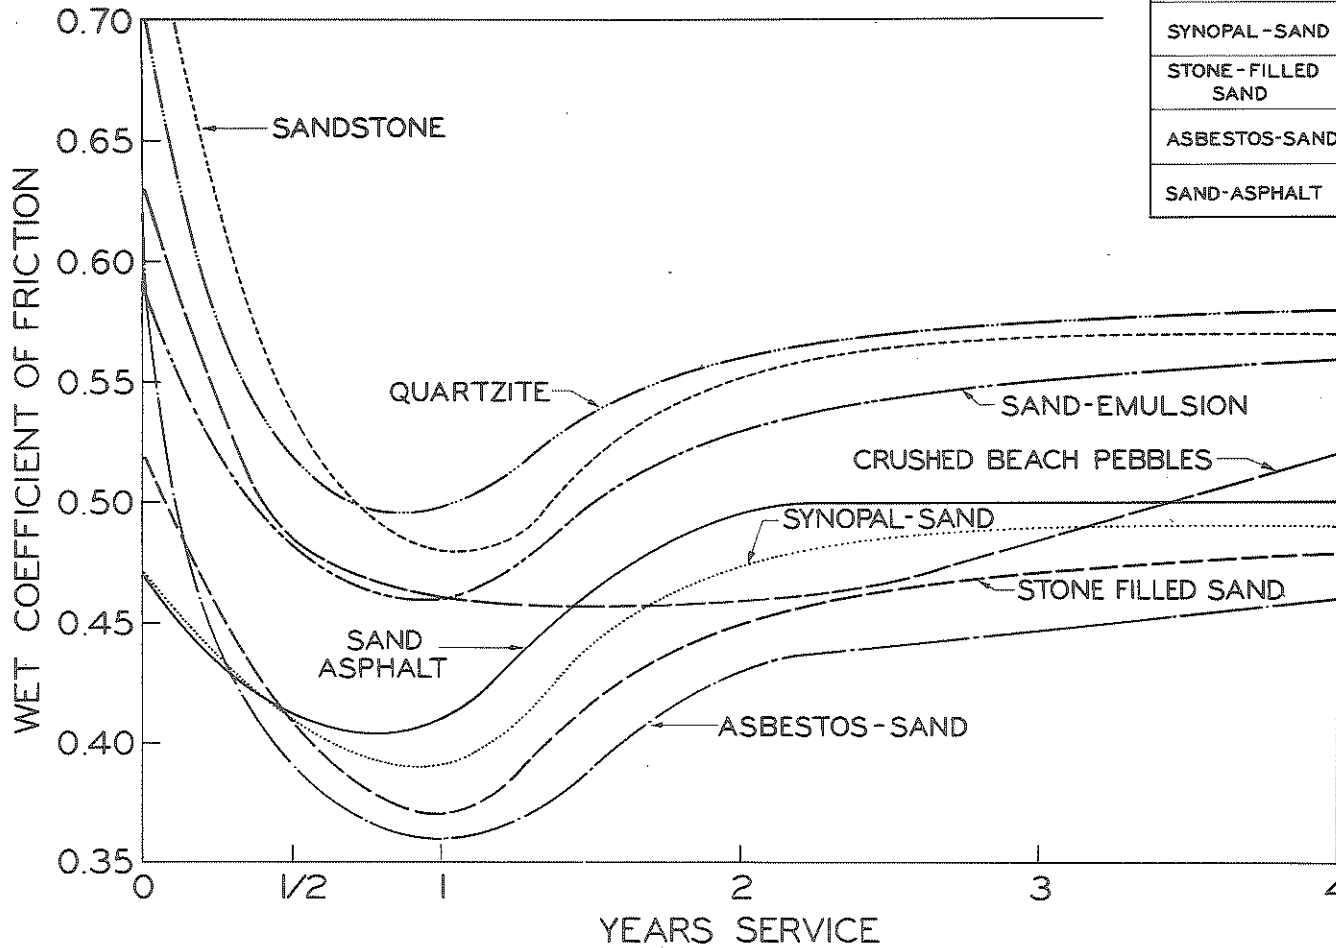
Figure 32. Curves of pavement skid resistance coefficients of different materials vs. years of service.

Considering that a satisfactory coefficient of friction should be over .35 or .40, it is indicated that excellent skid resistance can be obtained using special hard aggregates in the bituminous surfaces. However, to obtain the most for the money the uniformly graded sand-asphalt mixtures offer a satisfactory skid resistance and have proven through service to be durable. Therefore currently many of the critical areas on Michigan trunklines are being resurfaced with the more economical sand-asphalt mixtures.
