A Positive Guidance Evaluation of a
Diagrammatic Signing System

Report TSD-473-81

**TRAFFIC and
SAFETY
DIVISION**

MICHIGAN DEPARTMENT
OF
TRANSPORTATION

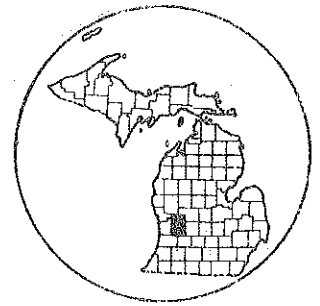
FIGURE 1
 POSITIVE GUIDANCE STUDY
 SITE

The Positive Guidance study zone was located along eastbound I-96 in the city of Walker, located northwest of Grand Rapids (Figure 1). The eastbound portion of the freeway is a 2-lane roadway that becomes a 3-lane roadway with the addition of an entrance ramp from M-37. The 3-lane section splits into two 2-lane roadways about 1,000 feet downstream of the entrance ramp from M-37 (Figure 2).

The M-37 SOUTH/FOLLOW I-96 sign at Station 273 allowed removal of the M-37 shield from the overhead diagrammatic signs. However, the M-37 shield at the freeway split was included to provide confirmation for on-ramp traffic destined onto M-37. M-37 duals with I-96 from Alpine Avenue easterly to East Belt Line Avenue on the east side of Grand Rapids (Figure 1).

I-296 formerly dualed with US-131 for a 3-mile segment between I-96 and I-196 (Figure 1). Since US-131 is the major north/south freeway in the area, the I-296 designation served no useful purpose other than to designate an interstate routing. With concurrence from the FHWA and AASHTO (American Association of State Highway and Transportation Officials), the I-296 designation was eliminated from all road signs, as well as from the official transportation map. However, the 3-mile segment of US-131 remains as part of the official interstate system even though it is not so designated on the signs.

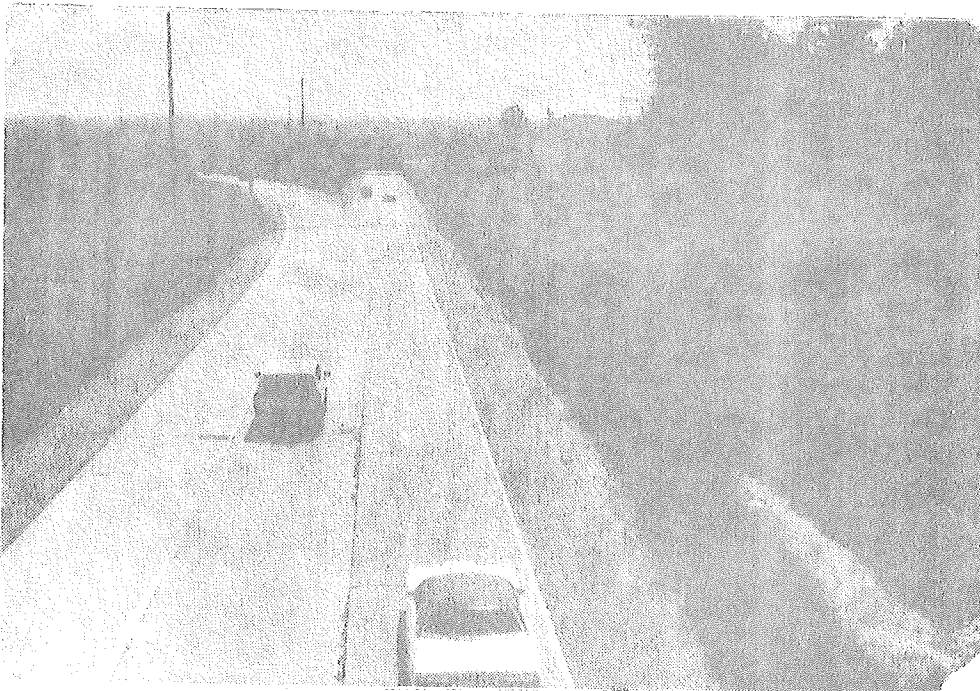
Figure 6. Looking easterly (from the M-37 overpass)
at downstream location.

All data was collected with two video recorders. The video equipment was set up on the M-37 overpass so that both upstream and downstream operations could be viewed and recorded (Figures 5 and 6).
