REINFORCEMENT OF ASPHALTIC CONCRETE  
OVERLAYS WITH PETROMAT FABRIC

MICHIGAN DEPARTMENT OF  
STATE HIGHWAYS AND TRANSPORTATION

Research Laboratory Section  
Testing and Research Division  
Research Project 71 NM-286  
Research Report No. R-972

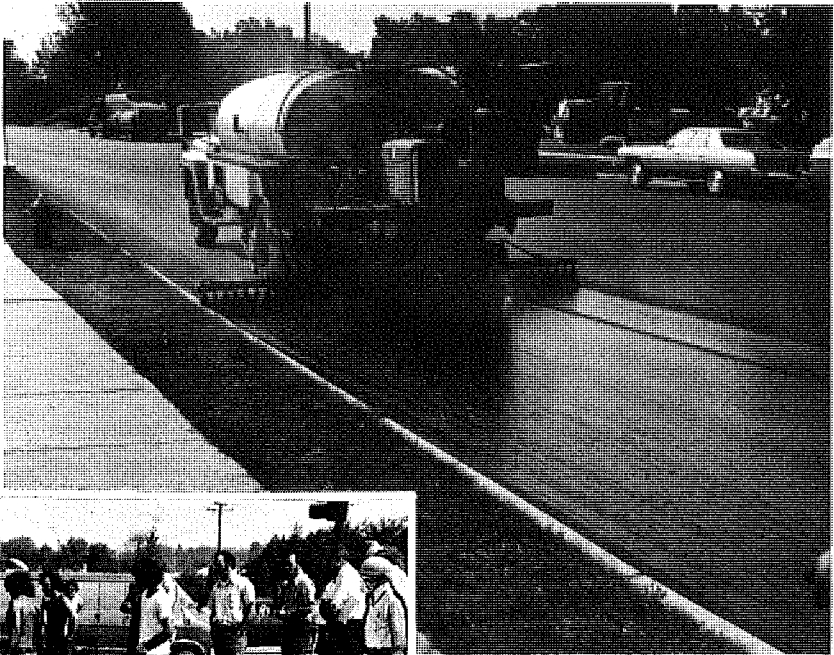
Figure 3. Spraying asphalt cement, 85/100 grade over 1-in. leveling course 25A. Application temperature 320 F and rate of 0.25 to 0.30 gal/sq yd.

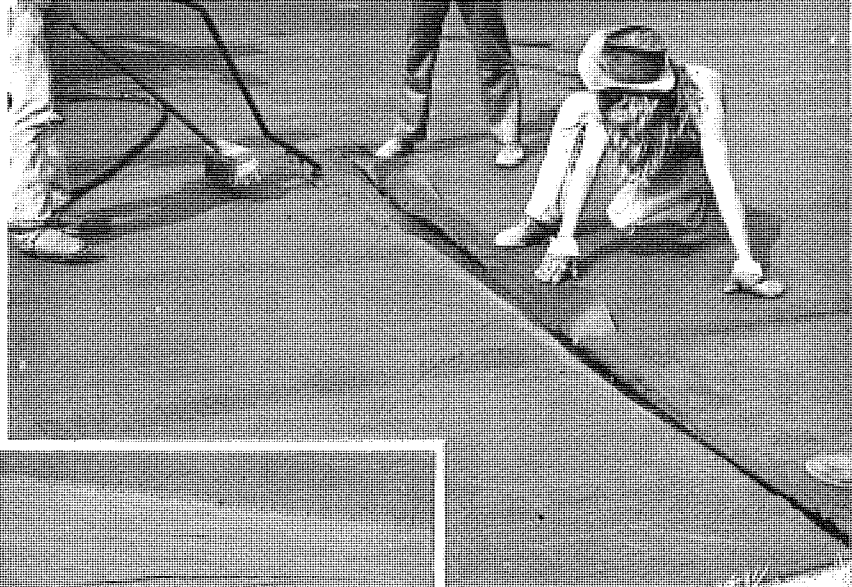
Figure 9. Overlapping two adjacent fabric mats in the direction of laydown; additional binder and brooming was applied manually to minimize pick-up by paving trucks.

1) Careful overlapping of two adjacent fabric mats to minimize pick-up by paving equipment was a time-consuming task (Fig. 9). This application required at least five minutes and three men at each 300-ft interval (project total; 80 times) to apply additional binder, brooming and flattening the 12-ft transverse joint.

2) Overlapping adjacent fabric mats at 300-ft intervals was a time-consuming task. Each Petromat transverse joint and lap required three men and at least five-minutes of hand application.

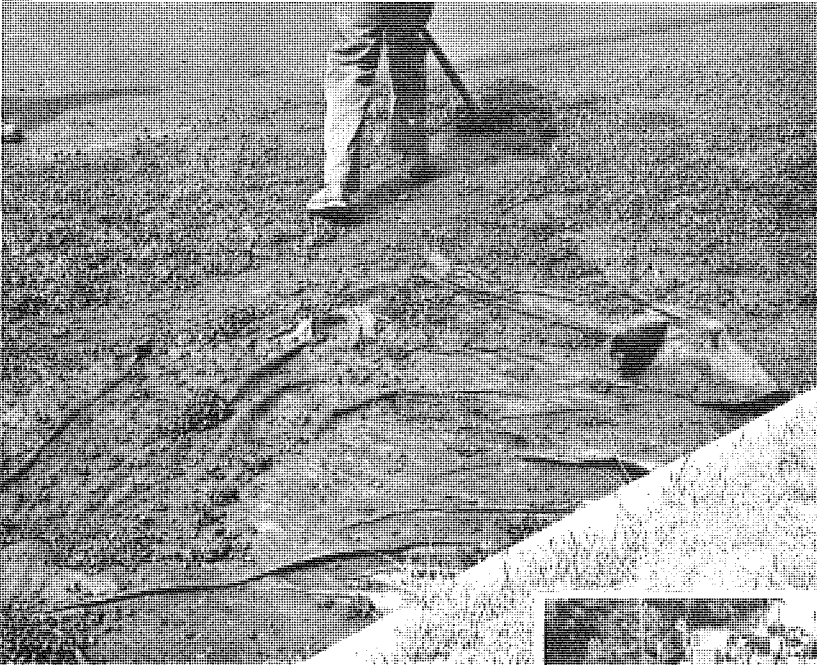
◀ Figure 12. A paving-truck driver inadvertently hit brakes and tore up outside edge of fabric. The damaged section (20-ft long) was cleaned and resurfaced.

3) Bonded fabric, subjected accidentally to braking by a paving truck, was severely damaged (Fig. 12).
