SCORE

Systematic Correction of Roadside Environment

TSD-SS-142-70

MICHIGAN DEPARTMENT OF STATE HIGHWAYS

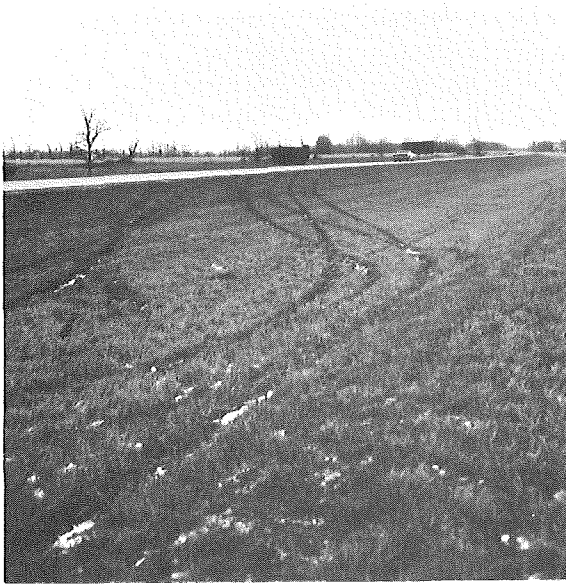
The following photographs of median skid marks show several instances where vehicles did enter a relatively flat median, but remained upright and in a driveable condition. These emphasize the desirability of gentle slopes, which the modern automobile can negotiate in a completely out-of-control attitude without turning over.

It should be noted that the point at which the drivers of these vehicles regained control was almost across the median, and several hundred feet downstream. Any obstruction to these free skidding movements (culverts, ditches, dikes, etc.) could certainly have caused the vehicle to overturn. Tracks such as these can be seen frequently.

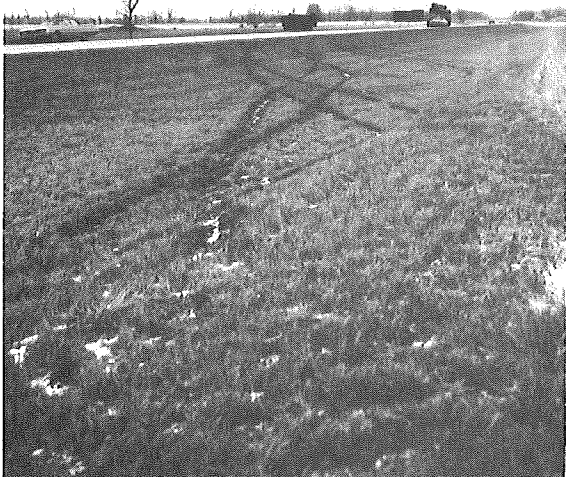
The driver of this vehicle lost control, turned completely around, but still remained upright sustaining no damage.

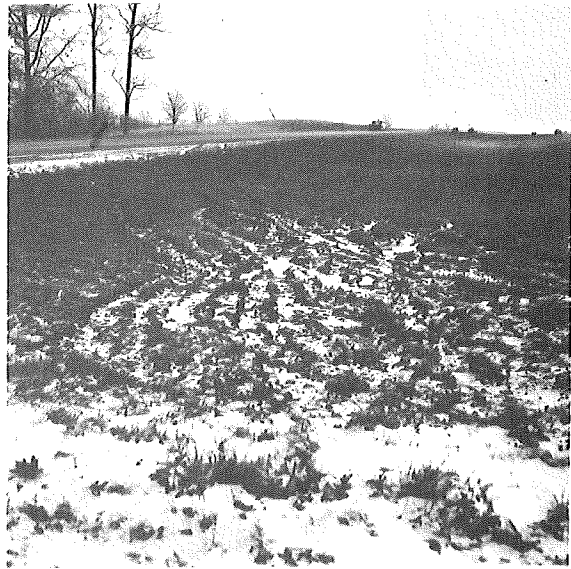
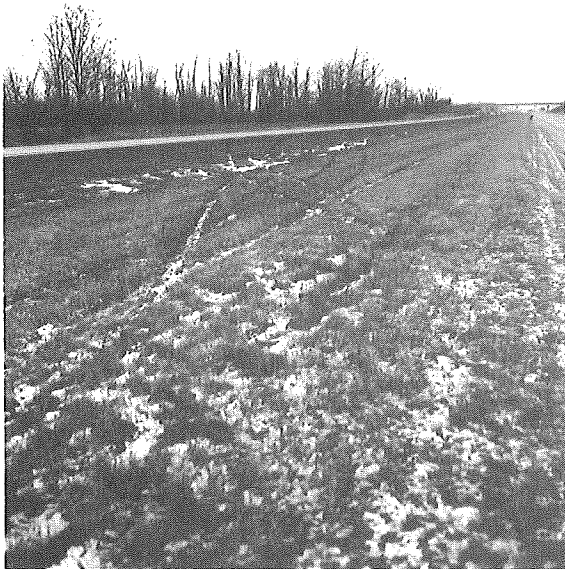
There appeared to have been two vehicles involved here, with neither being damaged.

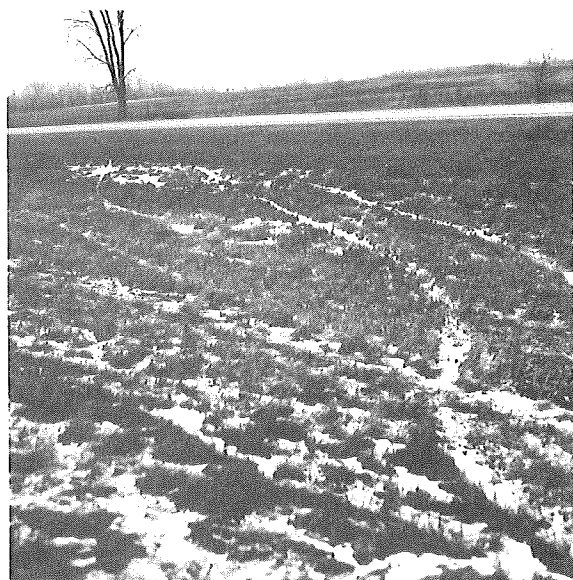
Note the tracks of a vehicle leaving the median and re-entering the paved portion of the roadway.

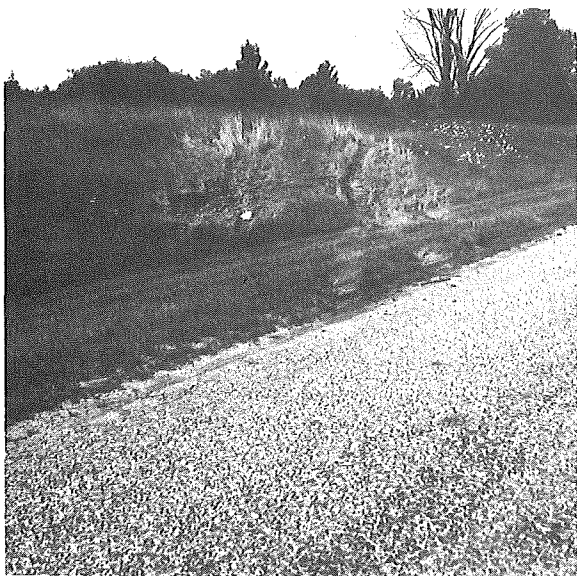
This photo shows a 1 on 4 back slope which an out-of-control vehicle struck while skidding sideways, causing the vehicle to overturn resulting in fatal injuries to the driver.

Slopes of 1 on 6 or flatter have shown adequate safety performance for out-of-control vehicles, while 1 on 4 slopes may have contributed to fatal accidents. Consequently, only slopes which are 1 on 6 or flatter should be considered for use near the roadside. Since only those sections of freeway which have been completed recently have the type of cross-section which utilizes 1 on 6 slopes, the problem of steep slopes near the roadway exists on older portions of the freeway system. Projects of slope correction in conjunction with removal of guardrail could be very beneficial in certain areas.

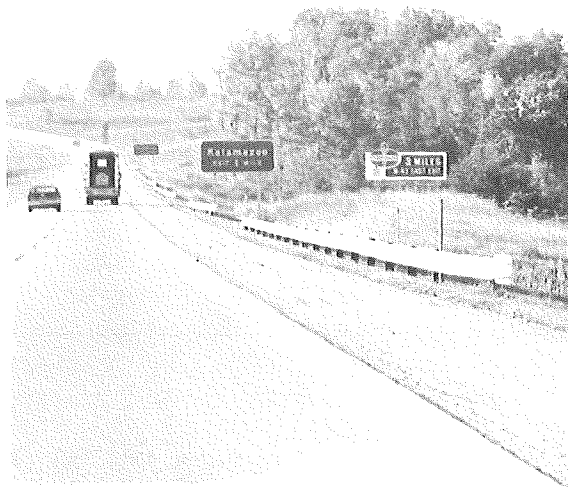
Connect short sections of guardrail to eliminate numerous end sections.

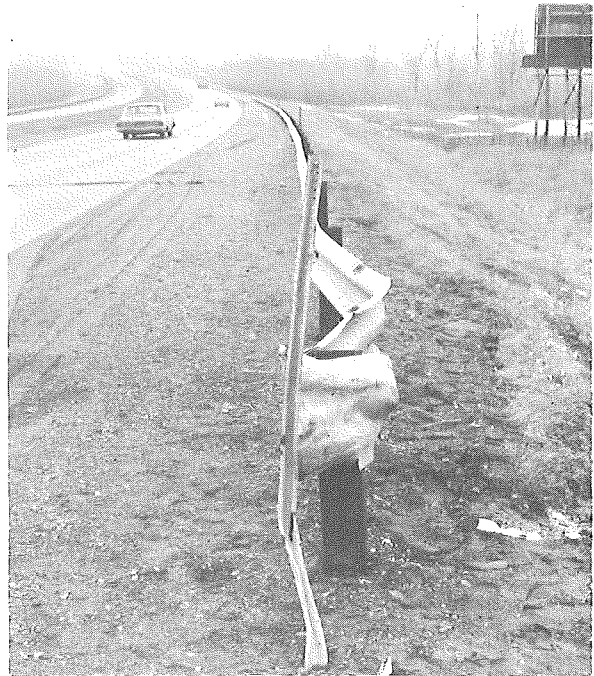
Note the damaged end section of guardrail and the recommended corrective treatment which was installed to prevent a future recurrence of the same type of accident.

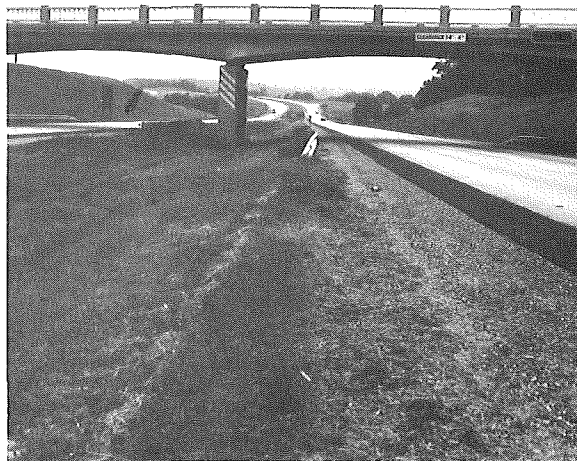
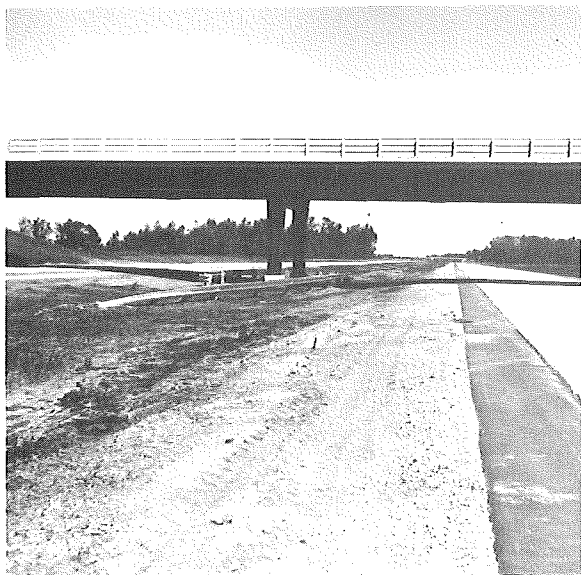
Improper location of guardrail can create an additional hazard, rather than offer protection from an existing hazard as intended. This guardrail is positioned so that a vehicle which leaves the roadway in advance of the hazard can pass behind the guardrail directly into the hazardous area.

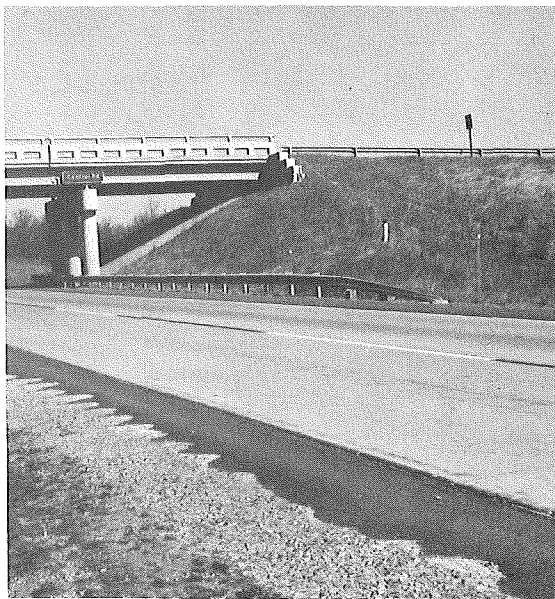
This short section of guardrail provides very limited protection from the pier and no protection from the concrete culvert.

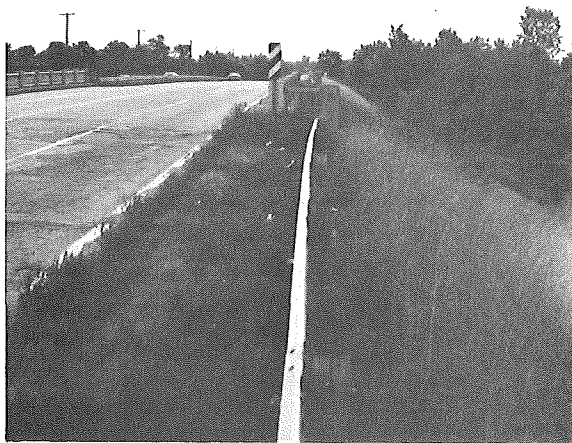
Present practice for terminating guardrail at a bridge requires attaching the guardrail to the face of the parapet.

This is a location where the hazard could be reduced considerably by flaring the guardrail and attaching the end to the face of the bridge rail as shown above.

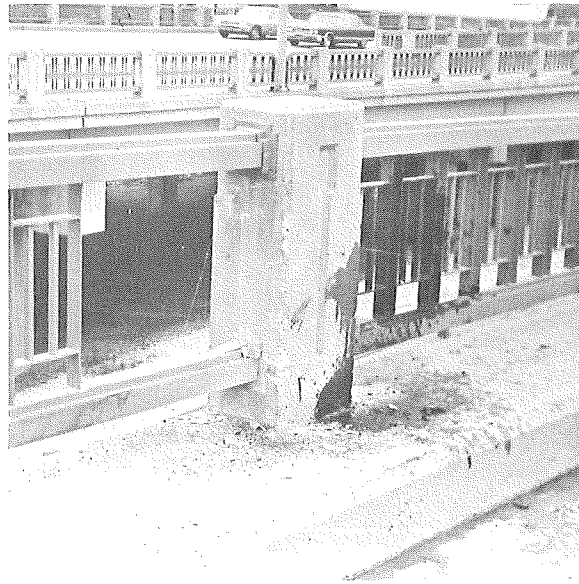
The impact with this concrete post was fatal to the driver of the vehicle.

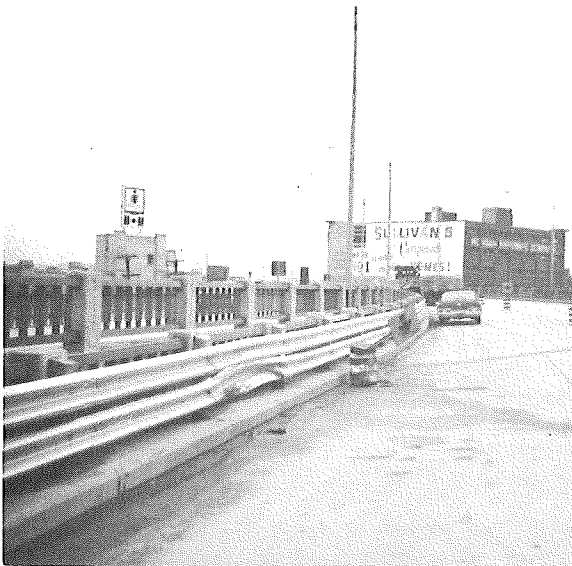
A use for guardrail which is presently experimental, but appears to have considerable merit, is the installation of the standard W beam guardrail to the post which supports the ornamental railing on bridges.

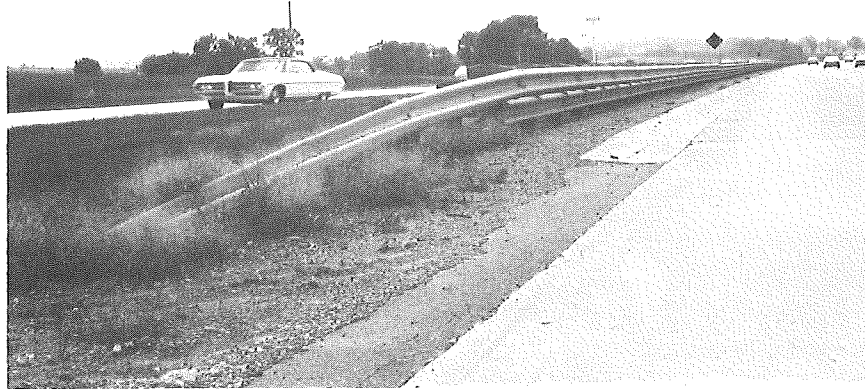
This impact with the guardrail produced only minor injury to the driver of the vehicle.

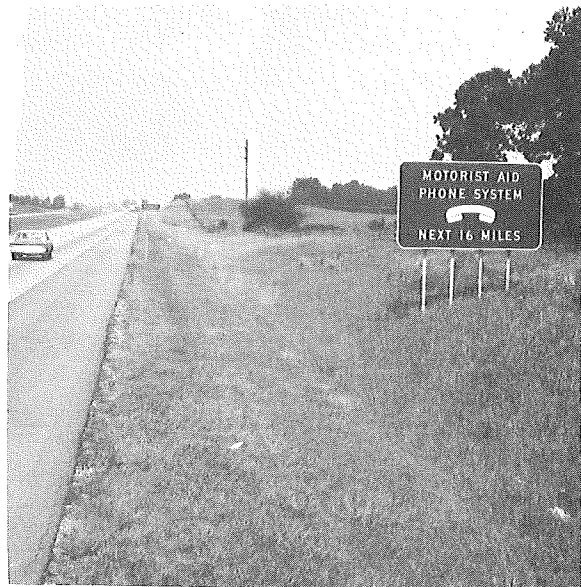
The guardrail in this photo offers only minimal protection from one of the two massive supports of this sign.

Locating signs at a distance of 30 feet from the edge of pavement, as shown, is desirable.

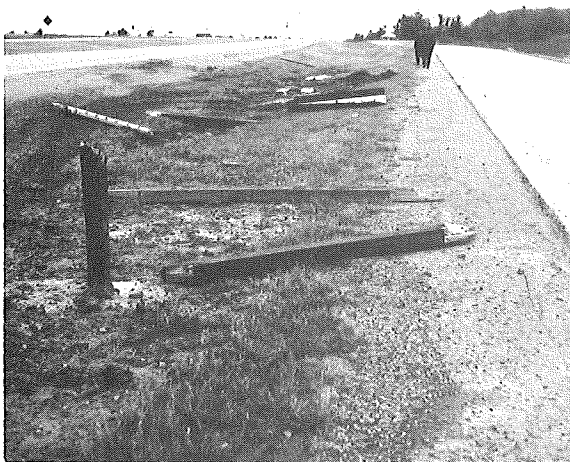
The use of breakaway sign supports eliminates the need for guardrail at this installation and consequently, reduces the potential for a severe accident involving a sign installation.

The accident experience involving breakaway signs thus far has been limited; however, in each case the performance of the supports has been excellent with the results being relatively minor vehicular damage with no injury to the occupants.

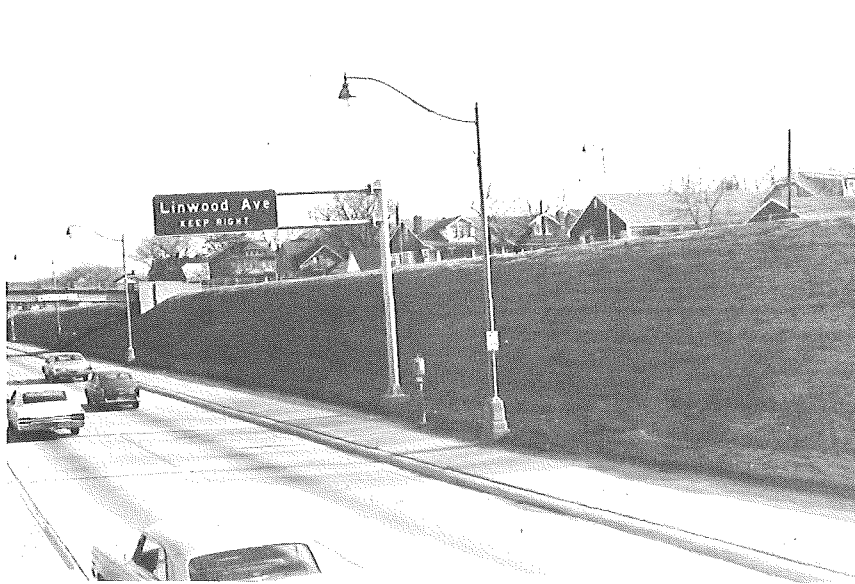
These photos show two similar sign installations. The upper photo shows a location of potential hazard to an out-of-control motorist; whereas the lower photo illustrates a guardrail installation which provides wayward vehicles protection from the sign support.

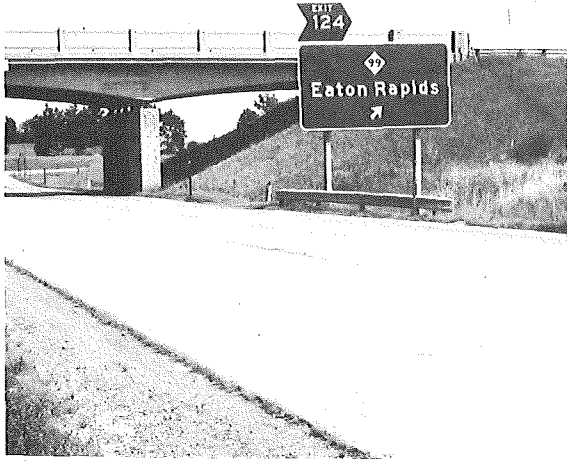
The guardrail offers the motorist protection from the sign supports, yet no protection from the bridge piers is provided.

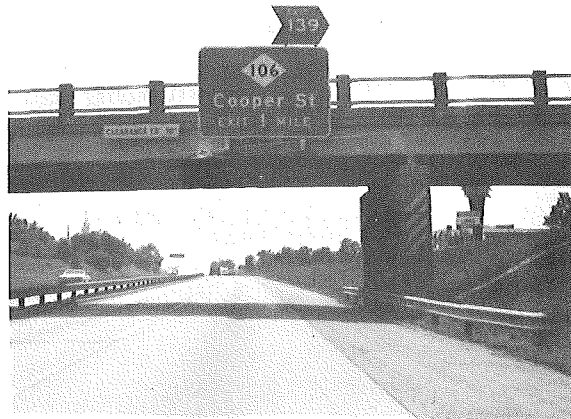
Bridge-mounted signs eliminate roadside obstacles and should be used whenever feasible.

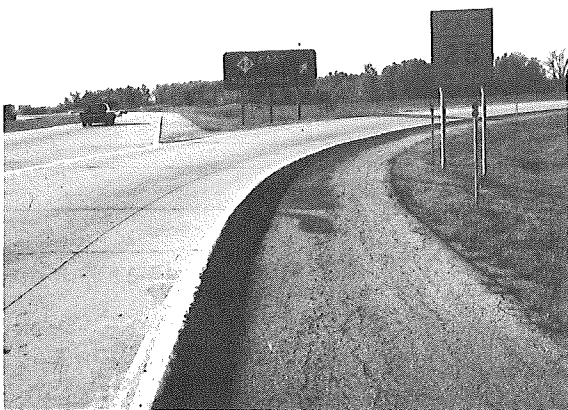
The hazard posed by sign supports and guardrail in the gore area can be reduced by the installation of wood sign supports and subsequent removal of the guardrail. The grading of the gore area should provide a smooth recovery area for wayward motorists.

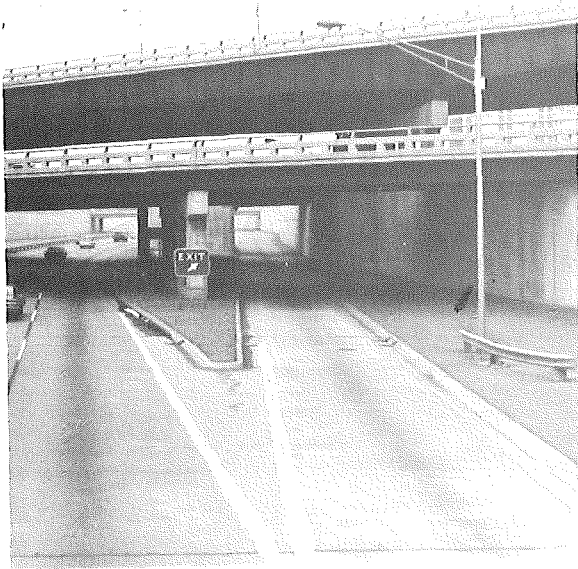
In gore areas where fixed objects, such as bridge piers or retaining walls exist, energy-absorbing devices will provide the best protection.

A device that has shown favorable results and one which is reusable after a small amount of maintenance is an assembly of water filled cylinders.

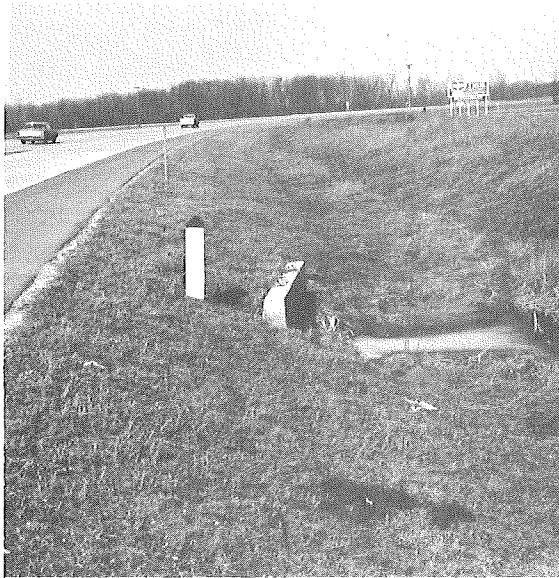
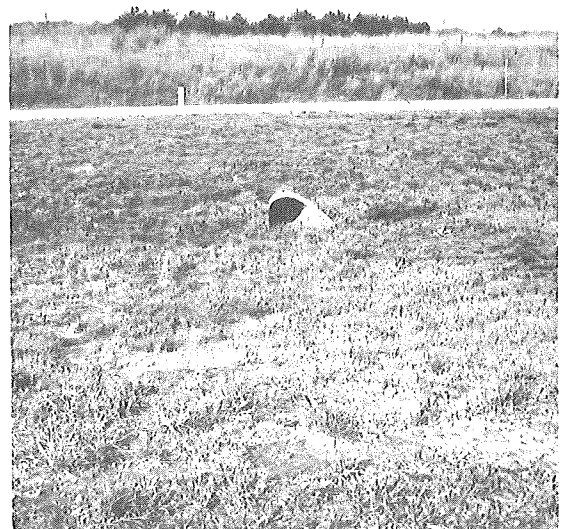
The elimination of many headwalls, as shown above, can be accomplished by simply replacing the headwall with the type of end section shown below.

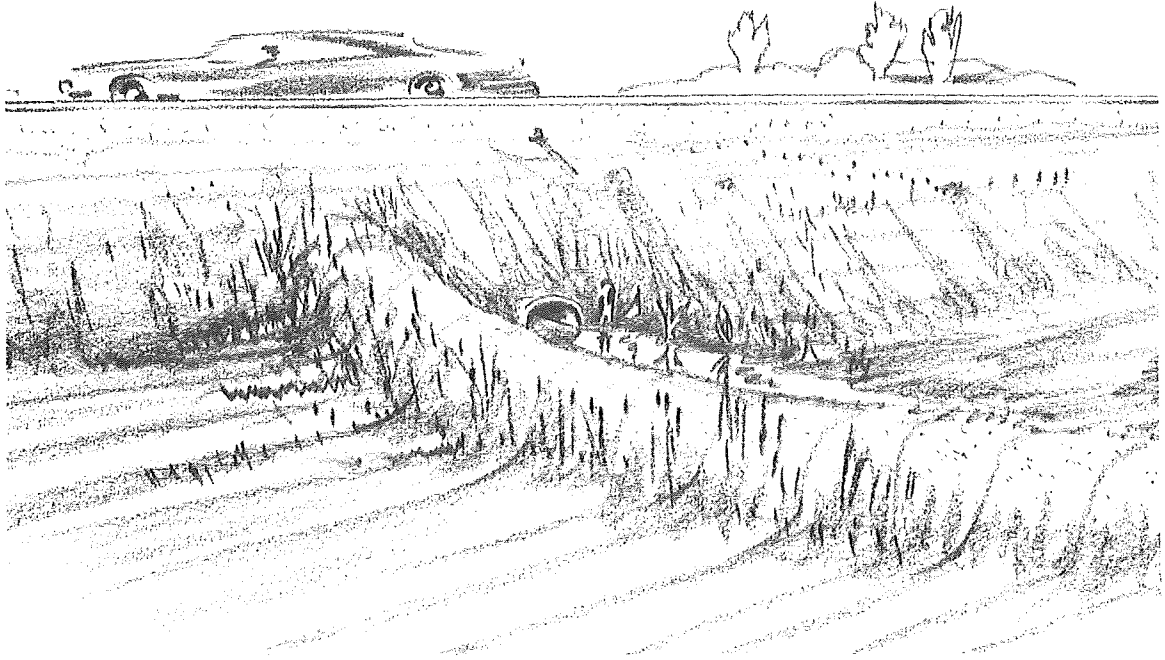
Median dikes are used to channel runoff to culverts which carry the water under the roadway and into drainage ditches. The actual shape of dikes varies considerably as shown in the illustrations. The above illustration shows a hazardous dike with steep sides. The illustration below shows a smoothly contoured dike which will function as intended but does not pose a hazard to wayward vehicles.

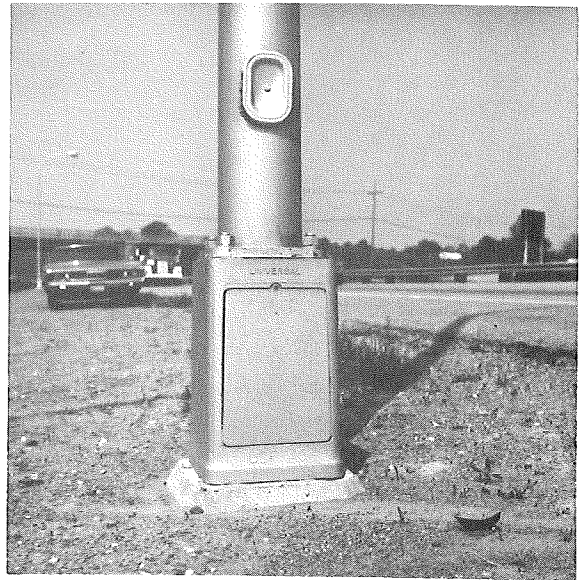
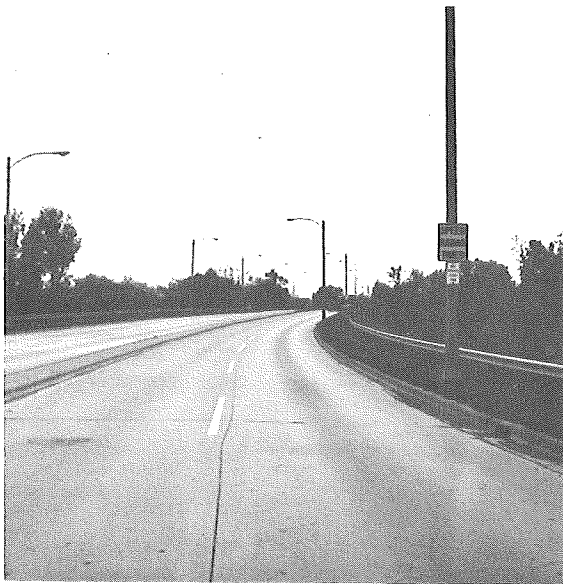
In areas where highway lighting is necessary the standards should generally be mounted on frangible bases and located as far as feasible from the edge of the roadway.

Where possible, the standards should be located behind existing guardrail used to protect the motorist from some other hazard.

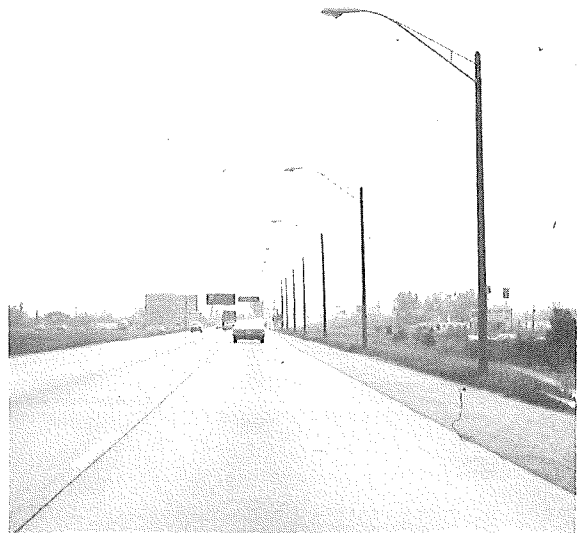
The main objective in the replacement of light standards should be the location in a protected area or the installation of a frangible base. This will reduce the severity of any future accidents with the installation.

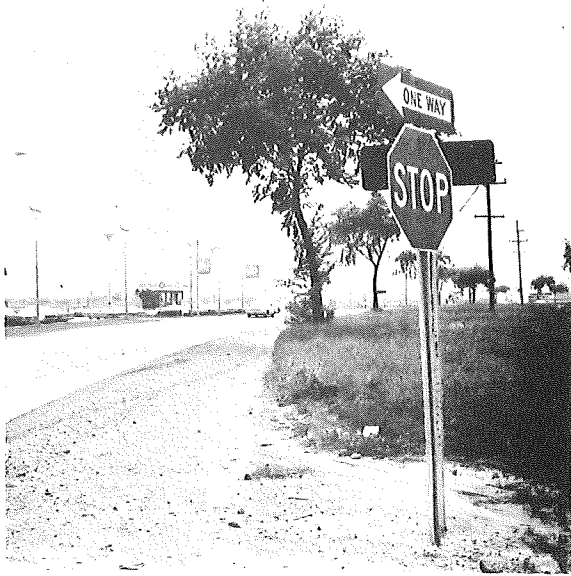
Tree removal is a very desirable roadside improvement, especially when the trees are located in target positions along curves or in areas where clear vision is necessary.

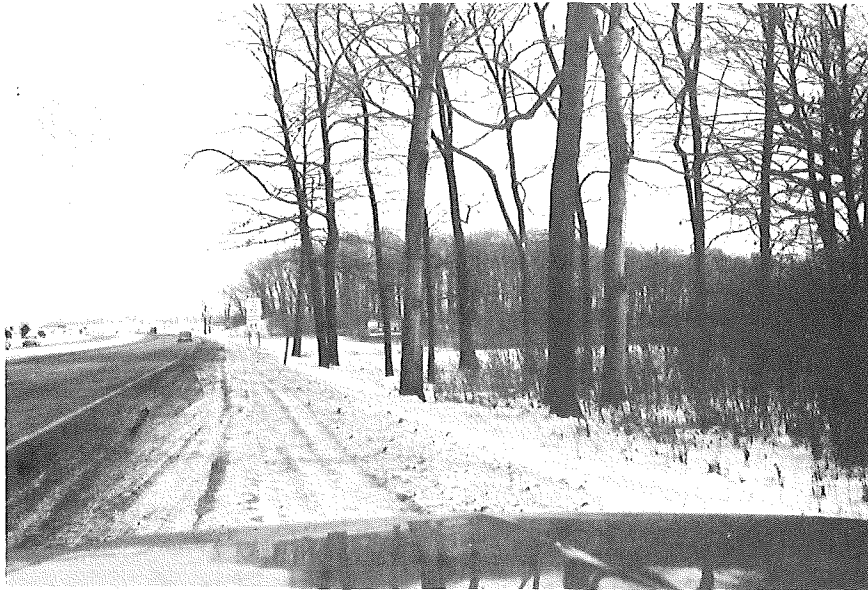
Some of the trees shown below are less than 30 feet from the edge of a freeway. Removal of trees to a distance of 50 feet is desirable along freeways.
