A TRAFFIC ACCIDENT ANALYSIS
OF HIGH ACCIDENT LOCATIONS
IN LAPEER COUNTY

Report TSD-SS-134-70

STUDY CONDUCTED BY THE
Safety & Surveillance Section
Traffic & Safety Division
Bureau of Operations
Michigan Department of State Highways

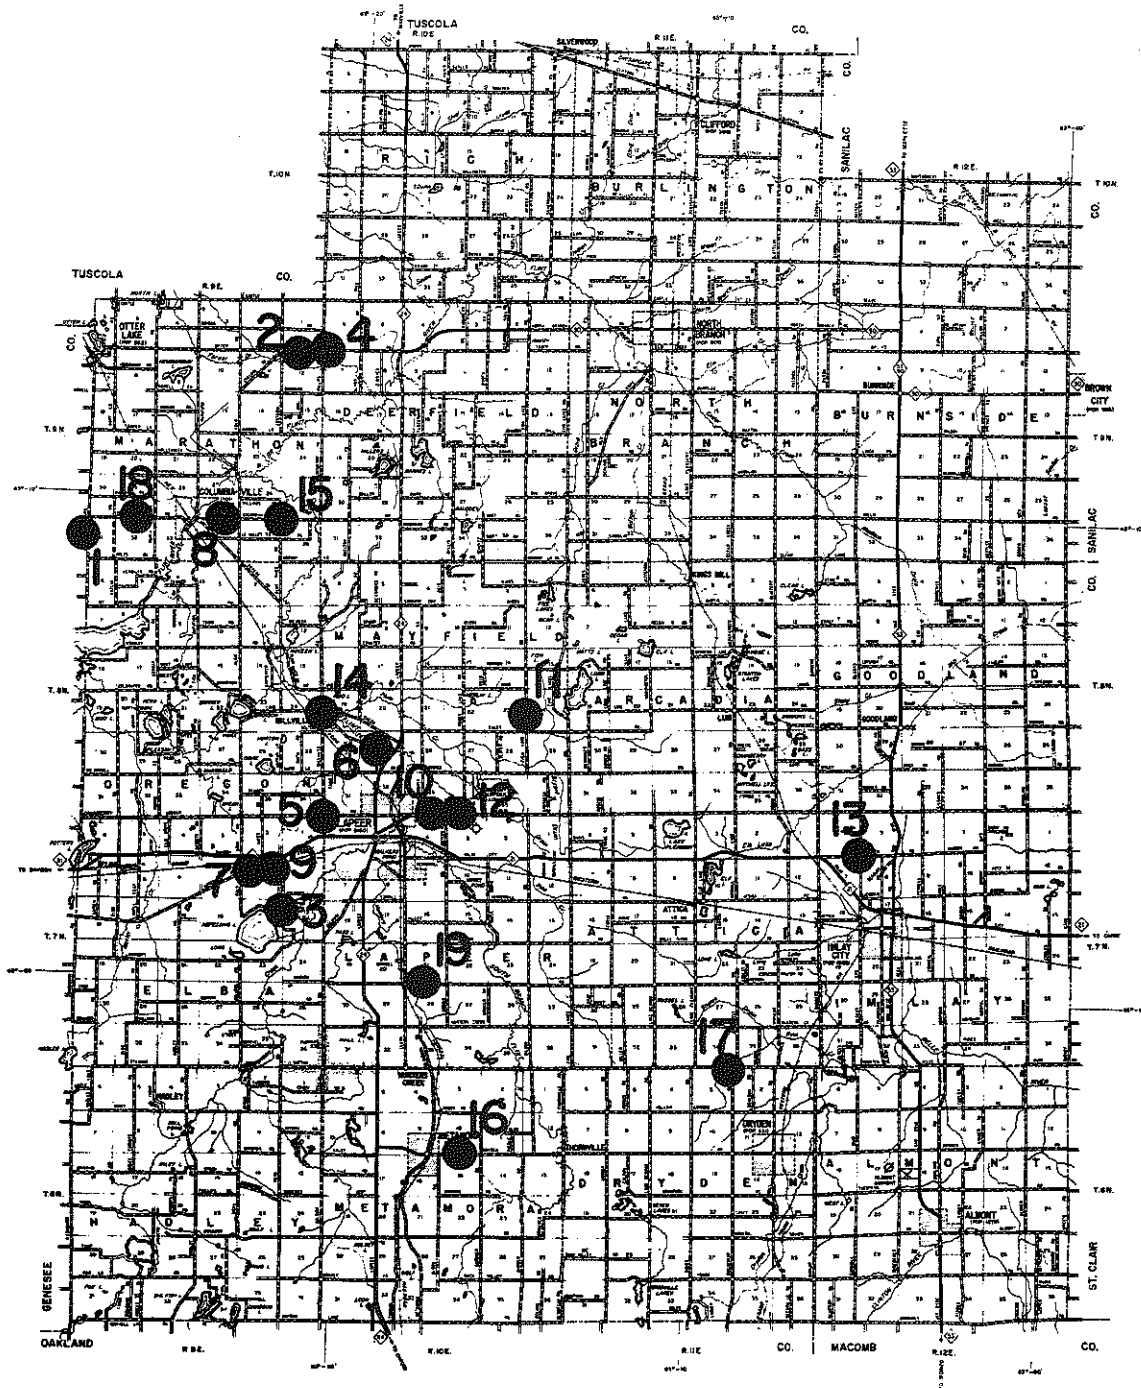
SPOT MAP
FOR
HIGH ACCIDENT
LOCATIONS

The accident data for Lapeer County shows 19 high accident locations (see spot map following page). After analyzing the data, it was apparent that no recommendations would be feasible for seven of these locations. Consequently, this report will discuss in detail only the remaining 12 locations. The collision diagrams and pictures for each of these will be found on the page following the discussion. The collision diagrams and pictures for the remaining seven locations are found in Appendix I.

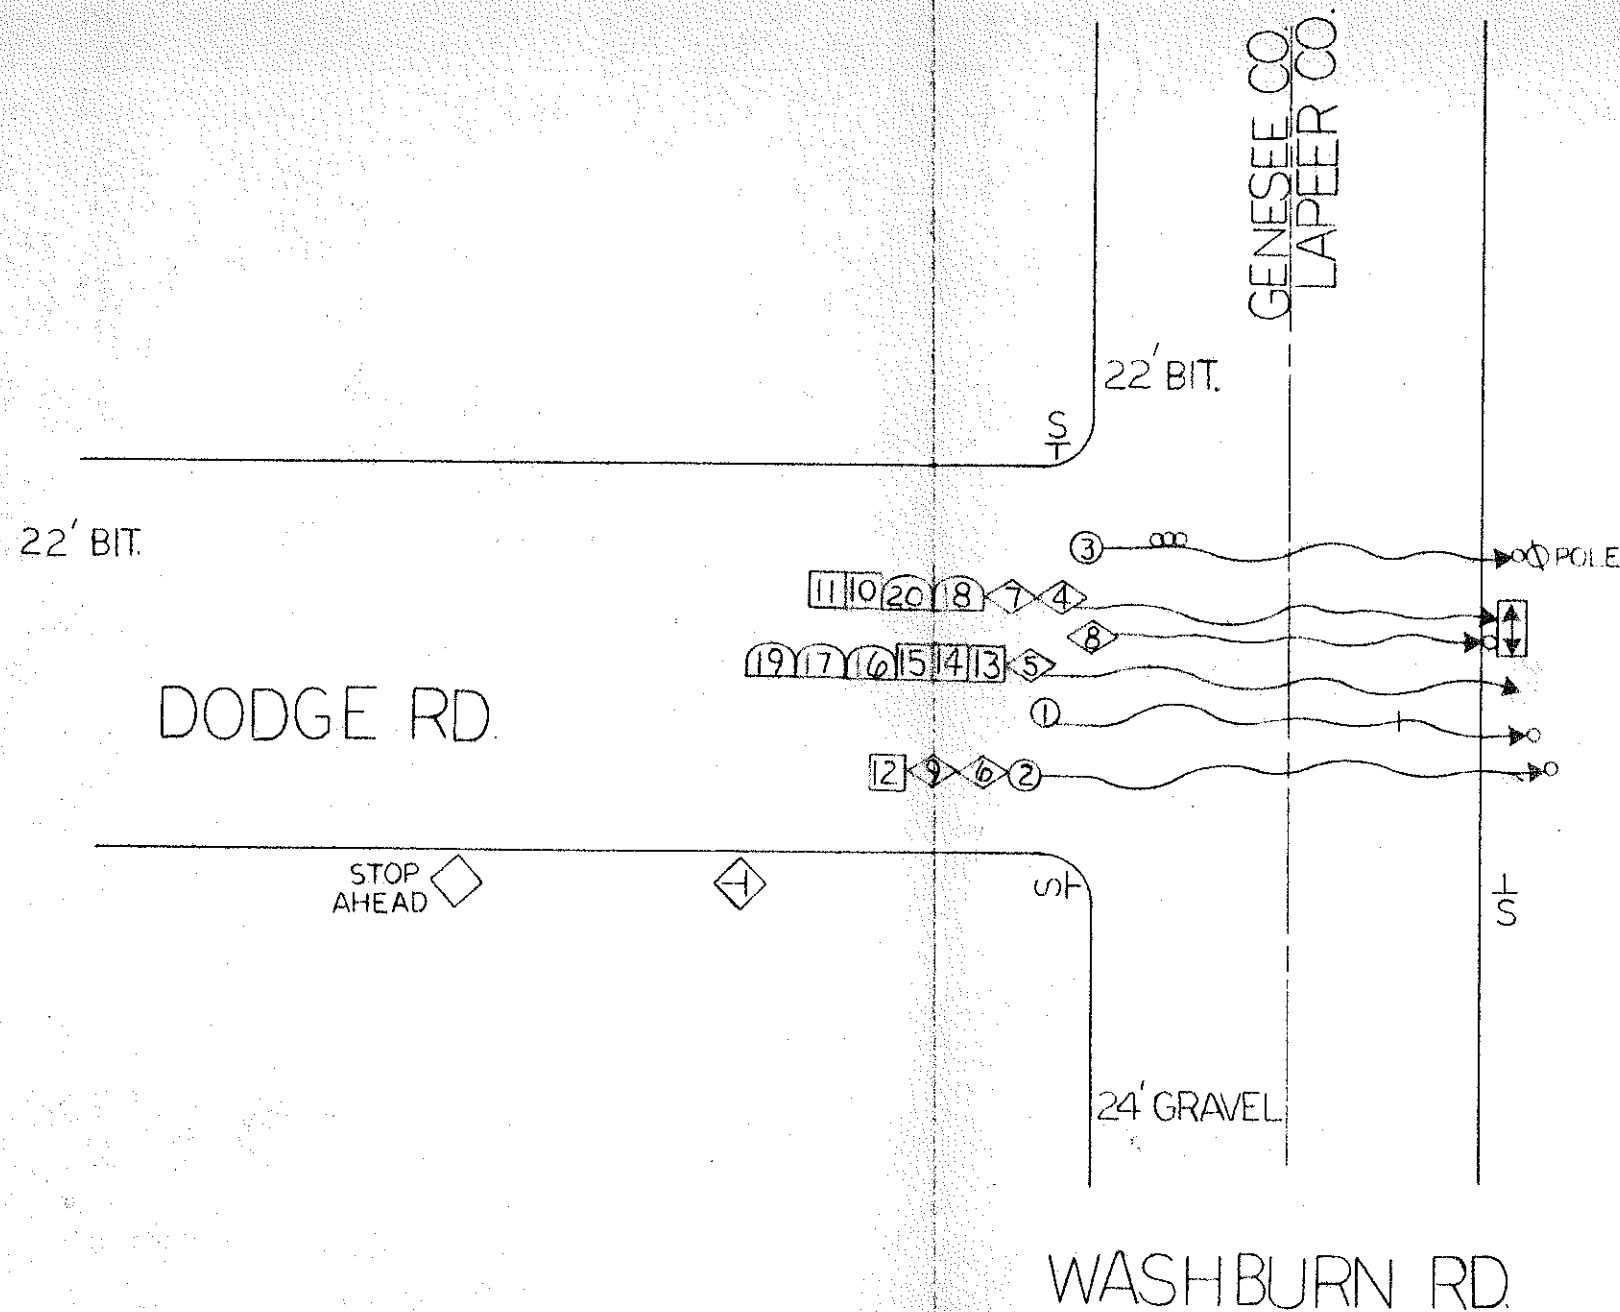
FIGURE 5

After studying this "T" intersection, a definite pattern became apparent. Out of the 20 accidents in the four-year period from 1966 to 1969, 19 of them happened at night. All 20 of these accidents occurred with the vehicles running off the end of Dodge Road. There were 13 accidents caused by excessive speed with six of these accidents occurring on wet pavement. This pattern suggests that the drivers are unable to realize in time that Dodge Road is a stop street, and that it also ends at Washburn Road.

It seems from the data that the drivers need a more pronounced warning that they are approaching an intersection. We recommend use of lattice background (see Section C, p. 141, Warning Signs - Michigan Manual of Uniform Traffic Control Devices - Appendix II, p. 103) which would give greater emphasis to the stop ahead

sign. We further recommend lattice background be placed behind the bi-directional target arrow or the target arrow could be increased in size to a 96 in. x 48 in. arrow (see Section C, p. 89 of the Manual - Appendix II, p. 98).

Since seven out of the 20 accidents involved personal injury and 13 out of the 20 involved property damage, we recommend that a safe landing area be created at the end of Dodge Road. Presently the area behind the target arrow consists of an open ditch approximately two feet below the pavement. If this area were filled and break-away supports for the target arrow used, personal injury and property damage would be reduced considerably.

We further recommend that skidometer tests be made at this intersection since a sizeable number of the accidents occurred on wet pavement. This service is available from the Testing and Research Division of the Michigan Department of State Highways. Prior arrangement should be made with Mr. L. T. Oehler, Engineer in the Research Laboratory Section of the Testing and Research Division, who will schedule the test.

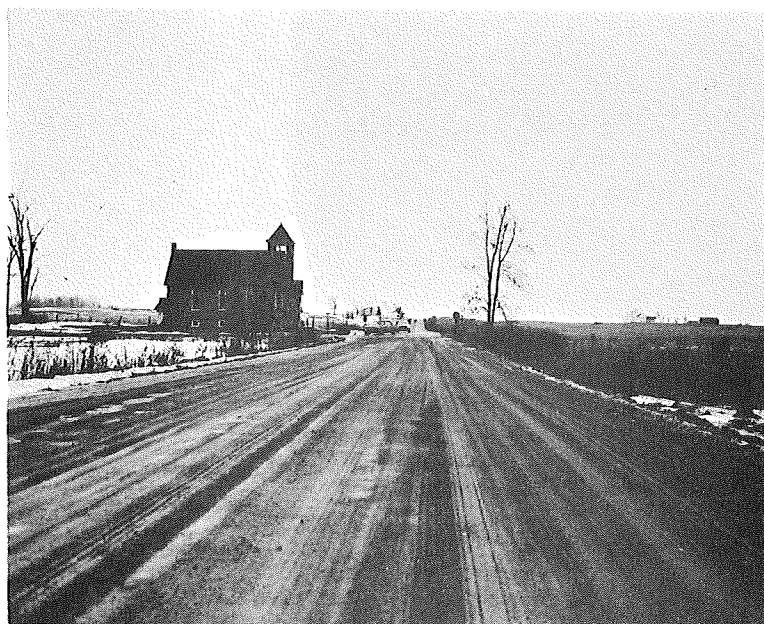
SOUTHBOUND
WASHBURN ROAD

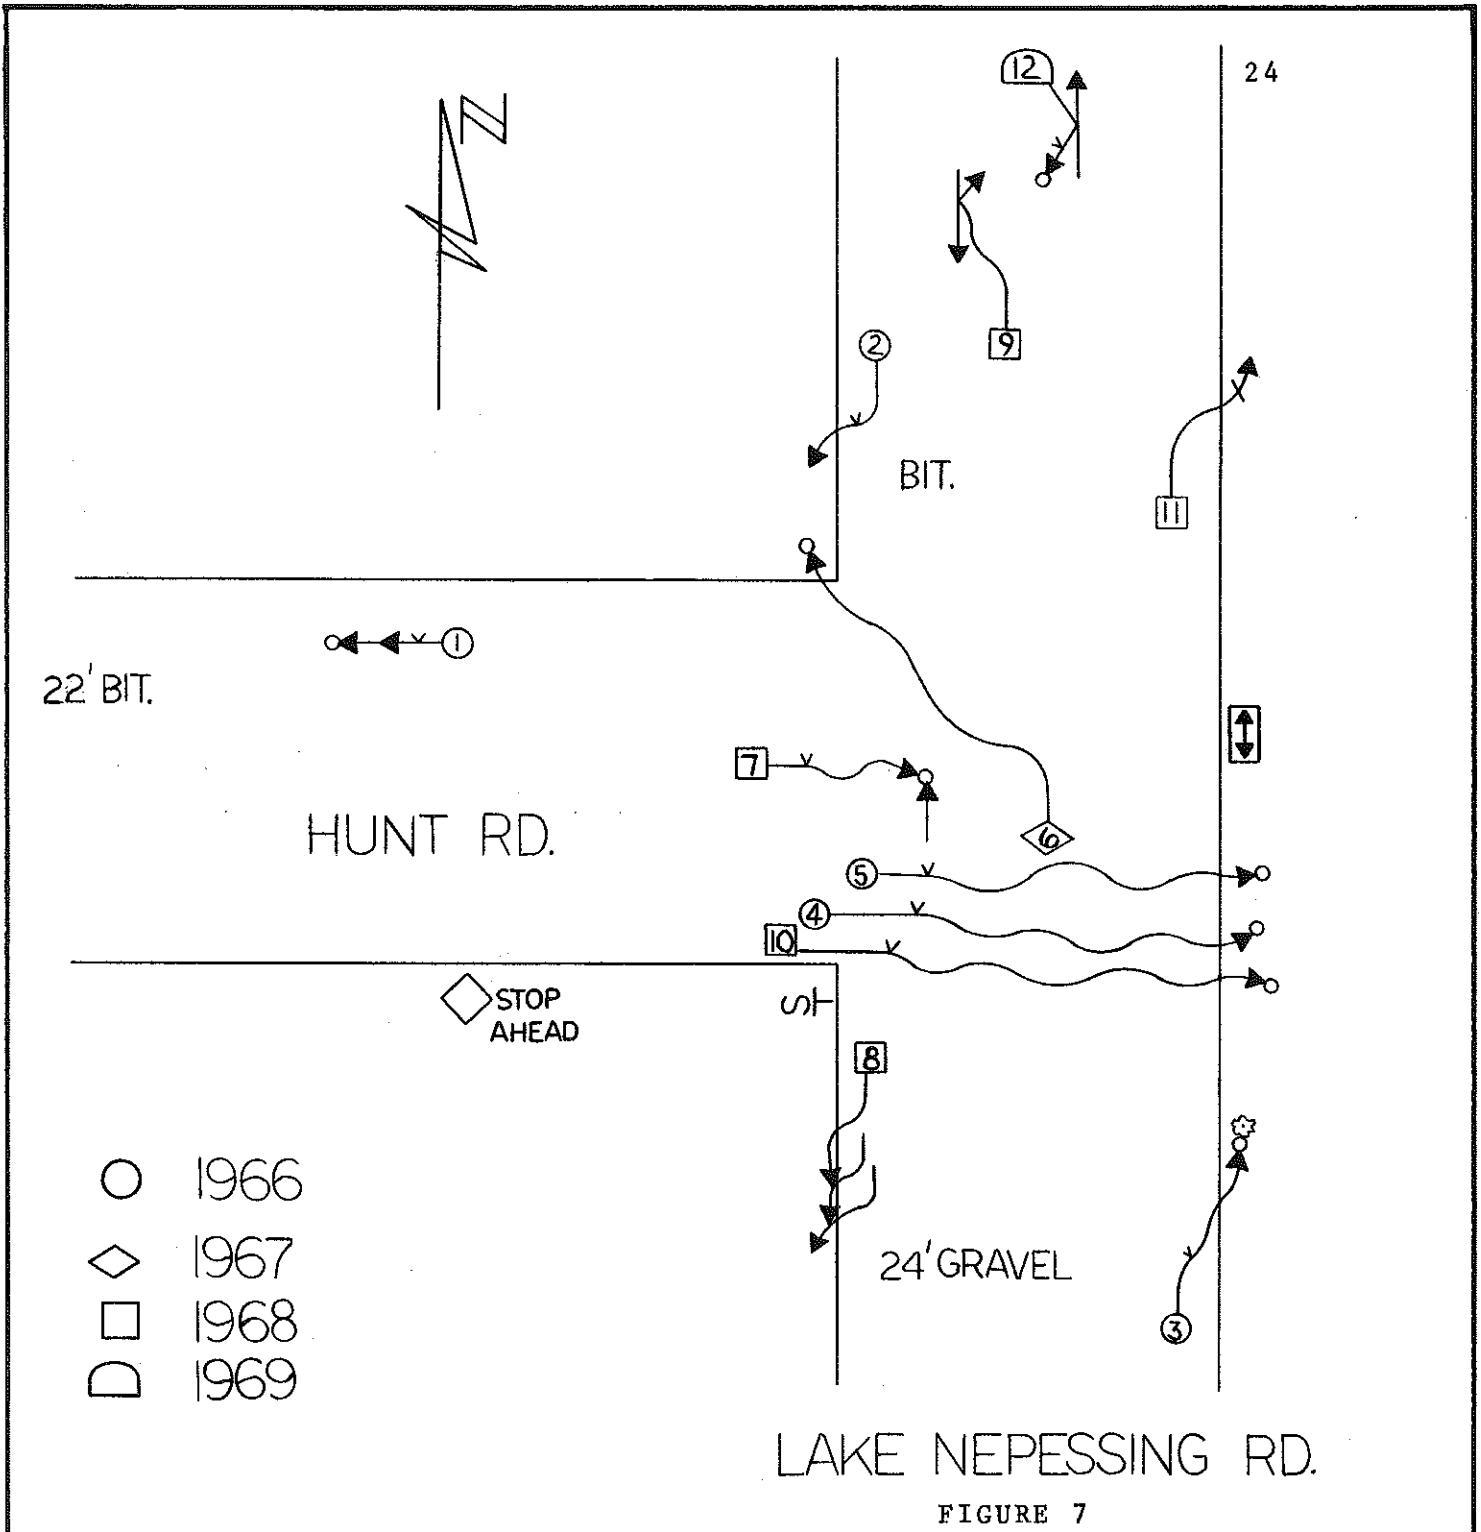
FIGURE 7

Period: 1966 THRU 1969
 ELBA TWP. Description LAPEER CO.
 LAKE NEPESSING RD. at HUNT RD.
 Accidents - Total 12
 P.D. 4 Injury 8 (11.)
 Fatal 0 ()
 Acc. Rate/mv _____
 Acc. Rate/mvm _____
 C.S. _____ Miles _____
 Drawn DVW Date 1-23-70 Rev. _____
 Plan No. _____ # 3

We recommend lattice background (see Section C, p. 141, Warning Signs - Appendix II, p.103) be placed behind the bi-directional target arrow at the end of Hunt Road or the target arrow could be increased in size to a 96 in. x 48 in. arrow (see Section C, p. 89 of the Manual - Appendix II, p.98). Either of these

improvements would make the target arrow more effective at night which is the time when the three ran-off roadway accidents occurred. Since all three of these accidents resulted in personal injury, we recommend that a safe landing area be provided in the area behind the target arrow. Removal of the trees at the end of Hunt Road should be included in creating the safe landing area.

Also the stop ahead warning sign on Hunt Road should be increased in size to a W-1-30 (see Appendix II, p.100) so that the sign will conform to the minimum size in the Michigan Manual of Uniform Traffic Control Devices.

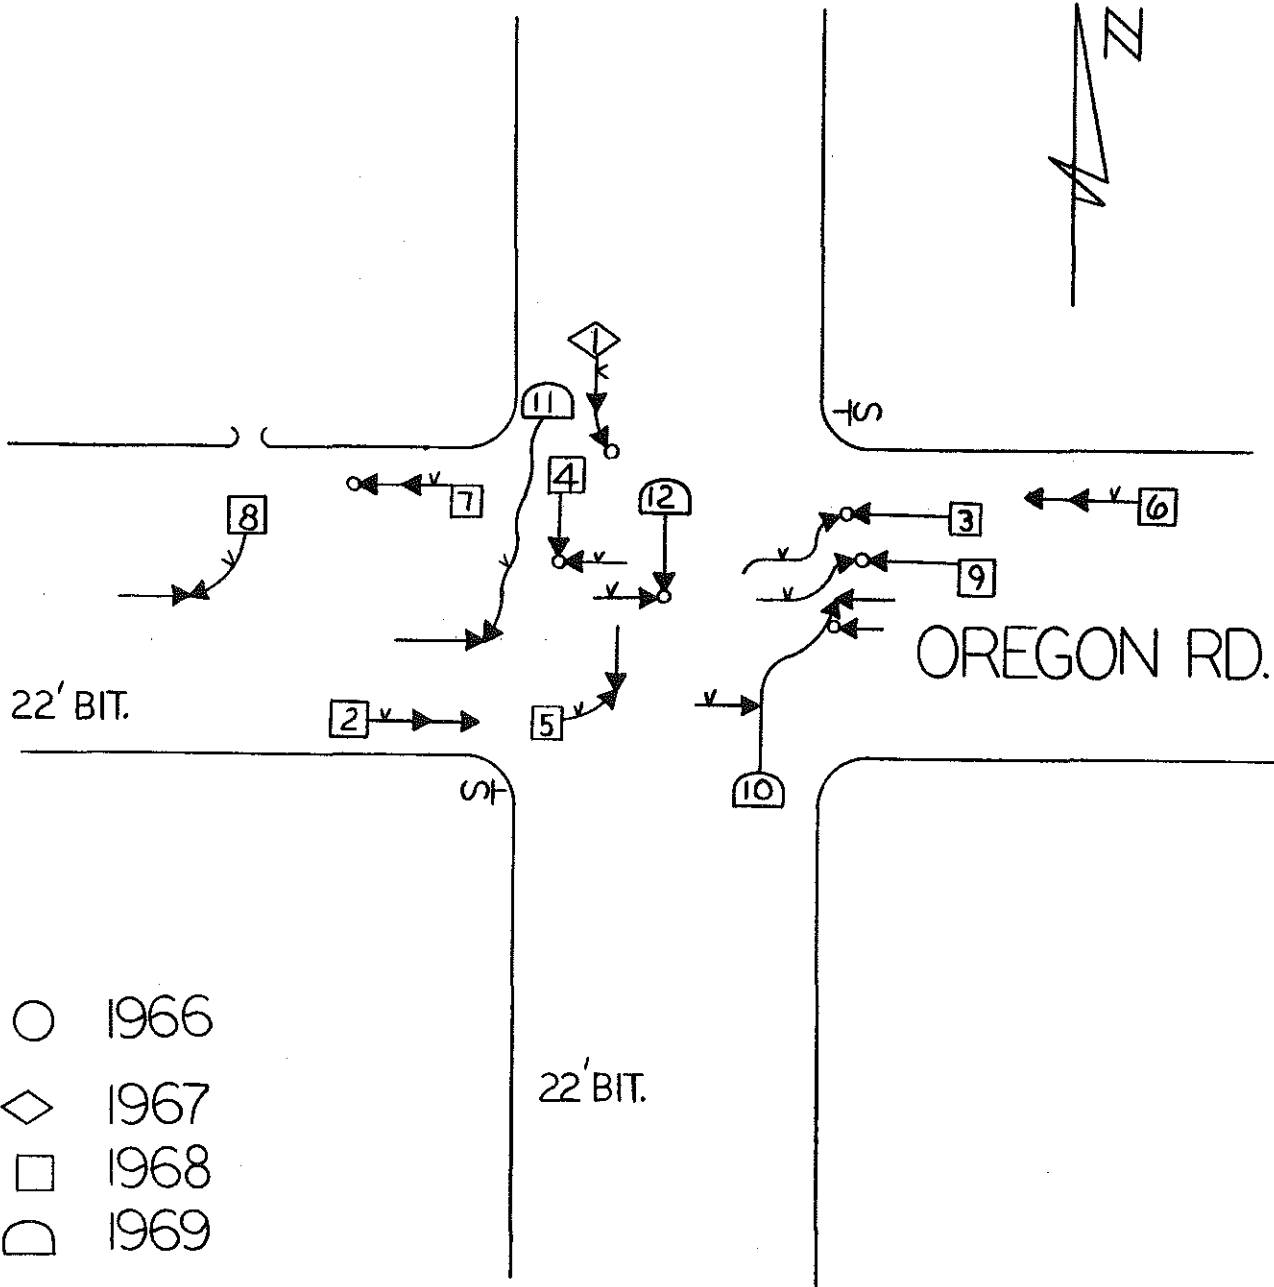
FIGURE 8

There were 12 accidents at this intersection during the four-year study period. Eight of these accidents occurred on dry pavement and nine occurred during the day. There were four right angle accidents, three of them involving either failure to yield the right of way or failure to stop at Millville Road.

Even though the stop signs on Oregon Road are both visible, three vehicles still drove through the intersection and claimed in the accident reports that they did not see the stop signs. The traffic on both Millville and Oregon is quite heavy due to a high school located in the southeast quadrant. Thus, even though there were only three accidents of this type, we recommend that stop ahead warning signs (see Section C, p. 94 of the Manual, Appendix II, p. 100) be placed on Oregon Road both east and west of Millville Road.
