A TRAFFIC ACCIDENT ANALYSIS  
OF HIGH ACCIDENT LOCATIONS  
IN THE CITY OF ADRIAN  
Report TSD-SS-191-71

**TRAFFIC and  
SAFETY  
DIVISION**

**DEPARTMENT OF STATE HIGHWAYS  
STATE OF MICHIGAN**

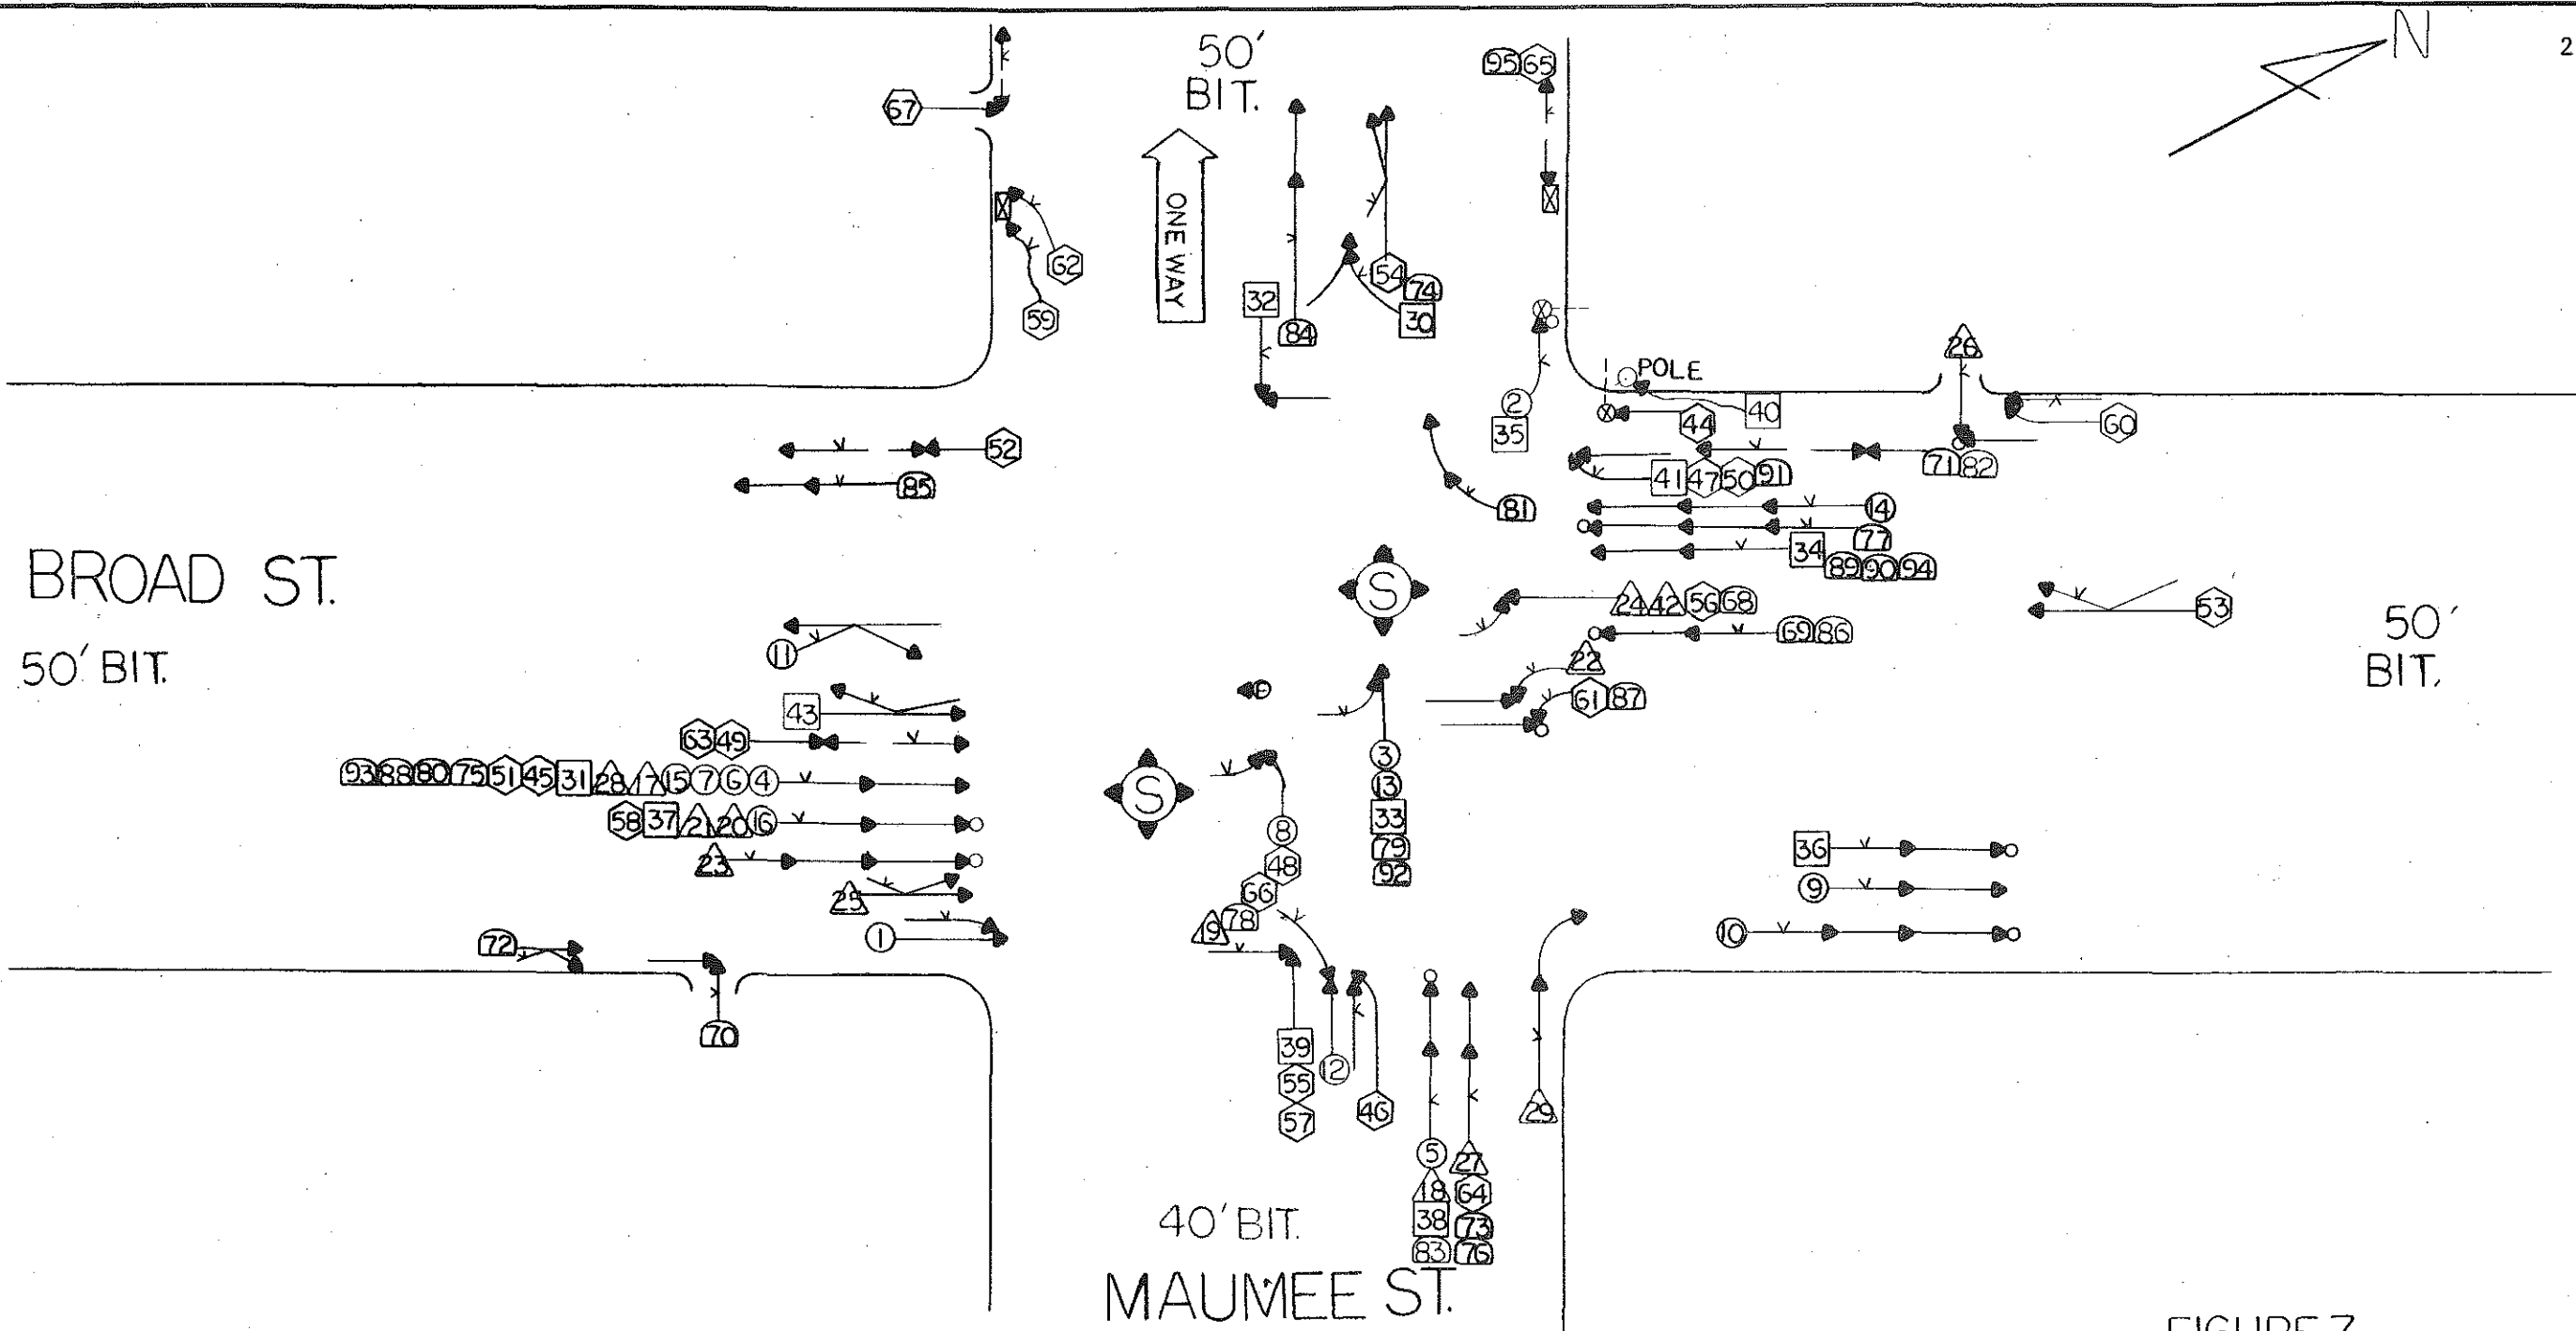
FIGURE 7

It was noted from the accident reports that, of the 42 rear end accidents, 14 were caused by vehicles which had already stopped, but the driver either let his foot off the brake pedal or said he thought the signal had changed. These accidents are very minor in nature and tend to distort the criticality of this type accident. If these accidents are subtracted from the total rear end accidents, there would be 28 rear end accidents which can't be considered too serious as this is a high volume\* signalized location.

The accident reports also revealed that 12 of the 16 angle accidents were caused by vehicles attempting the left turn from northbound Broad Street to westbound Maumee Street on the red flashing arrow.

Field investigation revealed a definite need for a separate phase for the northbound to westbound movement, as there is a heavy left turn volume in this direction. It is, therefore, recommended that the flashing red arrow be removed and a delayed left turn phase be added to facilitate this movement. Traffic counts will be necessary to determine the proper timing of the left turn phase.

If the one-way system is implemented it is recommended that the pavement be marked as shown on page 30; however, should the present system be retained, the pavement should be marked as shown on page 31. These changes are reflected in the new National Manual on Uniform Traffic Control Devices.

The overhead "Left Turn Lane" and "Thru and Right Turn Lane" signs, south of the intersection, should be replaced by symbol signs. These are Lane Use Control signs (R3-8-30, Appendix II, p.130). If the one-way system is adopted the signs should indicate a center left turn lane and the through lane. If the one-way system is not implemented, the sign over the right lane should be a "Thru and Right Turn" Lane Use Control sign (R3-9-30, Appendix II, p.130).

A final recommendation would be to obtain skidometer tests, as there were 27 accidents (28.4%) on wet pavement. Several policing officers also indicated on the accident reports that the pavement was slippery when wet. This service is available from the Testing and Research Division of the Michigan Department of State Highways. Arrangements should be made with Mr. Max N. Clyde, Engineer of Testing and Research.

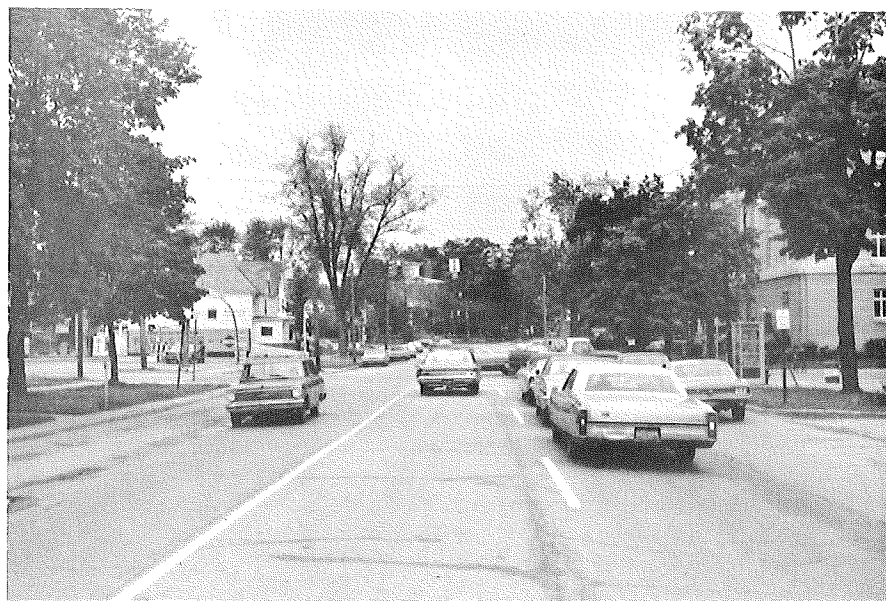
Figure 7A

NORTHBOUND  
BROAD STREET

SOUTHBOUND  
BROAD STREET

EASTBOUND  
MAUMEE STREET
