RESEARCH SPOTLIGHT

REPORT NAME: Repair of Bridge Deck Fascias

RESEARCH REPORT NUMBER: SPR-1730

New methods for preventing and repairing bridge deck fascia damage

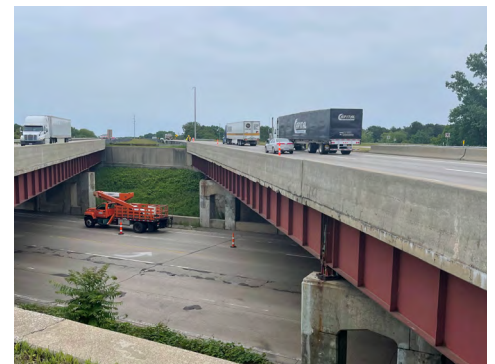
New tools, repair methods and bridge designs support MDOT efforts to repair existing bridge deck fascias and prevent deterioration in new bridges.
