CORROSION-RESISTANT DOWEL BARS

Research Laboratory Division
Office of Testing and Research
Research Project 52 G-64
Research Report No. R-591

State of Michigan
Department of State Highways
Lansing, June 1966

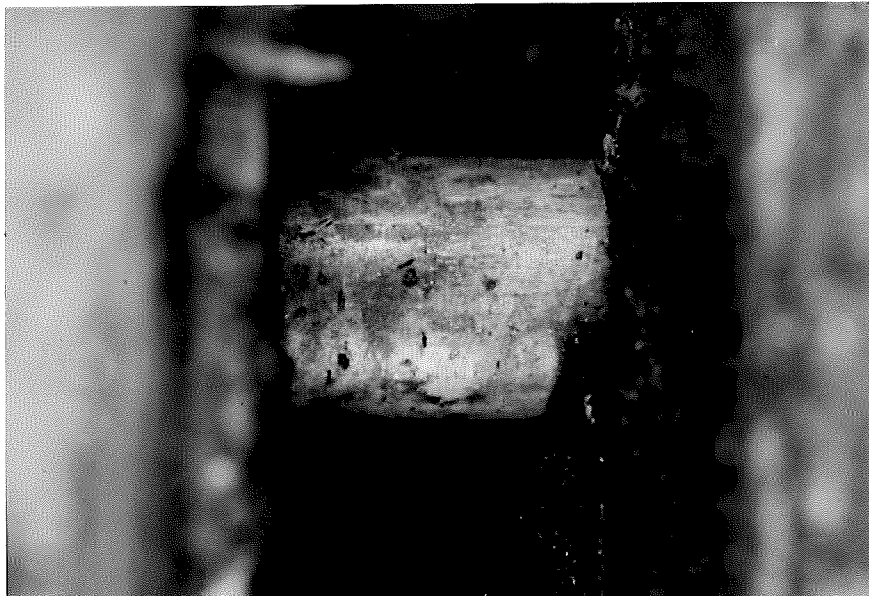
Figure 2. Surface condition typical of Monel and stainless steel sleeved dowels. Brown stains do not indicate corrosion.

On October 27 and 28, 1964 these experimental dowels received their closest inspection in seven years of service. Figures 2, 3, and 4 show typical conditions of dowels in areas of joint opening. A more thorough examination, which should be performed for final evaluation, would require removal of sample dowels from the pavement. The pictures represent the general condition of all dowels in each test series.

Briefly, the inspection indicated that nickel clad dowels, Monel sleeved dowels, and dowels sleeved in three types of stainless steel showed no indication of corrosion, whereas considerable corrosion has taken place in the standard hot-rolled steel dowel bars installed at the same time.

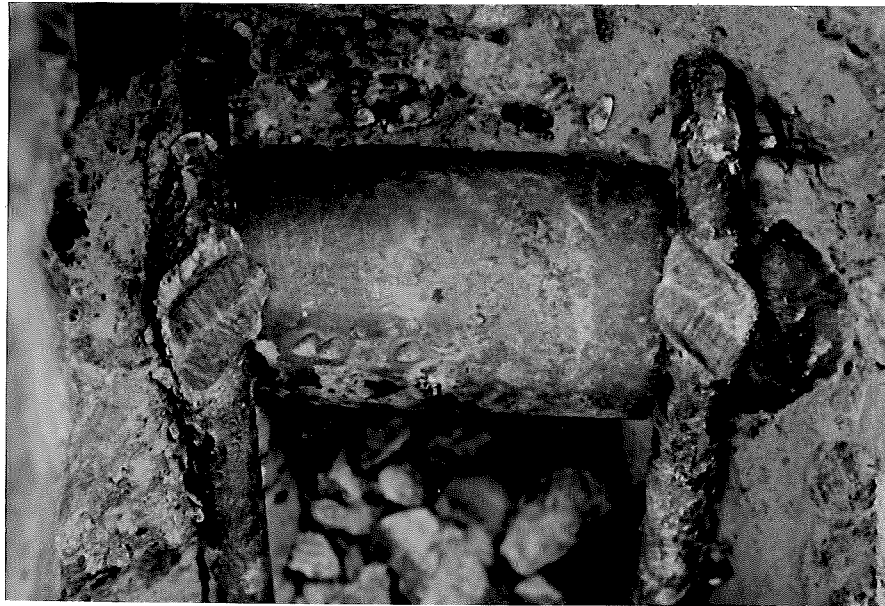
Figure 3. Typical surface condition of nickel clad dowels.

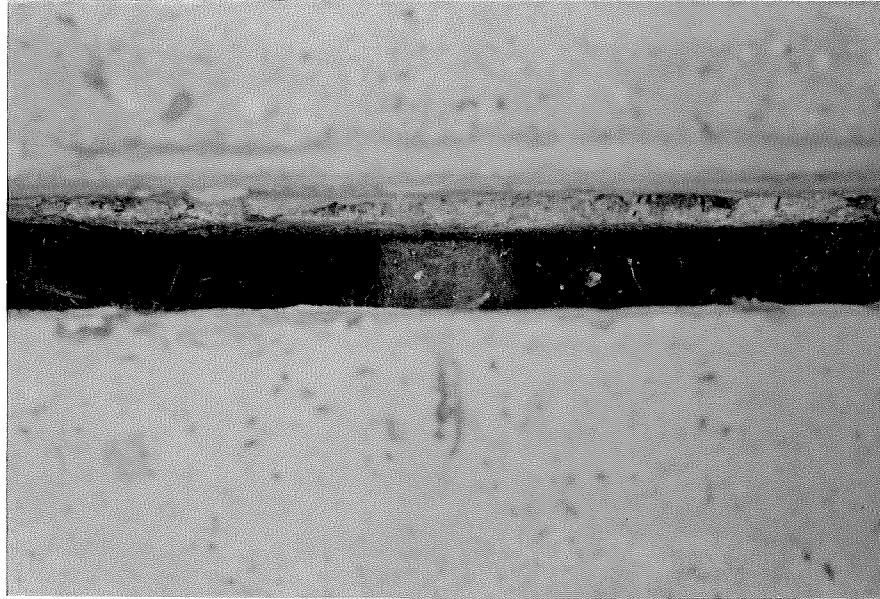
Sta. 451+92, Traffic Lane, Eastbound Roadway. The fourth dowel from the south pavement edge in the first joint east of Bridge S16 of 4109 was inspected. The groove width was 1 in., and the depth of embedment to the top of the dowel was 4 in. The bar surface (Fig. 5) was covered with red rust and minor pitting appeared to have occurred.

Figure 5. Typical corrosive condition of chromium-steel dowels.

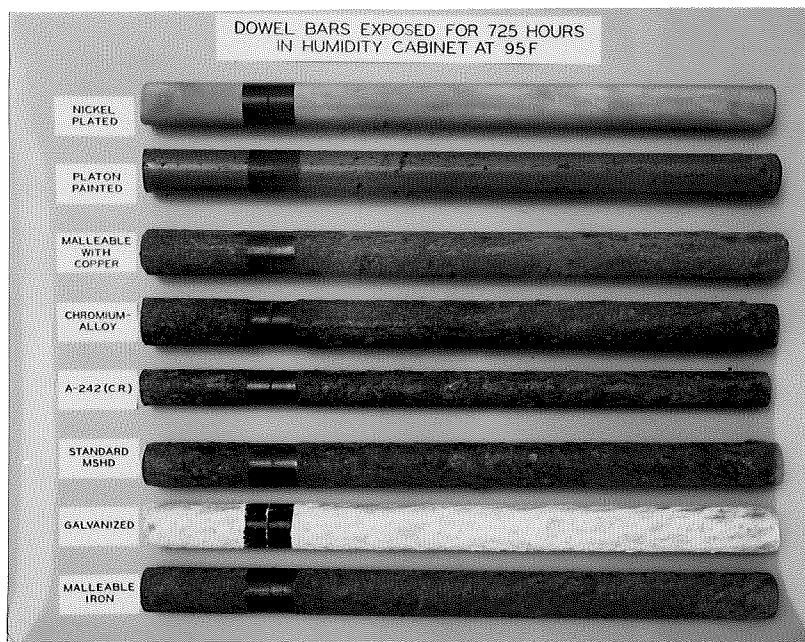
Six of the metal dowels included in the test rusted, with an increase in diameter ranging from 100 to 16 mils. The lacquer coated dowel developed minor spot rusting, while the nickel plated dowel showed no rusting, as shown in Figure 7. The increase in diameter of the dowels was as follows:

<u>Increase, mils</u>
Nickel plated	0
Lacquer coated (Platon)	0
Malleable iron with copper	40
Chromium alloy*	100
ASTM A 242 corrosion resistant steel (Yoloy-EHS)	40
Galvanized	25
Malleable iron	16

Figure 7. Condition of several dowel materials subjected to accelerated corrosion test.
