FINAL REPORT
THREE EXPERIMENTS WITH
TRANSVERSE PAVEMENT STRIPES
AND RUMBLE BARS

TSD-RD-216-72

October 1972

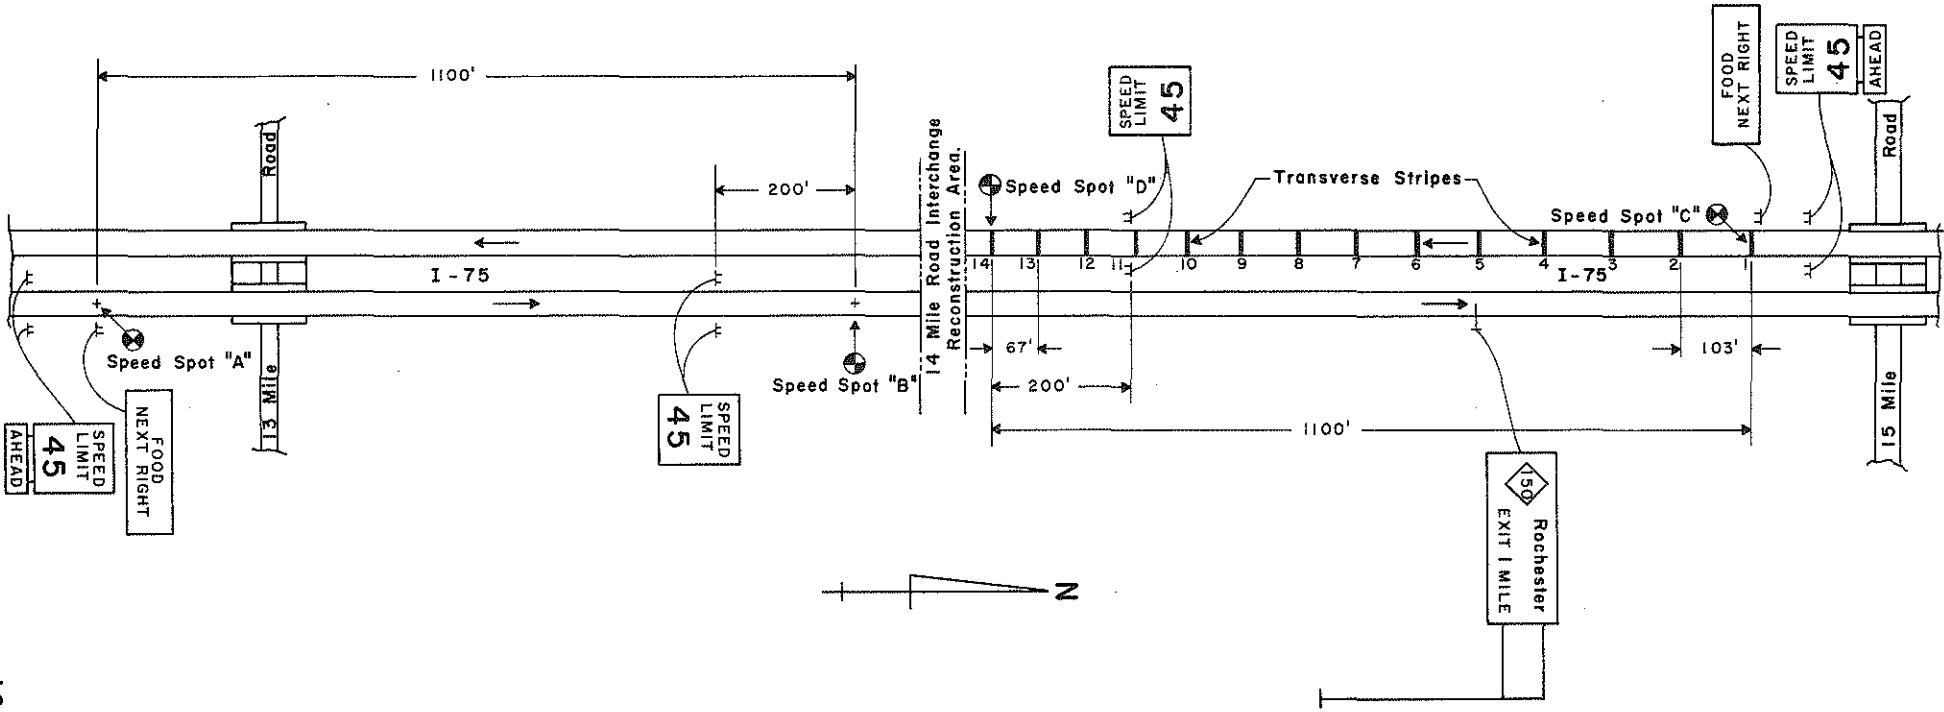
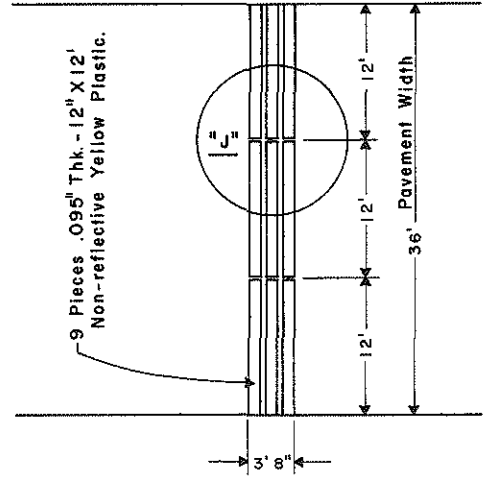
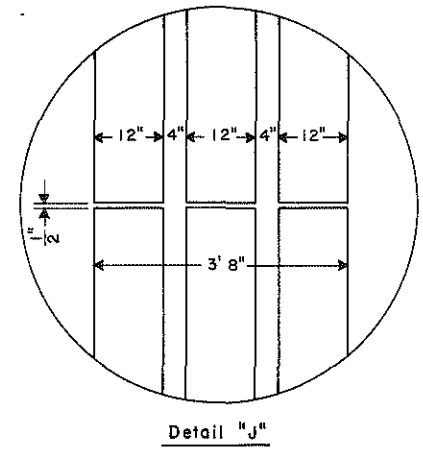
Figure 2 - TRANSVERSE PAVEMENT STRIPES ON I-75

STRIPE CONFIGURATION

Transverse pavement striping, in conjunction with usual warning signs and other devices, was used on the southbound pavement. The northbound pavement was not striped and was used for comparison. The gradients on the northbound and southbound roadways are almost equal. The stripes were approximately four feet wide and 36 feet long, and crossed three freeway lanes at right angles. Figure 2 shows their location in relation to the existing traffic control signs. Three parallel plastic sheets 12 inches wide

were laid with 4 inch spacing between each sheet for the purpose of adding a slight "rumble" effect to the visual stimuli (Figs. 3 and 4). The spacing between each set of stripes varied gradually from 103 feet to 67 feet. The vendor of the product closely supervised the work for adherence to recommended installation procedure.

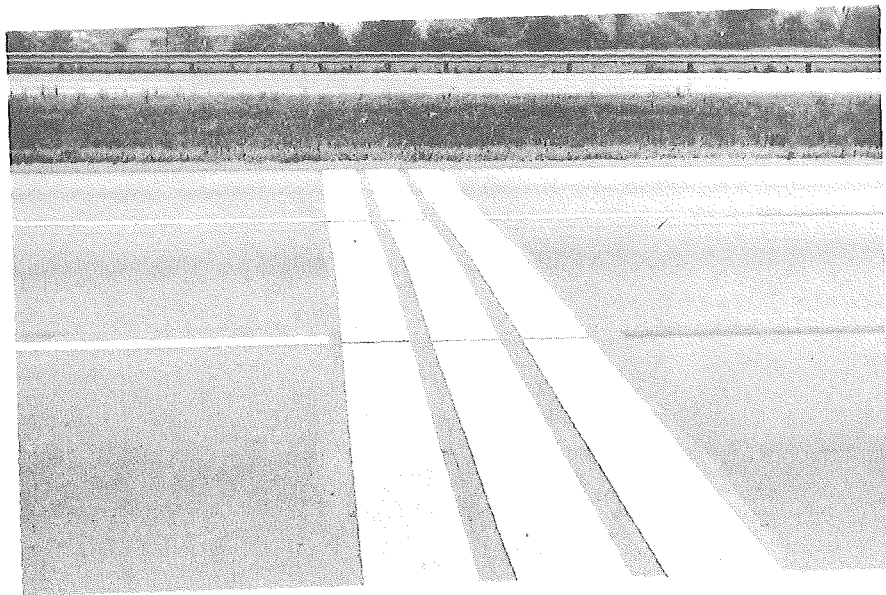
Fig. 3 - Side view of transverse stripes on I-75

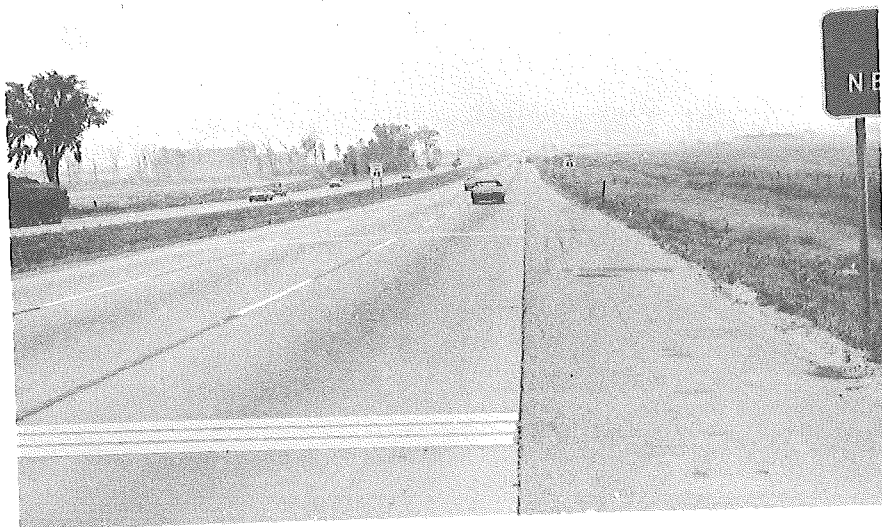
Fig. 4 - General appearance of transverse stripes on I-75

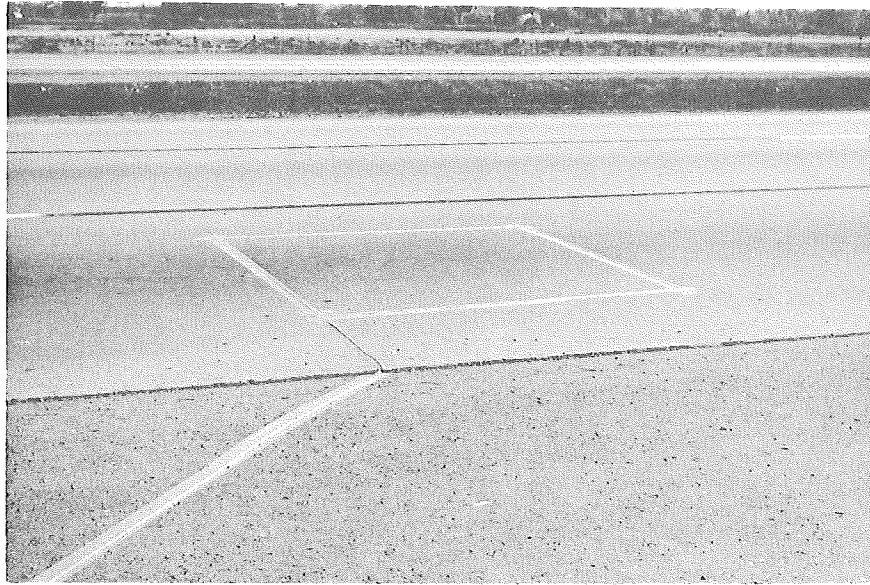
Fig. 5 - Induction loop taped onto pavement

The purpose in the use of loop detectors was a desire for a more accurate method of obtaining spot speeds. Radar speeds are not always accurate, especially under dense, multilane traffic conditions. The loop detection system was assembled from equipment available in the Department, and used two induction loops taped onto the pavement (Fig. 5), with a prescribed trap distance between them. Two electronic detectors were each connected to one of the loops and activated by a portable generator (Fig. 6). The output signals from the detectors were fed at a time interval measurement device functioning in combination with a paper tape printer (Fig. 7). These time interval data were converted to speeds by the office computer, based on the trap distance between the loops. At first a 32-foot trap distance was used. During the later experiments at other sites the use of a 29-foot 4-inch trap made occasional quick calculation

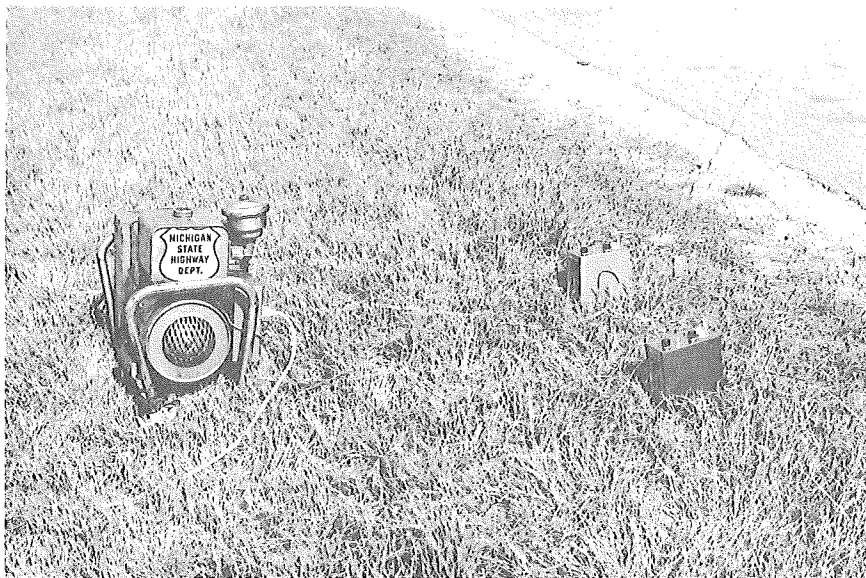
Fig. 6 - Electric generator and vehicle detectors

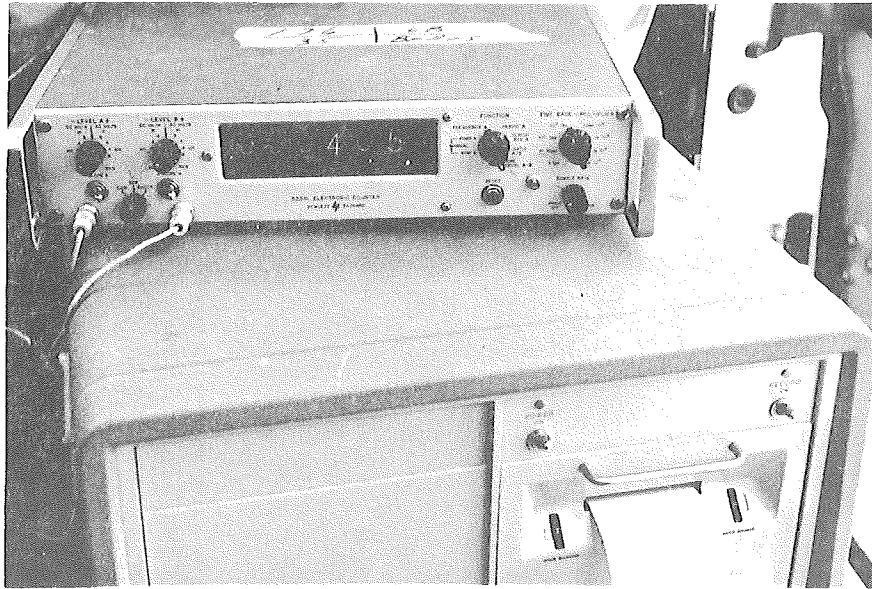
Fig. 7 - Electronic counter with time base,
coupled to tape printer

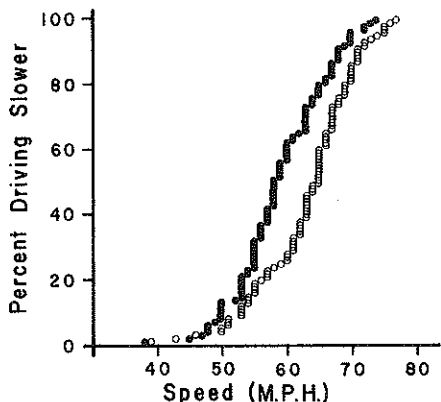
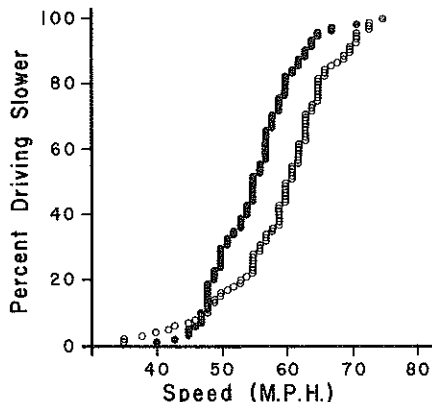
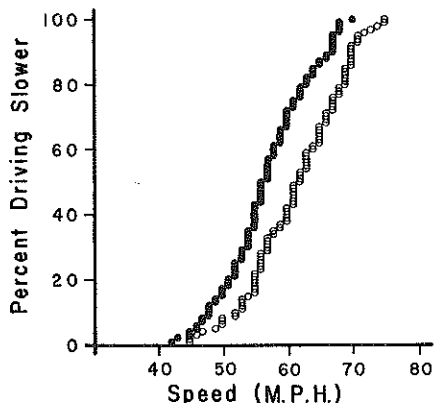
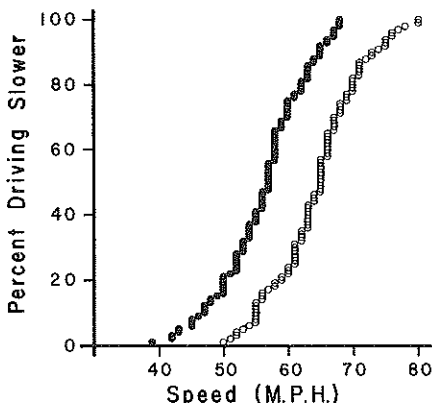
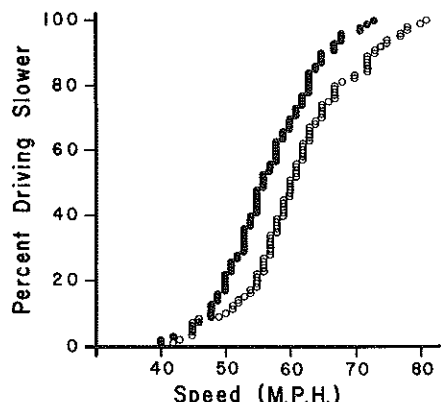
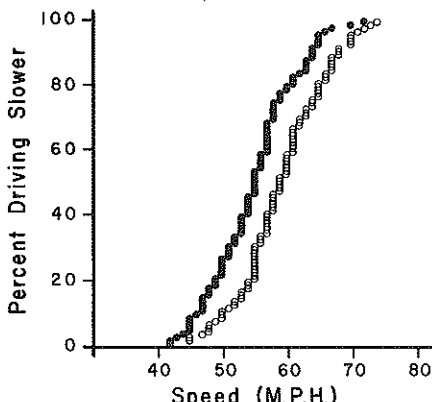
Fig. 8 - Effect of Pavement Stripes on Speed Distribution on I-75.

○ = BEFORE ZONE ● = BEGINNING OF ZONE
 85 Percentile Speed = 70 85 Percentile Speed = 67
 Average Speed = 63.2 Average Speed = 59.1
 Median Speed = 65 Median Speed = 58

PHASE-1 SPEEDS ON NB I-75
 Before Striping SB Pavement (8-29-69)

○ = BEFORE ZONE ● = BEGINNING OF ZONE
 85 Percentile Speed = 66 85 Percentile Speed = 61
 Average Speed = 59.3 Average Speed = 55.1
 Median Speed = 60 Median Speed = 55

PHASE-1 SPEEDS ON SB I-75
 Before Striping SB Pavement (8-29-69)

○ = BEFORE ZONE ● = BEGINNING OF ZONE
 85 Percentile Speed = 69 85 Percentile Speed = 64
 Average Speed = 61.5 Average Speed = 56.9
 Median Speed = 62 Median Speed = 56

PHASE-2 SPEEDS ON NB I-75
 Immediately After Striping SB Pavement (9- 8-69)

○ = BEFORE ZONE ● = BEGINNING OF ZONE
 85 Percentile Speed = 71 85 Percentile Speed = 63
 Average Speed = 64.5 Average Speed = 56.2
 Median Speed = 65 Median Speed = 57

PHASE-2 SPEEDS ON SB I-75
 Immediately After Striping SB Pavement (9- 8-69)

○ = BEFORE ZONE ● = BEGINNING OF ZONE
 85 Percentile Speed = 72 85 Percentile Speed = 64
 Average Speed = 61.1 Average Speed = 56.5
 Median Speed = 60 Median Speed = 56

PHASE-3 SPEEDS ON NB I-75
 Six Weeks After Striping SB Pavement (10-13-69)

○ = BEFORE ZONE ● = BEGINNING OF ZONE
 85 Percentile Speed = 67 85 Percentile Speed = 63
 Average Speed = 59.2 Average Speed = 54.9
 Median Speed = 59 Median Speed = 55

PHASE-3 SPEEDS ON SB I-75
 Six Weeks After Striping SB Pavement (10-13-69)

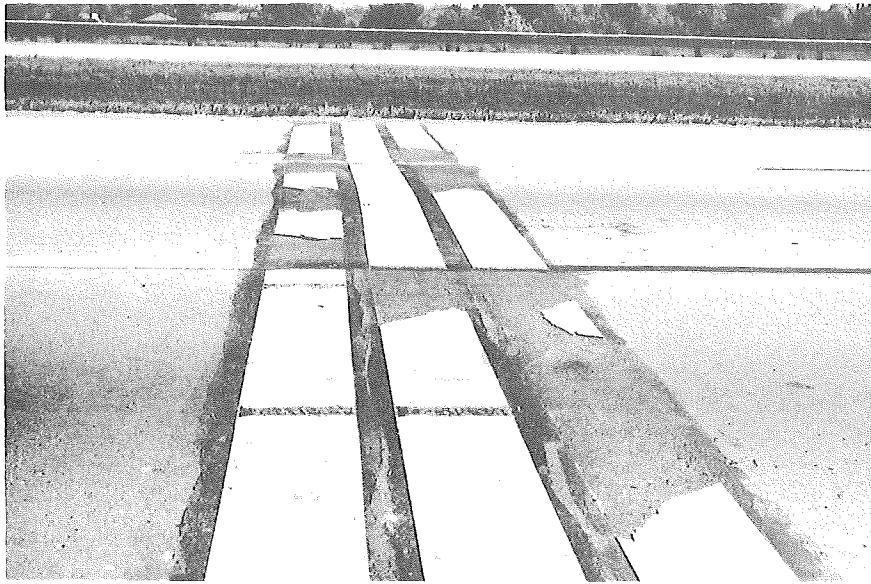
Fig. 9 - Plastic stripes after five weeks under traffic

Durability of the plastic sheets used for transverse pavement marking proved to be insufficient under the heavy and fast free-way traffic (ADT 30,000 in one direction). Figure 9 is a photograph of a typical failure, and was taken after a use of five weeks.

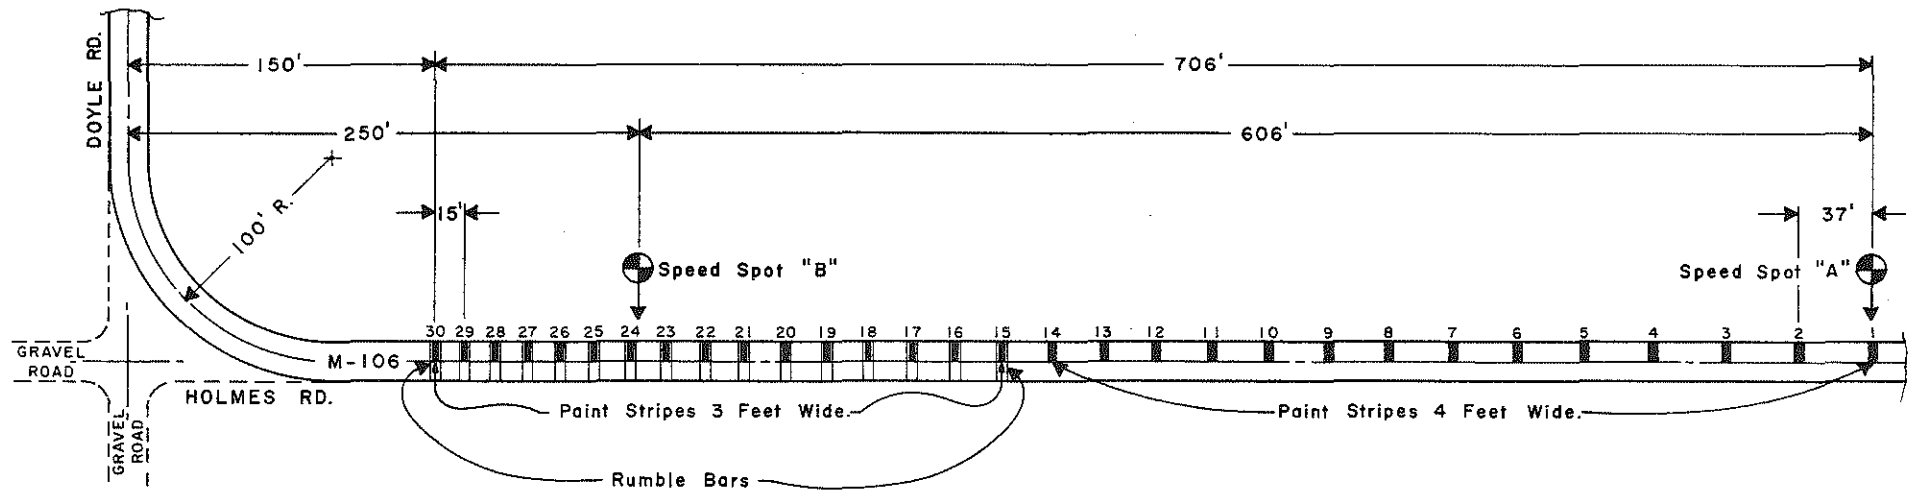
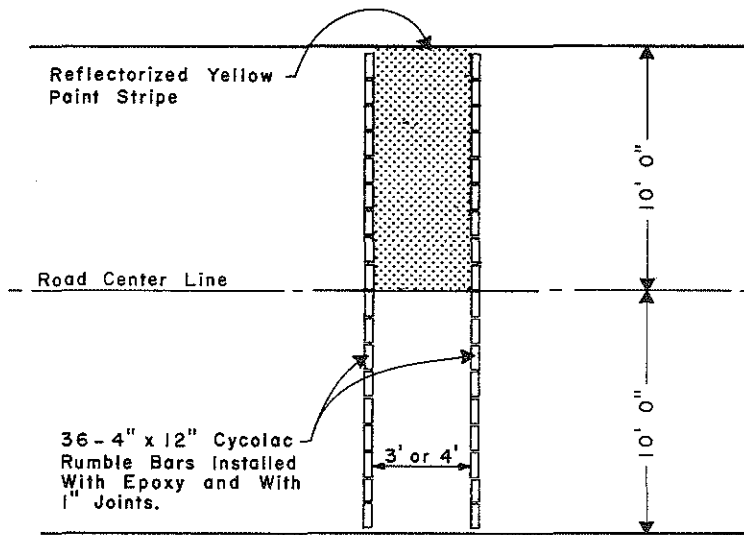
Figure 10- TRANSVERSE PAVEMENT STRIPES AND RUMBLE BARS ON M-106.

STRIPE & RUMBLE BAR DETAIL

The speed measurement apparatus developed for the I-75 tests, using pavement loop detectors, was used at spots A and B, shown in Figure 10, during the four phases of testing, except that during the fourth phase, tape switches instead of magnetic tape were used on the pavement. Also, at this test site, vehicle samples were caught first at the speed trap at A and again at B, making it possible to follow each vehicle and determine its actual speed drop individually. Any vehicle closely following another one was omitted from the sample. The equipment was housed in a van parked on a side road which was well hidden by a corn field so that it was not visible to approaching drivers.

The first set of speeds was measured before any pavement marking was done. The stripes were then painted by spraying yellow pavement-marking paint. The spacing was based on a flash frequency of two per second at the assumed travel speeds. It varied from 37 feet at the upstream end to 15 feet near the curve at the downstream end. There were 30 stripes in all. The first 14

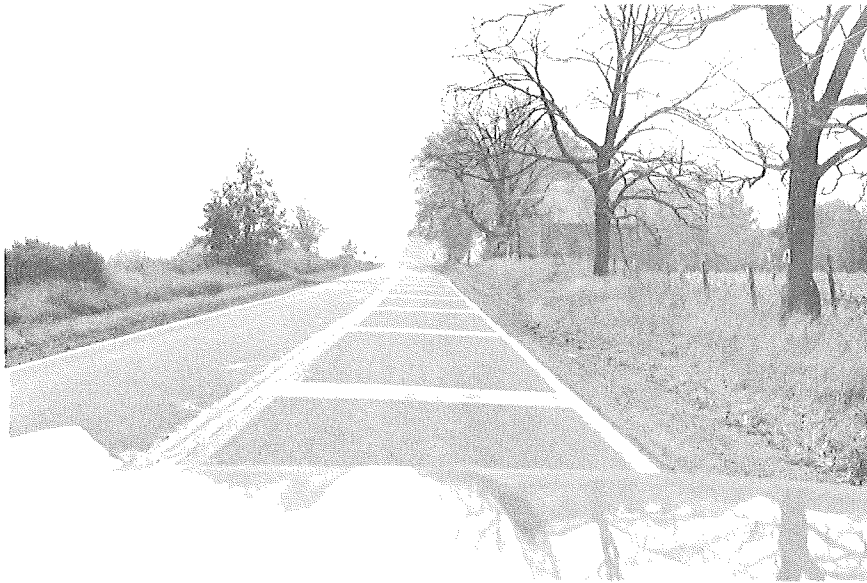
Fig. 11 - Paint stripes on M-106

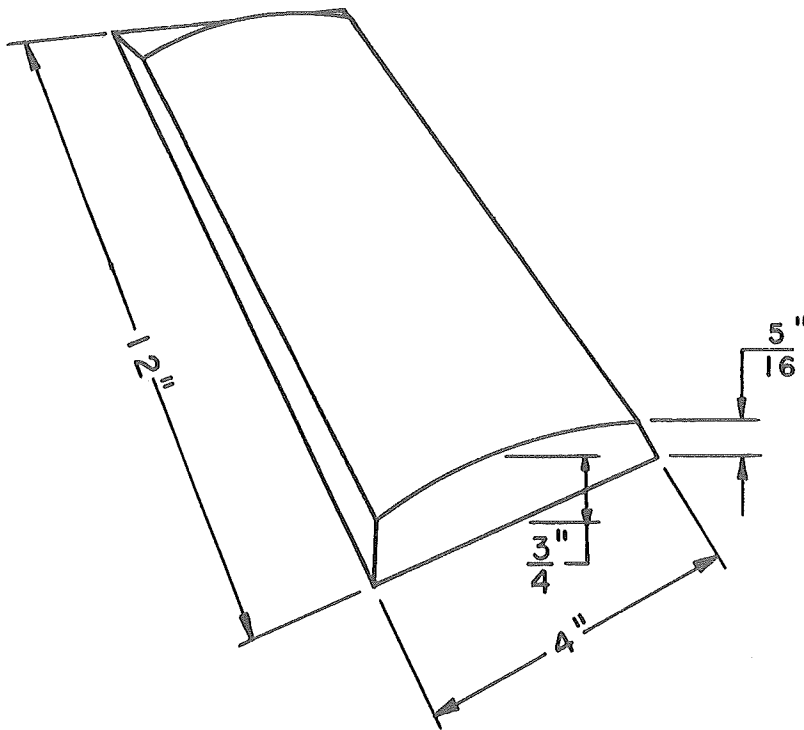
Figure 12-ABS PLASTIC RUMBLE BAR.

The rumble bars were intended by the manufacturers for use on areas from where traffic was desired to be kept away, such as channelizing islands, shoulders, etc. They had not been used so far on the traveled way. Therefore, some testing was done with these devices outside of public highways before installing them on M-106. The first test was done on the road to the Grand Ledge Maintenance Garage. Three rows were laid and driven over in passenger vehicles and in empty and loaded trucks. The ride over them did not appear to be too rough. The material withstood heavy truck wheels with no damage. A temporary butyl adhesive which came in rolls four inches wide was used in this installation.

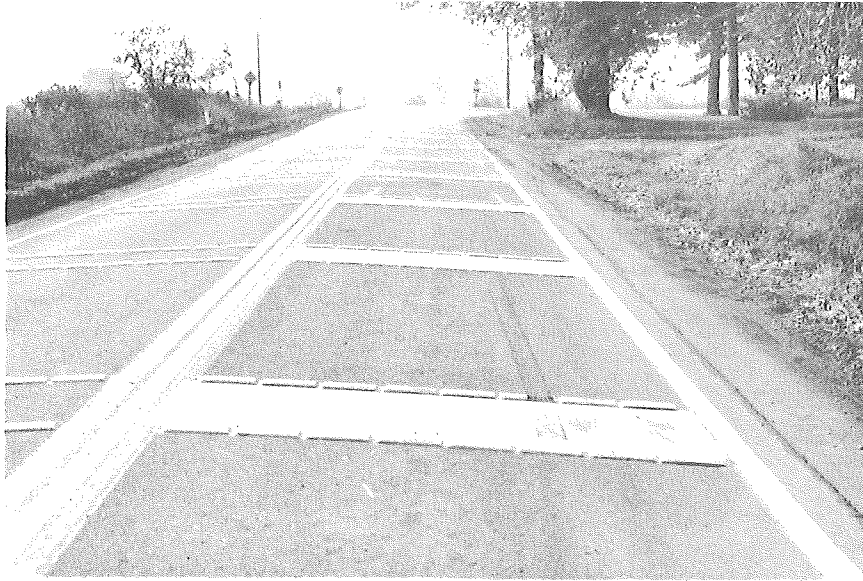
Fig. 13 - Rumble bars and paint stripes on M-106

Speeds for the second phase of the study were measured after the stripes were completed. For the third study-phase, hard plastic rumble bars, yellow in color, four inches wide and 12 inches long were installed as shown in Figure 10. The bars were made of ABS (acrylonitrile, butadiene, styrene), had a cambered top surface $3/4$ inch high in the middle and $5/16$ inch high at the two sides. The underside had a waffle-shaped ribbed structure. A three-dimensional view is shown in Figure 12. The photograph in Figure 13 shows the appearance of the road with the bars installed.

The bars remained undisturbed for several months until they were dislodged by snow plowing.

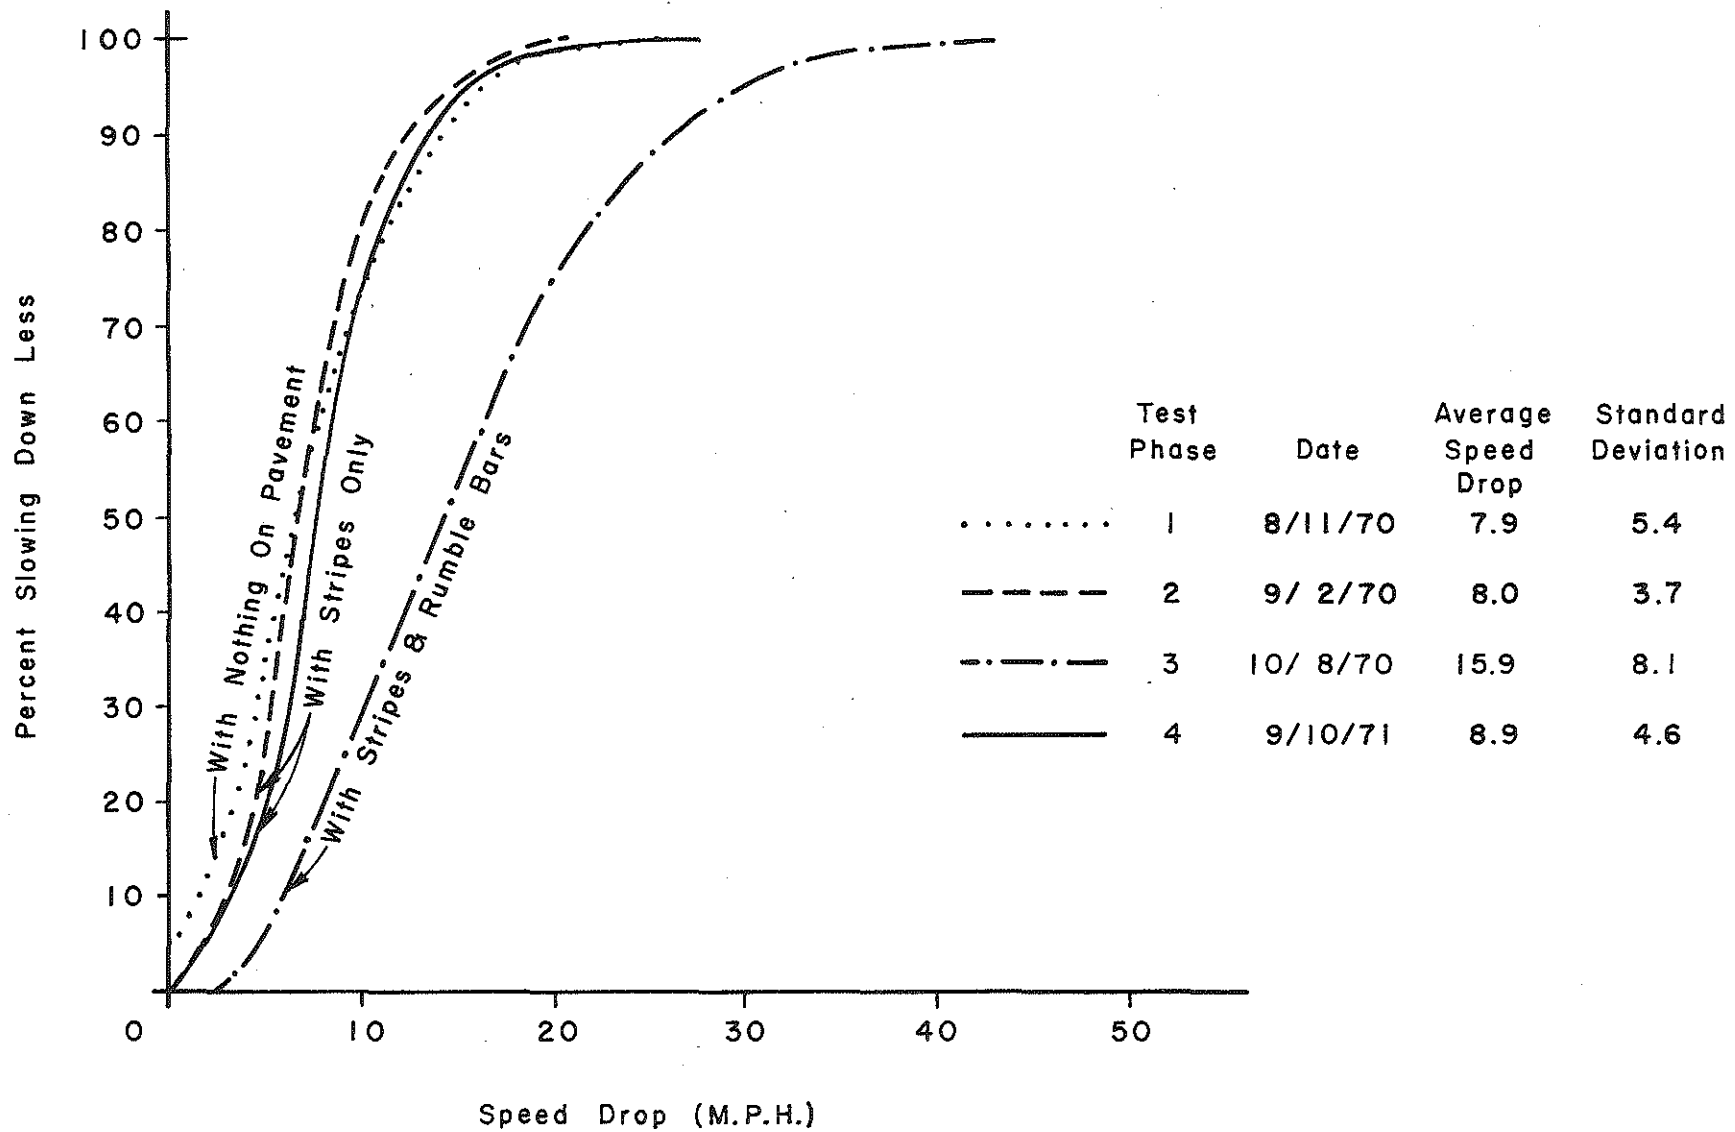
Figure 14-SPEED DROP OF INDIVIDUAL VEHICLES BETWEEN 1st AND 24th STRIPES ON M-106

Figure 14 shows the speed reductions of the vehicles between the two speed measuring stations A and B. This chart shows smoothed out curves rather than plots of actual speeds as in Figure 8. The data were compiled, as mentioned before, by taking two speed

measurements for each vehicle, by following individual vehicles. The average drop in speed during the four test phases is indicated in the tabulation in this Figure. The difference in the average speeds between Phases 1 and 2 is not significant. Neither is the difference between Phases 2 and 4. Phase 3, with rumble bars, however, is significantly different from the others. The characters of the three distribution curves are defined by the standard deviation quantities. The magnitude of the standard deviation would be an indicator of hazard, as discussed before. From this consideration it may be deduced that speed-reduction distribution improved during Phases 2 and 4, with the paint stripes alone, and worsened during Phase 3, with the rumble bars.

During speed measurements for all phases, some vehicles were observed to have traveled faster at the downstream location than at the upstream location. These were excluded from the data presented in Figure 14 showing the speed drops, but included in Figure 15 showing absolute speeds at the downstream location only.

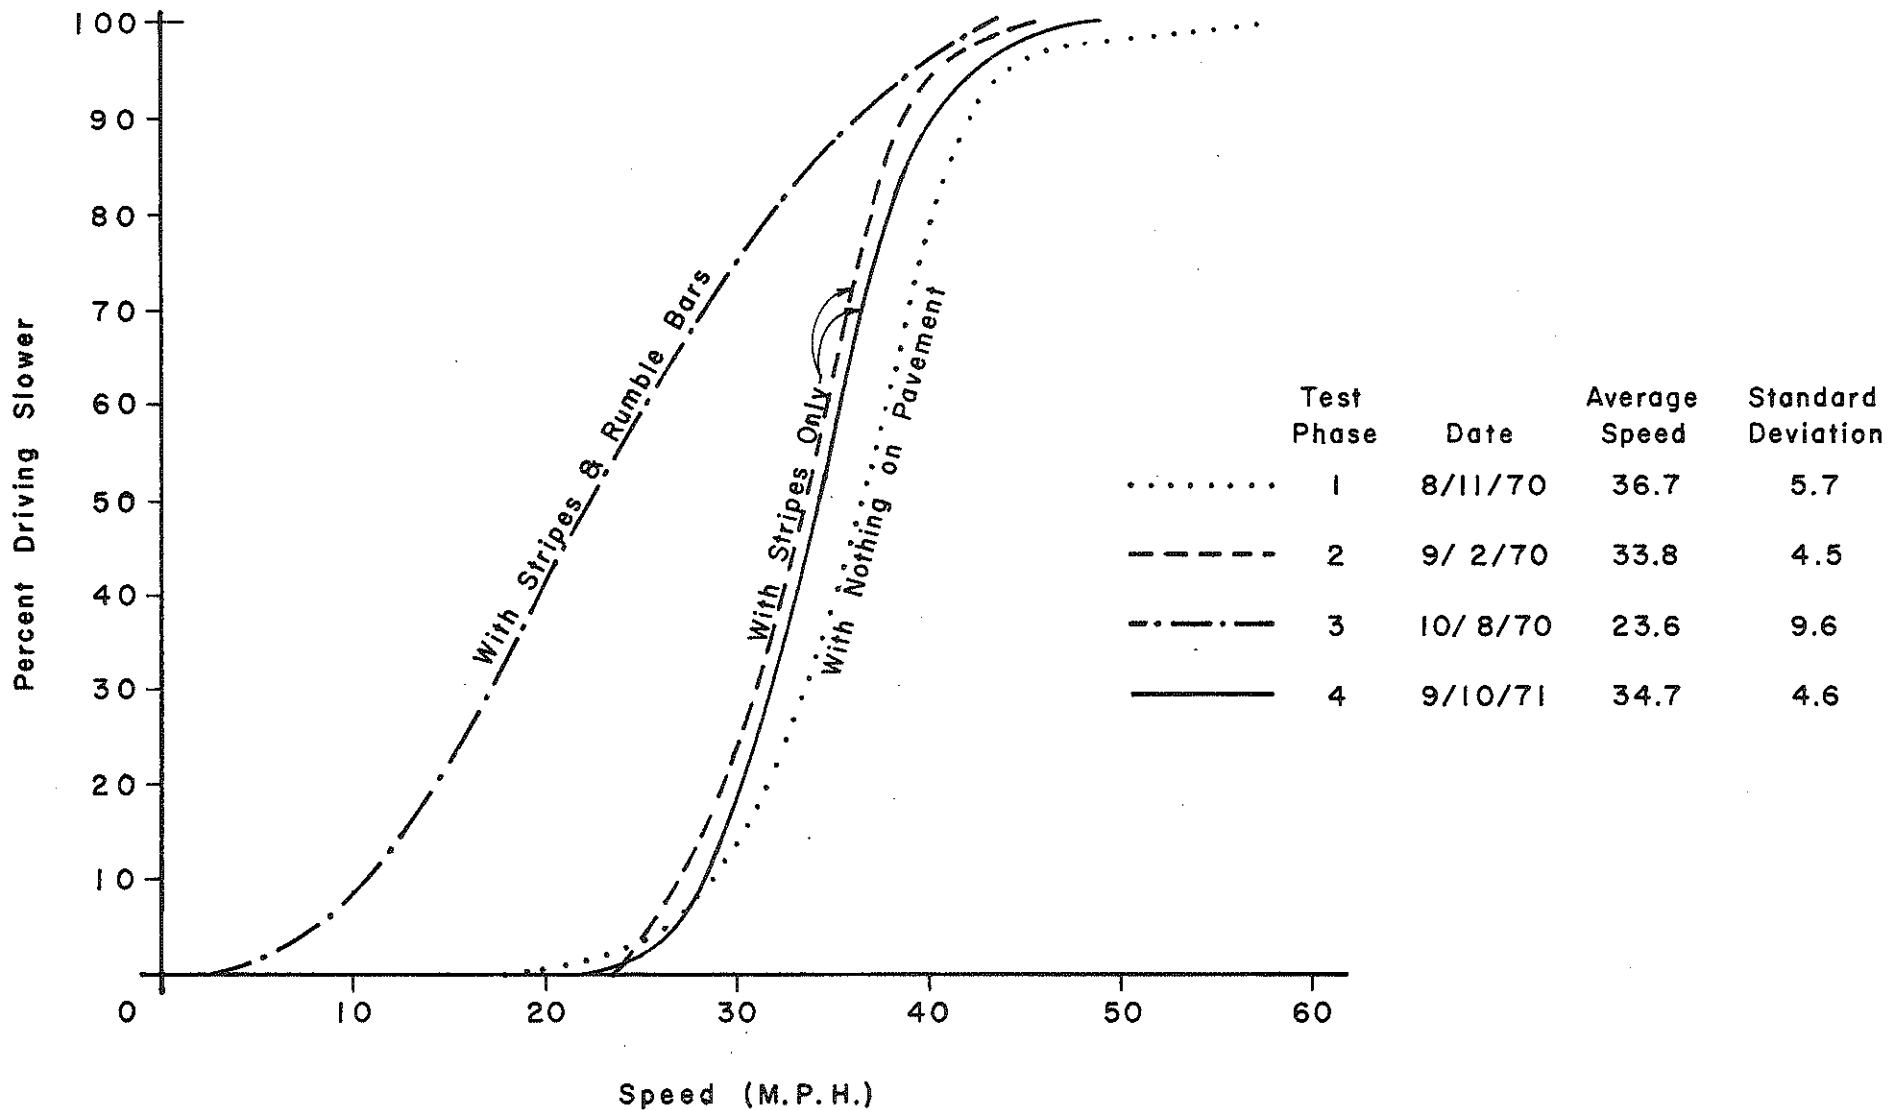
Figure 15-SPEED DISTRIBUTION OF VEHICLES PASSING OVER THE TEST ZONE ON M-106.

Figure 15 is a similar set of distribution curves for the four study phases. However, these are based on absolute speeds measured at Spot B near the downstream end of the test section. The average speeds during Phases 2, 3 and 4 were significantly different from Phase 1, with nothing on the pavement. Phase-3 speed, with the rumble bars, was also significantly different from Phases 2 and 4. Standard deviation improved during Phases 2 and 4, but worsened during Phase 3. If absolute speed near the downstream end of the marked area is considered as the relevant parameter, then it may be concluded that even with only the paint stripes, the speed reduction was significant. The reduction was 2.9 m.p.h. immediately after, and 2.0 m.p.h. one year after painting.

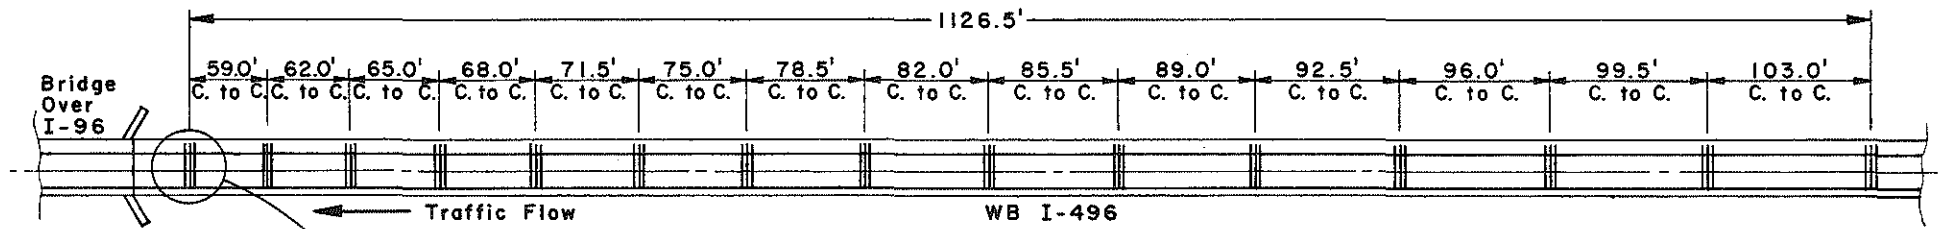
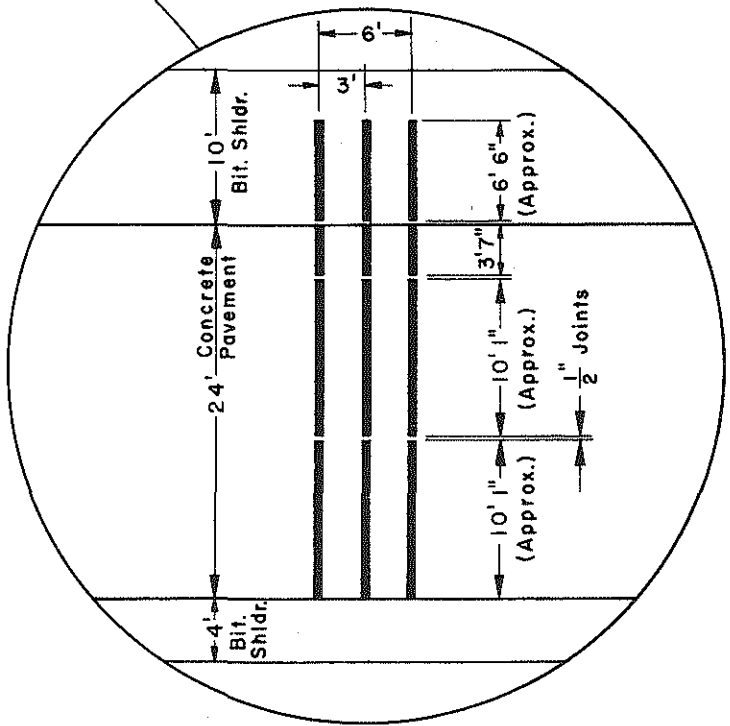
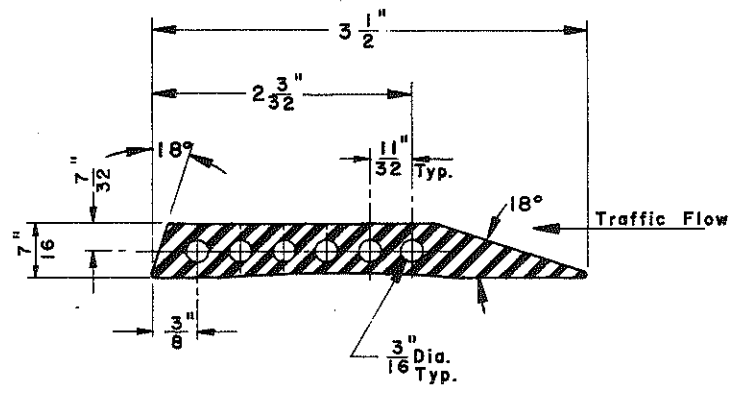
Figure 16-RUMBLE BAR INSTALLATION ON I-496

Installation Detail

Cross-section of Rumble Bar

A different type of rumble bar was next suggested for experimentation. This was made of flexible polyvinyl chloride, 7/16 inch thick and 3-1/2 inches wide. The edge facing traffic was beveled at a shallow slope of about 18 degrees, and the other edge had a steep angle of about 72 degrees (See Fig. 16). The bars came in 10-foot lengths with a tolerance of +2 inches -0 inch. This material appeared to be less severe in rumble effect than the earlier-tested variety, and it was decided to experiment with it at a new location.

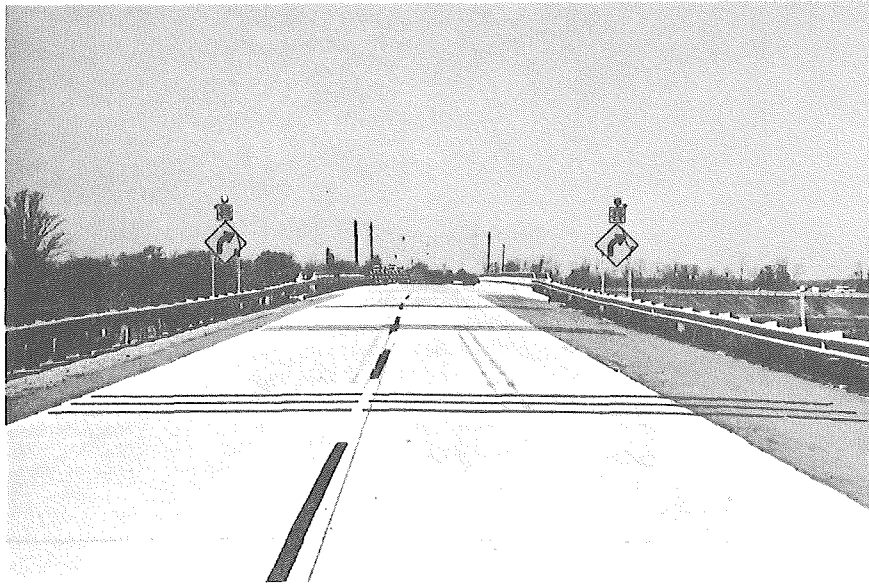
Fig. 18 - Driver's eye view of rumble bars on I-496

Three lengths of the rumble bar, adding to approximately 30 feet, were used on the approach to the loop so that they extended from the left edge of the 24-foot pavement, across the right edge and about six feet onto the right shoulder (see Fig. 16). Three parallel bars placed at three-foot centers were used to make up one rumble cluster. Fifteen clusters in all were used. The spacing between each rumble cluster diminished, in the direction of traffic flow, from 103 feet at the upstream end to 59 at the downstream end. The principle earlier described in laying out the pavement stripes was used in calculating the length of the total rumble area. A jolt frequency of one per second was used. A "Pavement Test Area Ahead" sign was erected for this location also. A driver's-eye view of the installation is shown in Figure 18, and a side view is seen in Figure 19.

The rumble produced was effective and yet not too harsh. Like the ABS bars, they had more punch at lower speeds such as 10 m.p.h. No driver complaints were heard. Favorable comments were made by some of the Traffic and Safety Division staff engineers who drove over the test area.

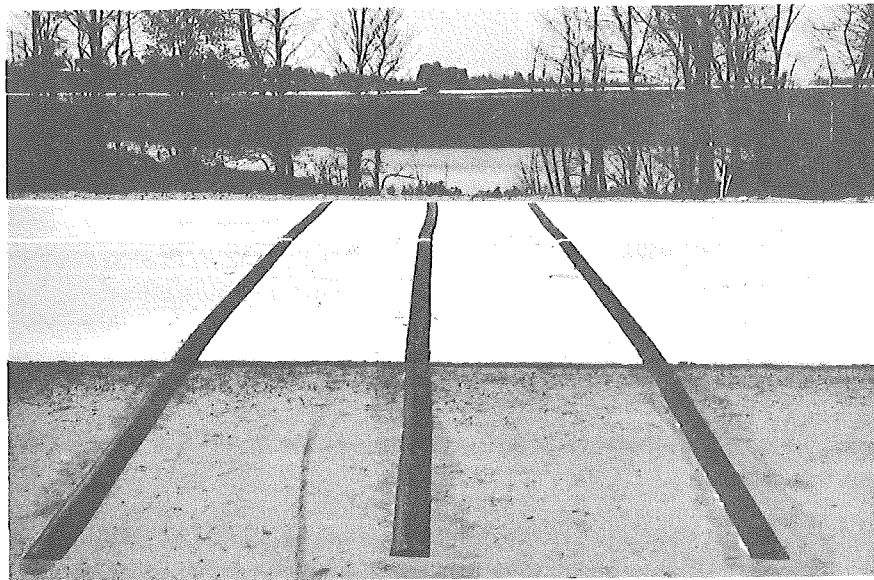
Fig. 19 - Side view of rumble bars on I-496

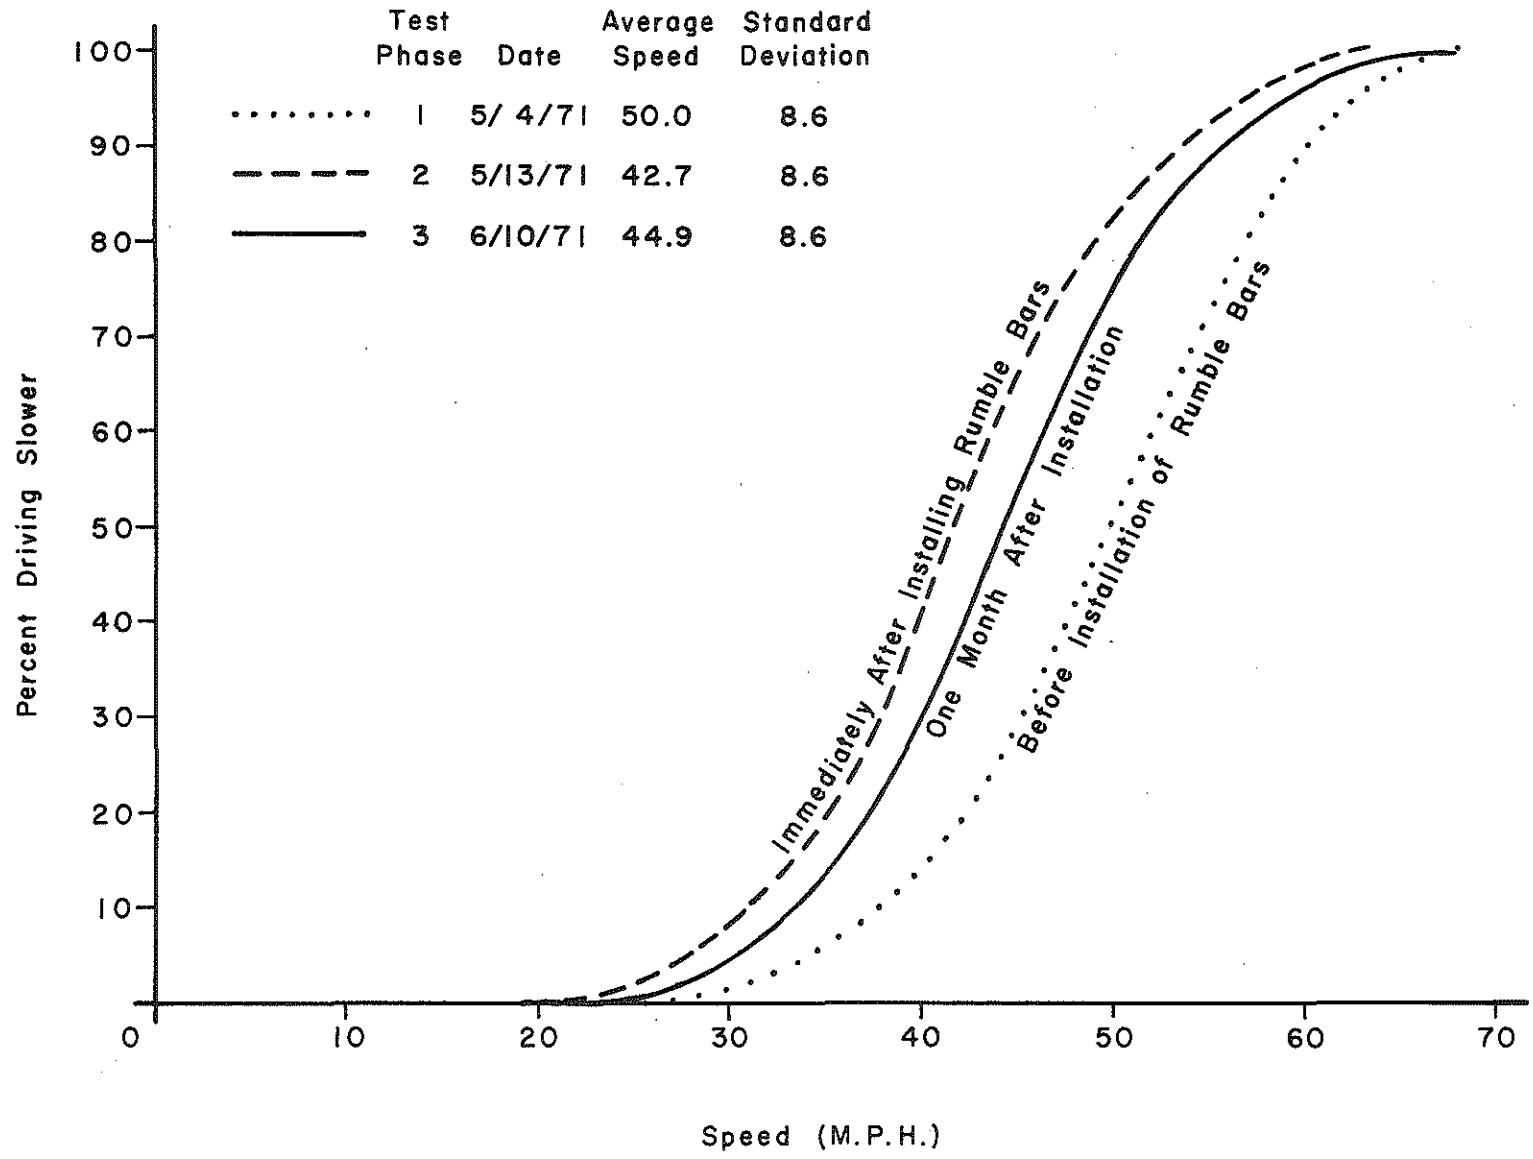
Figure 20 - SPEED DISTRIBUTION OF VEHICLES PASSING OVER THE TEST ZONE ON I-496.

bars resulted in an immediate drop of 7.3 m.p.h. (50.0 - 42.7) in the average speed of vehicles approaching the curve. As the novelty of the installation was gone in about a month, the average speed gained back 2.2 m.p.h. of the initial speed drop, and the net difference from the "before" speed became 5.1 m.p.h. (50.0 - 44.9).

Table 6 shows that there was no change in the standard deviation of the speed distributions in the three test phases. This type of rumble bar, therefore, did not have an adverse effect on the variance of speeds in the traffic stream as was the case with the bars used on M-106 where the standard deviation had increased (see Table 5). On the other hand, improvement in safety was indicated with the rumble bars because the skewness index changed from a non-normal value of +0.61 to normal values of +0.10 and +0.08, immediately after installation and one month after installation, respectively.
