## IDENTIFICATION OF CAUSES AND SOLUTION STRATEGIES FOR DECK CRACKING IN JOINTLESS BRIDGES

Report No. CEE-RR – 2012/04

Research Report for MDOT under Contract No. 2009-0746/Z1  
SPR No. 108522

**Department of Civil and Environmental Engineering  
Michigan State University  
East Lansing, Michigan**

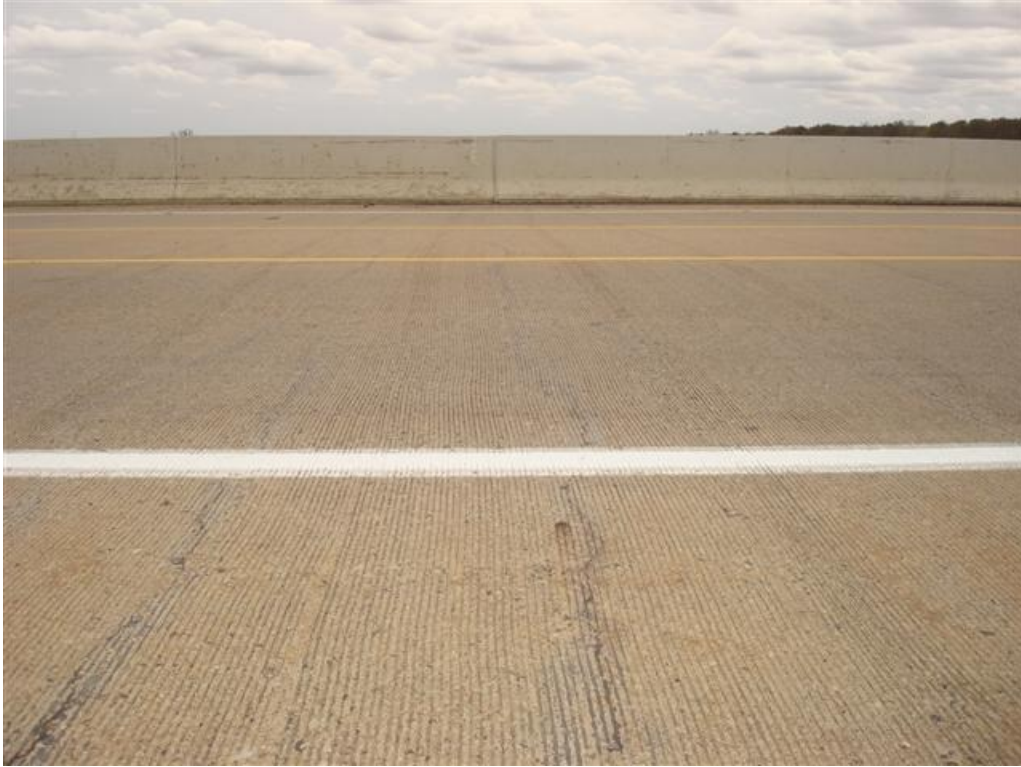
**Figure 13.** Typical transverse cracking in deck surface (Bridge No. 5: M-57 over US-127)

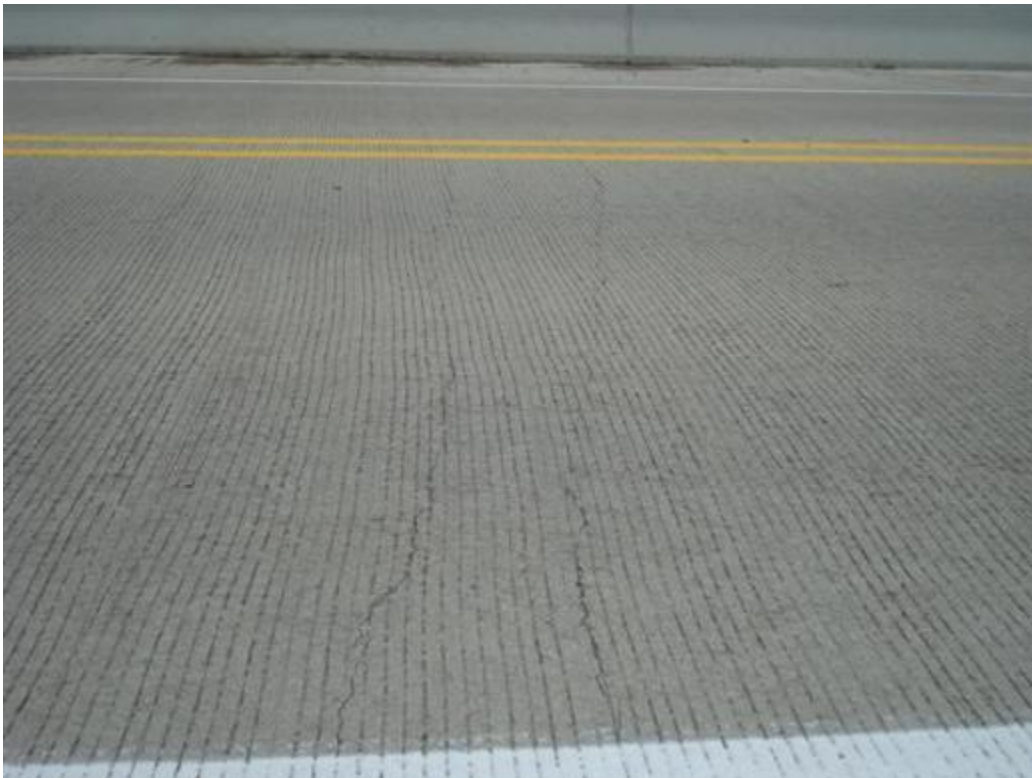
**Figure 41.** Transverse cracking in pier area

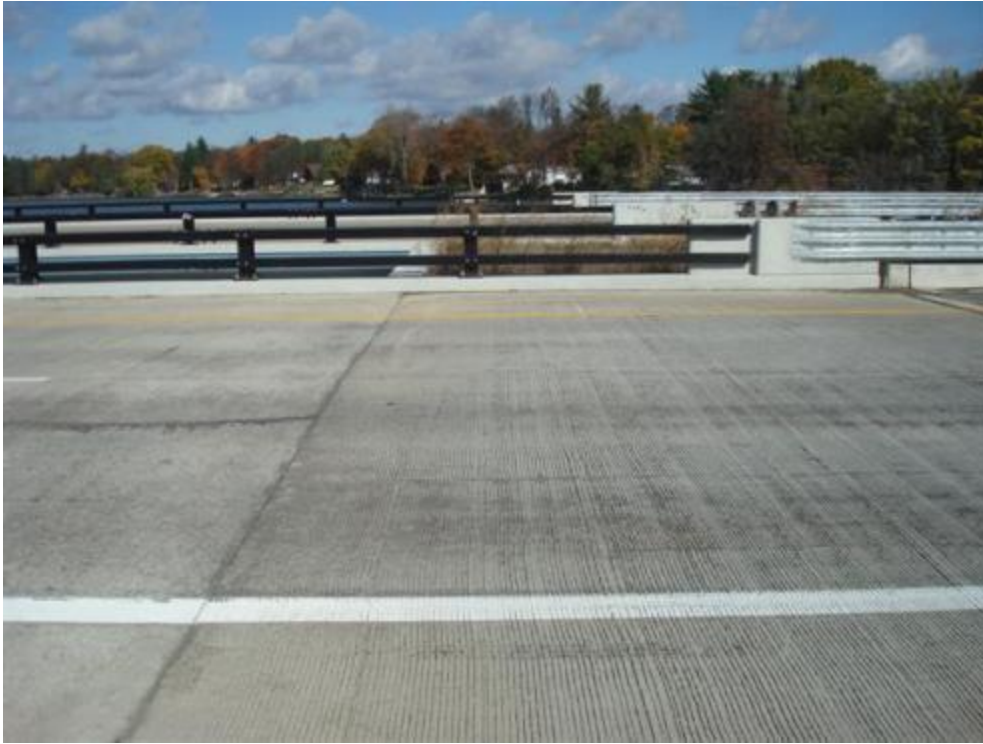
**Figure 56.** Longitudinal cracking in bridge deck

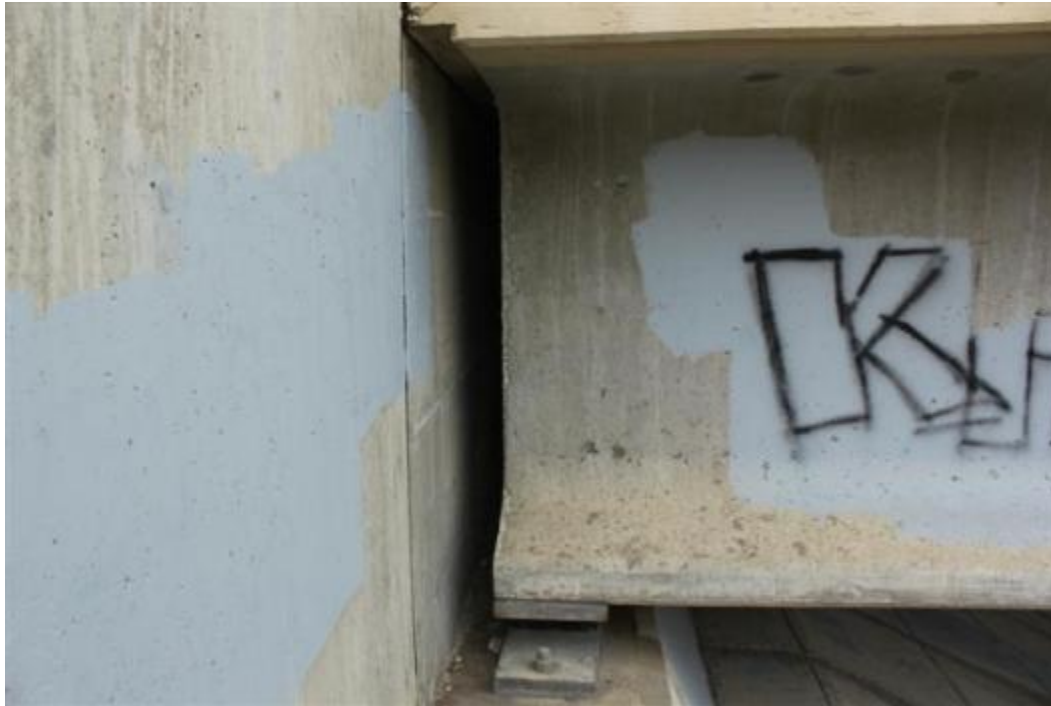
**Figure 101.** Non-integral abutment detail (note that beams are not cast into the abutment)

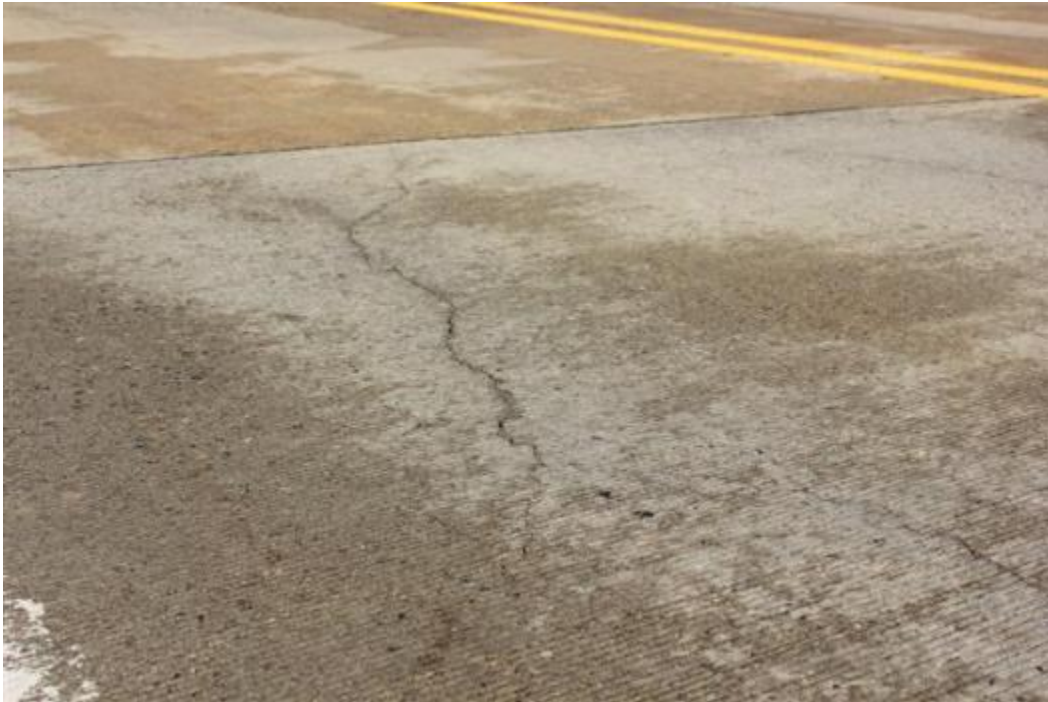
**Figure 125.** Longitudinal cracking
