**IDENTIFY CAUSES FOR UNDER
PERFORMING RUBBLIZED
CONCRETE PAVEMENT PROJECTS**

**FINAL REPORT
VOLUME I**

AUGUST 2002

**Michigan State University
Pavement Research Center of Excellence
Department of Civil and Environmental Engineering
East Lansing, Michigan 48824-1226**

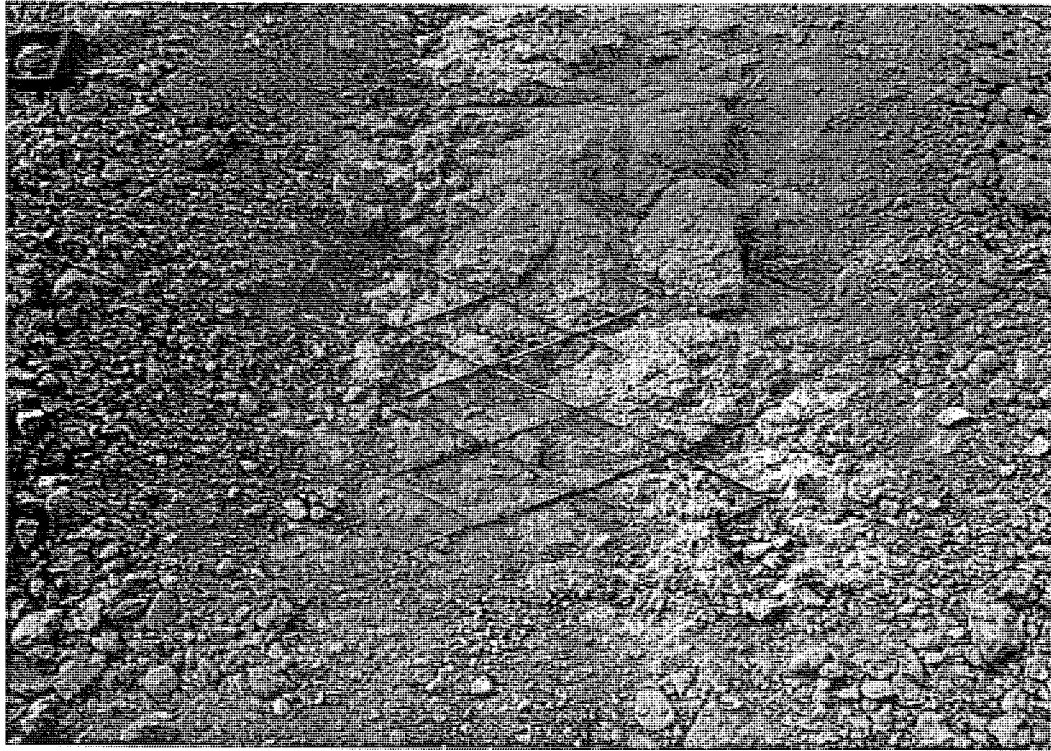
Figure 3.3 Partial debonding of the temperature steel (M21)

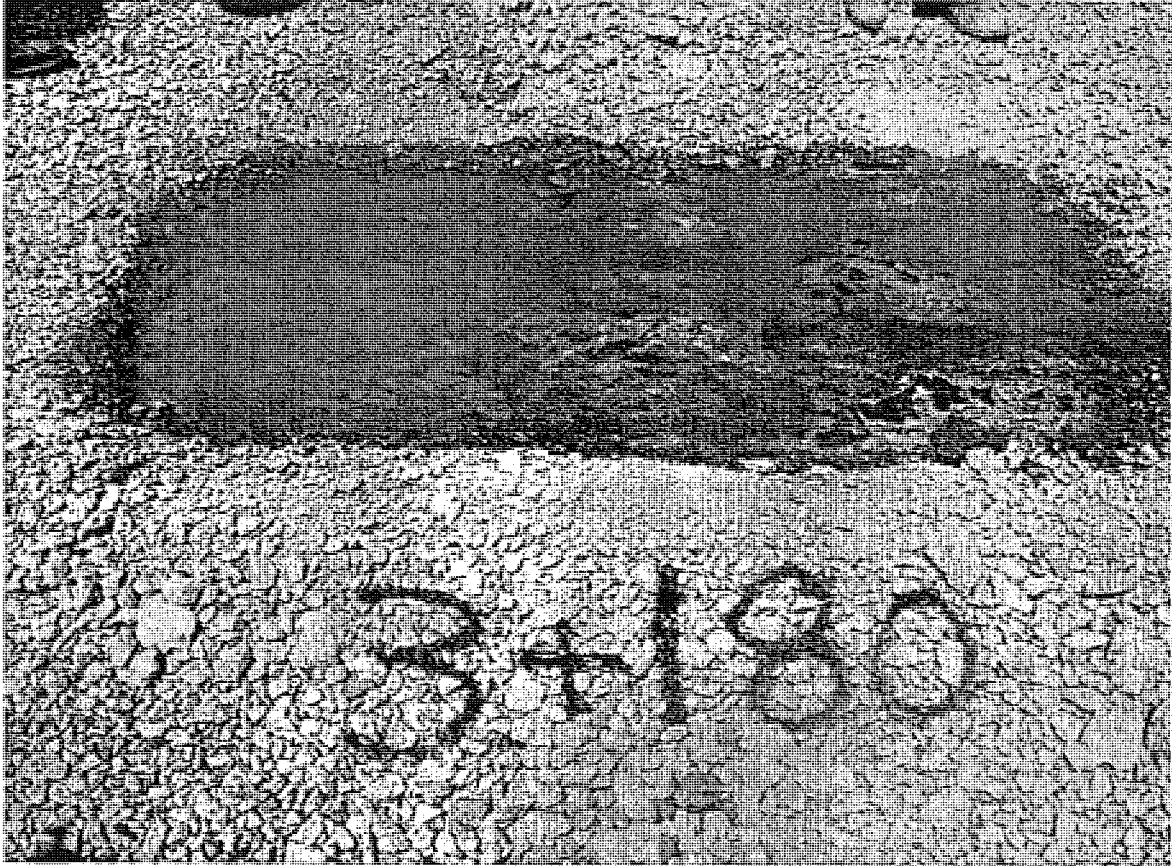
Figure 3.5 Trapped water above the fractured concrete in a trench (M-18)

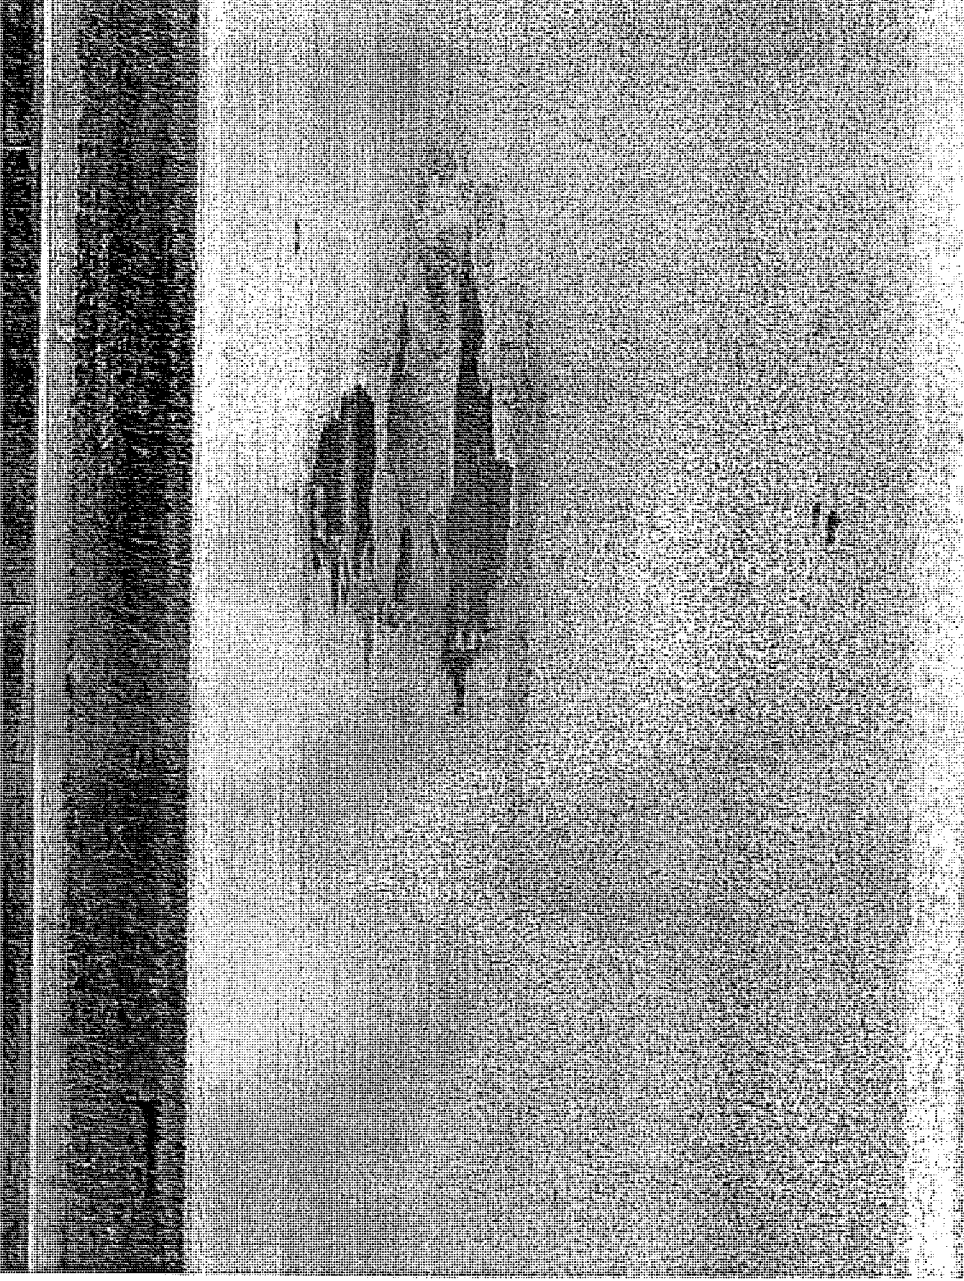
8. Shear failure (reported in the tables as patches) was found at three locations along I-196 south of Grand Rapids as shown in figure 3.16.

Figure 3.16 Shear failure along I-196 NB, Control Section 70024 Job Number 35987 BMP 12.6, EMP 15.6

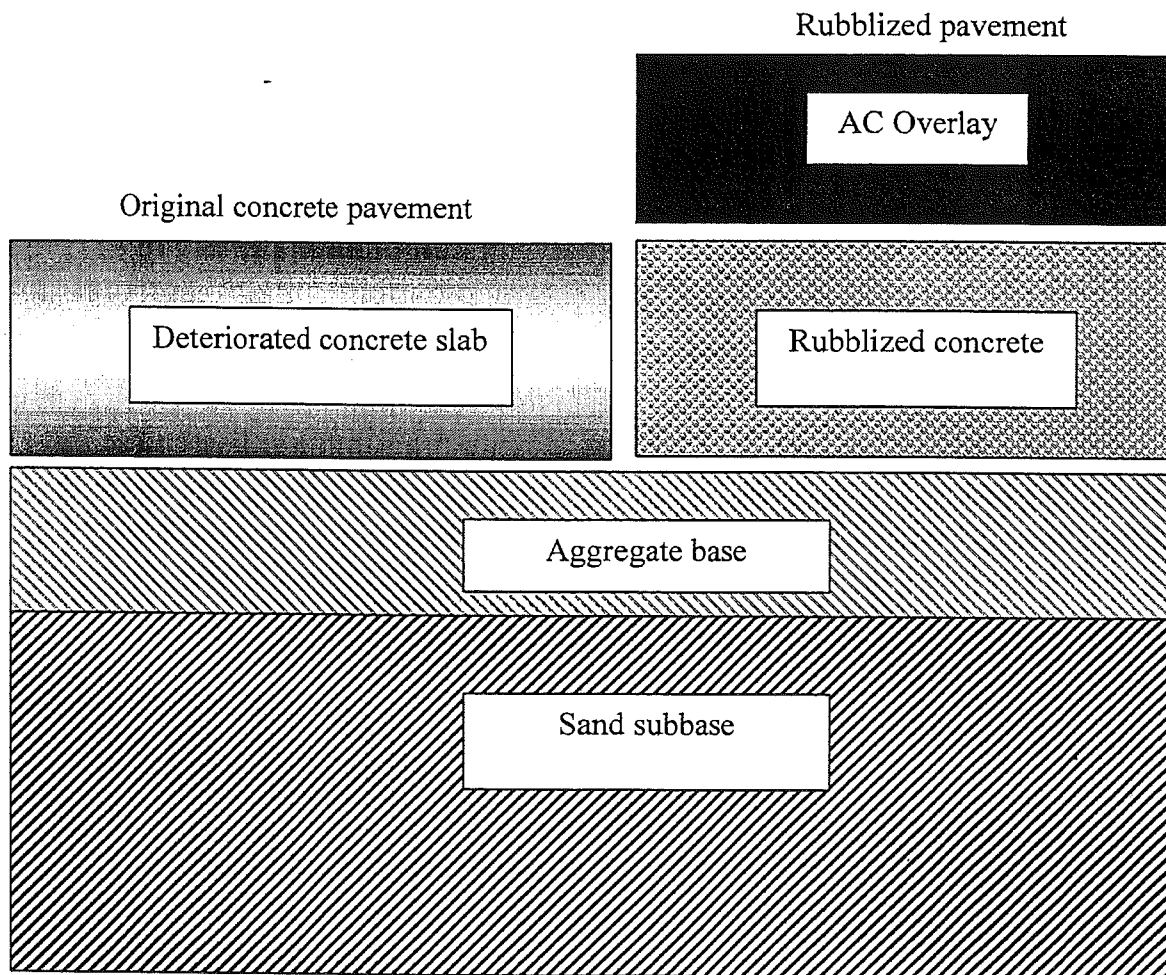
Figure 4.1 Concrete and rubblized pavement cross-sections

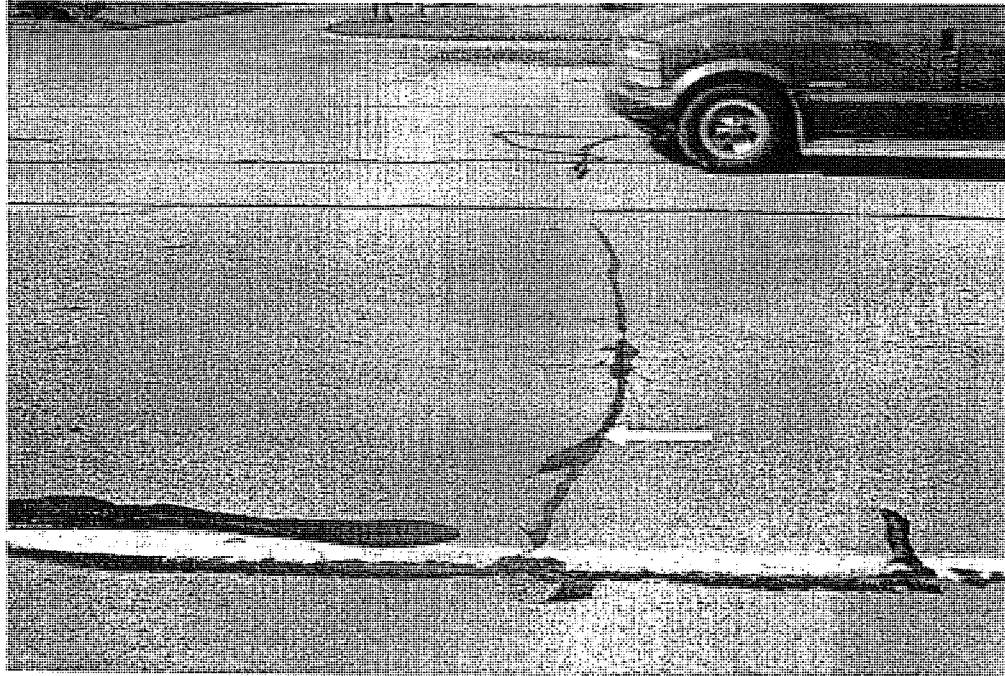
a) M-50

Figure 4.3 Reflective cracks in rubblized pavements

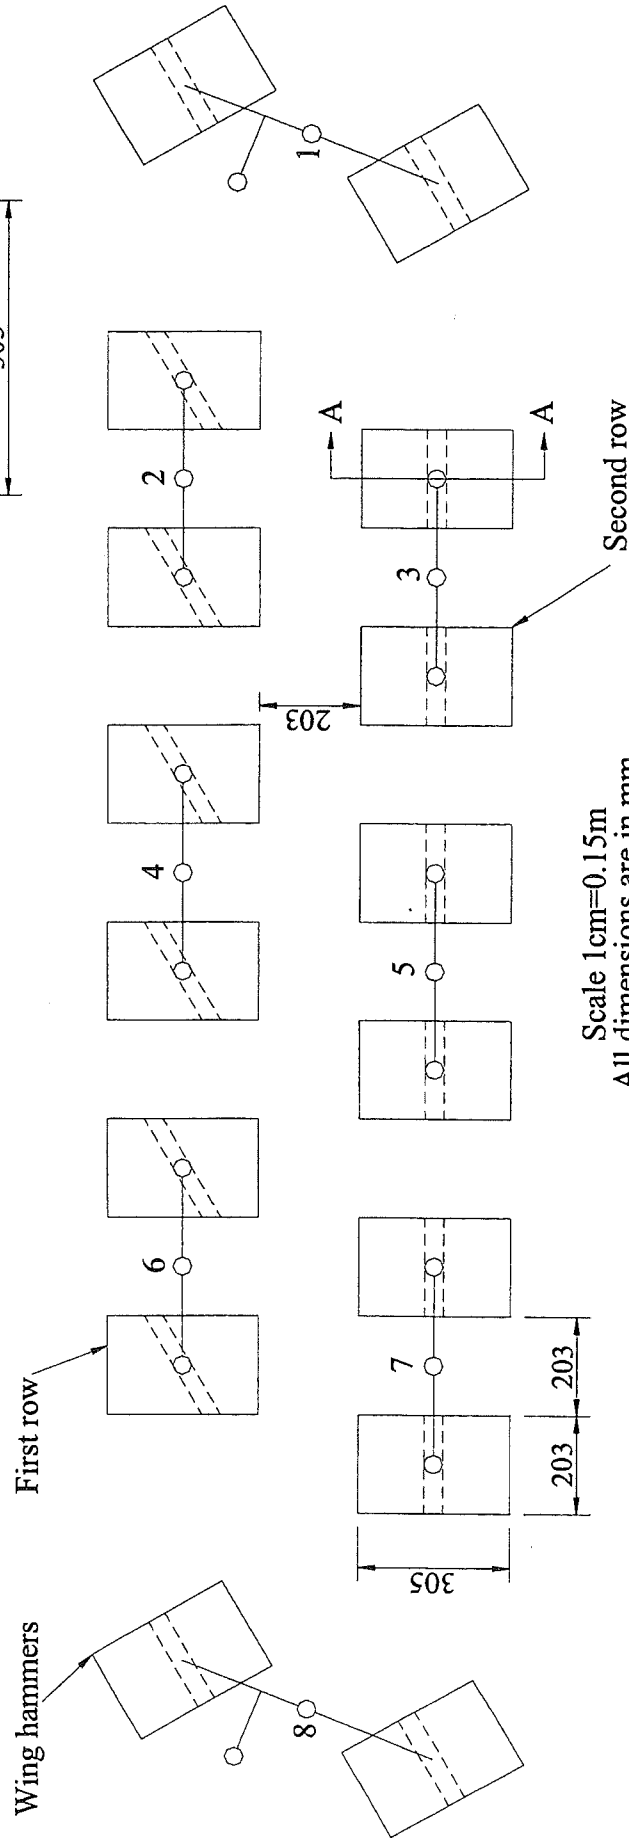
Figure 4.9 Typical hammer configuration of the multi-headed guillotine breaker (multi-head breaker)

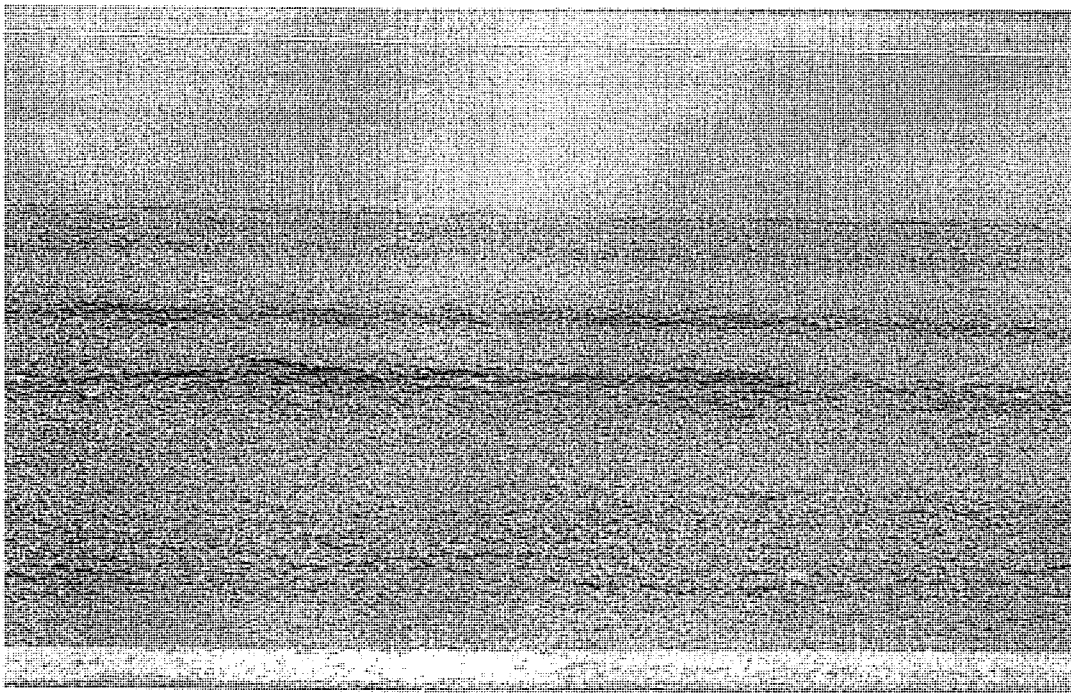
a) General view of a segregated area in the passing lane

b) A close-up view of the segregated area in the passing lane

Figure 4.10 Pavement condition in segregated and non-segregated areas along US 23 in May 2002, 2 years after construction,

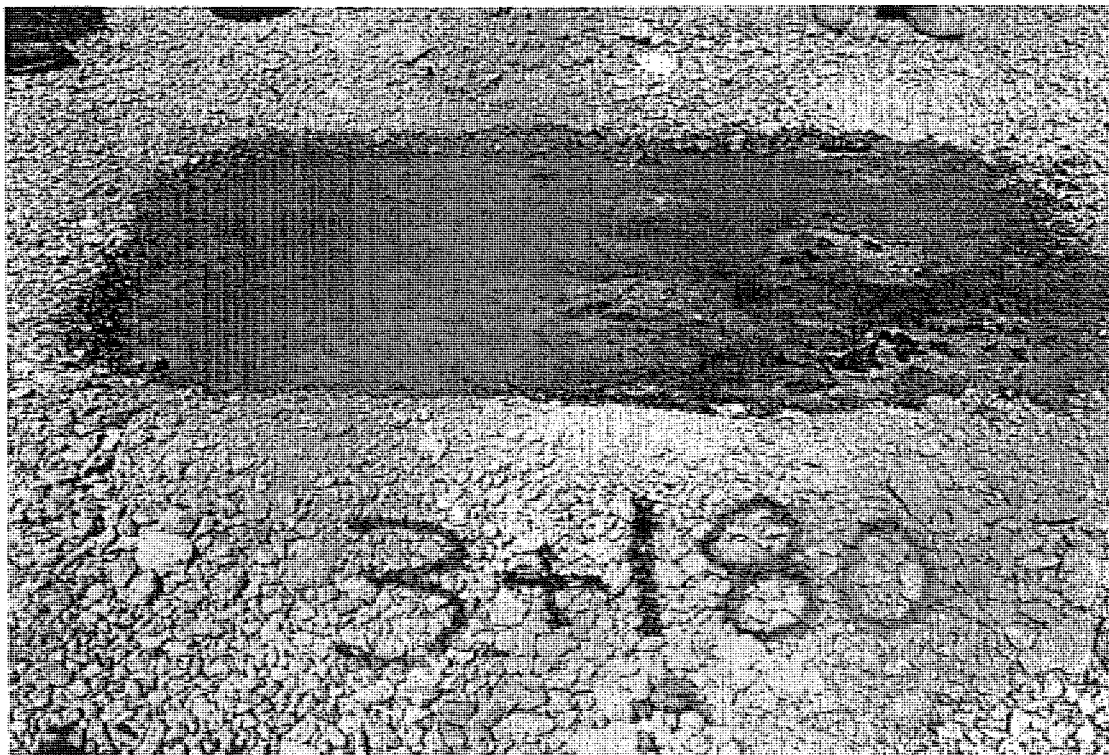
Figure 4.18 Trapped water above the fractured concrete in a trench along M-18

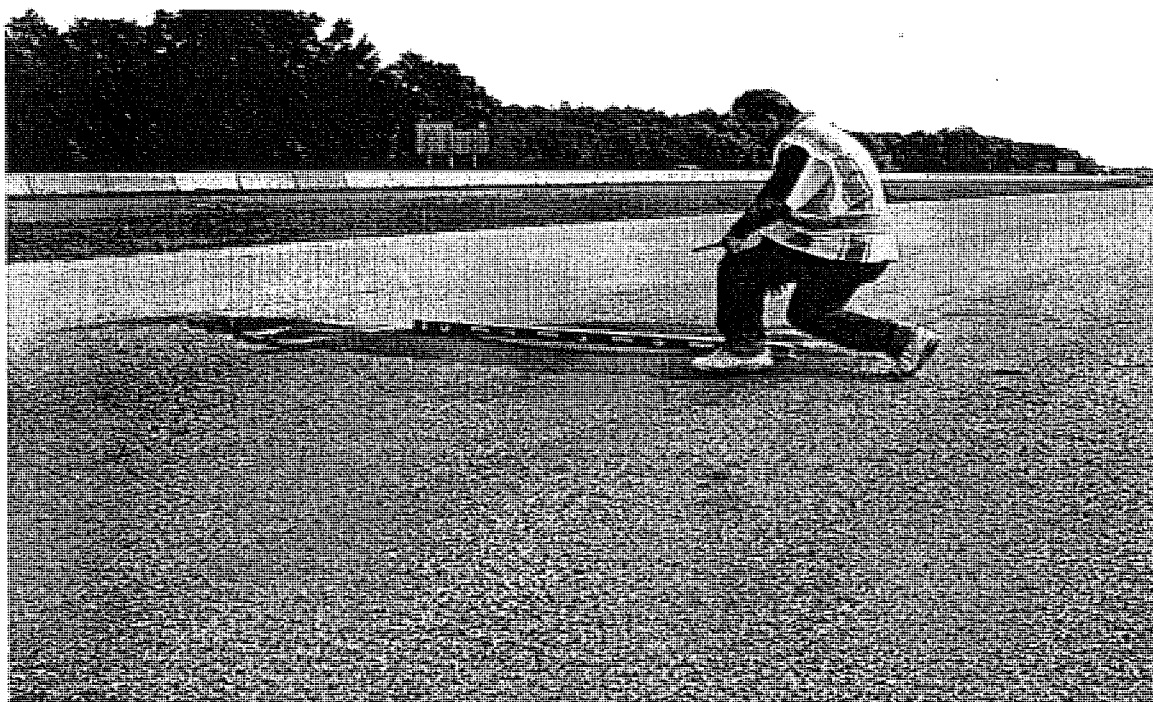
5. At some locations, the rubblization procedure caused some large concrete pieces (more than 8 in.) to rotate and/or penetrate the underlying base or roadbed material. This implies that the base and/or the roadbed soil have failed in shear action (bearing capacity). This failure is mainly caused by saturated base and/or weak roadbed soil. If the shear failure in the base and/or subbase is not corrected, the finished pavement will experience shear failures in these locations as shown in figures 4.19 through 4.21.

Figure 4.19 Shear failures in the rubblized pavement along NB I-196, August 2001

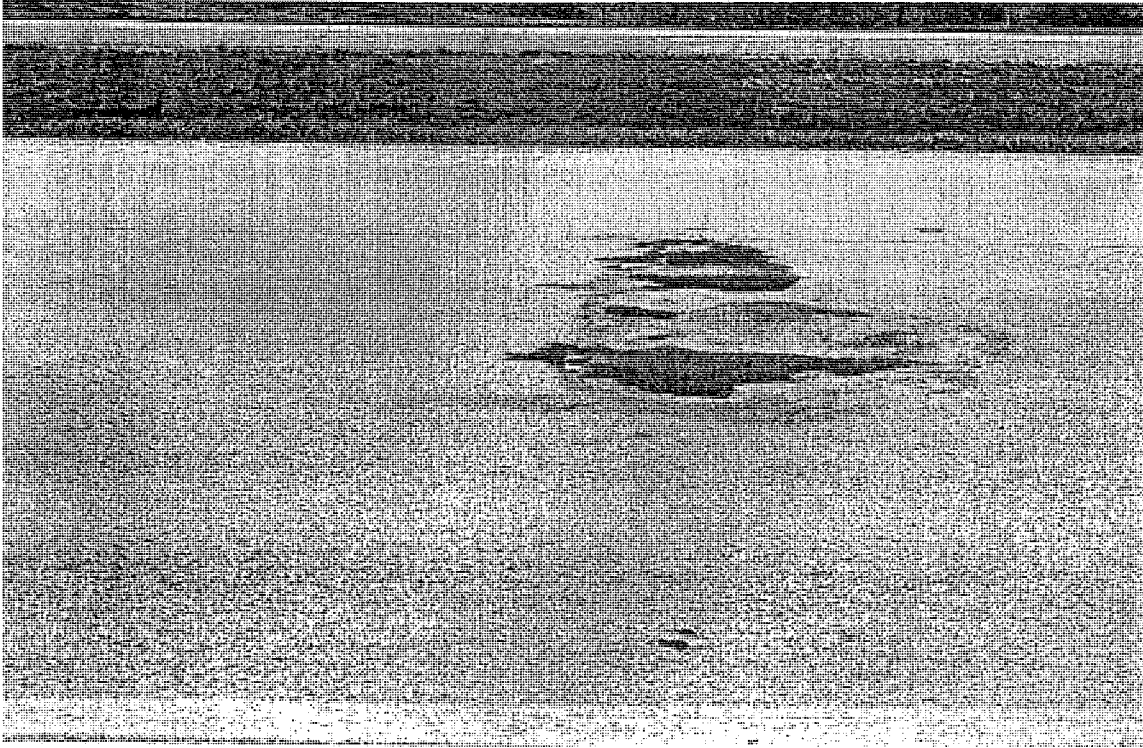
Figure 4.20 A shear failure along the rubblized pavement on NB I-196, May 2002
