EVALUATION AND ANALYSIS OF DECKED BULB T BEAM BRIDGES

MICHIGAN DEPARTMENT OF TRANSPORTATION
IOWA DEPARTMENT OF TRANSPORTATION
MINNESOTA DEPARTMENT OF TRANSPORTATION
WISCONSIN DEPARTMENT OF TRANSPORTATION
OREGON DEPARTMENT OF TRANSPORTATION

March 2015

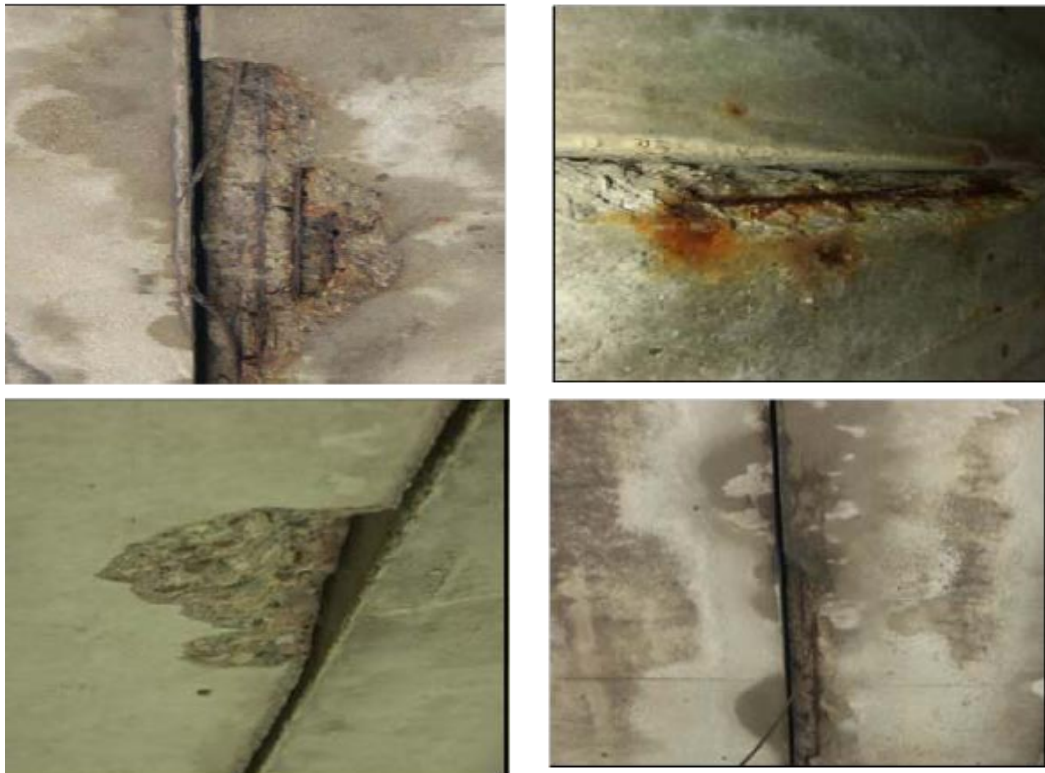
Figure 1.2-3 Deterioration of box beams at the shear key joints

The development of longitudinal cracks in the deck slab between the box beams is a major concern (Figure 1.2-2 and Figure 1.2-3) and is frequently reported by inspectors (MDOT 2005 and Lall et al. 1998). For instance, in 1990, an investigator from New York State Department of Transportation reported longitudinal cracks over the concrete overlay shortly after construction. A survey was conducted immediately after the report and included 219 bridges constructed between the years 1985 and 1990 in the state of New York. The results from the survey indicated that 54 % of the bridges built within the given period experienced longitudinal cracking as shown in Table 1.2-1 (Lall et al. 1998). The survey also indicated that longitudinal cracks extended from support to support in many bridges with a crack width in a range of 1/32 to 1/16 in.

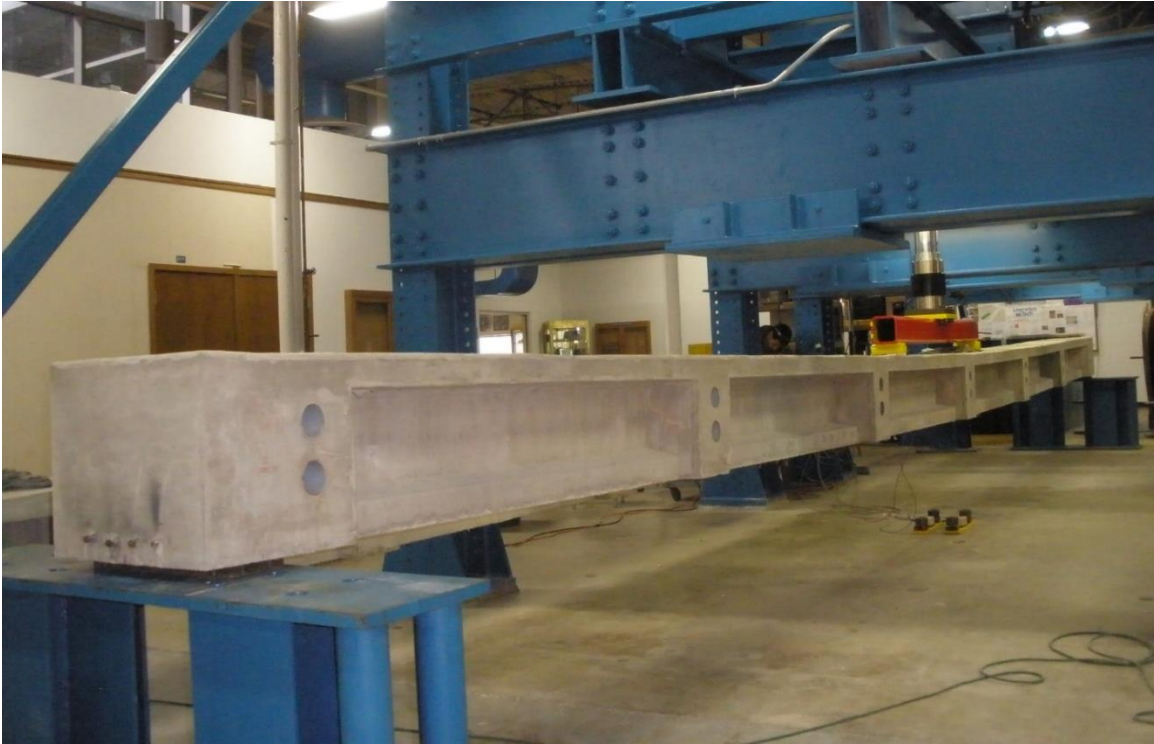
Figure 3.2-1 Typical four-point-loading test setup for control beams

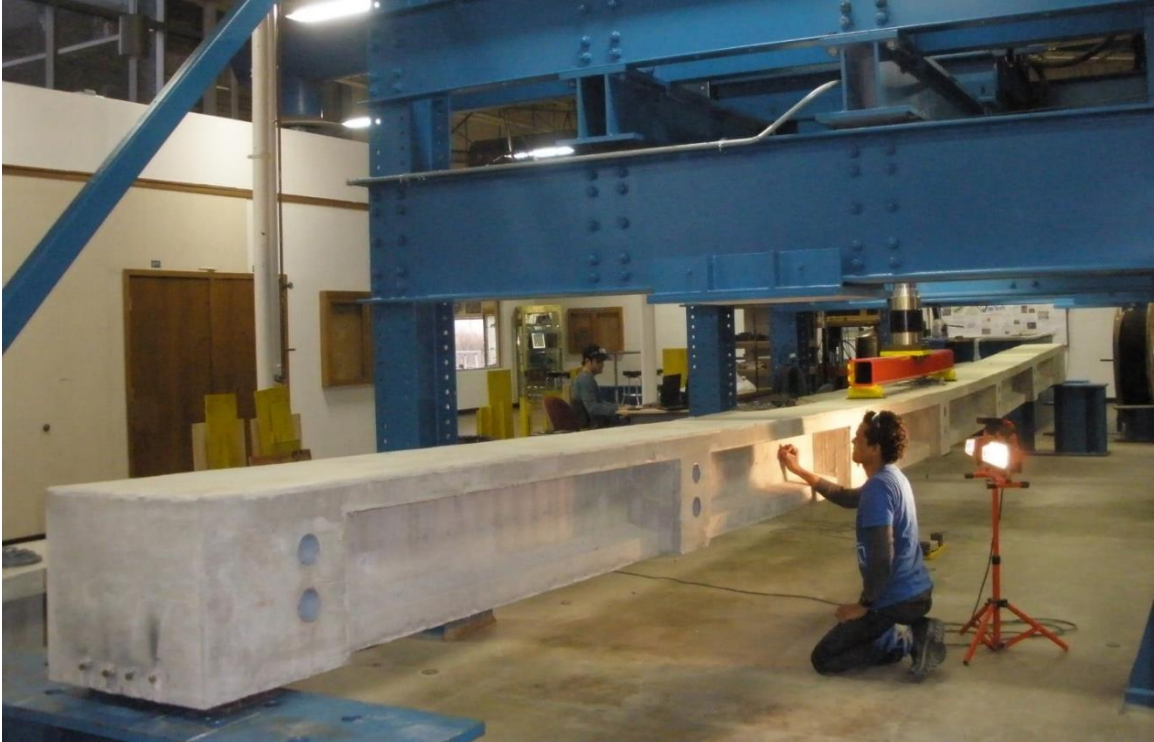
Figure 3.2-3 Crack mapping between load cycles

The load cycles were continued and new cracks were marked after every load cycle as shown in Figure 3.2-3. The cracks were vertical and uniformly distributed under the loading spreader but they were inclined outside the loading points due to combined effect of shear and moment. As shown in Figure 3.2-4, this control beam was characterized with a dense crack map before failure. The cracks typically overlapped the stirrups and the average distance between the cracks was around 4 in., which matched the spacing between the stirrups. It should be also noted that the beam exhibited a significant deflection before failure. The deflection can be visually observed as shown in Figure 3.2-5. In practice, this deflection will be difficult to go unnoticed and it will be accompanied by cracking and collapse of non-structural components such as utility pipes, sidewalks, and barriers. Therefore, it serves as a significant visual warning sign before failure.

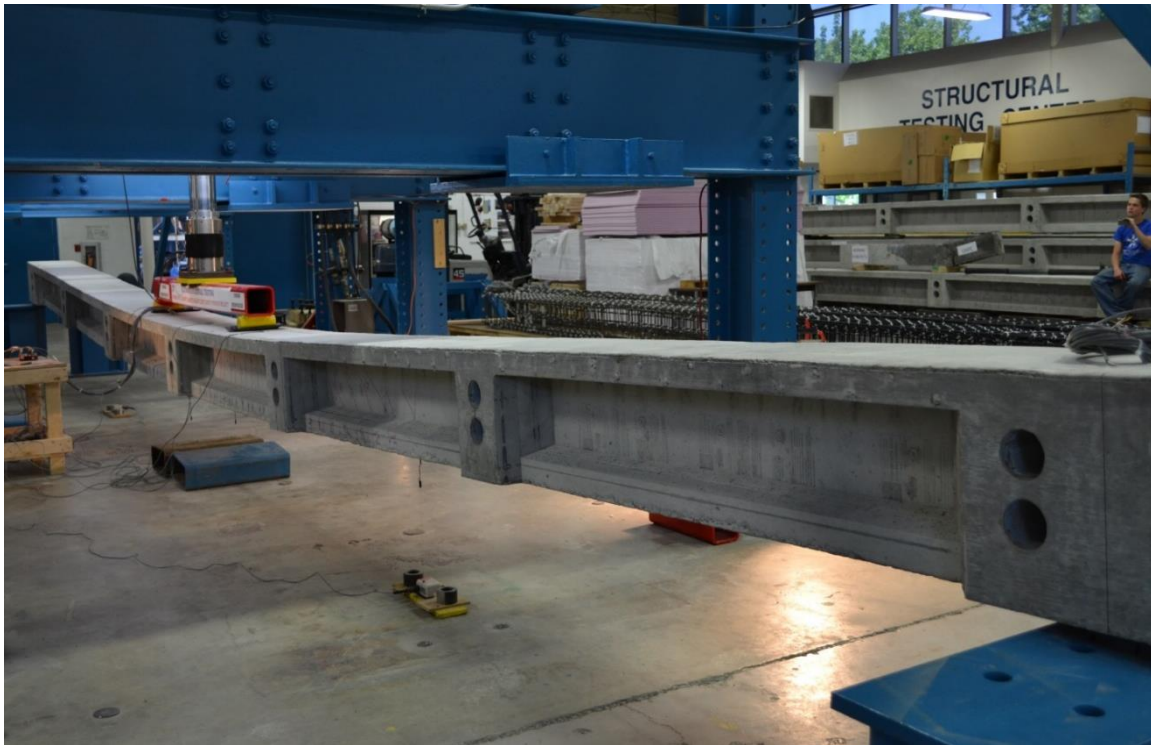
Figure 3.2-5 Deflection of Beam C-S-F-U

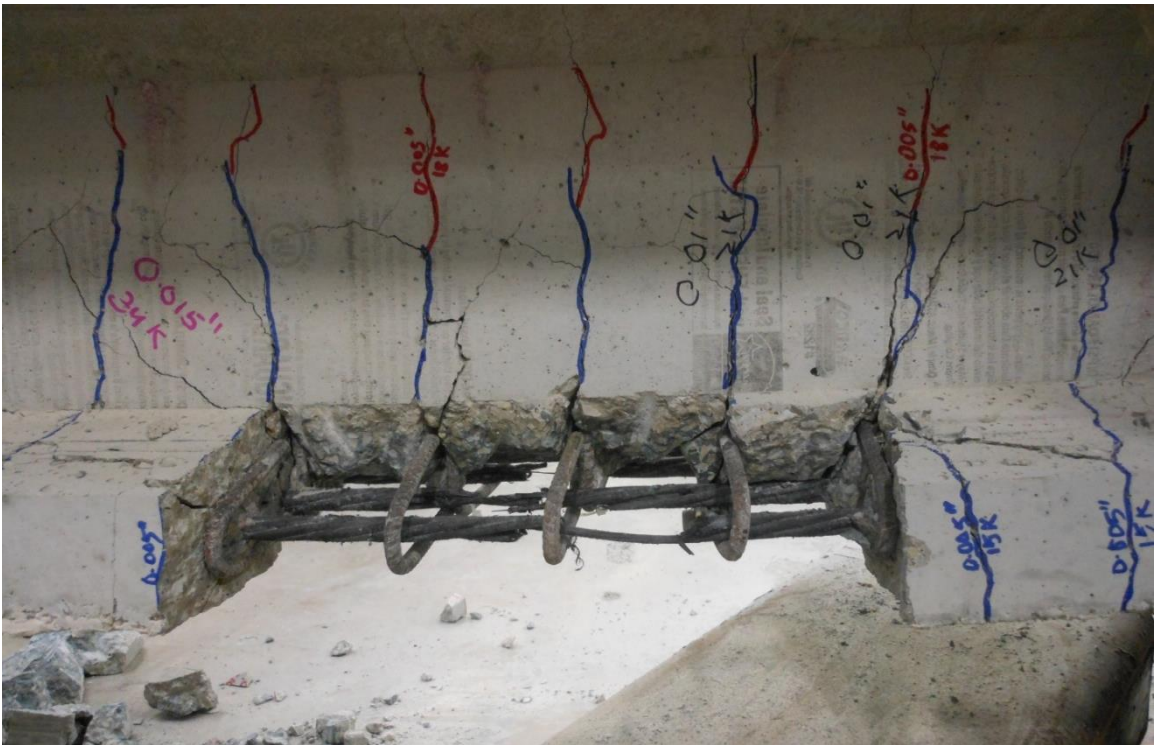
Figure 3.2-9 Rupture of prestressing CFCC strands in Beam C-S-F-U

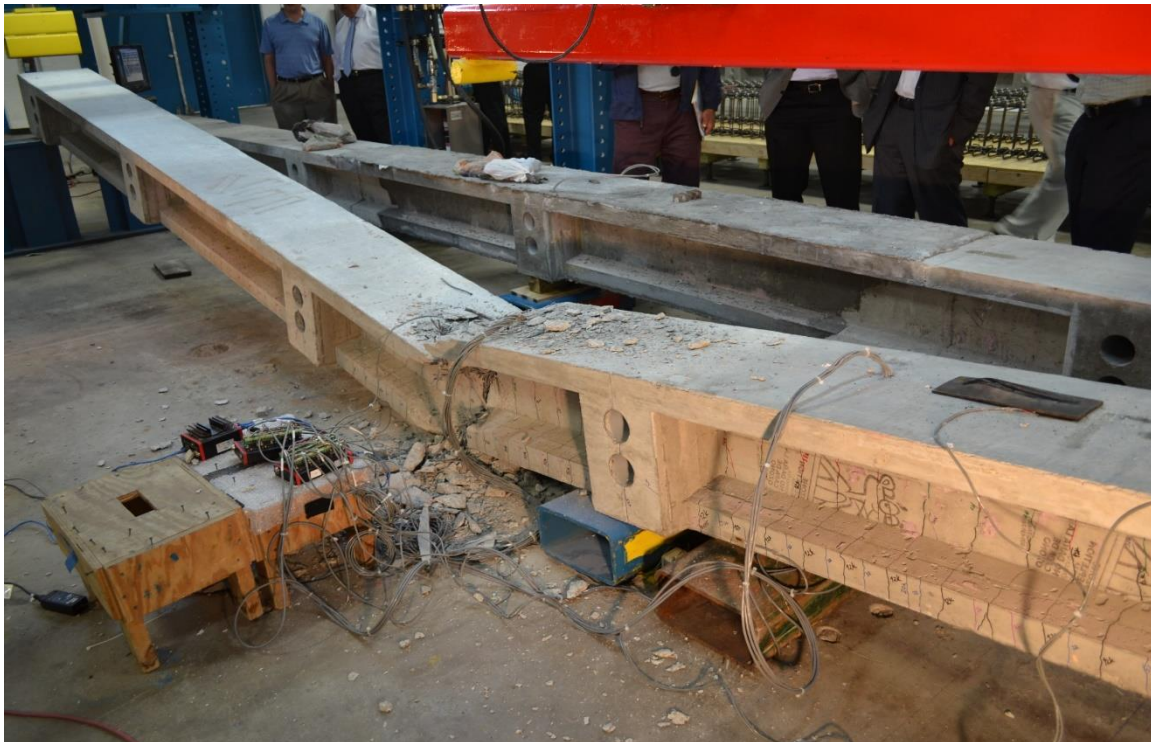
Figure 3.4-1 Beam C-S-F-O at failure

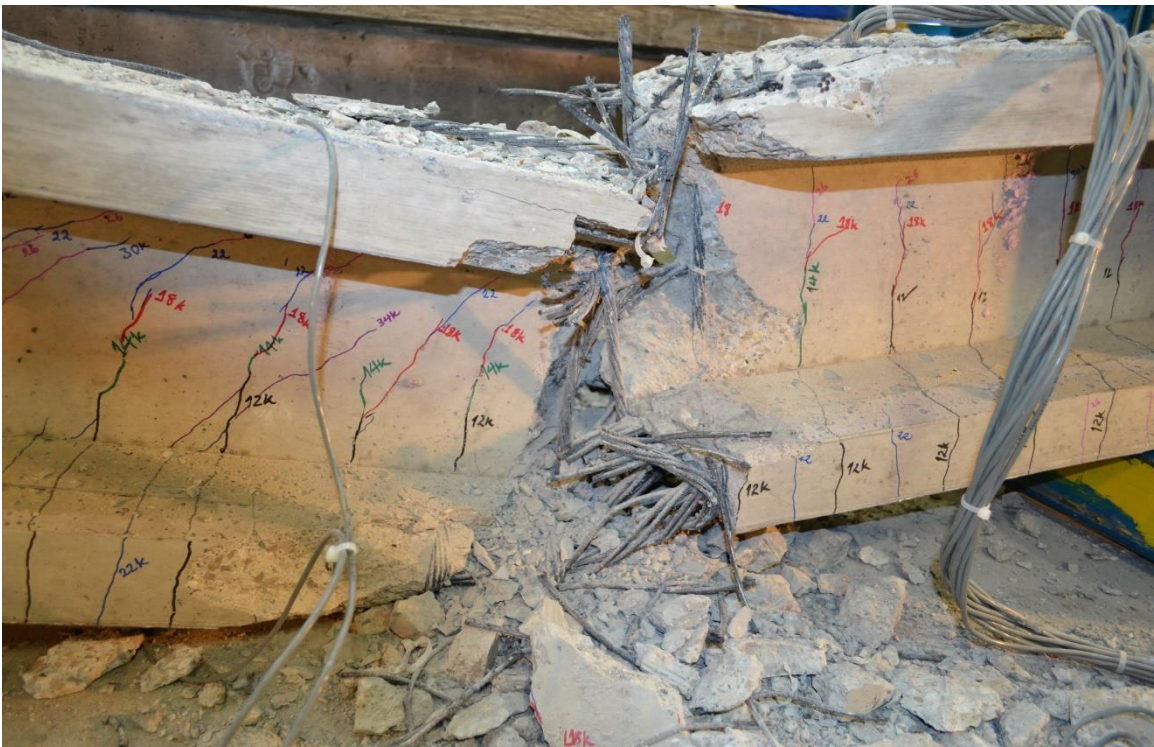
Figure 3.4-3 Close view showing the failure section of Beam C-S-F-O

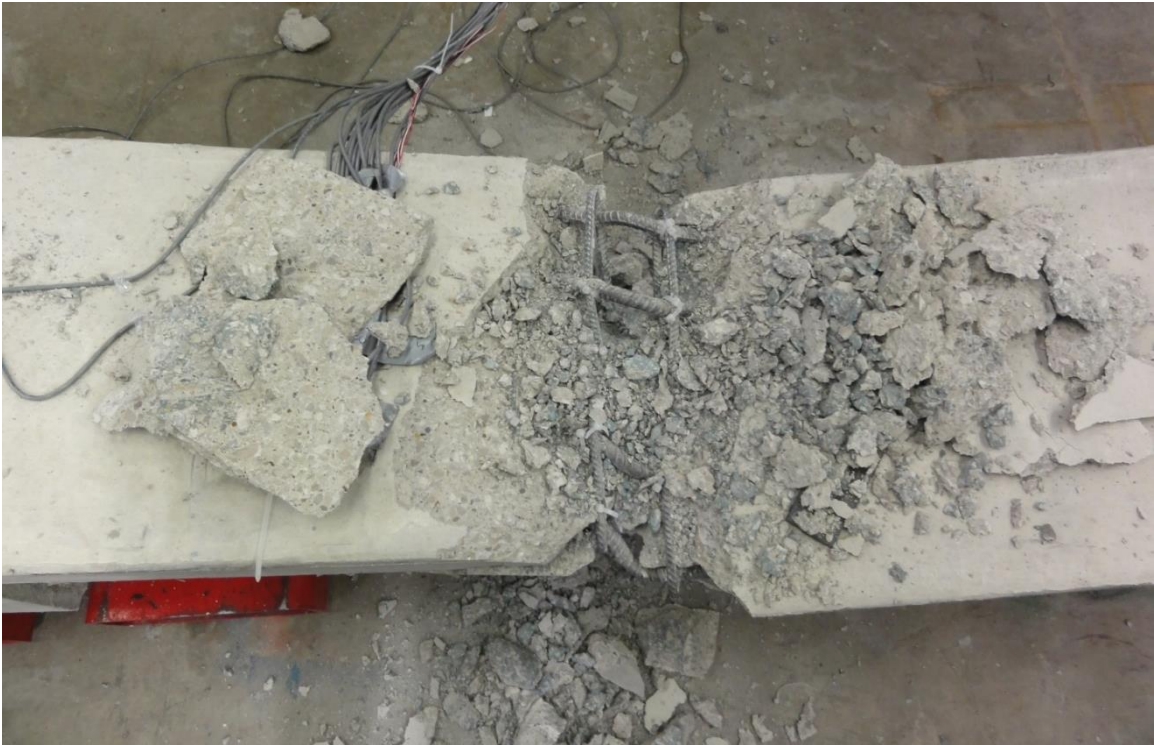
Figure 3.5-3 Buckling of top reinforcement in Beam S-S-F-U at failure

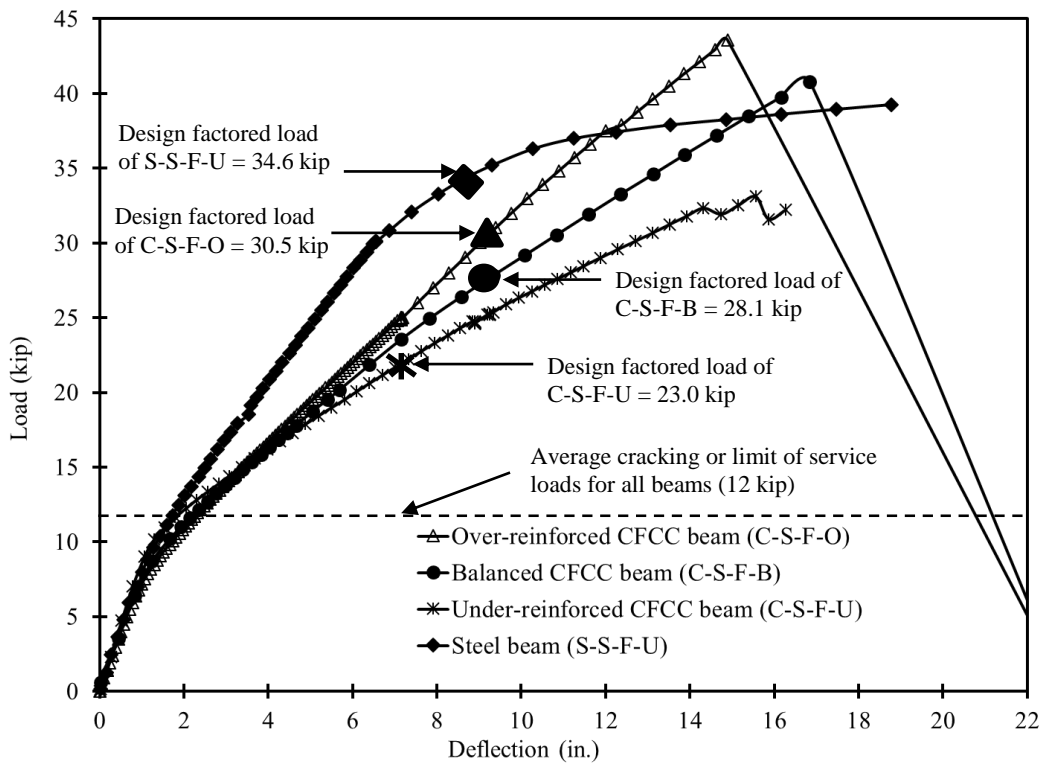
Figure 3.6-1 Load-deflection curves for all control beams tested in flexure

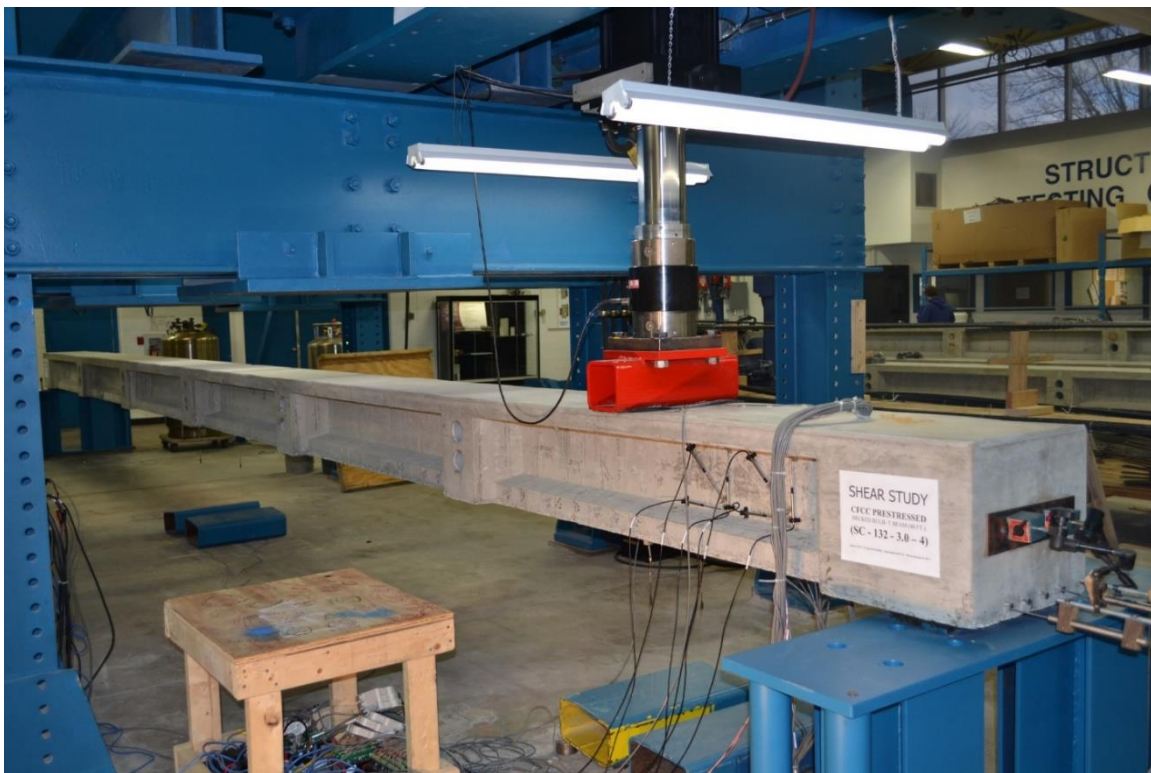
Figure 3.7-1 Test setup of Beam C-C-S-B

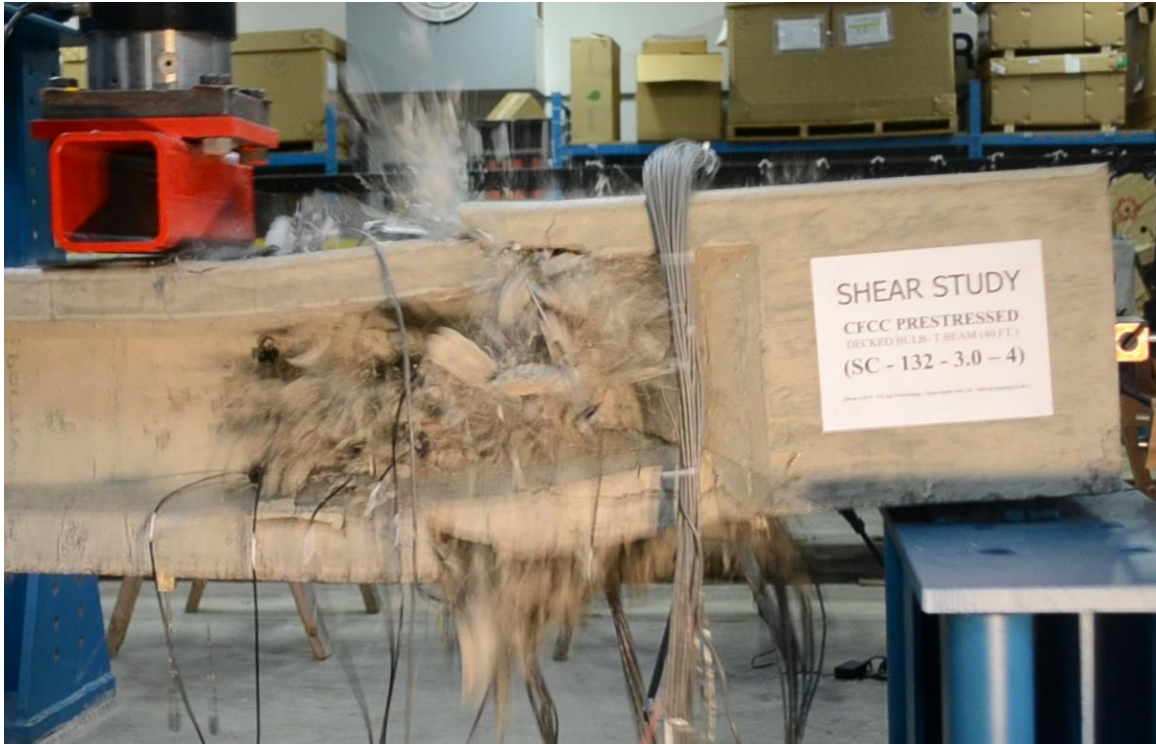
Figure 3.7-8 Explosive failure of Beam C-C-S-B

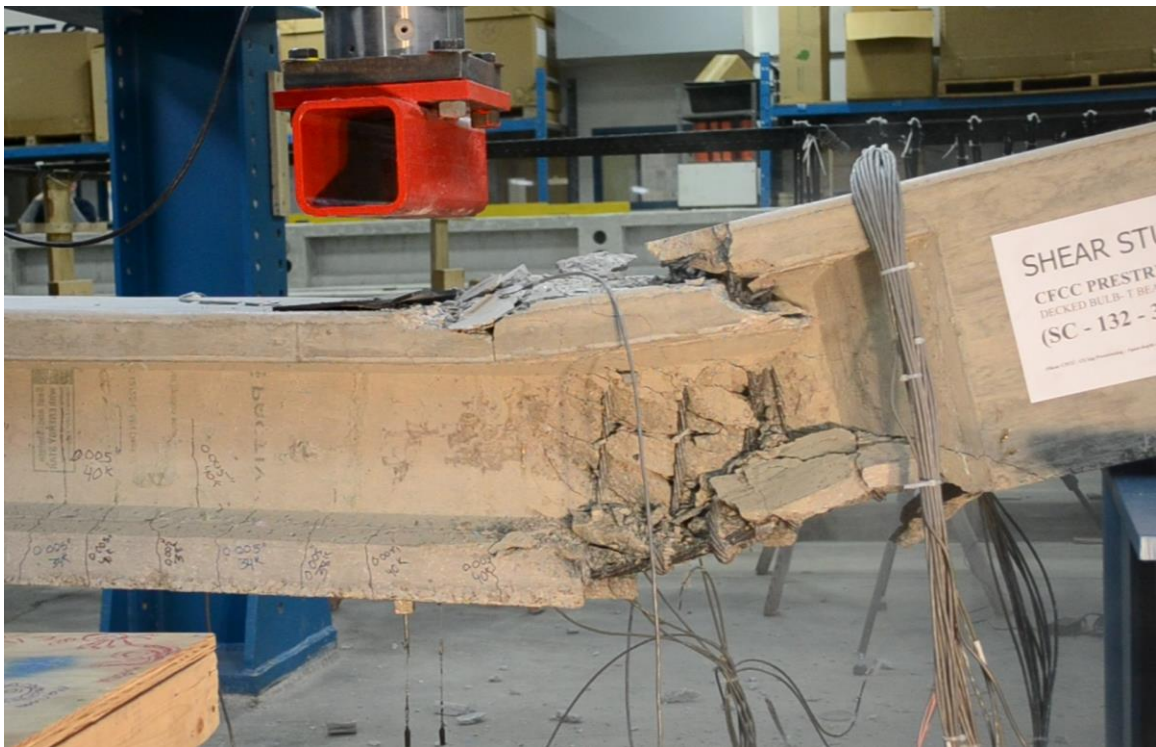
Figure 3.7-9 Beam C-C-S-B after failure

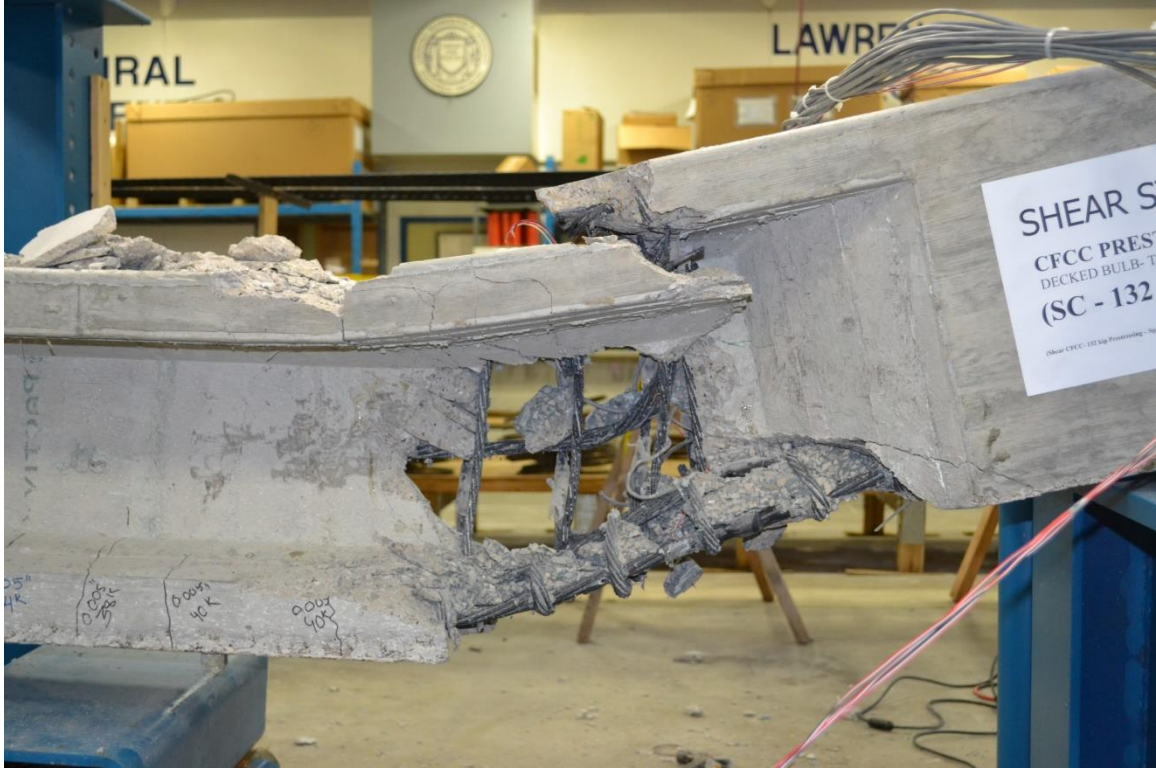
Figure 3.7-10 No rupture of CFCC stirrups was observed in Beam C-C-S-B

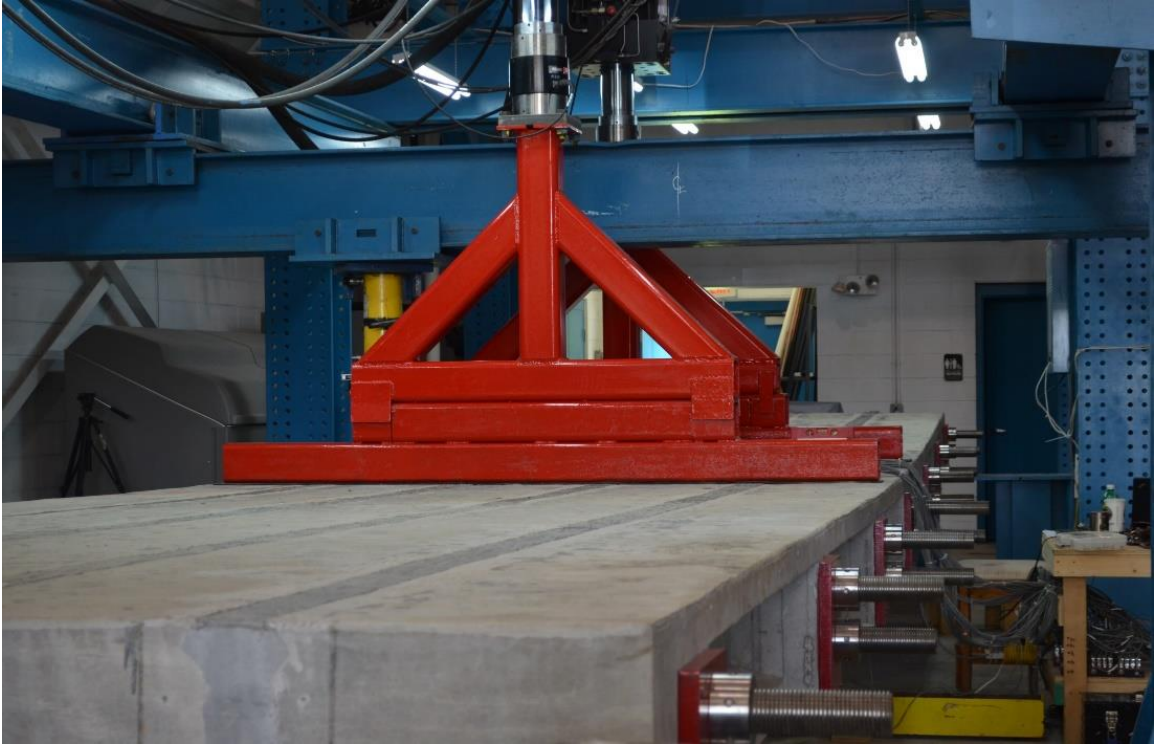
Figure 3.8-9 Four-point loading of bridge model

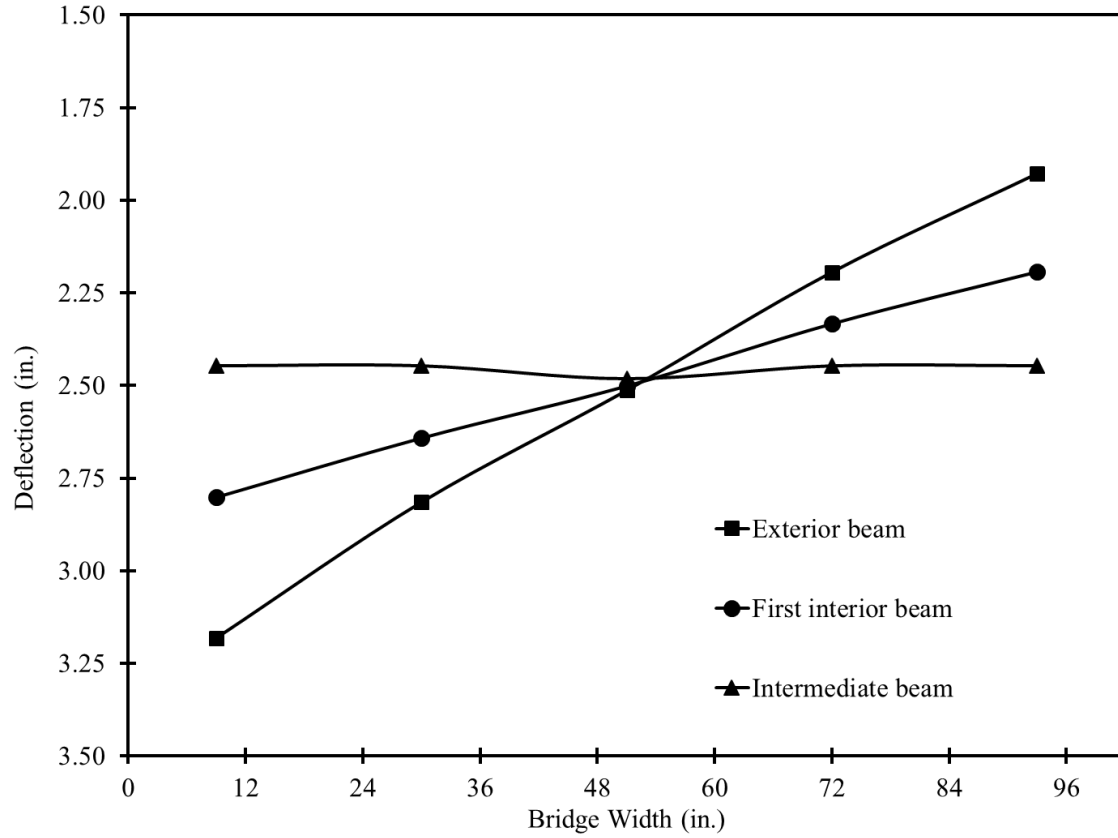
Figure 3.8-12 Deflection curves of bridge model due to post-cracking service load of 60 kip

Similar to the service limit state testing, the deflection of the bridge model was recorded and presented in Figure 3.8-12. As shown in the figure, the deflection curves indicated a uniform load distribution with no observed cracks or shear key distress. In addition, the distribution factors were calculated based on the deflection values as shown in Table 3.8-3 and compared with those obtained from service loads of 15 and 30 kip as shown in Table 3.8-4. As shown in the tables, the distribution factor did not significantly change even when the load increased from 15 to 60 kip. It should be noted that the recorded deflection values at service load of 30 kip are nearly double the values recorded at 15 kip. However, the deflection values at 60 kip is more than double the values at 30 kip. This is due to the cracking and loss of stiffness of the bridge model.

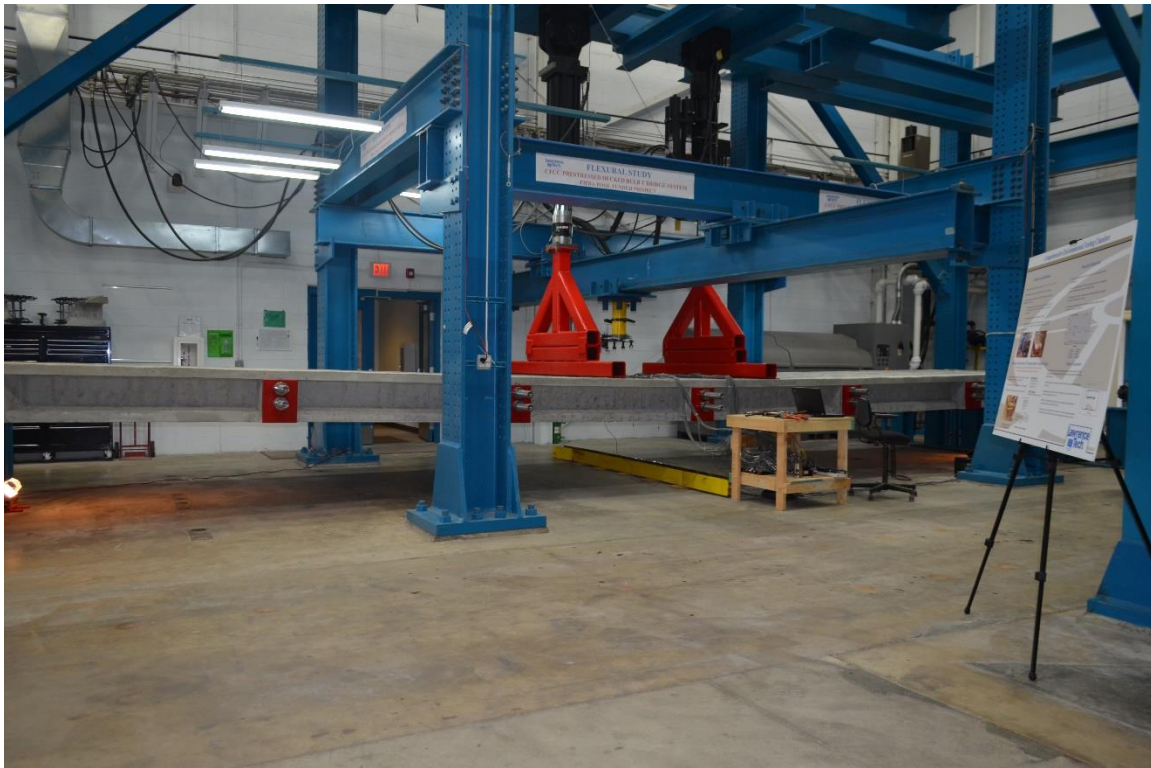
Figure 3.8-19 Load cycle test of bridge model

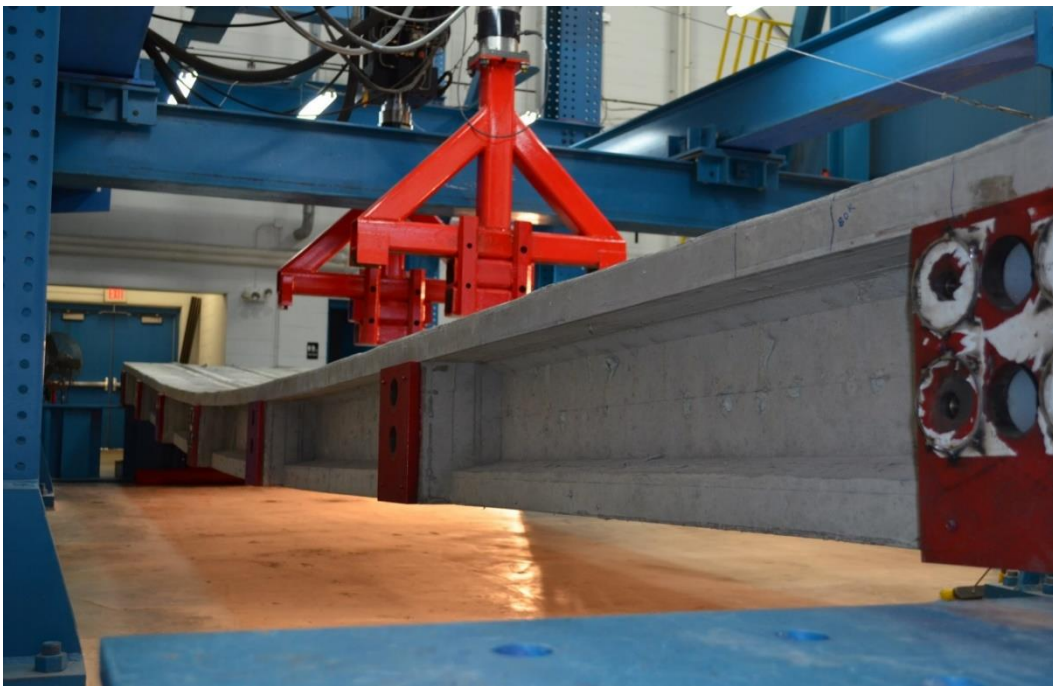
Figure 3.8-26 Bridge model at failure

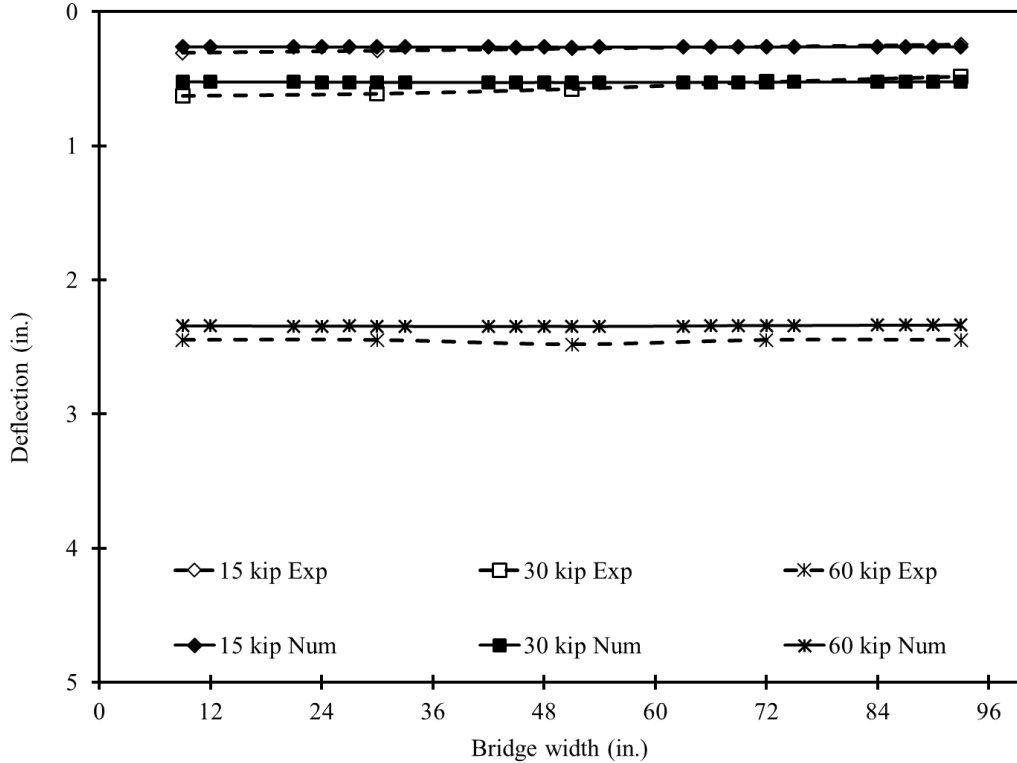
Figure 4.3-31 Numerical vs. experimental deflection curves with loads on intermediate beam
