# Enhance Bridge Image Attribution Through Automated Post Image Processing

**FINAL REPORT – FEBRUARY 2026**

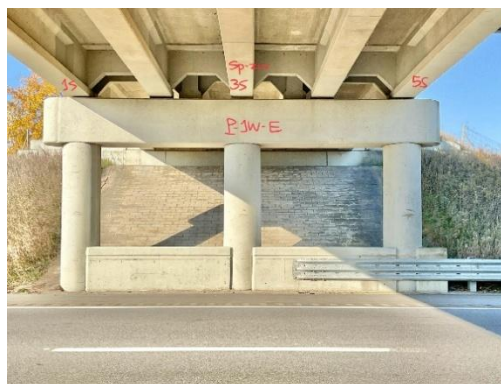
**Figure 2-2. Inspection picture with annotations.**

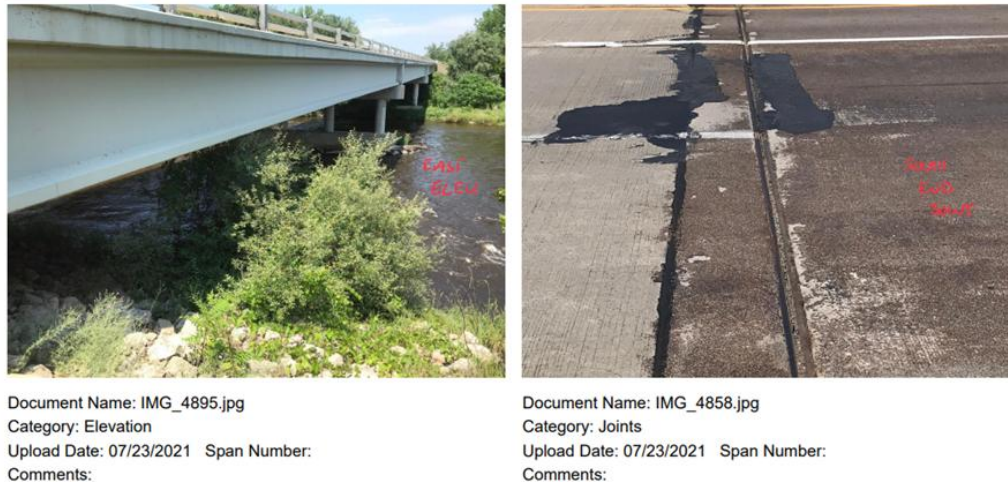
**Figure 2-3. Inspection images in MiBRIDGE, the bridge and culvert management system.**

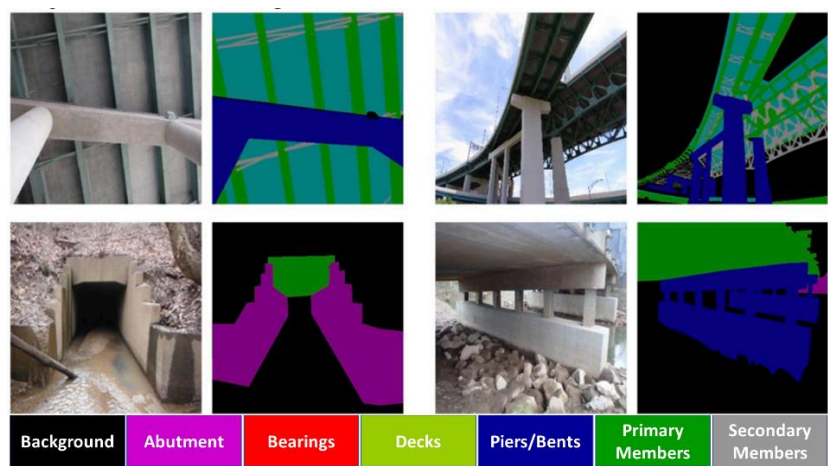
Figure 2-6. Bridge component classification used by Wang et al. (2025).

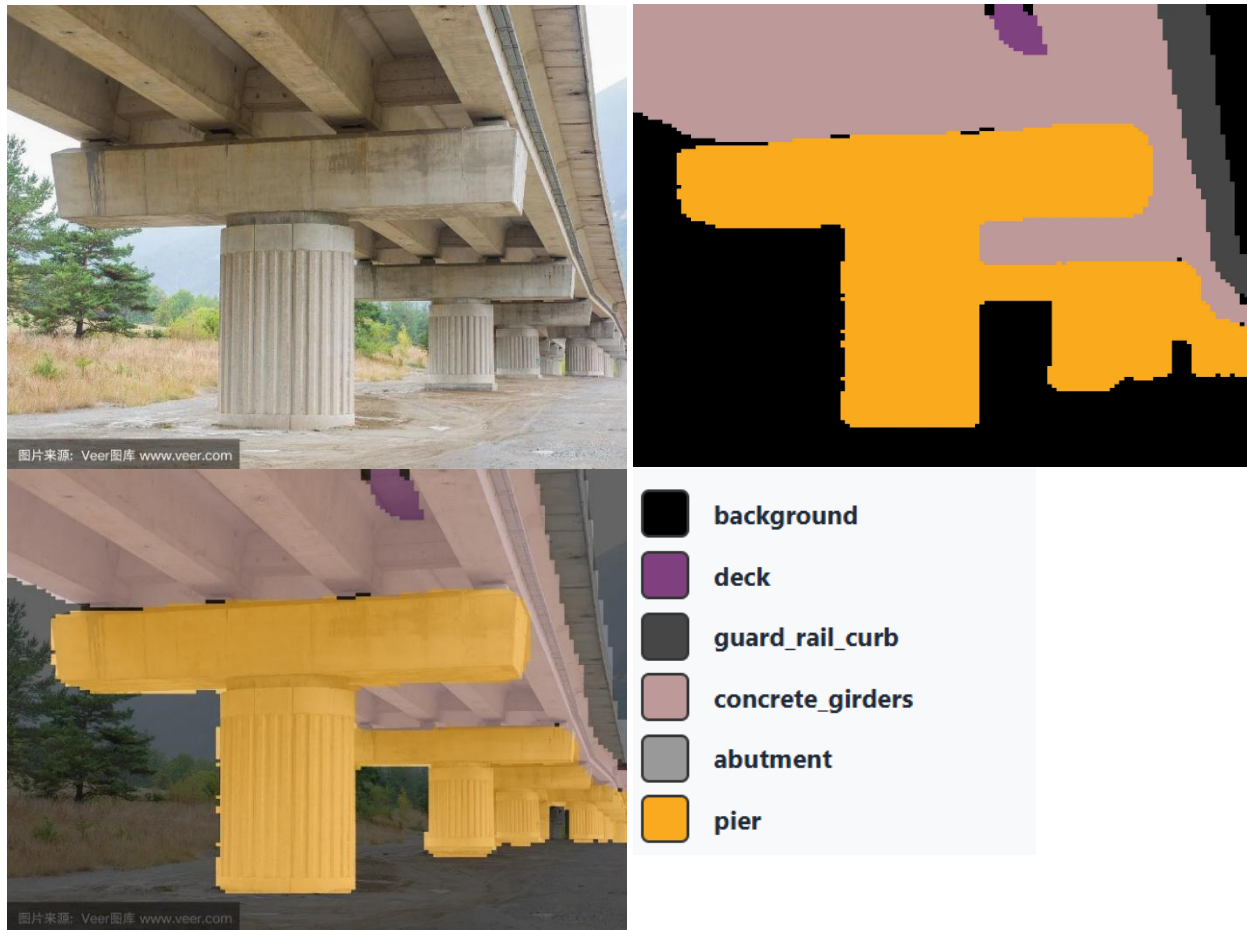
Figure 3-8. Segmentation results of a bridge with a hammerhead pier.

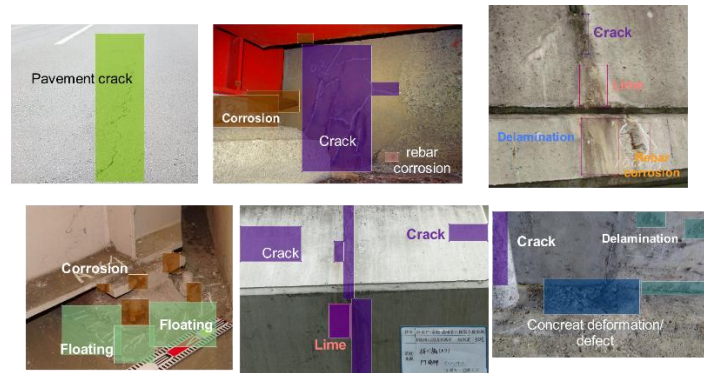
**Figure 3-9. A few examples of annotated images used for damage detection.**

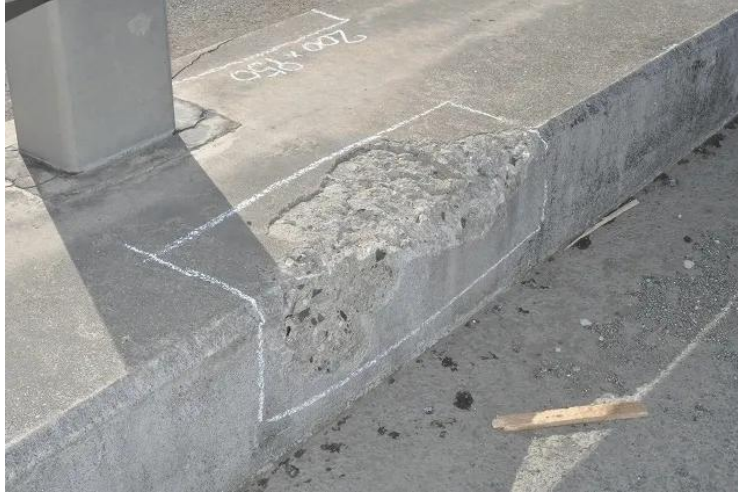
Figure 3-10. Image 10.jpg submitted for damage detection.

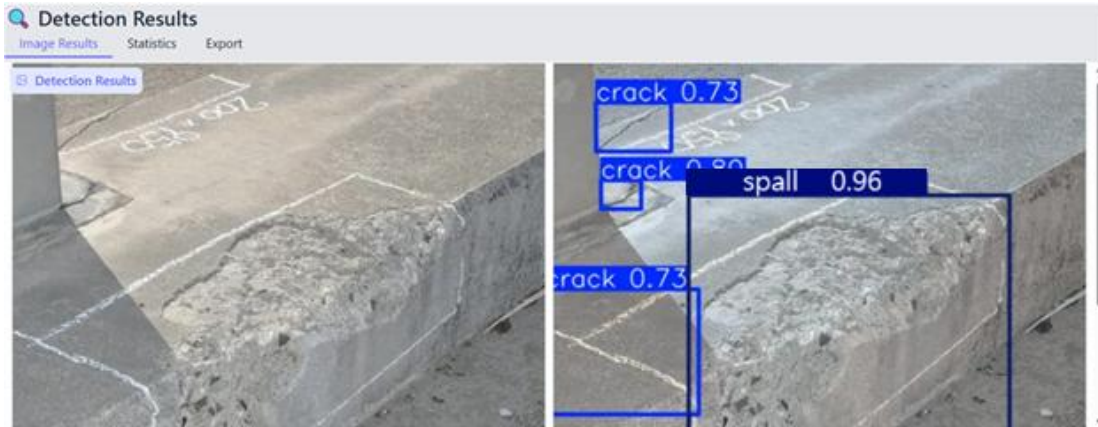
Figure 3-13. Damage detection results: damages shown in image 10.jpg.

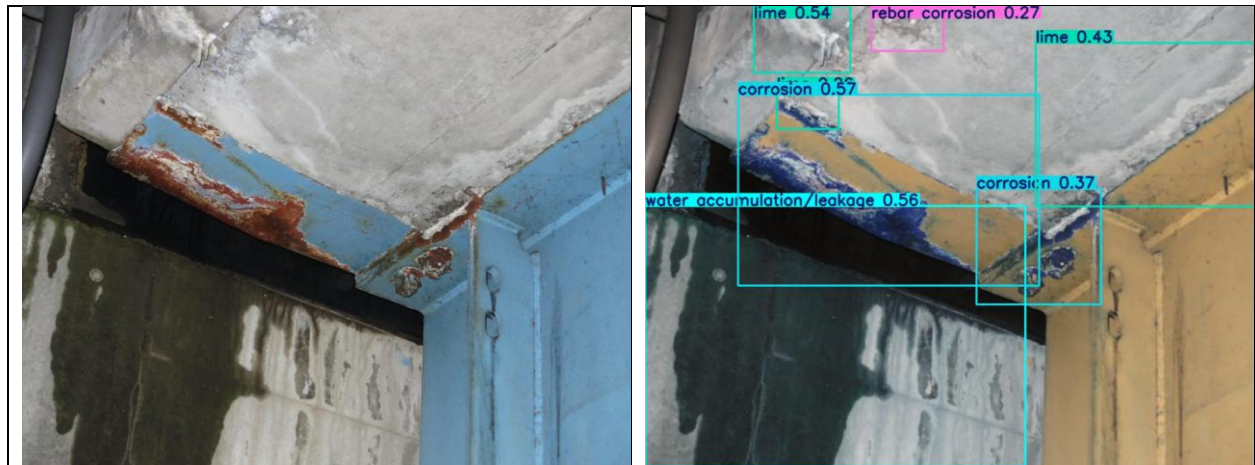
**Figure 3-16. Detection of damage in a steel beam bridge.**

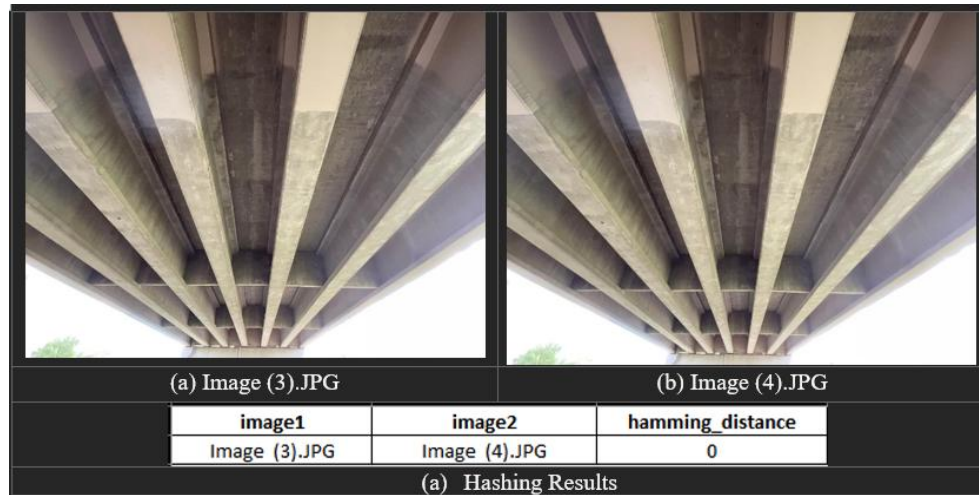
**Figure 3-20. Detection of identical images.**

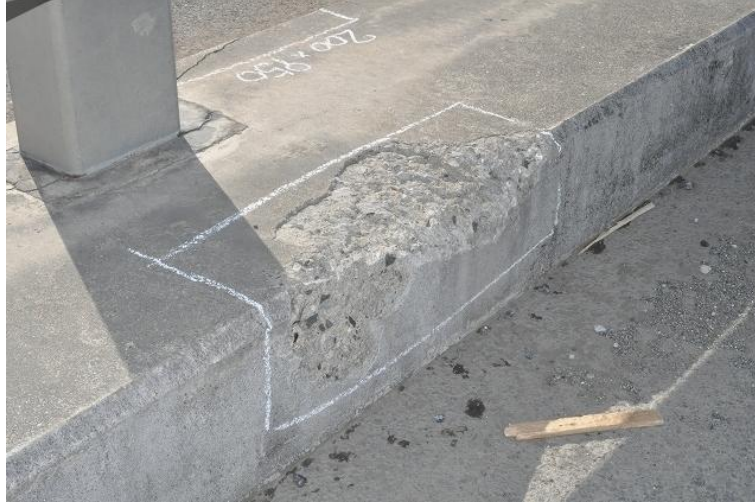
#### ☑ Visible Elements

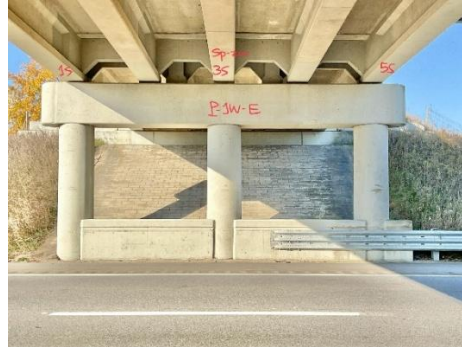
### ☑ VISIBLE ELEMENTS

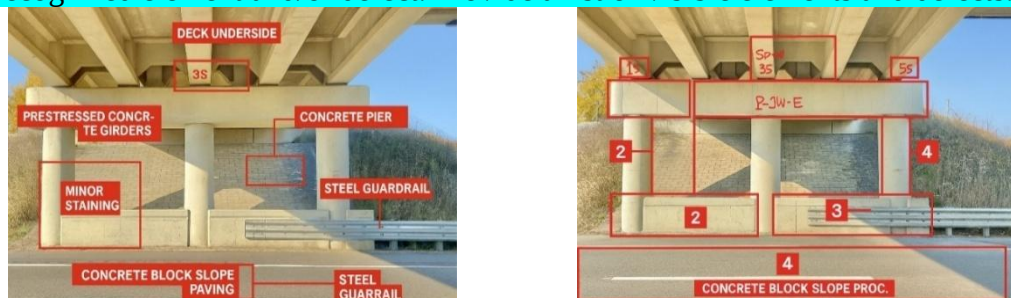
*Comment: Labels and bounding boxes are all over. The numbers provided in the figure are not explained.*

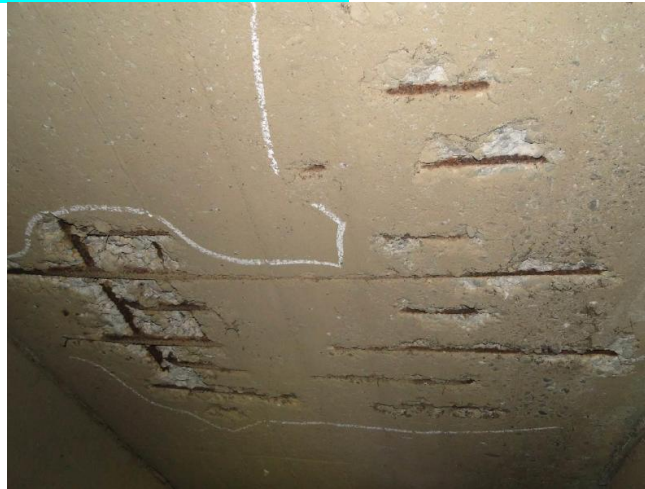
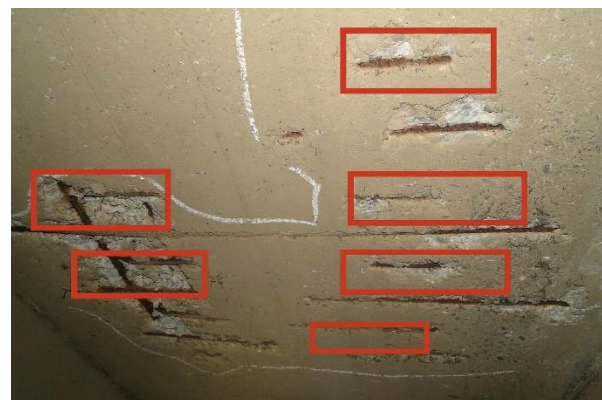
Below is a clear, inspection-grade response listing **all visible elements** and **all clearly visible defects** in the provided image using **MDOT/FHWA terminology**, along with the **image marked with red bounding boxes** (generated above).

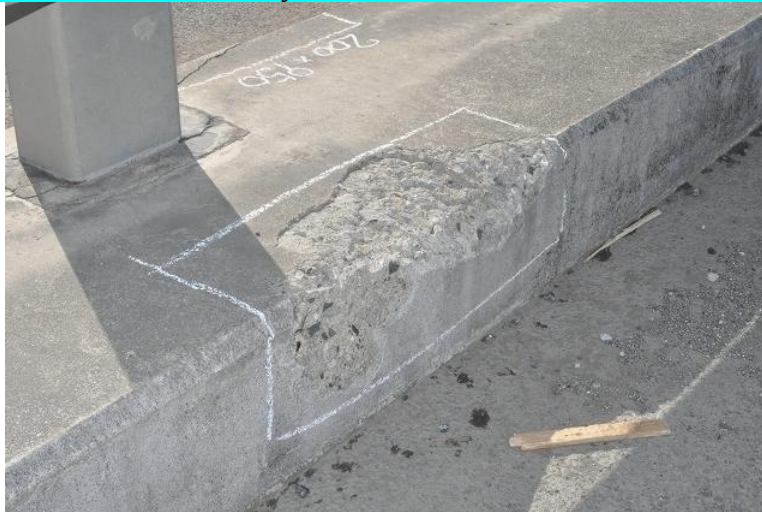
Based on the visual evidence in the image, here are the identified elements and defects using standard MDOT (Michigan Department of Transportation) and FHWA (Federal Highway Administration) bridge inspection terminology:

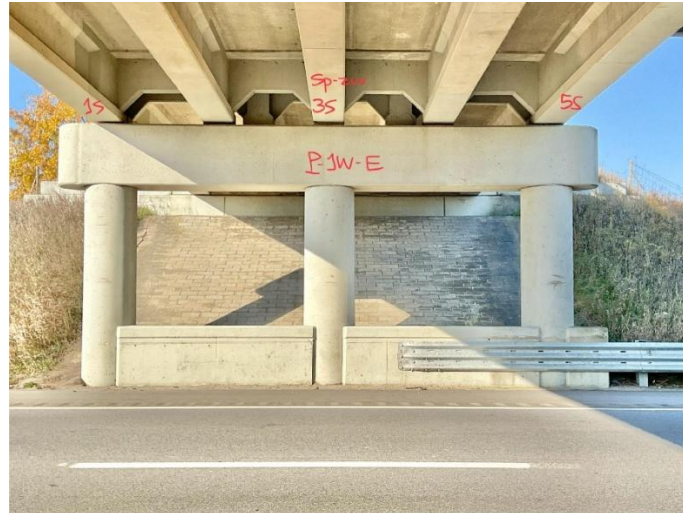
Based on the visual evidence in the image, which depicts a bridge pier and superstructure viewed from the roadway below, here are the identified elements and defects using standard MDOT (Michigan Department of Transportation) and FHWA (Federal Highway Administration) bridge inspection terminology.

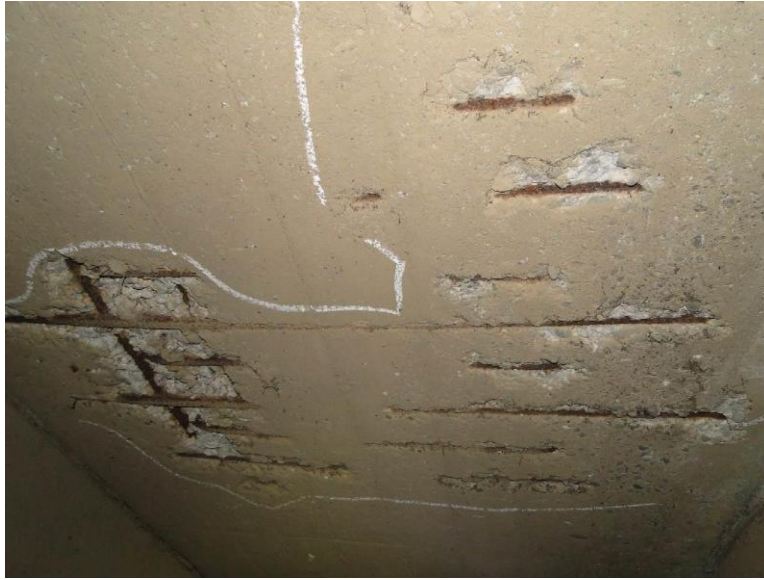
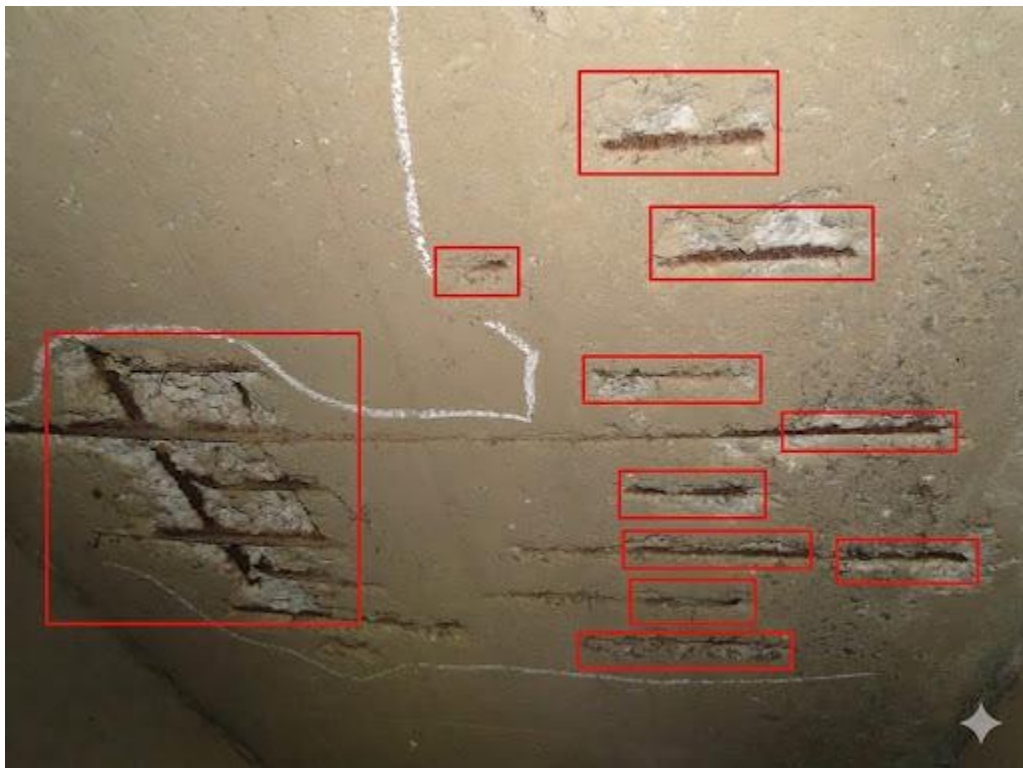
Prompt: provide clear labels to the recognized defects

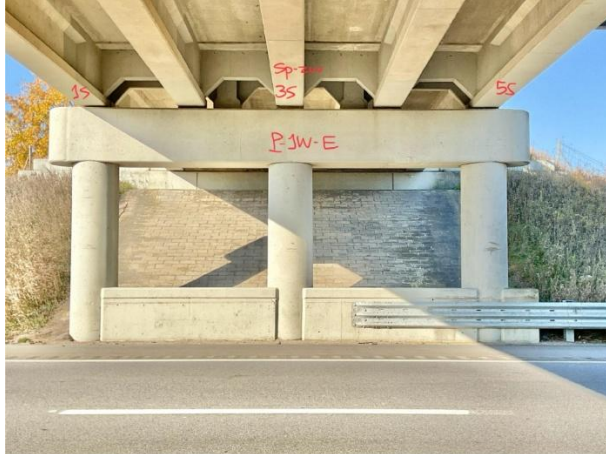
Based on the provided image, here is the identification of visible elements and defects using standard MDOT (Michigan Department of Transportation) and FHWA (Federal Highway Administration) bridge inspection terminology.

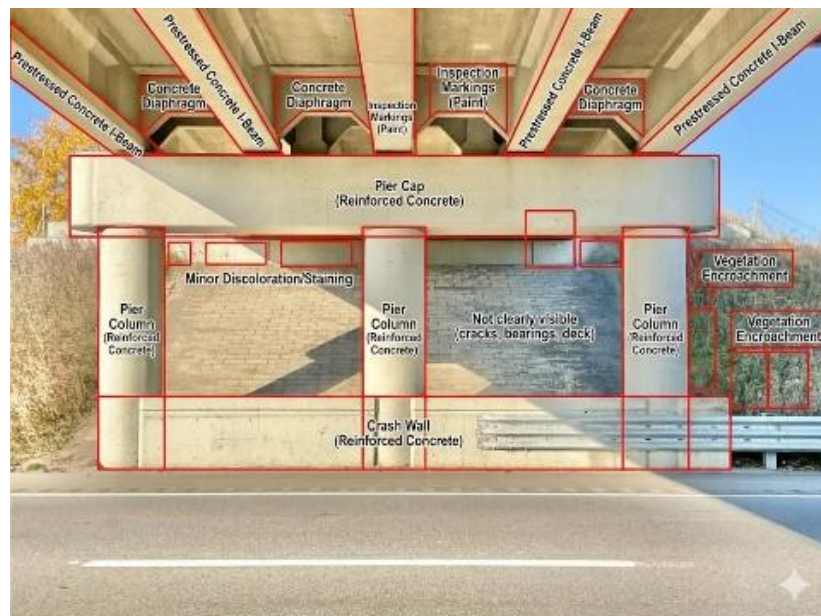
Prompt: Identify the following components and provide labels with bounding boxes:
