VIBRATION and DEFLECTION of ROLLED BEAM and PLATE GIRDER TYPE BRIDGES

VIBRATION AND DEFLECTION OF ROLLED BEAM
AND PLATE GIRDER TYPE BRIDGES

Highway Research Project 52 F-24

Research Laboratory
Testing and Research Division
Report No. 219
December 15, 1954

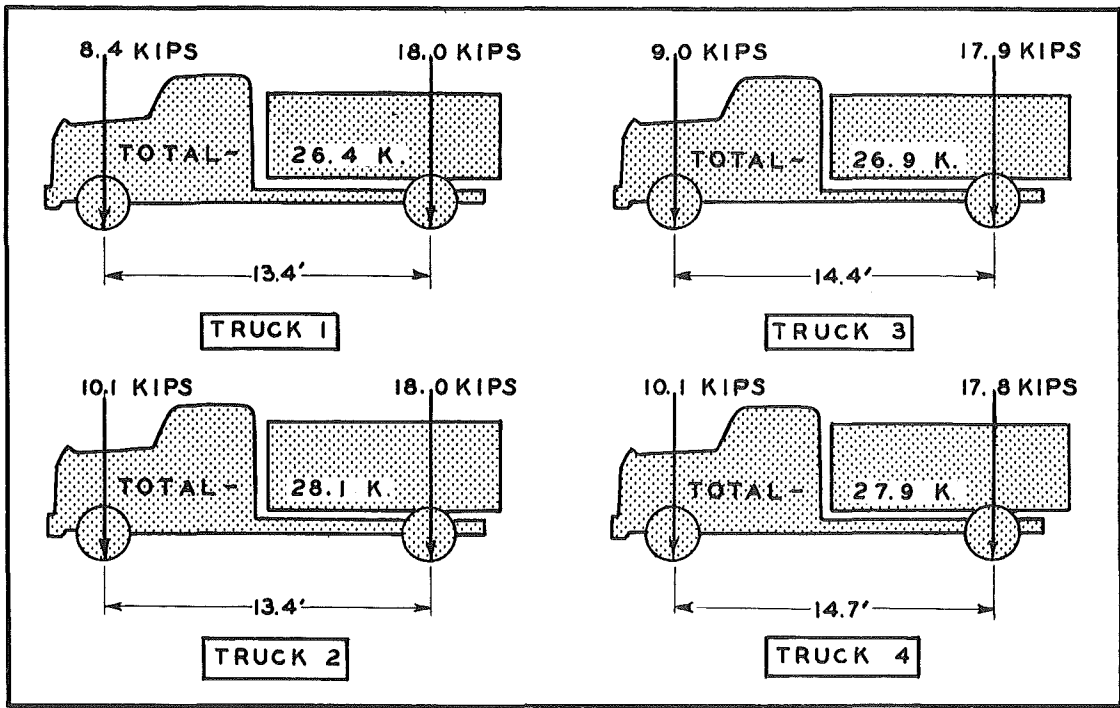
FIGURE 6-
LOADING DIAGRAM
OF FOUR COUNTY
MAINTENANCE
TRUCKS USED FOR CON-
TROLLED LOADING TESTS
ON FENVILLE BRIDGE.

Controlled Loadings, Two-Axle Trucks: In the controlled loading study, four county maintenance trucks were loaded and driven over the bridge at varied speeds, with and without boards on the spans to induce impact, and in definite sequence in certain cases, in an attempt to study some of the factors influencing vibration. All of these trucks were of the two-axle type with axle spacings of 13.4 to 14.7 feet and gross weights of 26.5 to 28.1 kips. Essential data on these trucks is given in Figure 6. The measurement of the static deflection was made for each span with each of the trucks respectively in the proper position on the span for the maximum effect. Previous to this testing phase, theoretical calculations of the natural frequency of the various spans had been made and the data on vibrations from the normal truck traffic had also been utilized to determine the natural frequency of the spans. Knowing the axle spacing of each truck, it was possible to calculate the speed for each truck for any given span, which would cause the time interval between the first and second axle of the truck passing any given point to be equal to the natural period of

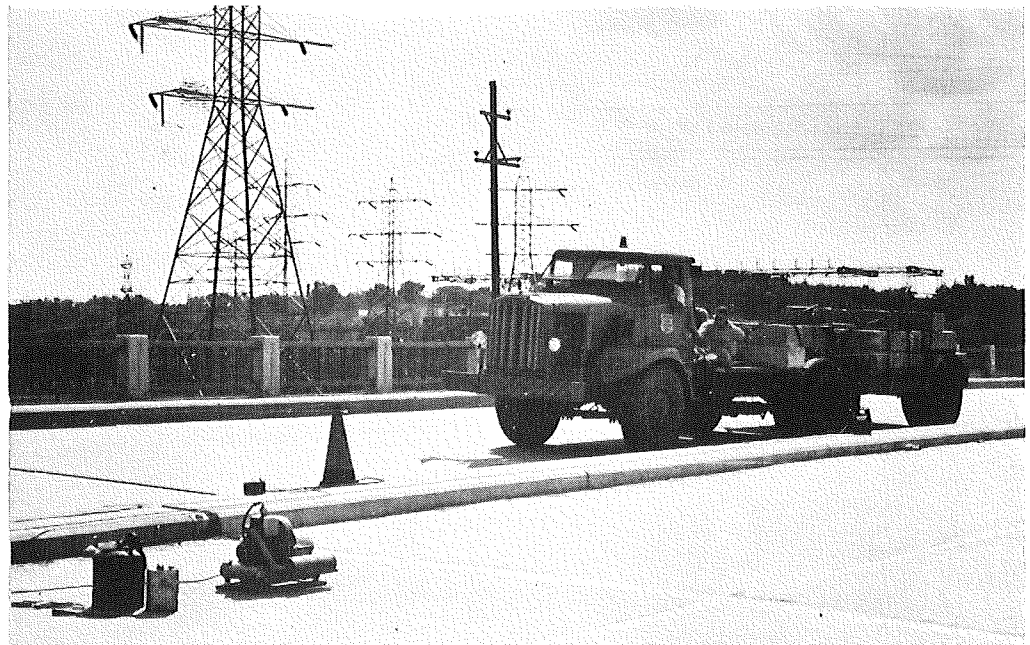
FIGURE 7 - A PHOTO-
GRAPH AND LOADING
DIAGRAM FOR THE
THREE-AXLE WALTERS
TEST TRUCK.

Controlled Loading, Three-Axle Truck: In the third phase of field testing, a three-axle truck was used under controlled conditions to extend the study begun with the county maintenance trucks. A photograph and loading diagram of this vehicle is shown in Figure 7. One unique part of this testing was the simultaneous recording of strains on the rear axle of the truck tractor with the bridge vibrations and deflections. This was done in an attempt to correlate the load variations, as reflected by axle strains as the truck passed over the bridge, with the bridge oscillations. Electrical strain gages attached to the axle indicated the variations in load on the axle and this was recorded permanently by means of a Brush oscillograph. Axle strains were previously calibrated with load variation, for as the truck was loaded with known loads,

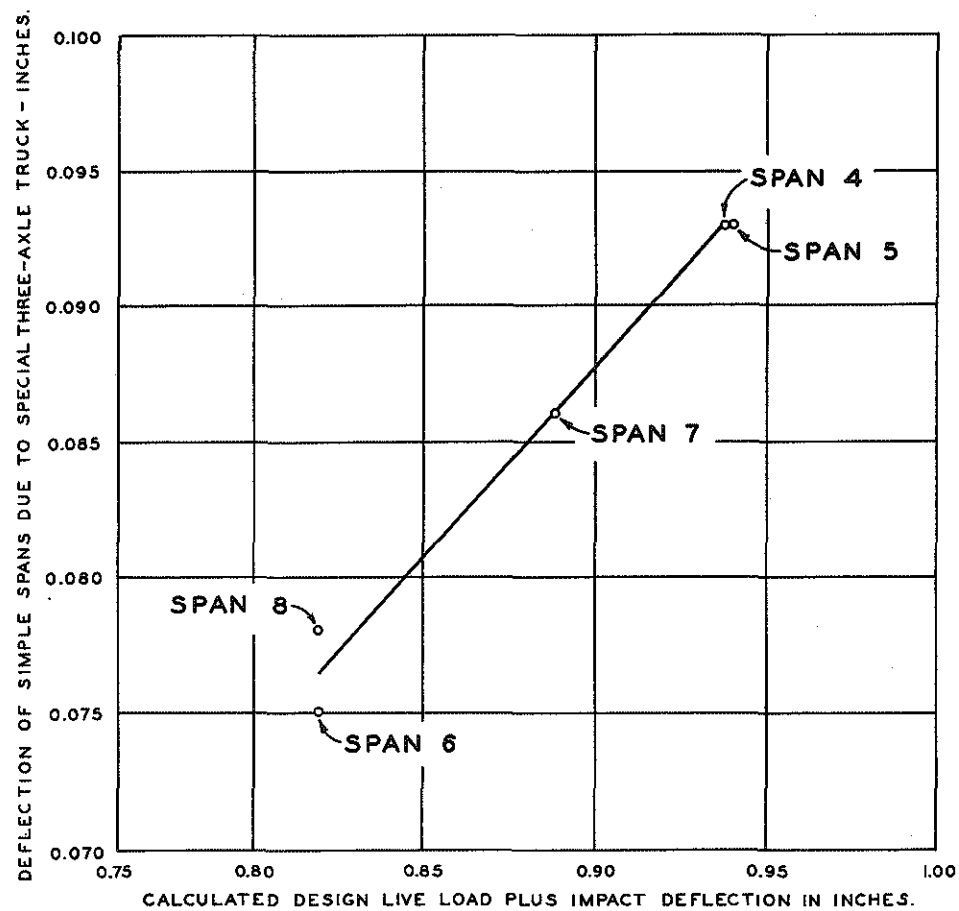
FIGURE 9

RELATION BETWEEN OBSERVED DEFLECTION AND CALCULATED DESIGN LIVE LOAD PLUS IMPACT DEFLECTION (SPECIAL THREE-AXLE TEST TRUCK).

It is interesting to compare the resulting deflections for the various simple spans, caused by a given vehicle and to correlate this with the two design considerations of "Depth to Span Length Ratio" and the "Calculated Design Live Load Plus

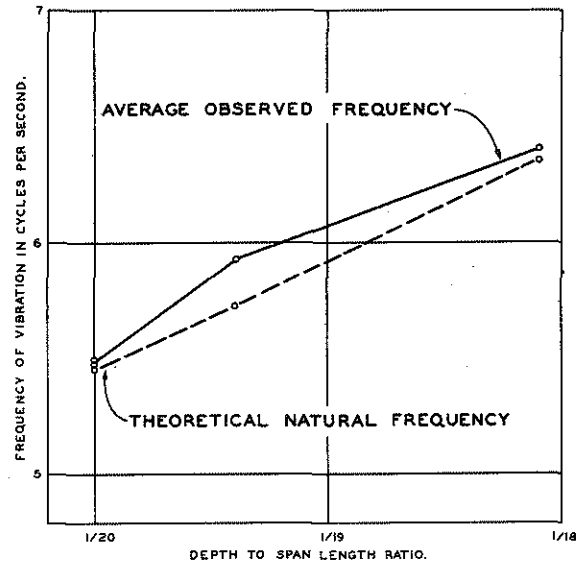
▲ FIGURE 14

AVERAGE OBSERVED FREQUENCY AND THEORETICAL NATURAL FREQUENCY OF VIBRATION COMPARED TO RATIO OF DEPTH TO SPAN LENGTH-FOR SIMPLE SPANS.

The difference between the theoretical and observed frequency was greatest for the three-span continuous structure but, for the simple spans, the largest difference was only 3.4 percent and the average difference for the simple spans only 1.2 percent. Figures 14 and 15 show the relation between the Average Observed Frequency of Vibration for the simple spans as compared to the "Ratio of Depth to Span Length", and the "Ratio of Design Live Load Plus Impact Deflection to Span Length",

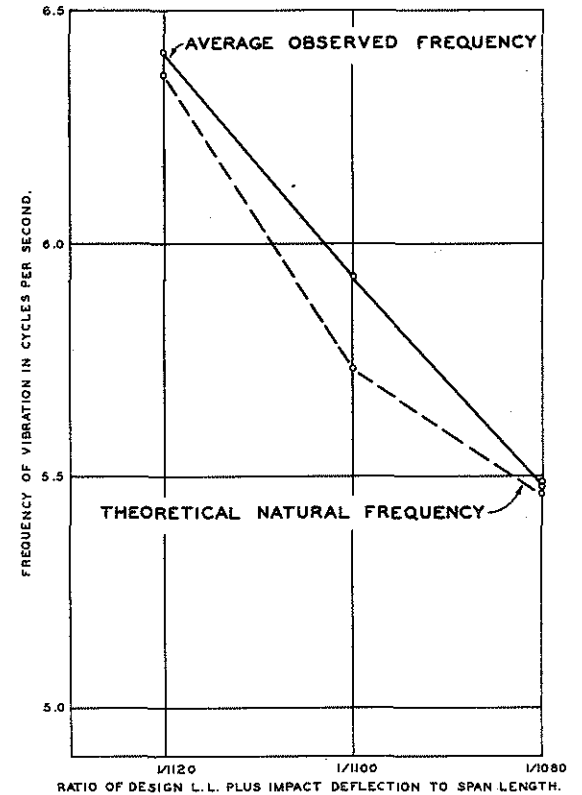
▲ FIGURE 15

AVERAGE OBSERVED FREQUENCY AND THEORETICAL NATURAL FREQUENCY OF VIBRATION COMPARED TO RATIO OF DESIGN LIVE LOAD PLUS IMPACT DEFLECTION TO SPAN LENGTH

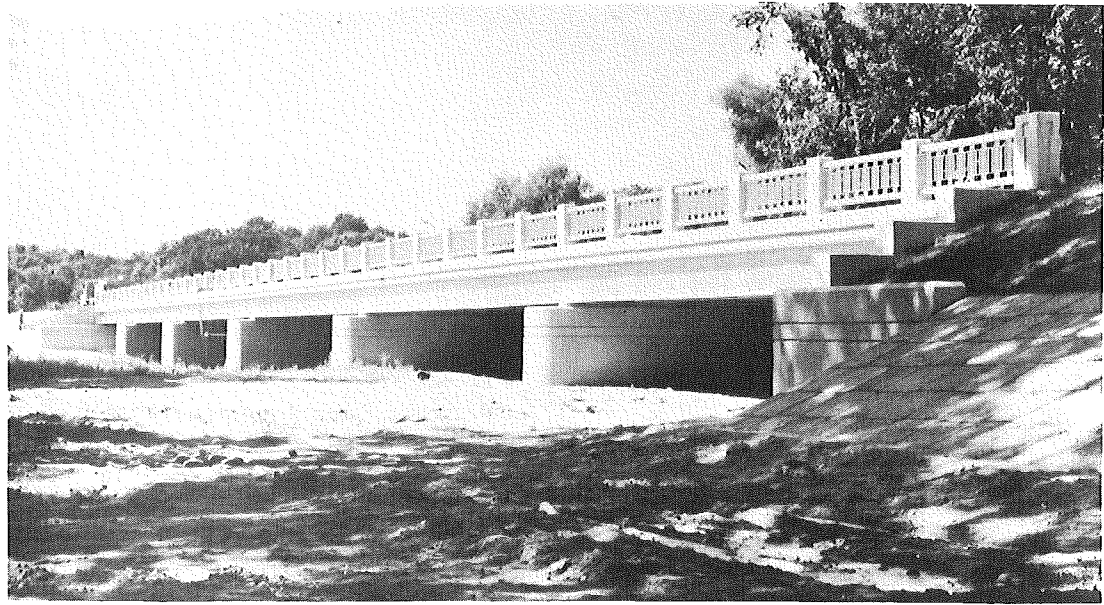
▲ FIGURE 20- GENERAL VIEW OF FENNVILLE BRIDGE.

A general view of the bridge is shown in Figure 20. Since this bridge is located on a lightly traveled road and truck traffic is rather infrequent, it was considered feasible to test the bridge only under controlled loading conditions, using

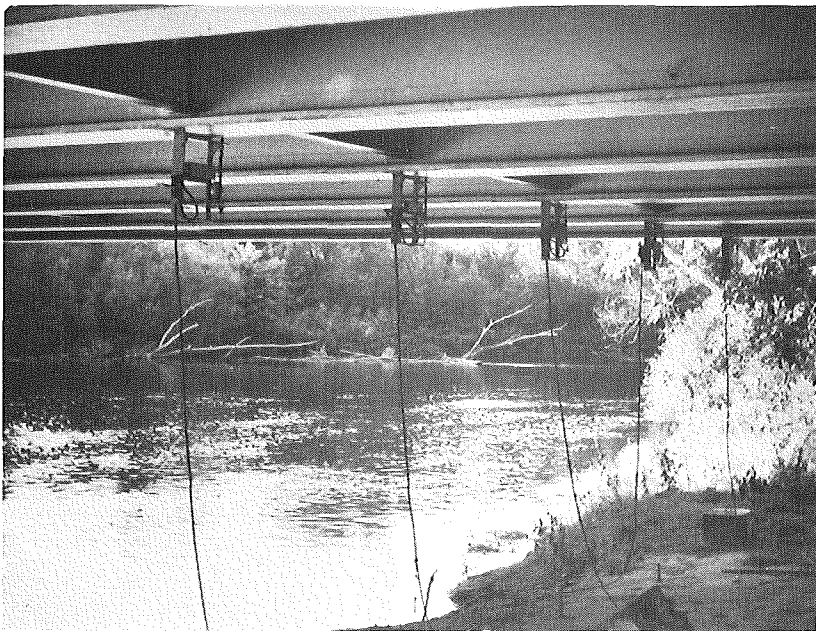
▲ FIGURE 21- DEFLECTOMETER INSTALLATION, SPAN 4.
