APPLICATION OF THESE ELEMENTS ON PROJECT  
F 71-01, 01, 12-12 NORTH OF JOLT TUNNEL

Research Project No. E-12 (2)  
Progress Report No. 1

Research Laboratory  
Testing and Research Division  
Report No. 127  
March 1, 1949

APPLICATION OF WHITE MEMBRANE ON PROJECT

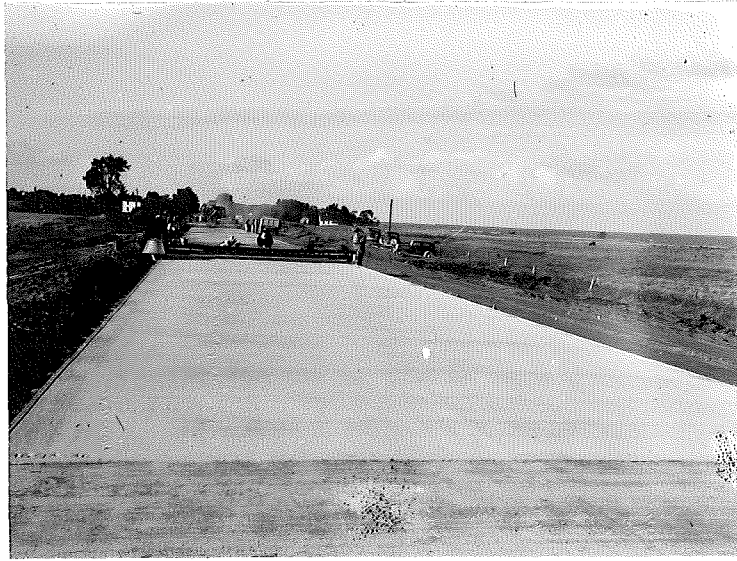
Figure 1. General view of curing project looking north from Station 1067+52.

At first the machine covered the pavement quite uniformly with the white compound, as shown in Figures 1 and 2. In a comparatively short time, however, the new type nozzles, which were fitted with individual screens, became clogged and marked ridging appeared (Figure 4). Because of the extremely slow setting and hardening of the concrete, the pressure of the spray was also indenting or perforating the surface of the concrete in irregular lines across the pavement which may be seen in the center foreground of Figure 4. This perforation was also noticed on sections of pavement cured previously with clear membrane, and was eliminated later on by freeing the nozzles and raising the spray bar of the machine.

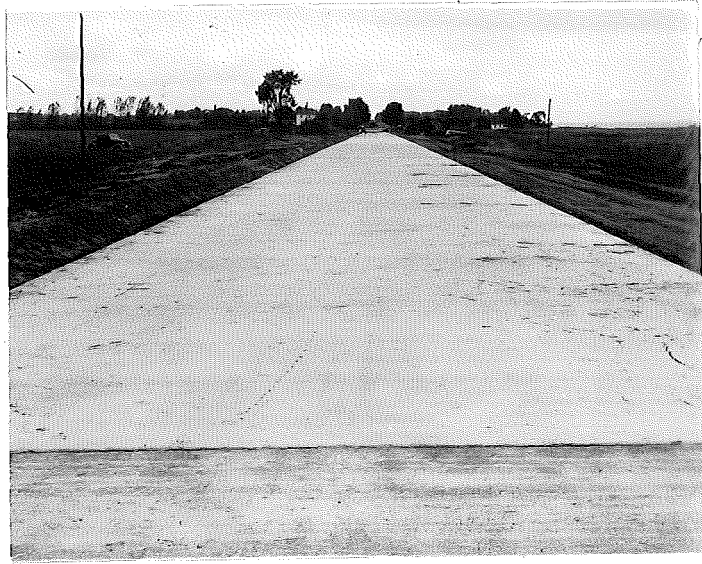
Figure 3. First day's pour immediately after removing forms on following morning, north Cree Station 1057+62.

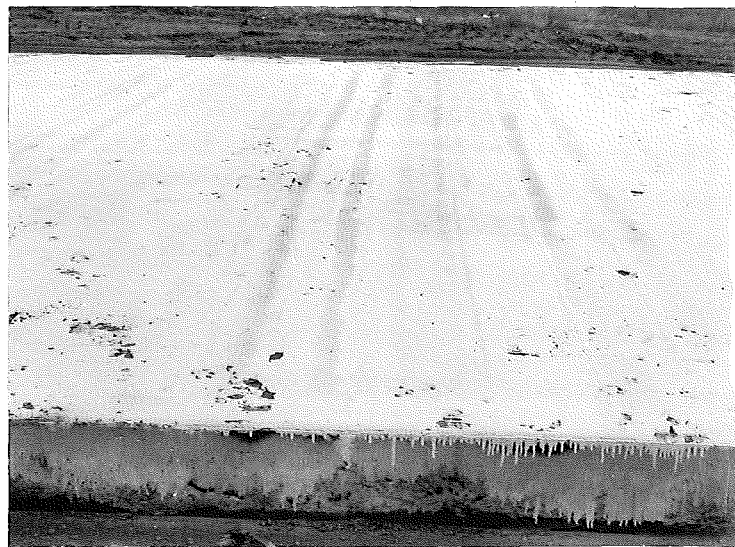
Figure 7. Ridging due to clogging of old type nozzles. This section was sprayed after dark. Station 1081+00.

After several attempts to keep the new type nozzles free from clogging were unsuccessful, the old conical-spray type were substituted at Station 1060+75. These nozzles performed well for a time, (Figure 5) but soon became clogged, resulting in ridging as before (Figure 6). Approximately half of the first day's pour was cured after dark using the old type nozzles and considerable difficulty was experienced in keeping them free.

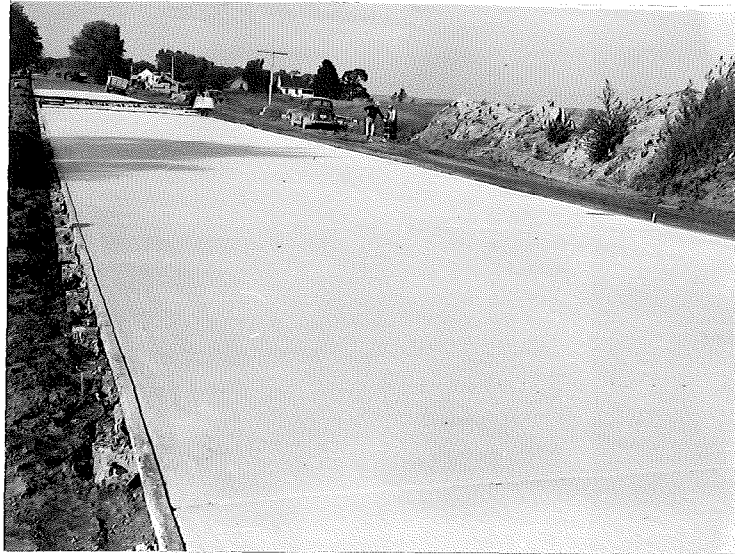
Figure 7. View of beginning of second day's pour. Application by double pass, using new nozzles with screens removed and spray bar slightly raised. Station 1066+71.

Before starting the membrane application on the second day's pour, the nozzles on the machine were again changed to the new, flat-spray type, but the individual straining screens were removed. Apparently the white pigment had been filling these screens and little trouble from clogging was experienced after their removal. Also the spray bar of the

machine was raised about 6 inches and a much more uniform application resulted. In addition to these modifications, the curing compound was applied by a double pass of the machine across the pavement, using a more rapid rate of transverse travel and overlapping one-half the width of the path laid down by the spray bar on each pass. All of the above-mentioned changes resulted in a very uniform application and elimination of the previous defects, (Figures 7 through 11). There was occasional clogging in some of the nozzles from foreign material gaining entrance during the filling of the tank on the machine, but the same kind of trouble occurs with the clear compound. Defects and nonuniformity of the coating are much more obvious with white compounds than with the clear, however.

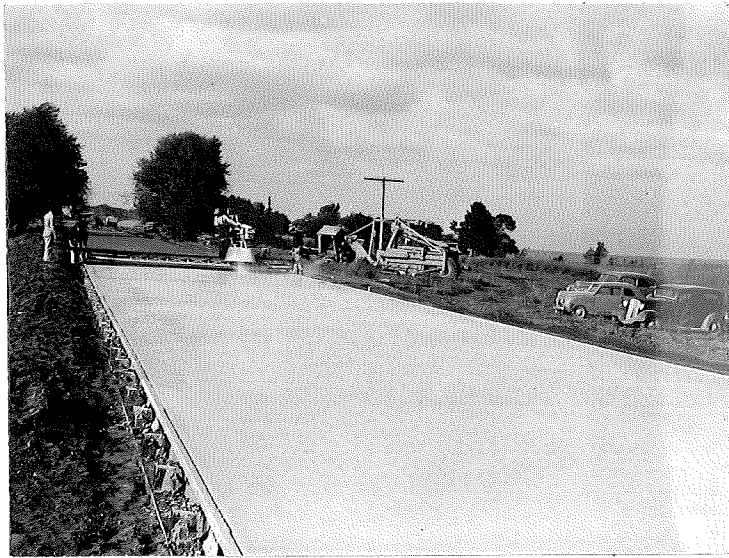
Figure 11. Another view showing uniformity of application with double pass and new nozzles.

Spraying equipment used on the job was of the type furnished by the vendor to contractors for regular construction work, and is illustrated in Figures 10 and 11. For this experiment, however, new spray nozzles

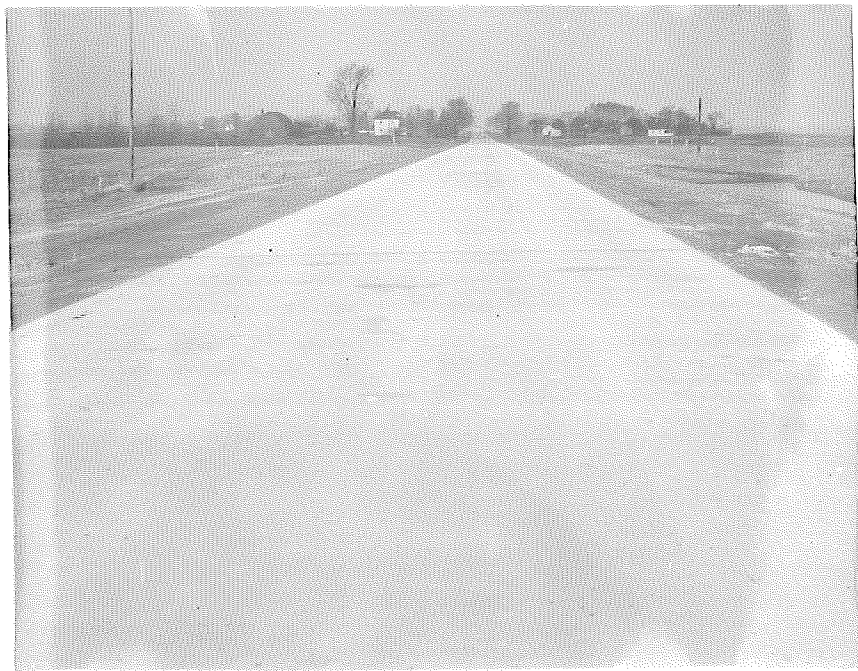
Figure 12. Looking north from beginning of project; 8 weeks after application. Intermediate color in center of picture is due to spraying white membrane on day-old concrete.

Weathering Characteristics: The photographs of Figures 12 through 15 show that the white membrane weathered away uniformly without mottling or other unsightly effects. Actually, it would be difficult at present

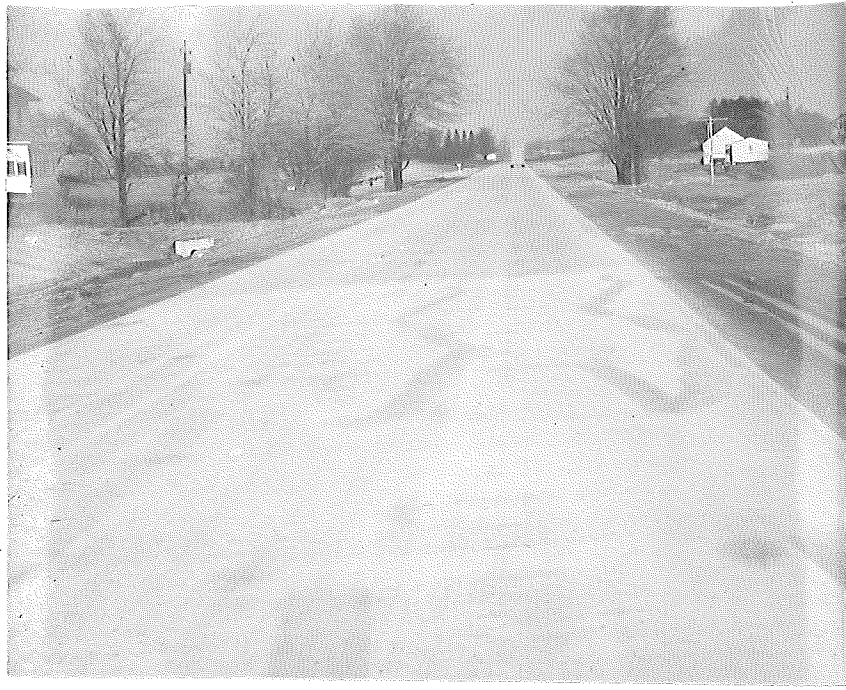
Figure 13. Looking north beyond end of curing project. Sun  
back of camera. Although application was heaviest here, the  
contrast is not marked.

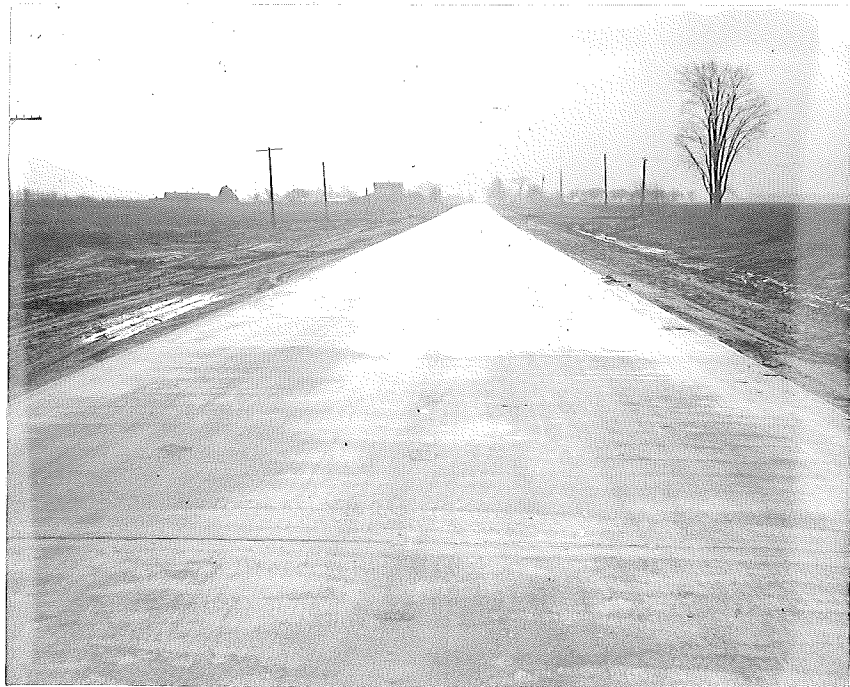
Figure 14. Looking south into the end of curing project. Sun  
in front of camera. Contrast is more evident when looking into  
the sun.
