EVALUATION OF OPEN HEARTH SLAG
AS A HIGHWAY BASE MATERIAL

MICHIGAN DEPARTMENT OF STATE HIGHWAYS

Research Laboratory Section
Testing and Research Division
Research Project 68 E-43
Research Report No. R-739

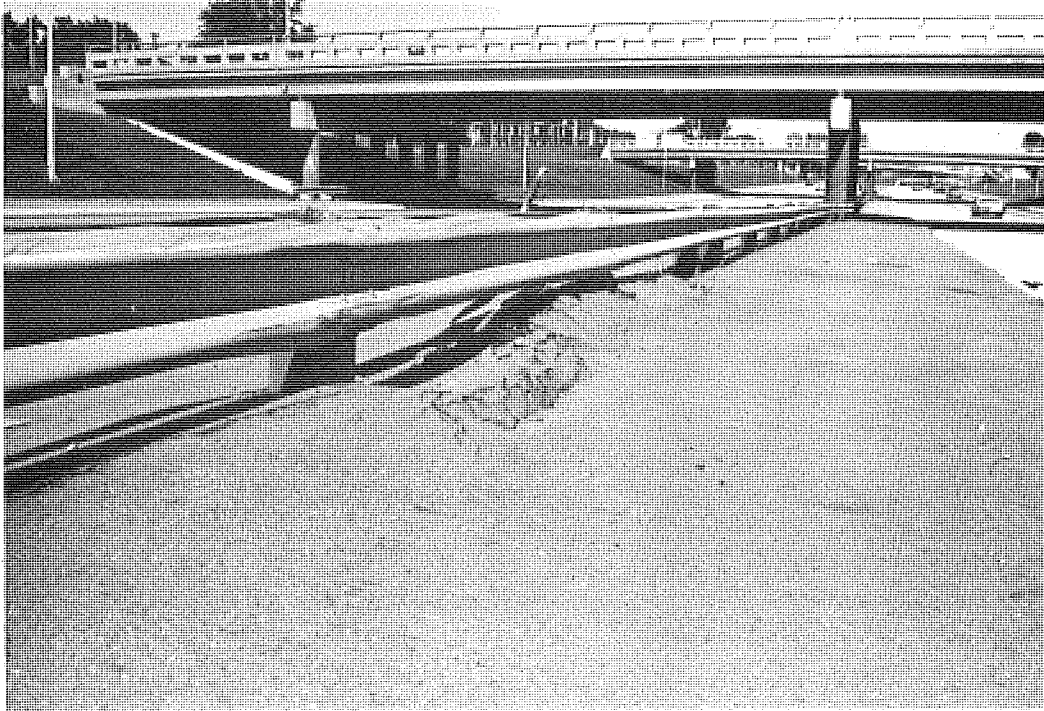
Figure 2. Median heaving along the Fisher Freeway.

Open hearth slag was used both as selected subbase and for the construction of class AA shoulders for approximately 4.8 miles of the Fisher Freeway (I 75) constructed through Detroit from 1965 to 1968. Difficulties due to the use of this material were first evidenced by differential heaving of the median areas as shown in Figure 2. A similar problem was also observed in an unpaved parking lot at the Detroit Metropolitan Airport (Fig. 3).

Heaving and buckling of bituminous surface

Bulging and cracking of bituminous surface

An inspection of the Fisher Freeway between Vernor and Outer Drive (Control Section 82194) in December 1969 showed approximately 80 percent of the slag-based median paving to be heaved. Magnitudes of the distress range from slight surface cracking and bulging to buckling and rupture of the bituminous surface similar to that already shown in Figure 2. Samples of slag obtained from the base in these areas show a slight residual expansive activity when subjected to the laboratory's volume change tests.

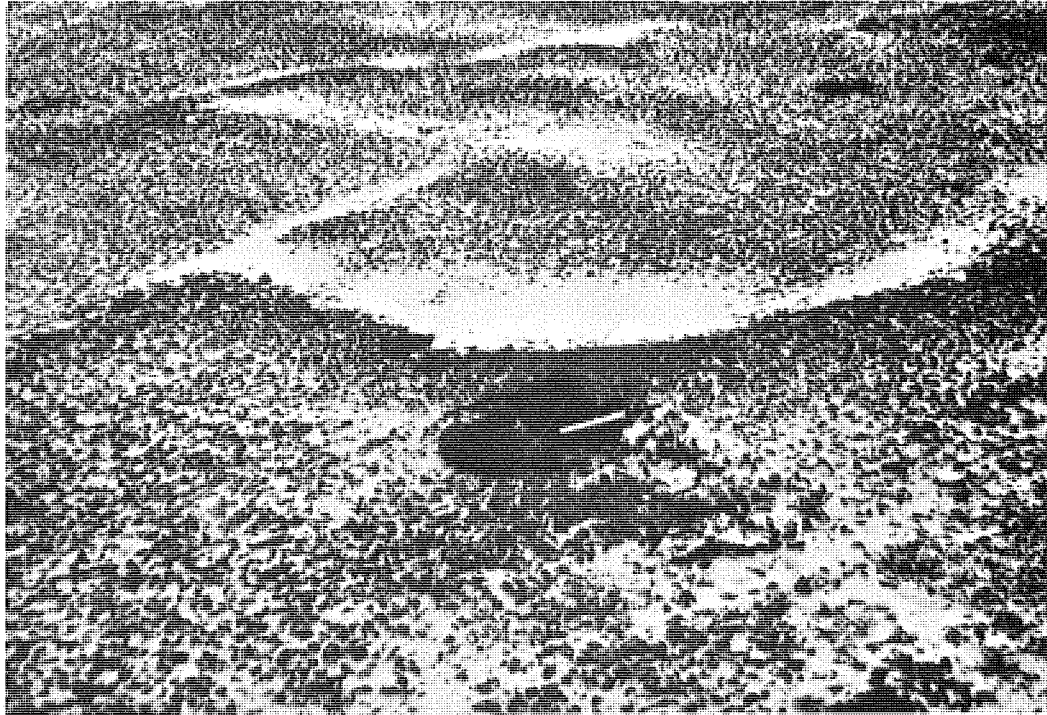
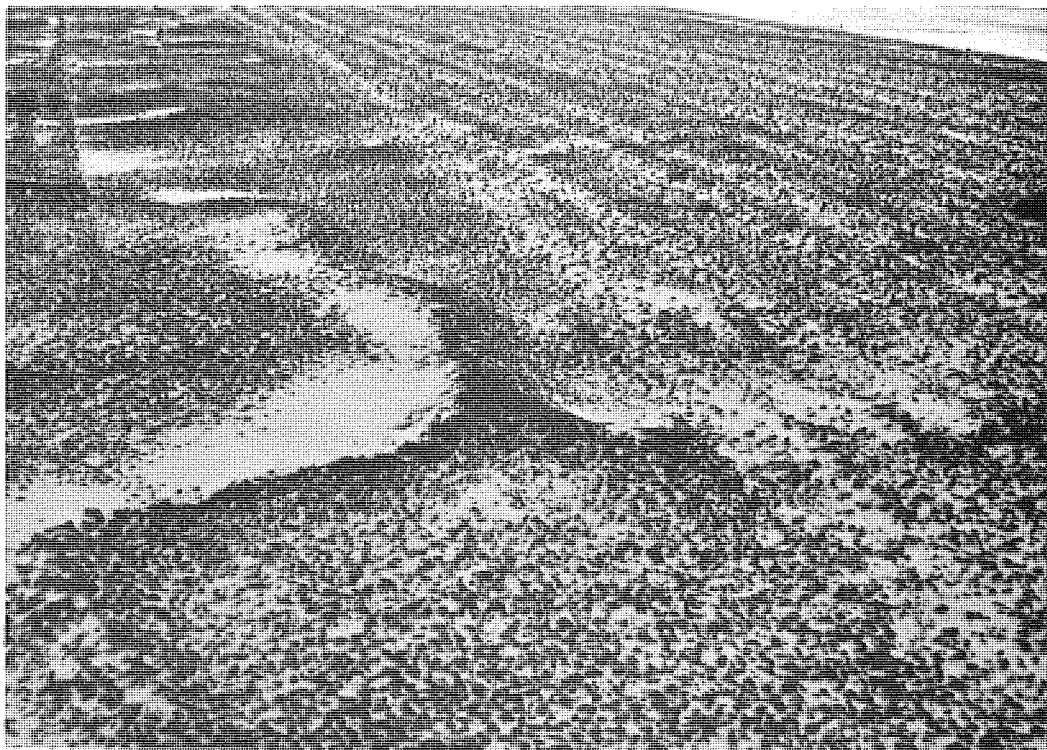
Figure 3. Unpaved parking lot at Detroit-Wayne Metropolitan airport.

The exact time between construction and the start of heaving is not known, and appears to vary with different conditions. Surface distress was observed on the Fisher Freeway three to four months after construction, whereas the same problem was not readily noticed at the parking lot until about a year after construction.

Surface crust

Heaving
