STATIC AND DYNAMIC PROPERTIES OF  
ANCHOR BOLTS FOR SIGN SUPPORTS

Research Laboratory Section  
Testing and Research Division  
Research Project 77 F-153  
Research Report No. R-1197

Michigan Transportation Commission  
Hannes Meyers, Jr., Chairman; Carl V. Pellonpaa,  
Vice-Chairman; Weston E. Vivian, Rodger D. Young,  
Lawrence C. Patrick, Jr., William C. Marshall  
John P. Woodford, Director  
Lansing, June 1982

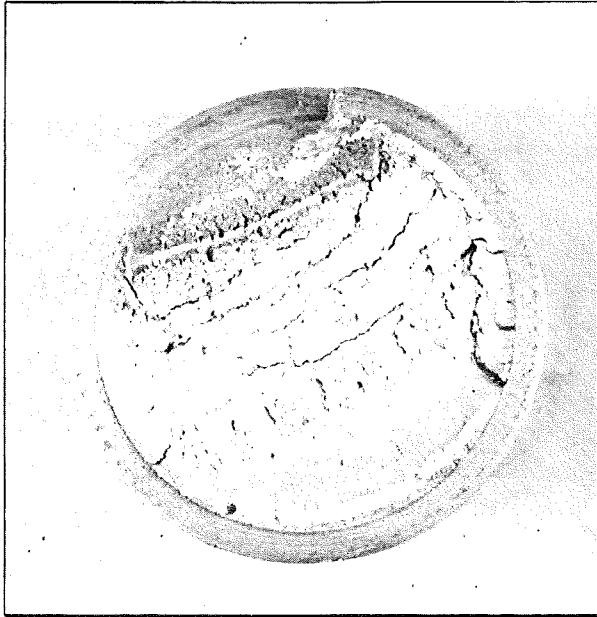
Group 2, No. 7B

Group 4, No. 34

Group 2, No. 8B

Group 4, No. 41

Figure 7. Typical examples of the appearance of the fatigue fracture surface.

Typical examples of the fracture surfaces of the fatigue specimens are shown in Figure 7, showing evidence of the progression of the fatigue crack across the face and the resulting total failure with very little plastic deformation of the bolt. Static tests (not illustrated) give an entirely different type of failure, where large deformations, distortion of the threads, and considerable reductions in area occur. These, of course, are the result of overload to failure in one single, slowly applied cycle of loading; while the fatigue failures result from thousands or millions of applications of significantly lower loads.

The fatigue fracture faces shown in Figure 7, also are typical of the failures that have occurred on actual structures in the field.
