MICHIGAN
STATE HIGHWAY DEPARTMENT
Charles M. Ziegler
State Highway Commissioner

CONCRETE PAVEMENT JOINT SAW-CUTTING
AND SEALING EXPERIMENT US-27

Construction Project F19-41, 06 F-68(9)

Research Laboratory
Testing and Research Division
Report No. 175
April 9, 1952

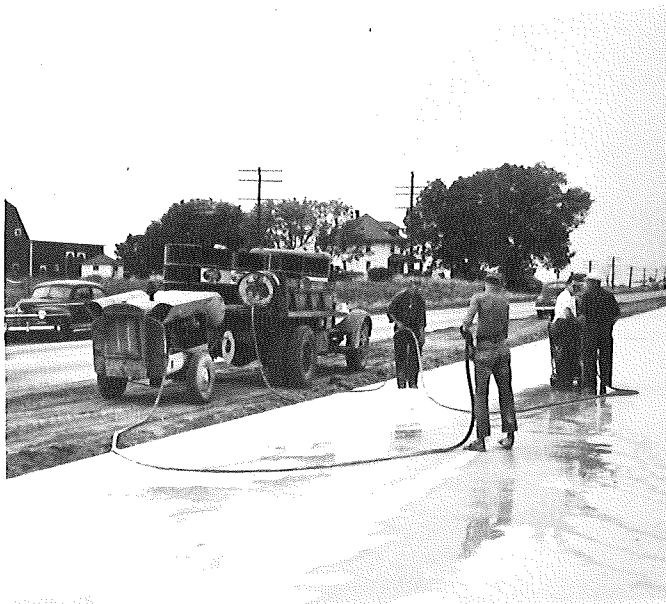
FIGURE 3. OPERATION OF CUTTING LONGITUDINAL CENTER JOINT. NOTE WATER & AIR SUPPLY LINES.

All sawed joints were cut on August 14th to 17th, inclusive, using a Clipper Model C-130 concrete cutting saw furnished by the Clipper Manufacturing Company, 2800 Warwick, Kansas City 8, Missouri. Sawing was done by personnel from the Clipper Company, supervised by Mr. E. W. Perkins. Total length of center cut was 3,760 lineal feet, average depth 2 inches, average width $5/32$ inch. Average cutting speed was 48.6 inches per minute. A total of 4 saw blades were used but one of these was a replacement blade and is not included in figuring costs. Slurry from the cutting operation was flushed out with air.

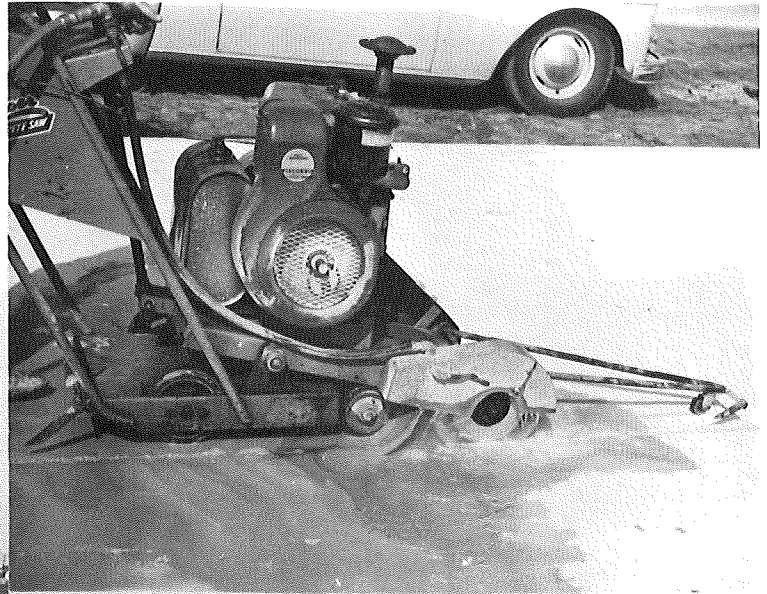
FIGURE 2. CLIPPER SAW, MODEL C-130, USED FOR CUTTING LONGITUDINAL CENTER JOINT.

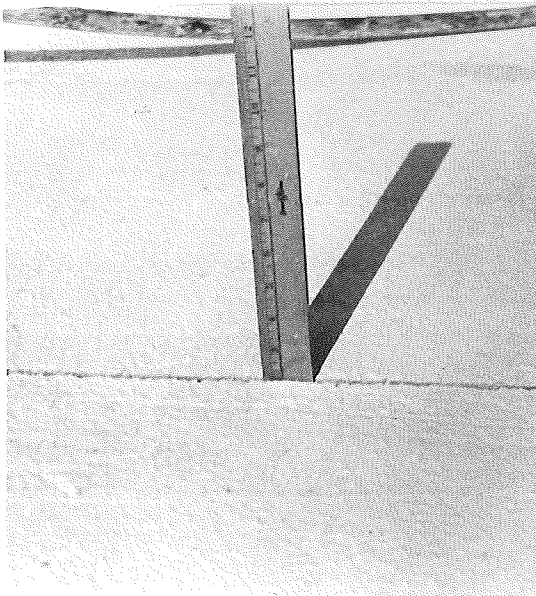
FIGURE 4. SHOWS DEPTH OF SAWCUT IN CENTER JOINT.

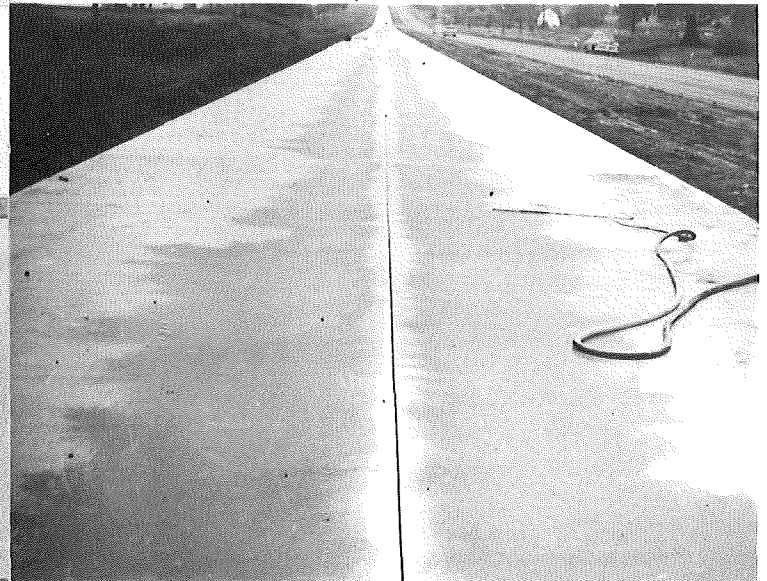
FIGURE 5. SHOWS LONGITUDINAL CENTER JOINT AFTER CUT HAS BEEN MADE, BUT PRIOR TO SEALING.

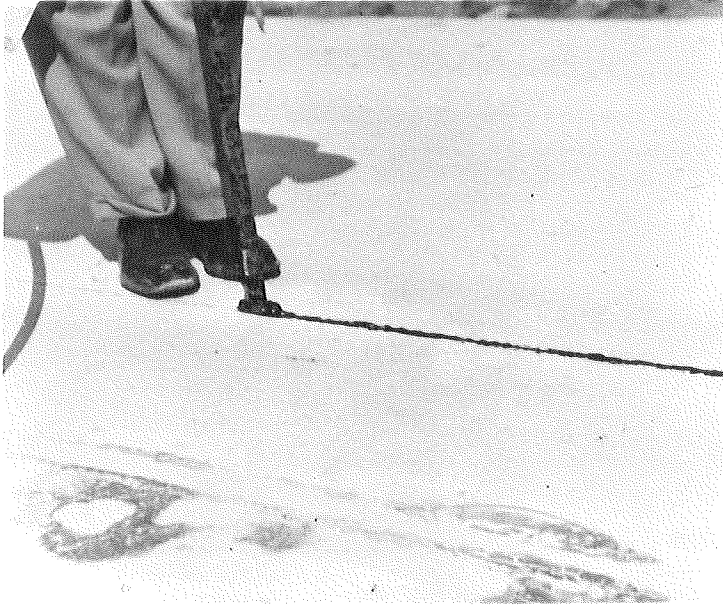
FIGURE 7. APPLICATION OF PRESSTITE NO. 77 TO CENTER JOINT.

Sealing of the longitudinal saw-cut center joint followed the cutting operation as soon as possible. Sealing was done with a solvent type cold-applied joint sealer No. 77, supplied by the Presstite Engineering Company, St. Louis, Missouri. This material was pumped directly into the joint by means of a special nozzle connected to a long, high-pressure hose. The hose was connected to a pump which was attached to a 55-gallon drum containing the material. Pump and accessories were furnished by Pyles Industries, Inc., 8926 Second Avenue, Detroit 2, Michigan. Sealing was done by personnel from the Presstite Company under the supervision of Mr. R. B. Shofstall, and included the dates August 16th to 18th. The center cut was blown out with air immediately prior to sealing.

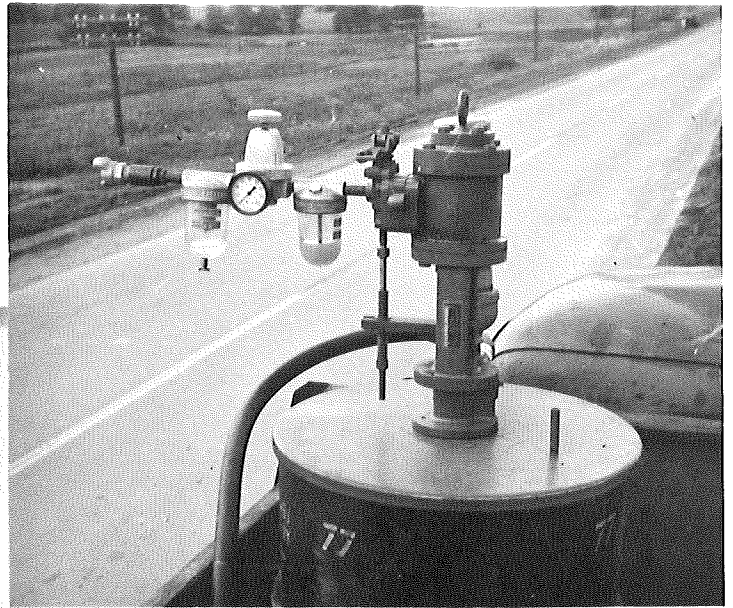
FIGURE 6. PUMPING EQUIPMENT FOR APPLICATION OF PRESSTITE NO. 77.

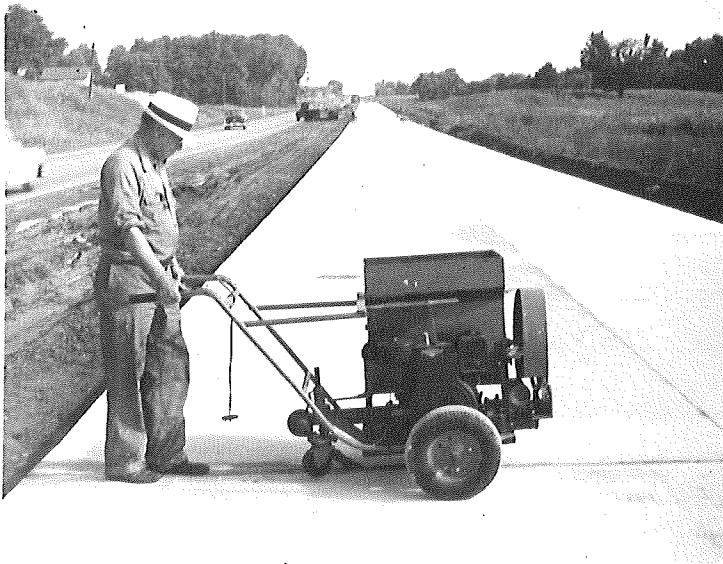
FIGURE 8. PRESSTITE ENAMELITE MACHINE FOR APPLICATION OF PRESSTITE NO. 88 TO CONTRACTION JOINTS.

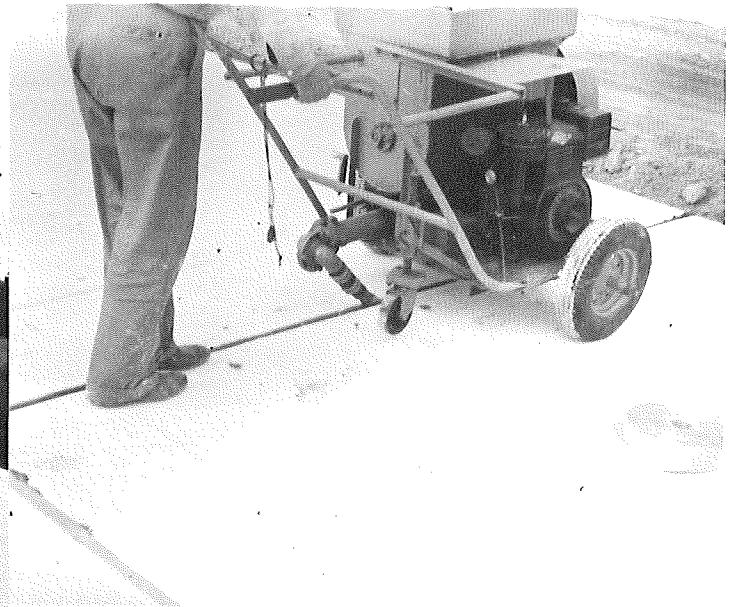
FIGURE 9. PRESSTITE ENAMELITE MACHINE FOR APPLICATION OF PRESSTITE NO. 88 TO CONTRACTION JOINTS.

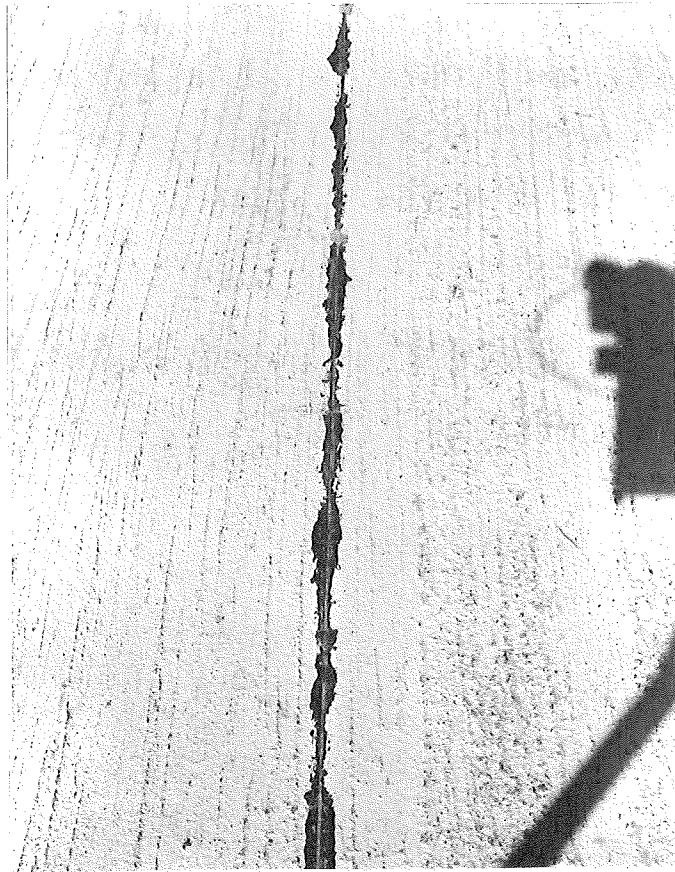
Figure 10. Condition typical of sawed center joint after five months.

Inspection at an age of 5 months showed that the center joint was in excellent condition. There was no evidence of cracking, of loss of material by seepage, of extrusion, or of spalling of the concrete adjacent to the joint. This project will be kept under continuous observation by Research Laboratory personnel, and its condition will be recorded at suitable intervals.
