A STUDY OF PAVEMENT DEFLECTIONS ON FAULTED AND
CRACKED PAVEMENT SLABS ON US-24A, SOUTH OF ERIE

Highway Research Project 53F-31

Research Laboratory
Testing & Research Division
Report No. 223
February 15, 1955

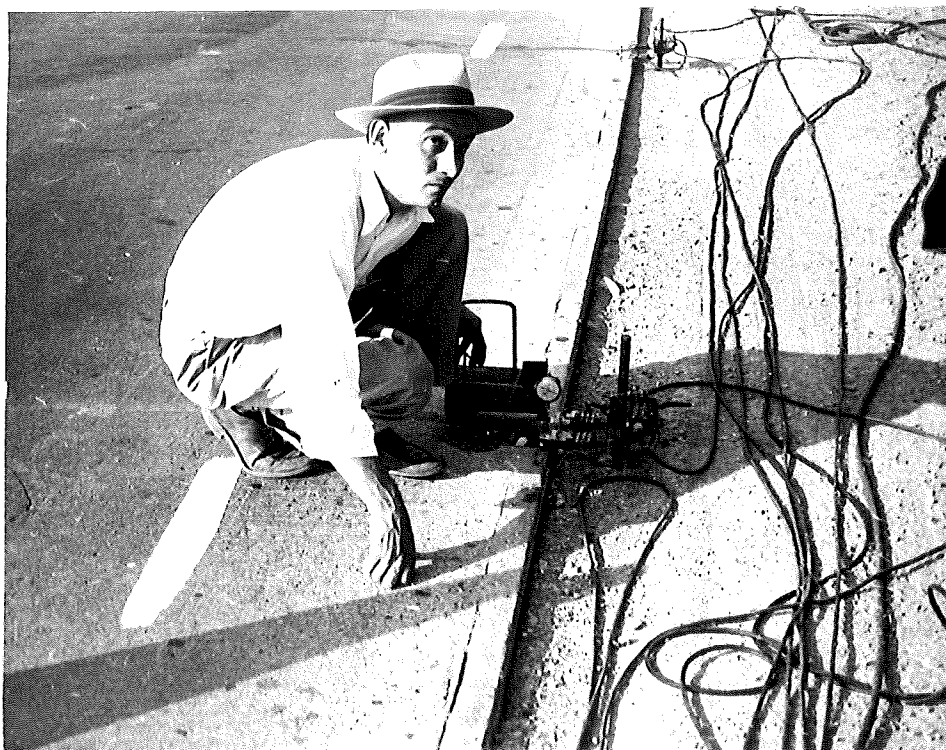
FIGURE 3. CALIBRATION OF DEFLECTOMETERS IN THE FIELD BY A MECHANICAL CALIBRATOR CONSTRUCTED BY THE LABORATORY.

Wire resistance strain gage deflectometers (see Figure 2) were used to obtain the movement of the pavement edge under the truck loads. These deflectometers were electrically connected to a twelve-channel Hathaway recording oscillograph which produced a photographic trace as a permanent record of the pavement deflection. The deflectometers were calibrated in the laboratory previous to field testing or mechanically in the field as shown in Figure 3. Thus the change in resistance of the strain gage could be related to the movement of the pavement which in turn led to a relation between the recorded trace deflection and the pavement deflection.

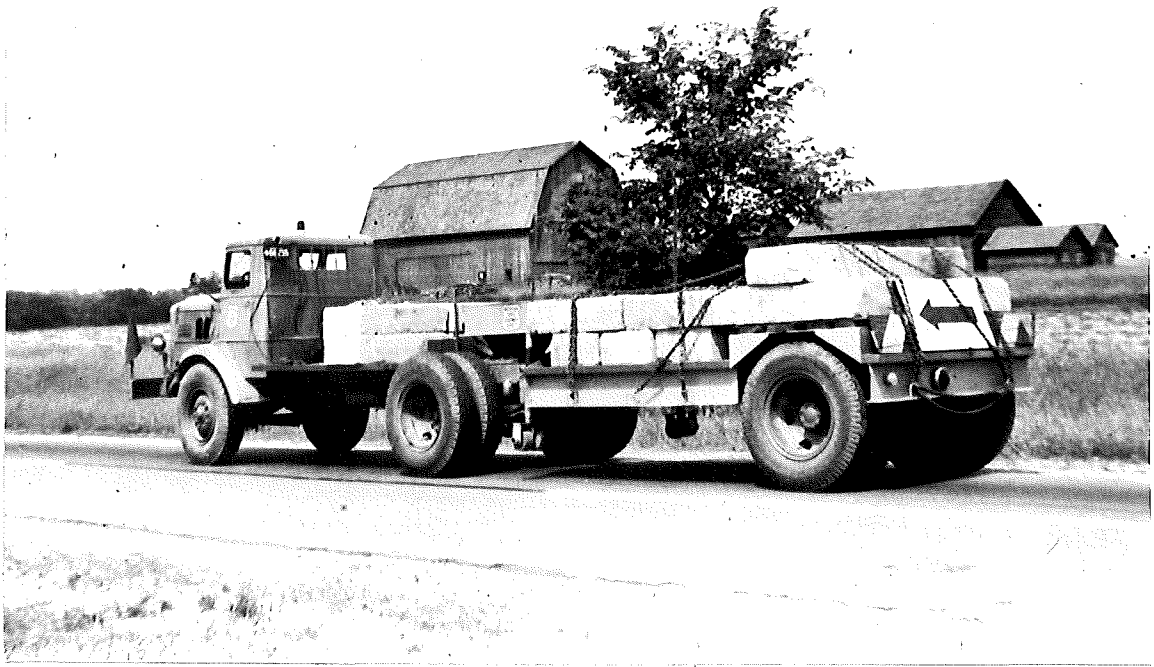
FIGURE 4. PHOTOGRAPH AND LOADING DIAGRAM OF WALTERS TEST TRUCK.

The Walters test truck was loaded in such a manner as to give as nearly as possible 18,000 pounds on the tractor drive axle and 22,000 pounds on the trailer axle. A photograph and a loading diagram for the truck are shown in Figure 4. The truck was driven along a painted guide stripe which positioned the outside edge of the tire contact area for the load axles at one foot from the pavement edge. Deflections were
