Investigation of Breakaway Light Standards

**Testing and Research Section
Construction and Technology Support Area
Research Project TI-2047
Research Report R-1474**

April 2006

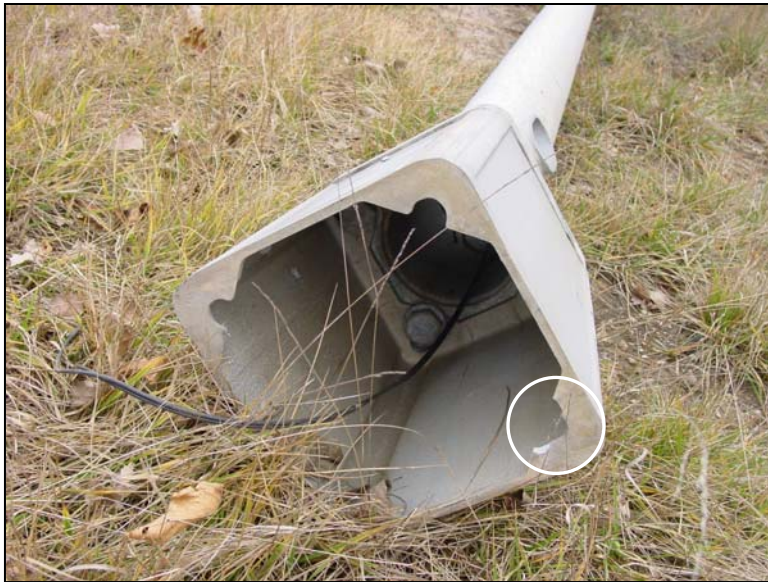
Between the period of November 24, 2004 and December 9, 2004, MDOT staff began investigating the cause of the failure and inspected other breakaway light standards along the US-131 highway corridor in the immediate 5-mile vicinity of the toppled breakaway light standard. Breakaway light standards are composed of a pole, arm, breakaway transformer base, and foundation. A breakaway transformer base is made of cast aluminum, and has tabs on the bottom for mounting to the foundation, and on the top for installation of the pole. The breakaway light standard that fell was bolted to a steel screw-in foundation (a steel auger-type casing with a base plate attached to the top). It was noted that the breakaway transformer base was relatively intact except for a broken tab on the lower right corner and a scratch on one face. See Figure 1. This photograph was taken after the breakaway light standard was moved to the shoulder area.

Figure 1. Toppled breakaway light standard that struck traffic

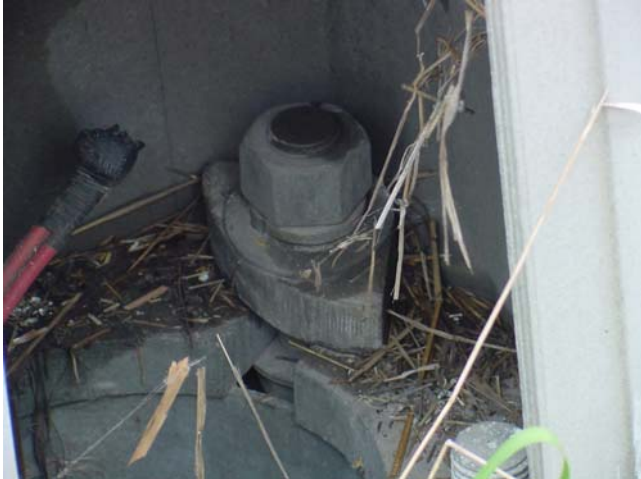
Another steel screw-in foundation was located along the same corridor. It appeared intact, with large wedge shaped anchor clips used to secure the breakaway transformer base to the foundation. See Figure 2. Note the presence of a lock washer under the nut, on top of the wedge anchor clip.

Figure 2. Steel screw-in foundation in the vicinity along US-131

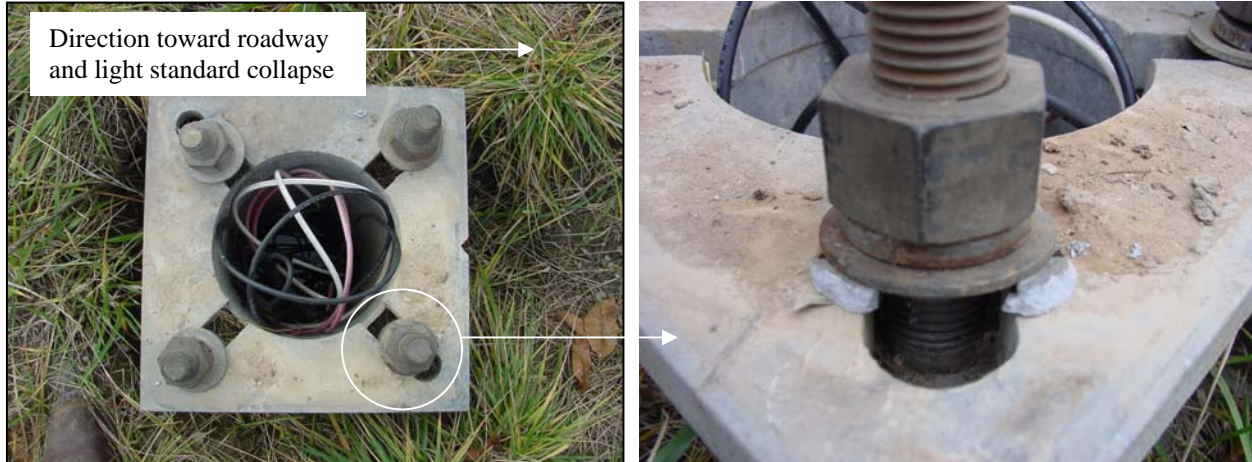
The foundations on other breakaway light standards in the immediate vicinity on US-131 were of the concrete cast-in-place type. Other breakaway light standards in the area were noted to be in varied condition, and one appeared to have been struck by a vehicle recently. The anchor bolts for the fallen breakaway light standard were still attached to the steel base plate, and were able to slide along the slotted opening, except for the one corner bolt that retained the broken breakaway transformer piece (wedged under the washer). See Figure 3.

Figure 3. Steel screw-in foundation is shown on left and a close up of the broken breakaway transformer base tab on the right. Note the slot openings in the base plate of the steel screw-in foundation.

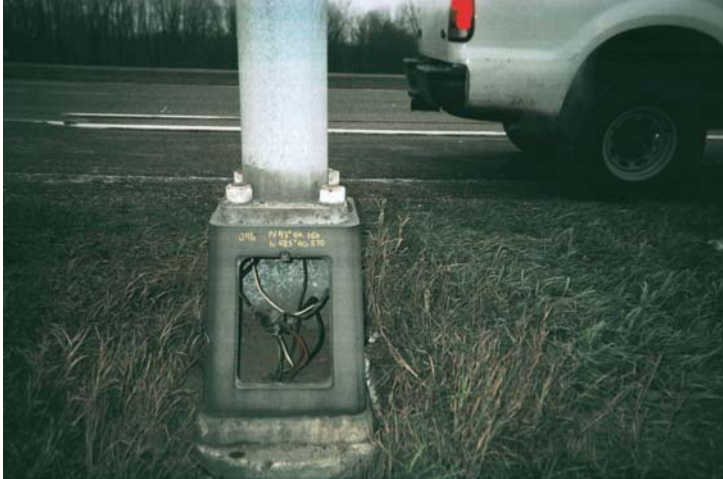
Figure 5. Missing access door.

Defect Type	Cause for corrective action
Access panel door broken or missing	Replacement of access panel is required to prevent access to electrical lines and to minimize environmental exposure.
Dig out and regrade foreslope	Removing soil around foundation minimizes exposure to harsh soil conditions, and allows proper inspection.
Light standard knocked down by vehicle	Replacement of the breakaway light standard is required to maintain effective lighting.
Loose, improper or missing connections (arm, washer, nut, etc)	Proper connections are required for the breakaway light standard to achieve full design capacity.
Place on new foundation	The original foundation is damaged, improperly sized, or irregular.
Remove leveling nuts and lower structure	Breakaway performance of the transformer base is dependant on mounting the transformer base flush to the concrete foundation.
Replace breakaway base	The breakaway transformer base is damaged from impact and remains in service, but for safety reasons must be replaced.

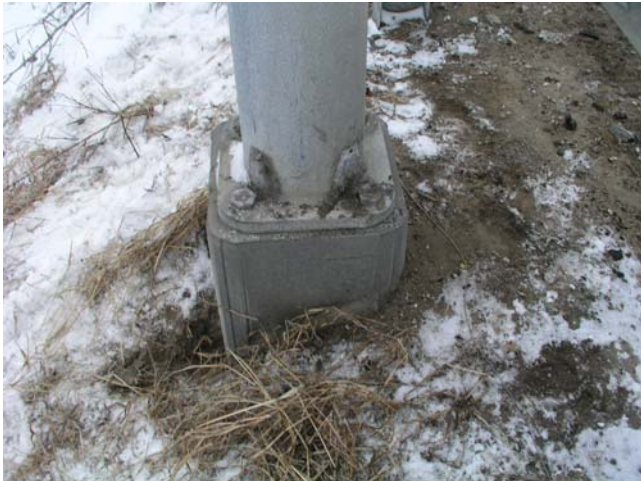
Figure 6. Dig out and regrade slope.

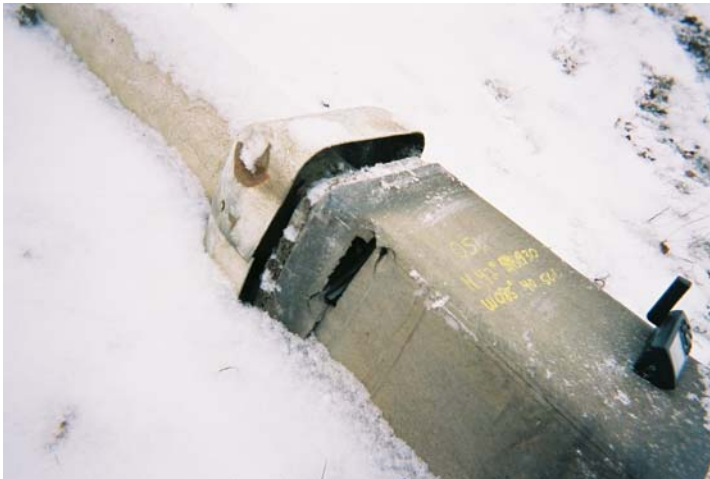
Figure 7. Breakaway light standard struck by vehicle.

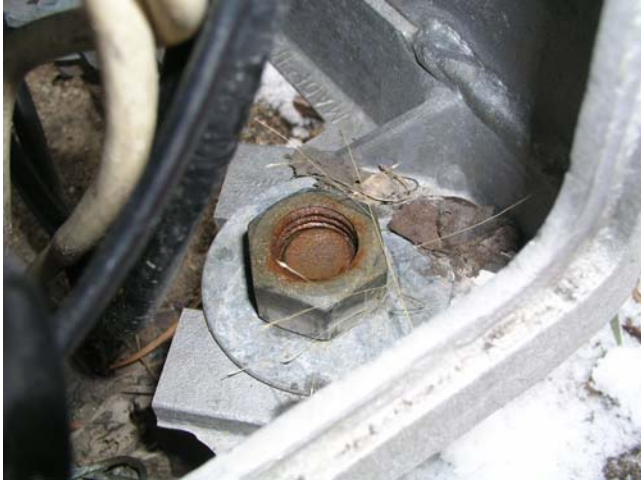
Figure 8. Incomplete nut engagement to the anchor bolt.

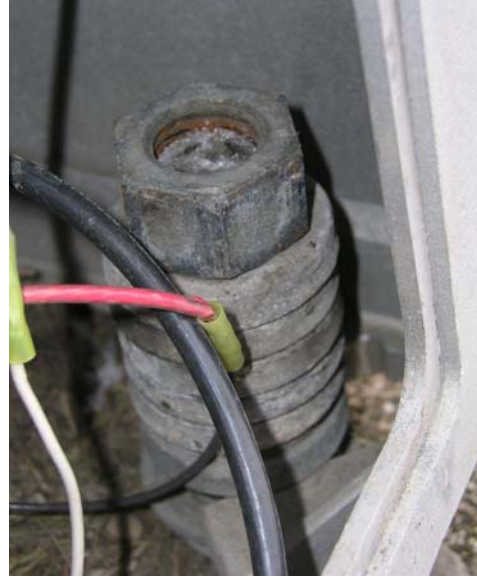
Figure 9. Stacked washers and incomplete nut engagement to the anchor bolt.

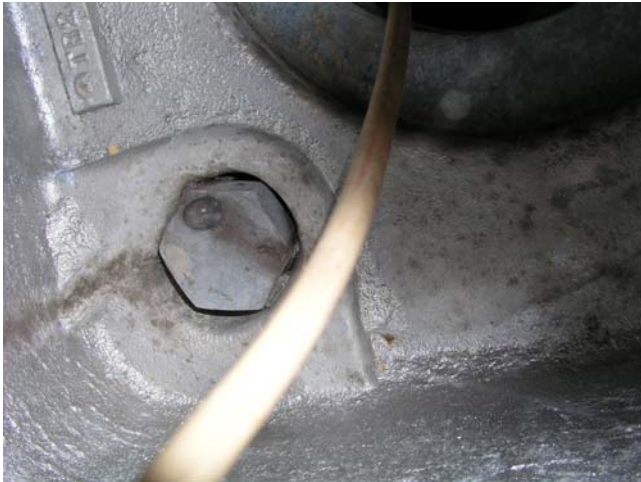
Figure 10. Replacement of top bolt assembly required due to missing washers.

Replace top bolt assemblies	The bolt assemblies connecting the breakaway transformer base to the pole are damaged or incomplete. Proper connections are required for the breakaway light standard to achieve full design capacity.

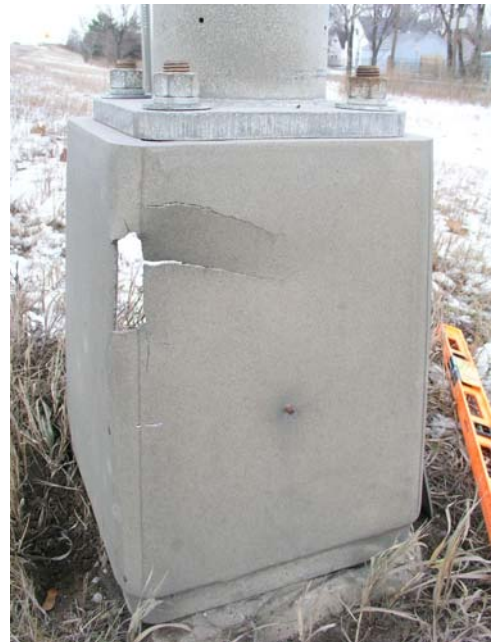
Figure 11. Damaged breakaway transformer base.

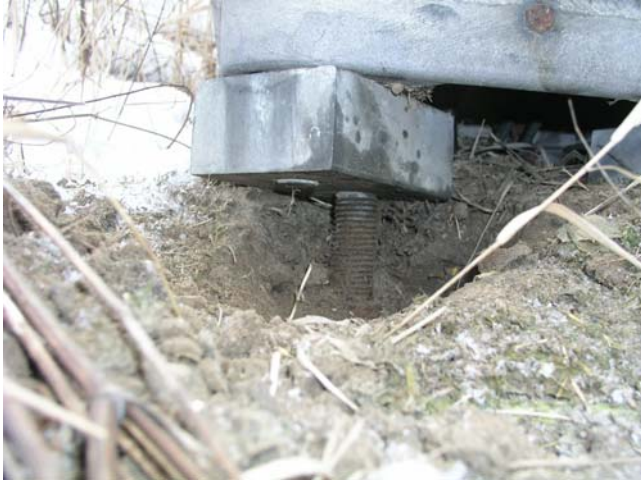
Figure 12. Place on new foundation.

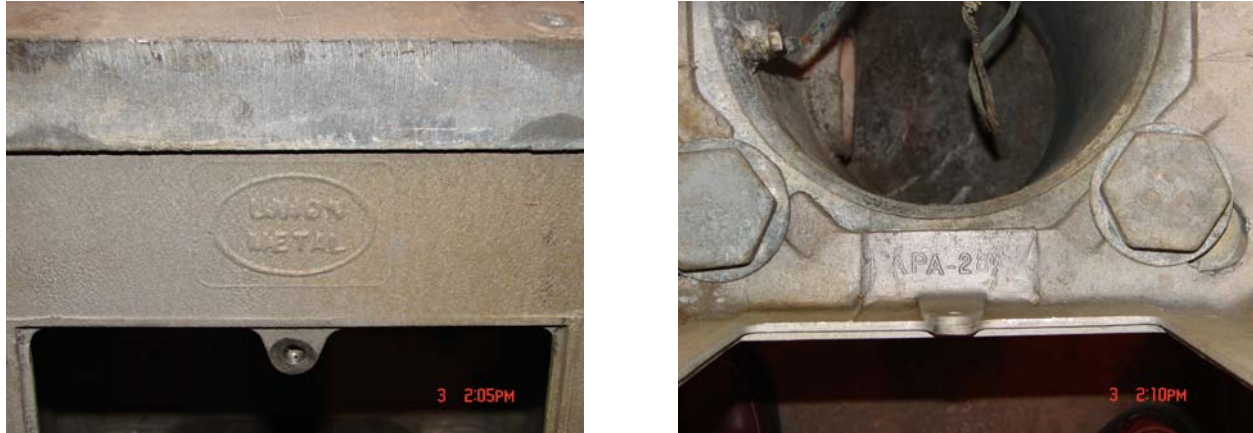
While breakaway light standards needing removal were identified as the inspection reports came in weekly, and the remaining action items sorted by priority, a concurrent task in the investigation of the breakaway light standard collapse on US-131 involved examination of the steel screw-in foundation and the breakaway transformer base. The purpose was to determine whether the breakaway light standard retrofit in 2002 was with hardware approved by the Federal Highway Administration (FHWA). The Union Metal A2852 breakaway transformer base was identified by the logo and die stamp APA 2852 on the base. See Figures 13 and 14.

Figure 15. Die stamp APA 2852. The 52 is not legible due to die stamp imperfection.

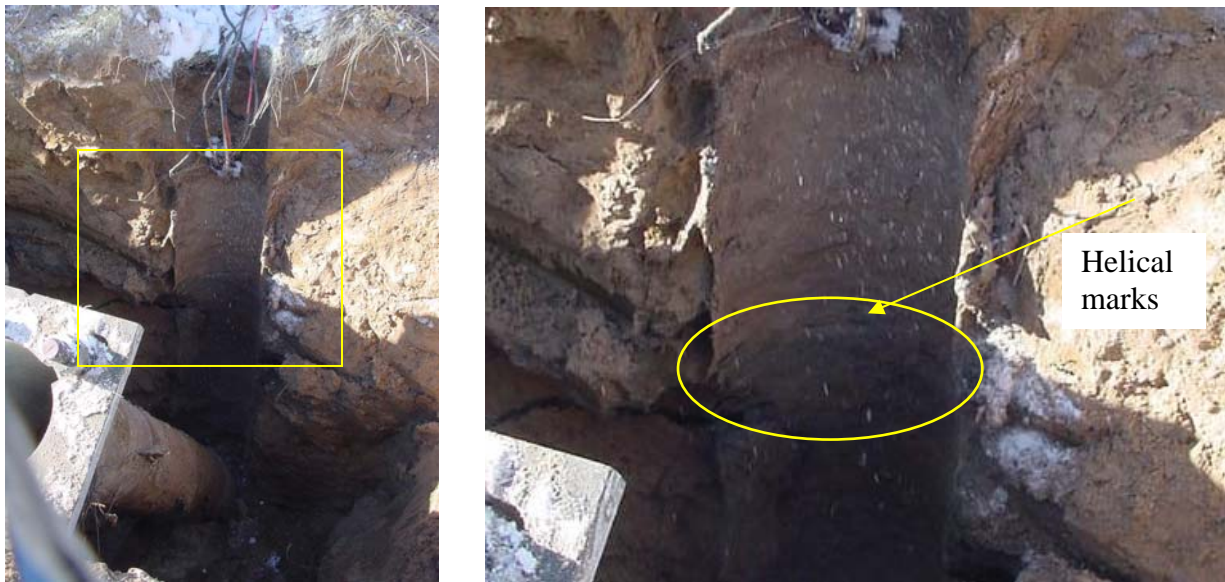
On January 21, 2005, the steel screw-in foundation (7-ft long, 10-in diameter, single helix) at the fallen breakaway light standard location on southbound US-131 was removed and salvaged by MDOT personnel. The soil subsidence around the foundation was measured, as well as soil samples taken at 1 ft depth intervals at foundation location and at 3 ft distance away from the steel screw-in foundation. The purpose was to verify the installation method of the steel screw-in foundation, whether torque and thrust or preboring was used. Torque and thrust method uses the steel screw-in foundation as an auger to drill into the ground, and the steel screw-in foundation is left in place. Preboring involves simply drilling an oversized hole, placing the foundation, and backfilling. The torque and thrust installation is required by the manufacturer to

develop full structural capacity through interaction between the soil and the steel screw-in foundation. Local soil conditions, however, determine the ultimate capacity.

The ground immediately around the steel screw-in foundation measured 12 in below the top of the steel plate, and 1.5 ft away the ground measured 5 in below the top of plate. The difference in elevation of 7 in indicated some subsidence or possibly soil erosion around the foundation, as it was located on the fore slope. The interior of the steel shaft was observed to have soil present at an average depth of 43 in as measured from the top, indicating torque and thrust installation. Water was present inside the shaft at the auger. The ground was frozen 5 to 6 in up from the shaft end. No voids in the soil around the steel shaft were observed during removal operations, and helical marks were present in the soil (arrow) indicating rotation of the auger. These factors indicate torque and thrust was used for installation of the steel screw-in foundation. See Figure 16.

Figure 16. Steel screw-in foundation removal. The picture on the right is a close-up of the inset rectangle in the left photo.

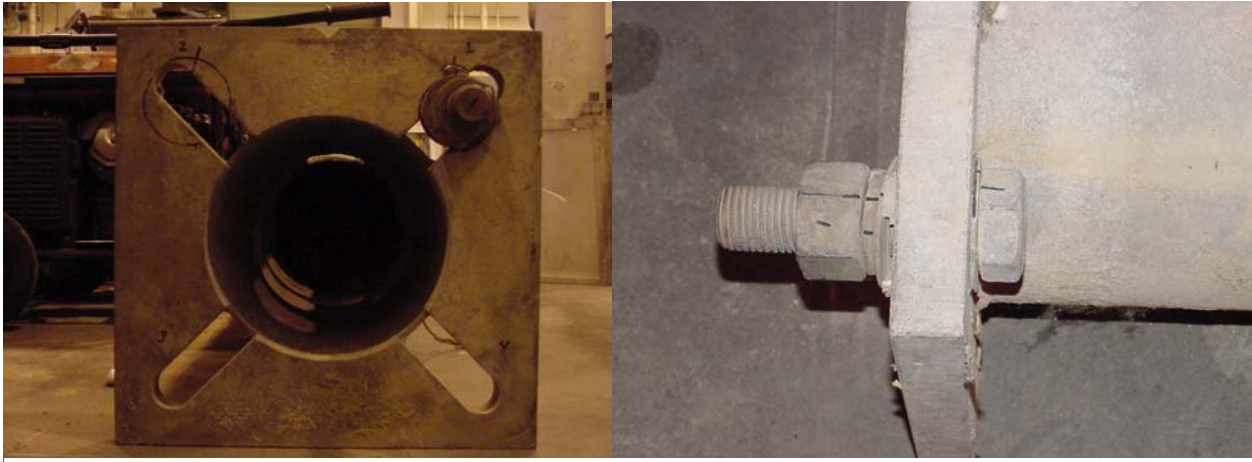
The steel screw-in foundation was examined visually. The steel screw-in foundation consists of a 7-ft long, 10-in diameter, 1/4 in thick steel tube with a single helix auger tip, and the top surface is a 17 1/2 in x 17 1/2 in x 1 1/2 in thick steel base plate. The predominant characteristic noted on the base plate itself was the existence of slotted holes to accommodate variation in bolt circle sizes.

The ASTM A325, 1½ in diameter, 7-in length anchor bolts are mounted from the bottom of the steel plate and secured by the mounting nut for the breakaway transformer base. See Figure 18.

Figure 18. Steel screw-in foundation. Note the open slots used to accommodate variable bolt circle sizes.

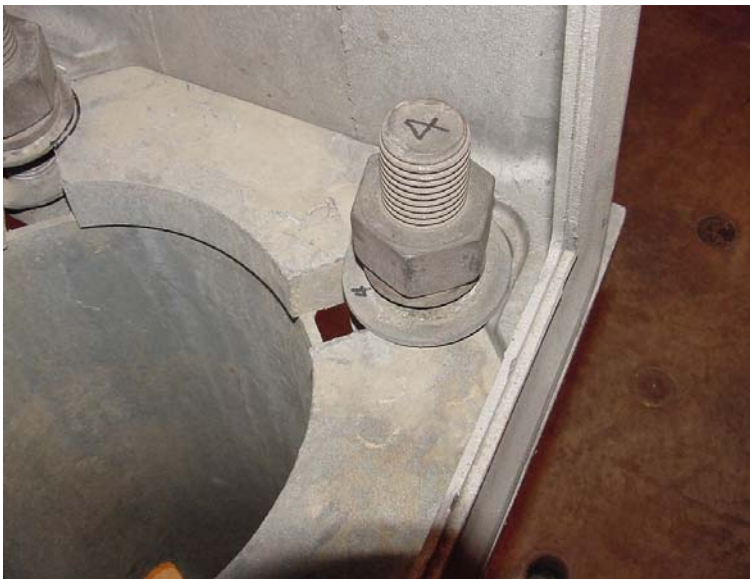
When the breakaway transformer base is mounted to the steel screw-in foundation, and prior to tightening the mounting nuts, the anchor bolt assembly is free to move along the gap in the slot from the breakaway transformer base tab to the outside edge of the steel screw-in foundation tube. When assembled, the washer contacts only a portion of the breakaway transformer base tab, a ½ in gap is present along the steel screw-in foundation slot, and the washer is sloped greater than 6° (presence of gap between washer and lock washer). See Figure 19.

Figure 19. Reassembled Union Metal A2852 breakaway transformer base and Aluma-Form steel screw-in foundation assembly.

When the breakaway light standard is subject to wind loading and vortex shedding (resonant oscillations of the breakaway light standard in a plane normal to the direction of wind flow), movement could occur over time to work the anchor bolt washers loose, given the 6° angle, minimal engagement of the breakaway transformer base tabs, and existence of open slots on the steel screw-in foundation plate (for the variable bolt circle sizes). The remaining three intact tabs

Investigation into the breakaway light standard collapse on southbound US-131 revealed the following probable cause of failure. The slots to accommodate variable bolt circle sizes on the steel screw-in foundation allowed movement of the anchor bolts. The improper installation of a non-approved Union Metal A2852 breakaway transformer base, by not using the required anchor clips, resulted in minimal washer contact to the breakaway transformer base tabs. The sloped tab surface promoted freedom of movement from wind force and loosening of the foundation to breakaway transformer base connections on all but one bolt. Wind force was then sufficient to overcome the resistive force of one bolt connection and break the tab. As the wind that day was gusting from the west-southwest, blowing into oncoming traffic on southbound US-131, and the arm (weighing 100 lbs) was cantilevered out towards the roadway, the breakaway light standard collapsed in the general direction of the wind and roadway.
