MICHIGAN
STATE HIGHWAY DEPARTMENT

Subject: Chemical Analysis of Cover Plate Material from Bridges S09 and S10 of 82022 (I 94 over Ecorse Road). Research Project R-62 F-67. Report No. R-406.

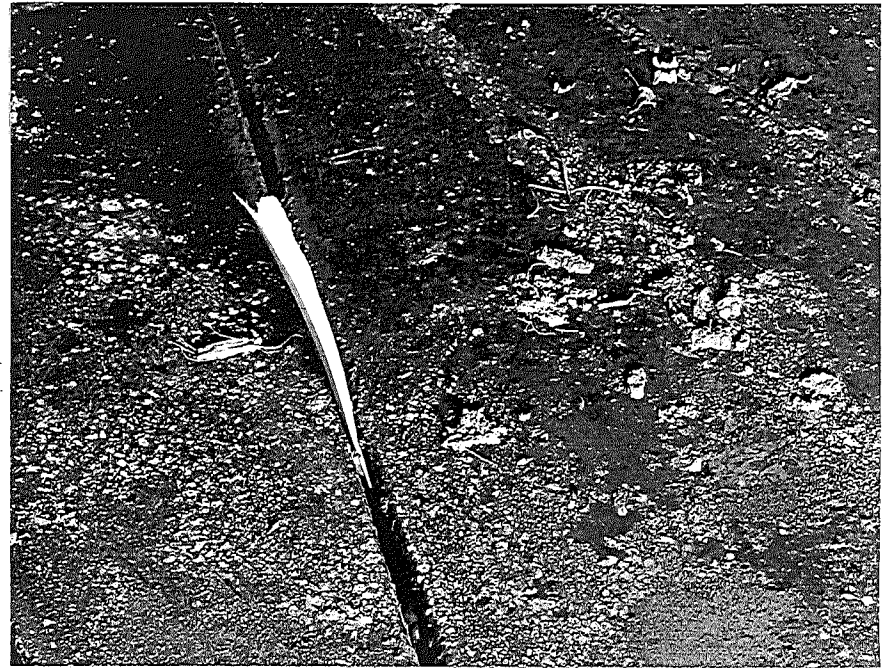
Figure 2 (above). Fabrication of cover plate from scraps. Folded paper shows depth of groove. Welded only on other surface.

Figs. 1 through 5 show samples of cover plate submitted to the Research Laboratory Division after removal from the bridges. The samples appear to have been assembled from scraps of various sizes and shapes. They were joined by extremely poor welds; and the surface ground off to hide the welds. Fig. 5 shows the plate removed from

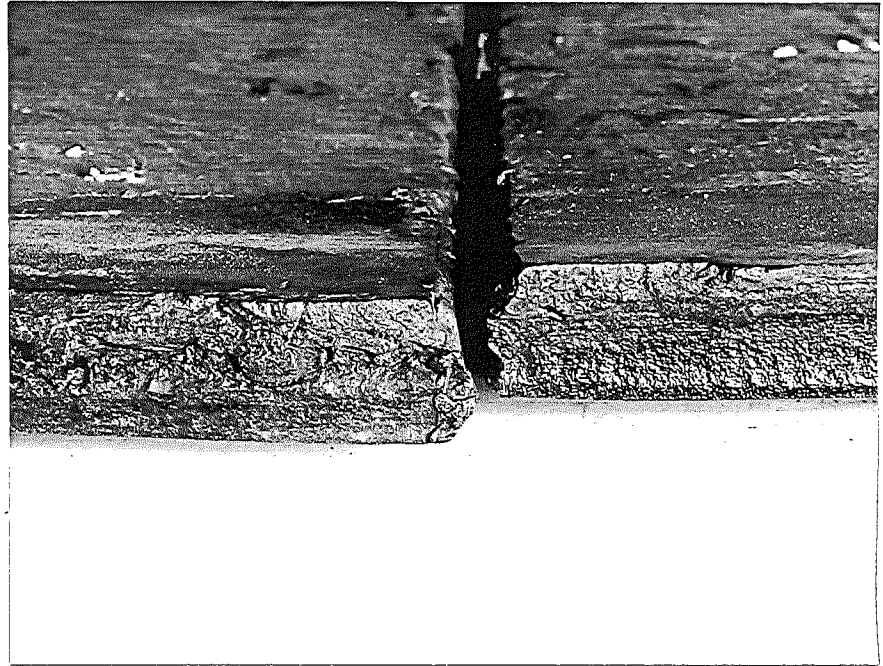
Beam F, Span 2, adjacent to the large fracture. There was evidently no fusion of the two plates. All that held the plates together was the weld metal, about 1/8 to 1/4 in. thick across the outside surface of the plate. The resulting discontinuity in the cover plate provided an extreme stress concentration in the flange at that point, which was the primary factor causing the flange to fracture and the crack to progress into the web.

The purpose of this discussion is to emphasize that the chemical makeup of the steel is not necessarily the primary influence in determining whether a brittle fracture will occur. Considering the nature of the welding which was done in the fabrication of these beams, the extreme stress concentration and the residual welding stresses can be regarded as the primary causes of the ensuing fracture.

Figure 5. Weld which caused large brittle fracture in bridge. Note weld only at upper surface.
