INSPECTION OF SIGN SUPPORT STRUCTURES

**Research Laboratory Section
Materials and Technology Division
Research Project 83 TI-955
Research Report No. R-1302**

**Michigan Transportation Commission
William Marshall, Chairman;
Rodger D. Young, Vice-Chairman;
Hannes Meyers, Jr., Stephen F. Adamini,
Shirley E. Zeller, Nansi I. Rowe
James P. Pitz, Director
Lansing, September 1989**

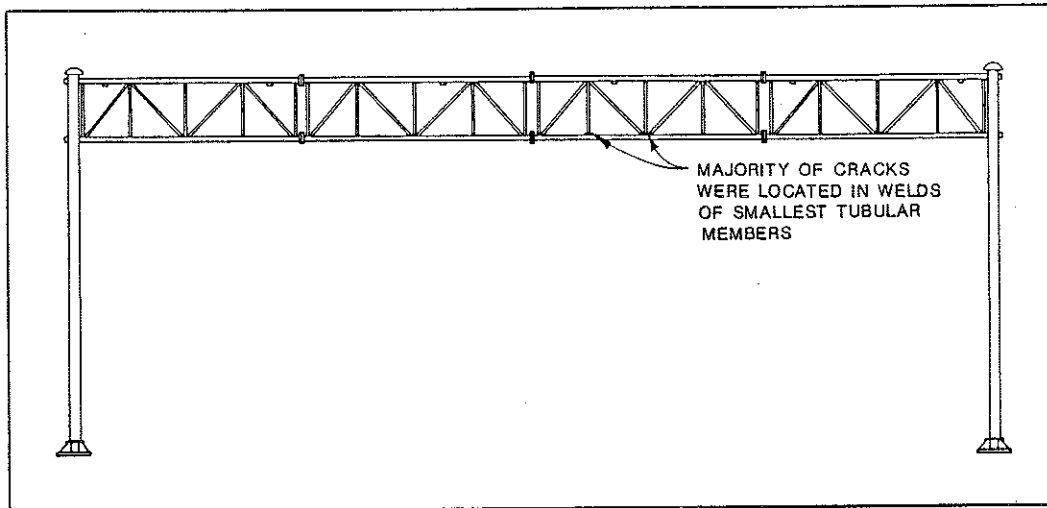
Figure 4. Typical overhead truss installation.

Cracking of welds and splitting of tubular truss members - Ninety-five percent of this cracking was located around the weld that connected the tubular truss members to the top and bottom chords. In some instances, the cracking in the weld led to the splitting of the tubular member, possibly due to water getting into the tube and freezing during the winter. This type of cracking and splitting of the tubular truss members was neither localized geographically, or by its position in the truss, nor dependent on the age of the structure (Fig. 4). Cracks in the welds and splits in the tubes were observed on trusses installed as little as a year ago. Several possibilities exist such as inadequate weld penetration and stresses due to shrinkage during weld cooling, but we believe that the majority of these weld cracks were caused during the transportation and erection process. While erecting the trusses the construction crews often have a tendency to force the flanges of misaligned trusses into full contact by overtightening the connection bolts rather than shimming between the flanges. This practice may lead to the overstressing of individual members causing the development of random cracks.

After examining current fabrication procedures with several MDOT inspectors, we have found that shops that fabricate trusses for the State of Michigan have already solved this problem. Flanges are bolted together, the trusses aligned, and the flanges are then welded to the tubular truss members. This prevents any misalignment from occurring.

These procedures should prevent most misalignment problems in the future, though there might be a problem if the structure has been hit and damaged truss members are replaced. Here, careful use of already existing procedures will assure a proper fit.
