PARCLO TERMINAL STUDY

Evaluation of driver errors and turning movements

TSD-G-110-69

#### I-196 at Coloma Road Hagar Township, Berrien County

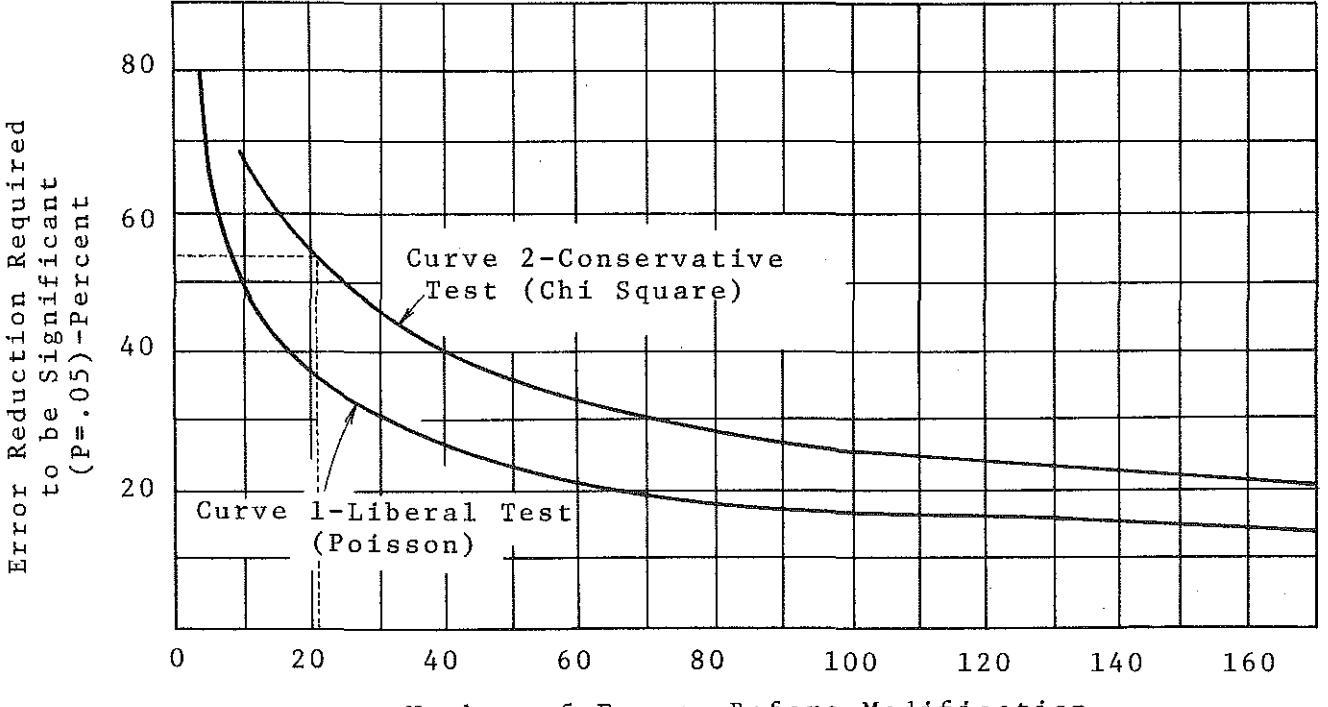
Number of Errors Before Modification

With 21 errors before reconstruction, the conservative test (curve 2) requires an improvement of approximately 54% to be significant. Therefore, with an 81% reduction of errors after reconstruction, the improvement is definitely significant.
