RESTORATION AND PREVENTIVE MAINTENANCE OF CONCRETE PAVEMENTS

J. E. Simonsen A. W. Price

Research Laboratory Section Materials and Technology Division Research Project 79 G-245 Research Report R-1267

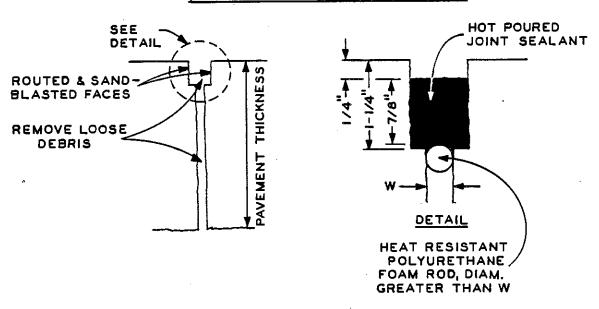
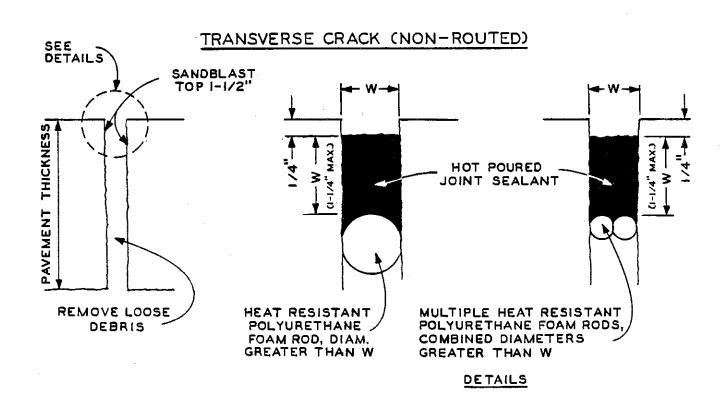
TRANSVERSE CRACK (ROUTED)

Special Details for Sealing Transverse Open Cracks With Hot Poured Joint Sealant

Sealing transverse cracks - Cracks selected for sealing are routed to a width of 1 in. and to a depth of 1-1/4 in. Cracks open more than 1 in. do not need routing. Spalls along the cracks are repaired using "Set 45." The crack is formed through the spall repair area using flexible form material which follows the curvature of the crack. The routed groove is sandblasted followed by cleaning with oil-free compressed air. For cracks wider than 1/4 in. a polyurethane backer rod is inserted into the crack below the routed groove to form a reservoir for a hot-poured sealant.
