APPENDIX A

JACK PARKER'S INTERIM REPORT DECEMBER, 2002

1. **PURPOSE OF THIS REPORT:** This is a response to a request by Michigan Dept of Transportation to evaluate the effects that an old gypsum mine beneath I-196 might have on the stability of that highway - in both near and long terms.

APPENDIX B
UPDATED
KENT COUNTY GEOLOGIC
STABILITY STUDY FOR THE
JOHN BALL ZOOLOGICAL
GARDEN EXPANSION WEST OF
I-196

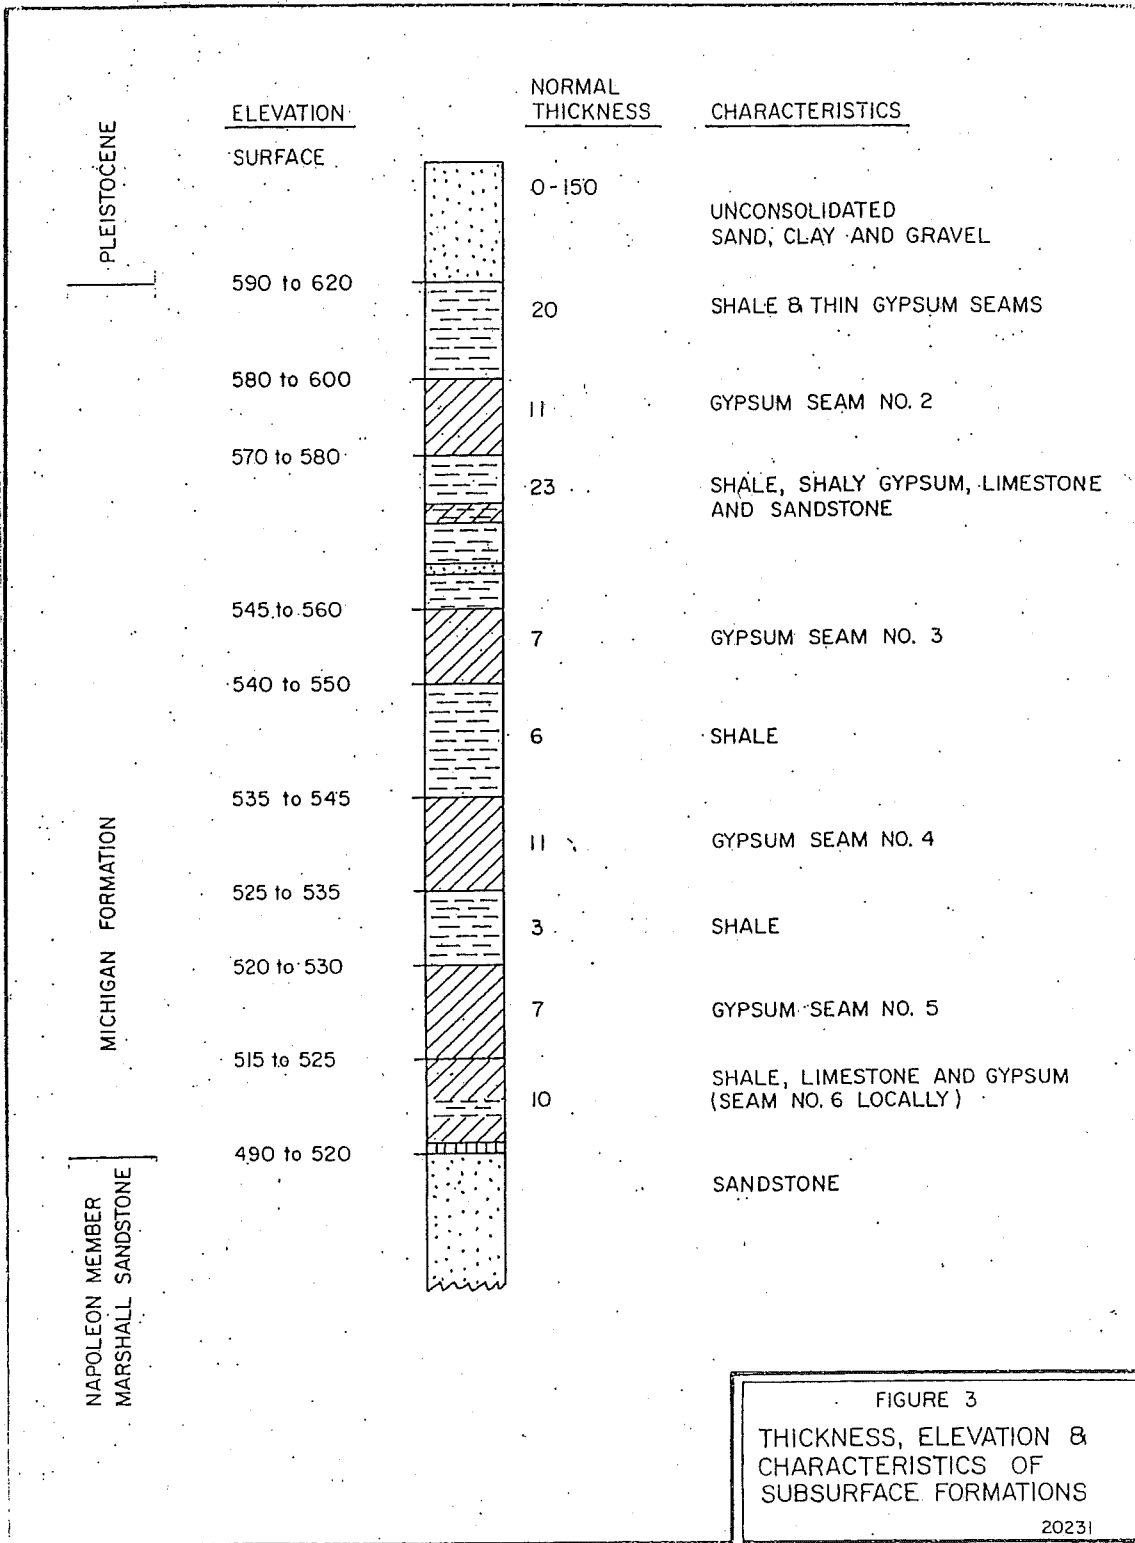
Figure 2 Thickness, elevation and characteristics of the subsurface formations at the Domtar Mine.

- Feature 2: There are six gypsum layers associated with the mine with the upper layer identified as # 1 down to lowest layer # 6. Figure 2 does not show the # 1 seam, but labels it as shale and thin gypsum seams, with the remaining seams numbered.

- Feature 4: The bedrock between the unconsolidated overburden and the #2 seam forms the roof rock over the #2 seam. As shown in Figure 2, the average thickness of the roof rock is about 20 feet. However, five drill holes from a 1963 drilling program indicate that the roof rock thickness varies from a high of 35 feet in the north to seven feet at the northeast corner of the mine. Mine maps show that in the southern part of the mine the roof rock was very thin to absent, which precluded mining the #2 seam in portions of the south. A major sinkhole in the southern part of the mine can be correlated with the absence of the roof rock over the #2 seam. There was an additional drilling program in 1966, but this data was not available for inspection. In general, the roof rock tends to be thicker in the north center portion of the mine while thinning to the east, west and south. The primary control on the thickness of the roof rock is the amount of erosion that occurred during the advance and retreat of the glaciers and the action of the Grand River. The stability of the roof of the #2 seam is an important factor in the formation of sinkholes.

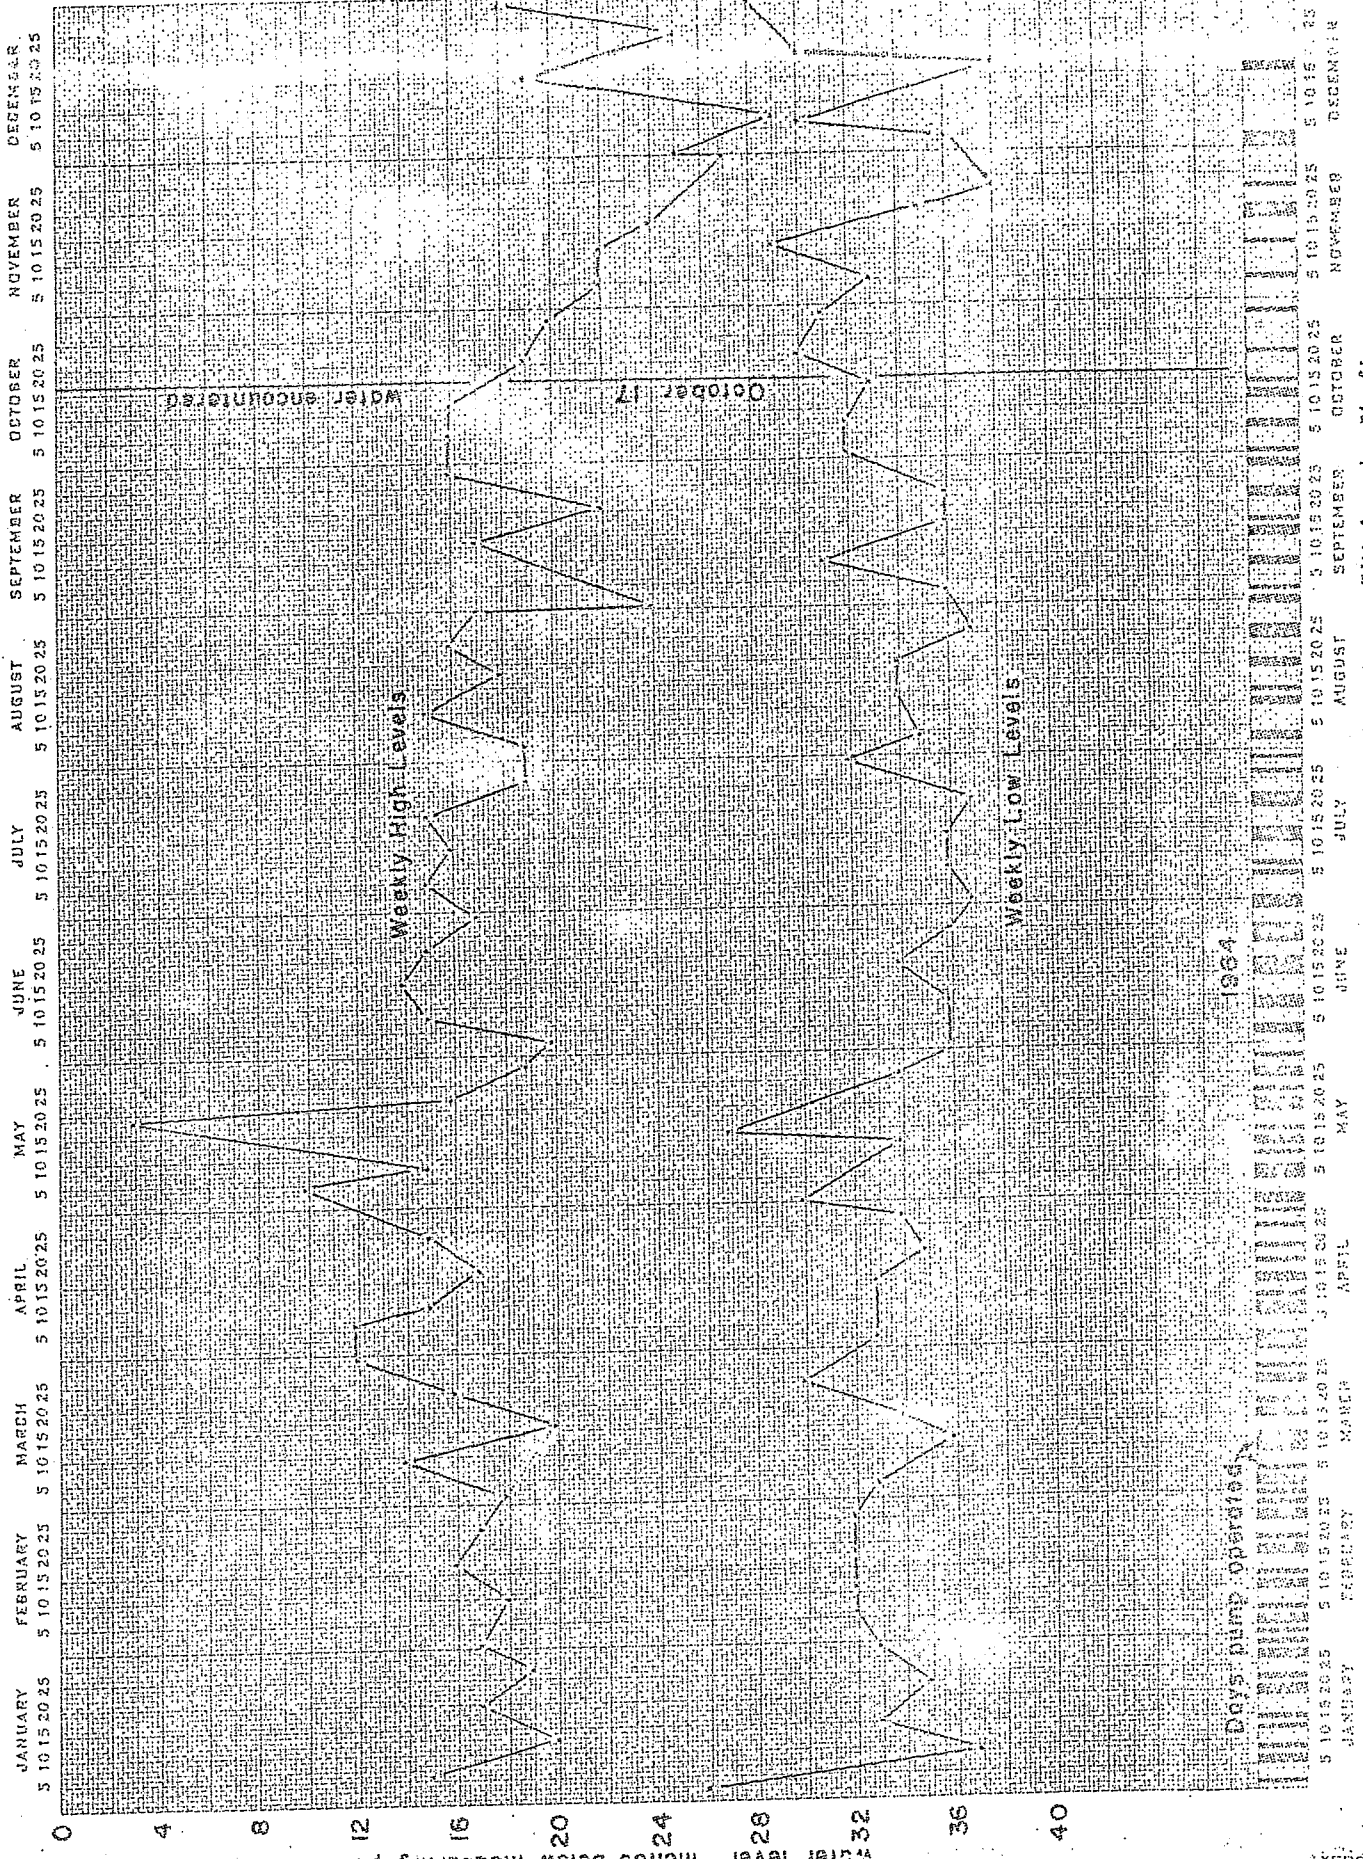
Figure 2 is a graph summarizing the weekly high and low water levels measured in the Pittsburgh shaft and the days the dewatering pump(s) were in operation. It is very apparent that the water encounter of October 17 represented an "interception" of water which previously found its way into the Pittsburgh shaft. The rapidity of the effect on the Pittsburgh shaft supports the theory that a solution channel was intercepted. Most recently, I understand the amount of water entering the mine has been decreasing, necessitating throttling of the pump in the mine. Though the exact cause of this cannot be identified, one or more of the following causes may be responsible for the diminishing flow.

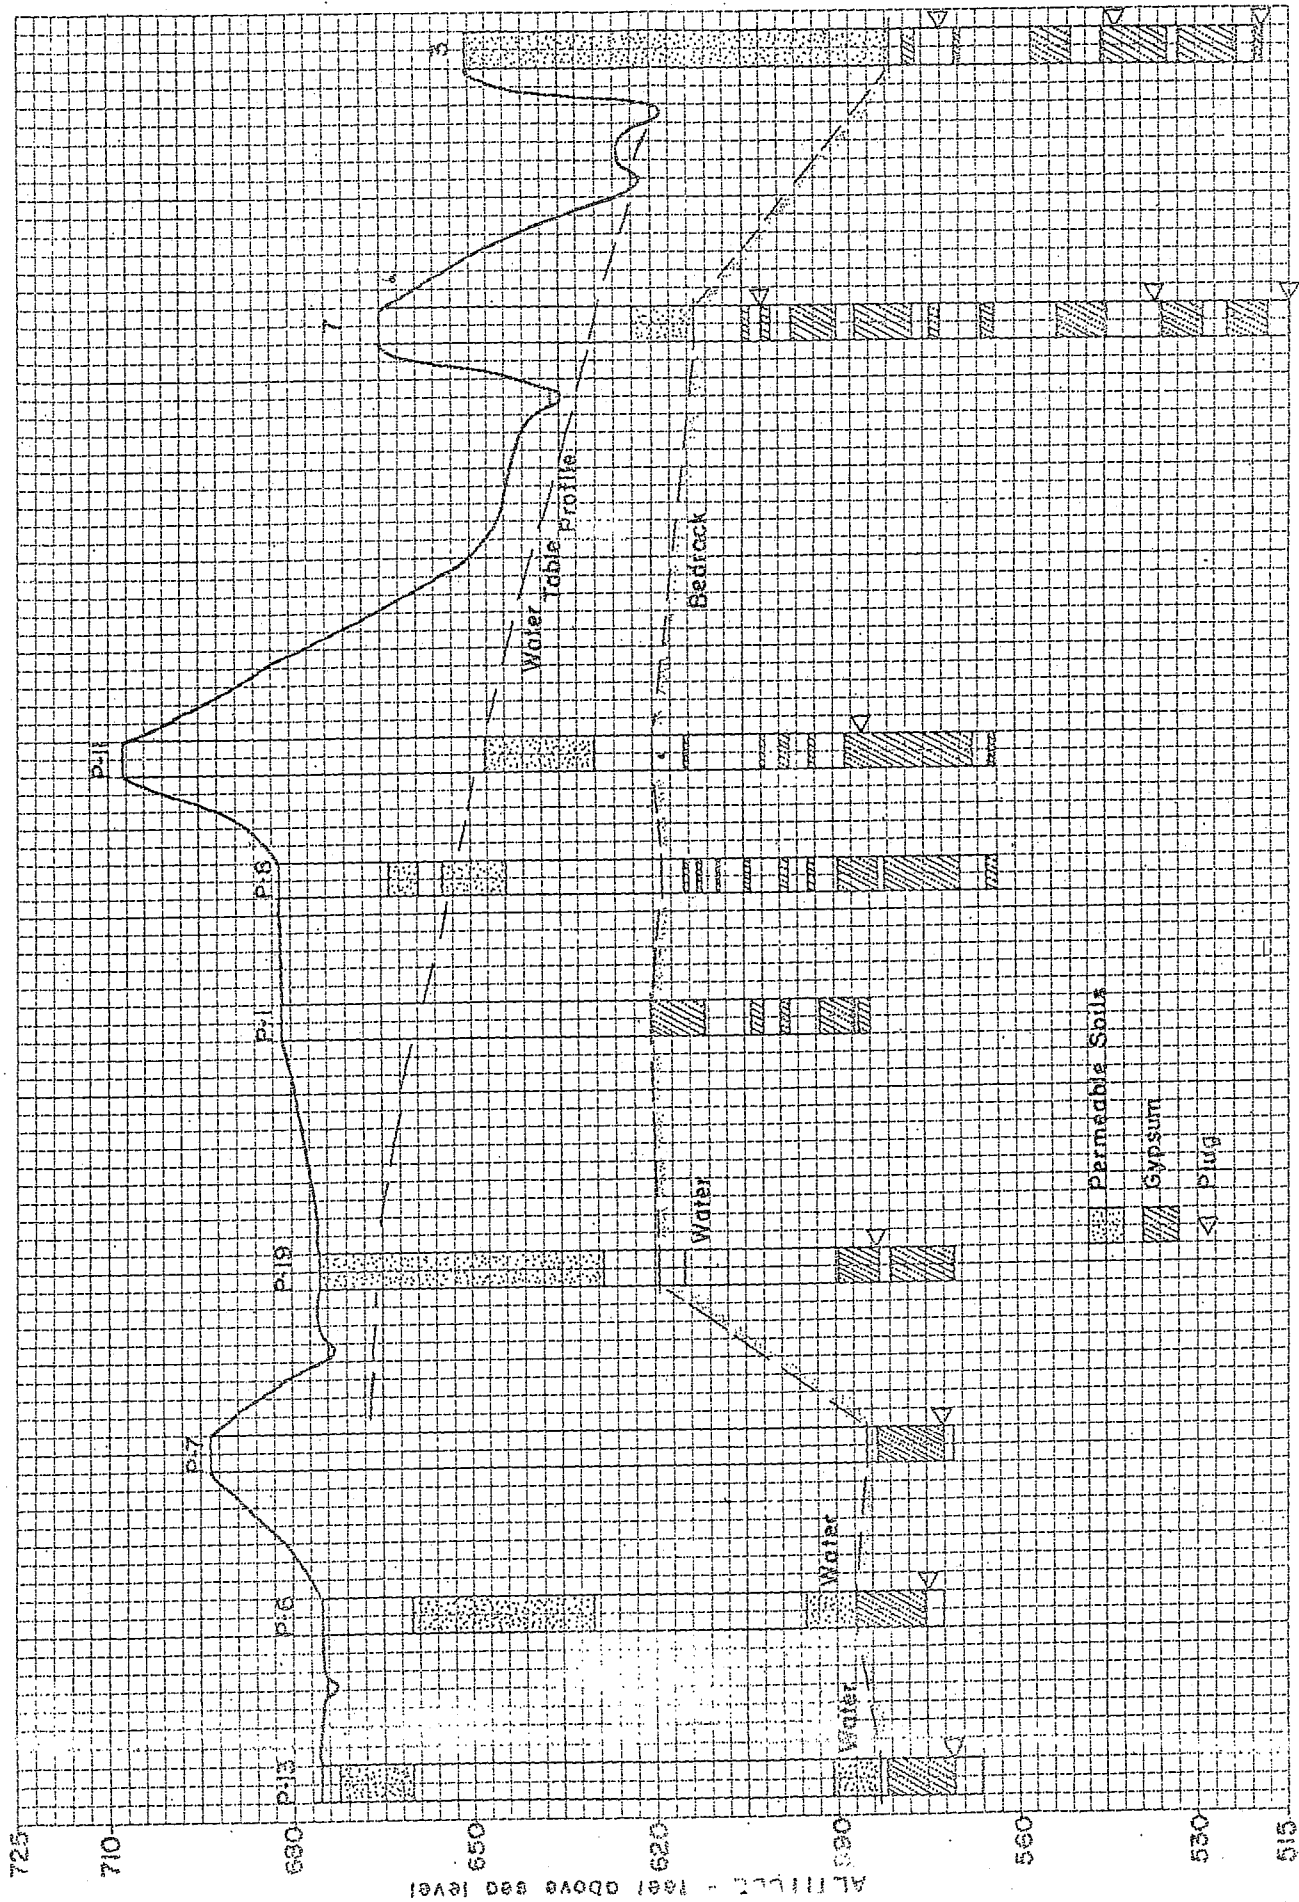
Fig. 3 - Section A-A' Paralleling Stream

Figures 3 and 4 are cross sections portraying the distribution of permeable unconsolidated soils and their relationships to the underlying consolidated rocks. The vertical scales of the sections are exaggerated out of proportion with the horizontal scale. The horizontal well relationships are proportional to the distances between wells along the lines of the sections as shown on figure 1. Section A-A' (Fig. 3) also shows the estimated water table profile. The sections clearly show the soil and water head conditions are suitable for migration of ground waters from the glacial drift into the consolidated rocks. Analyses of the water quality at the flow site in the mine (Hardness 63-69 grains per gallon and Chlorides 91 to 114 parts per million) and at the Pittsburgh shaft (Hardness 93g/g and Chlorides 167 ppm) are also indicative of such migrating ground waters rather than native waters within the rocks.

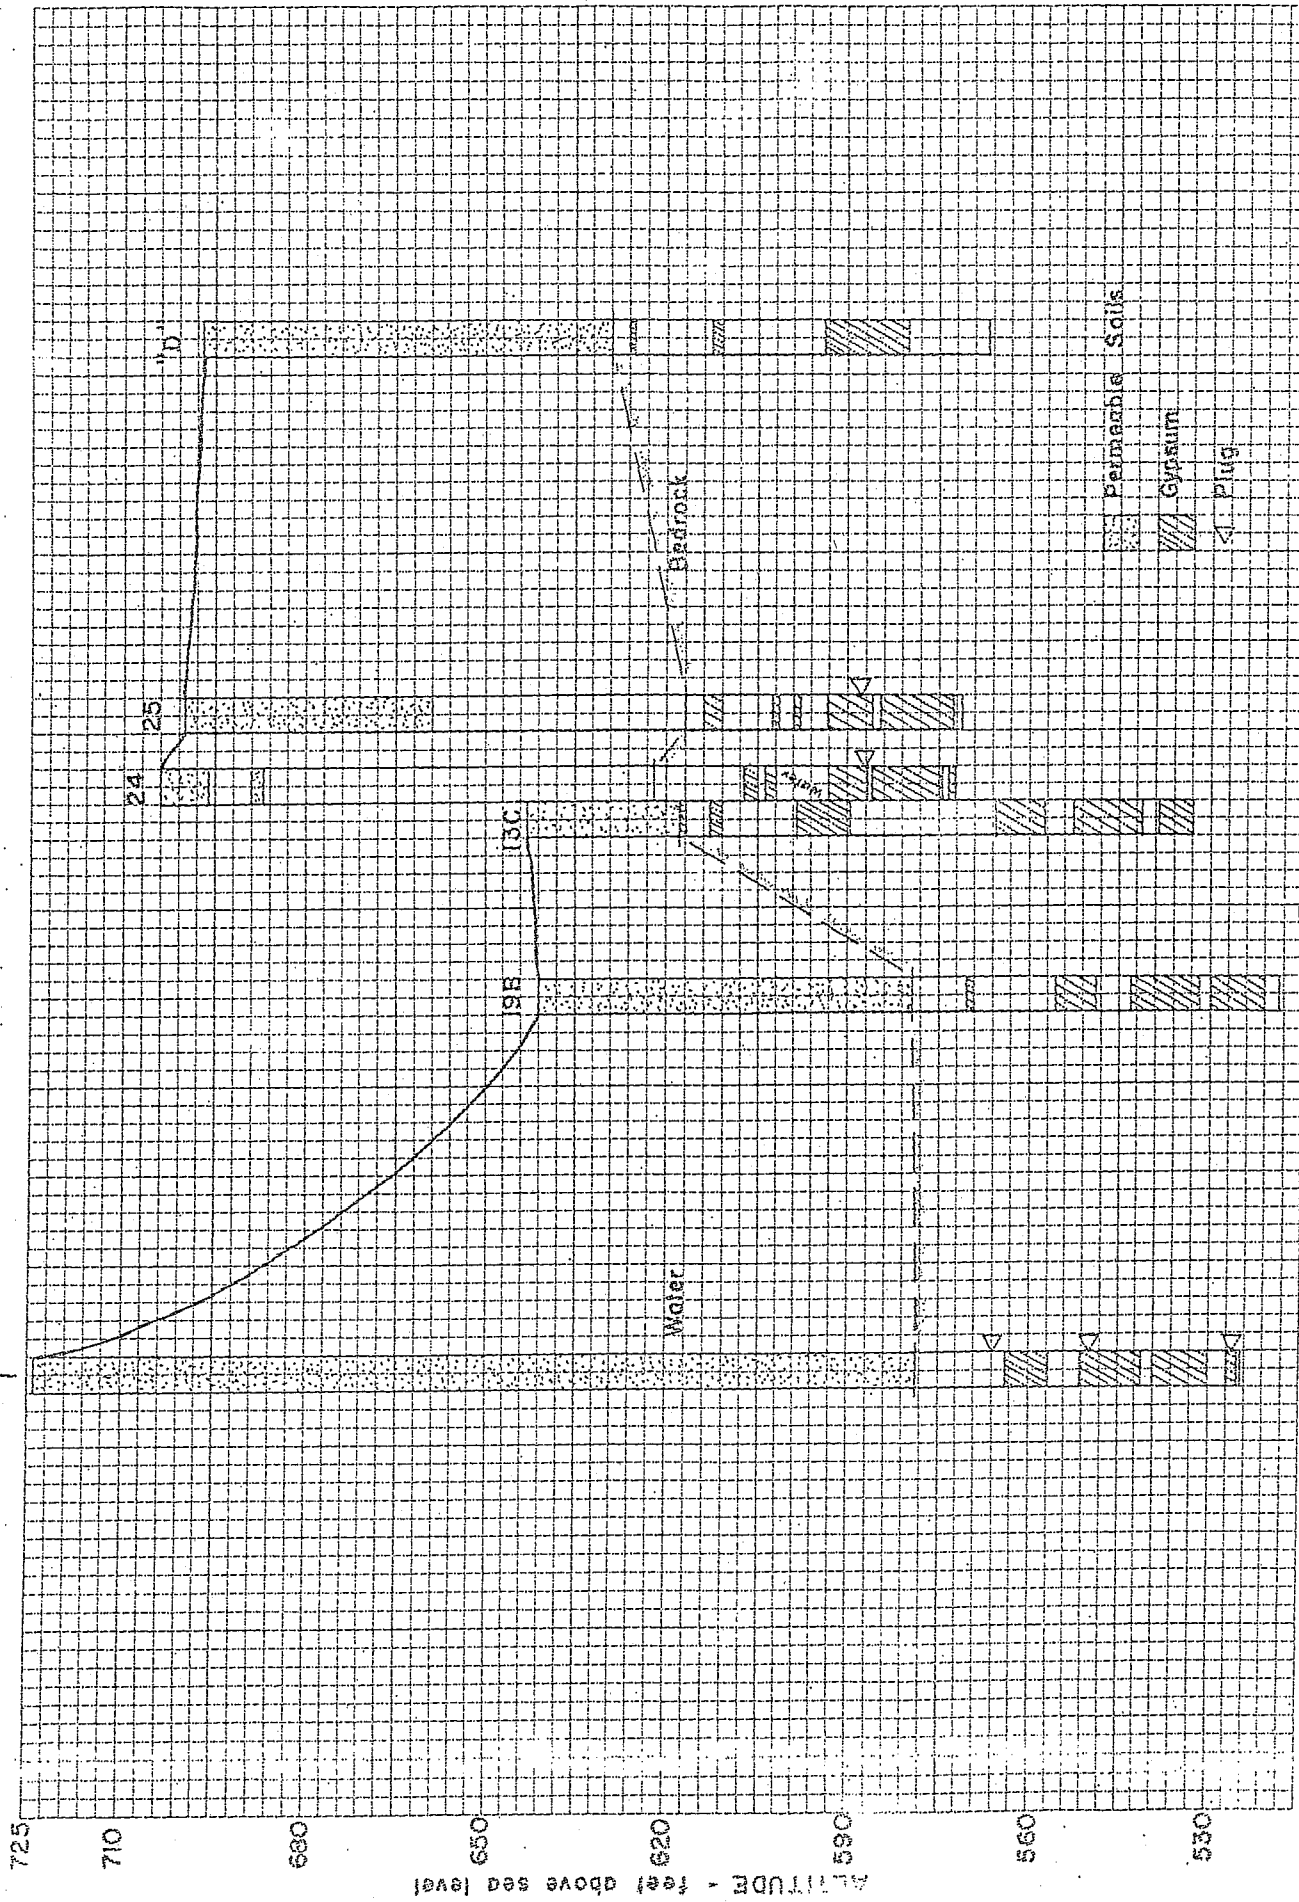
Fig. 4 - Section B - B' East - West thru Water Problem Area.

The recent encountering of water, though not the first, emphasizes the need to avoid working too close to the "pinch out" of the formation or in areas where the roof of consolidated rocks may be thin or saturated with water. The presently available information, as shown by the bedrock topography, indicates that such conditions exist west of your operation, in the vicinity of the water encounter and in the southern portion of the area next scheduled for mining. The latter is based on a few scattered well records and should be explored by drilling to clarify the existing information. Recommended locations for six exploratory holes are shown on figure 1 and numbered in the suggested order of drilling. Depending on conditions encountered at each site, it may be necessary to drill offset holes to clarify the geologic picture if unusual conditions are encountered. During the drilling, the glacial soils should be carefully logged and water levels measured where ground waters are encountered. Electric logging of the open rock holes would be in order if water is encountered in the rock and stands in the hole. The logging would identify the water producing zone or zones missed or mudded off in the drilling process.
