STEEL EVALUATION OF VEHICLE-DAMAGED
STRUCTURE (S08 OF 39022), 38th ST
OVER I 94 NEAR KALAMAZOO

MICHIGAN DEPARTMENT OF
STATE HIGHWAYS AND TRANSPORTATION

J. D. Culp

Research Laboratory Section
Testing and Research Division
Research Project 75 TI-275
Research Report No. R-1029

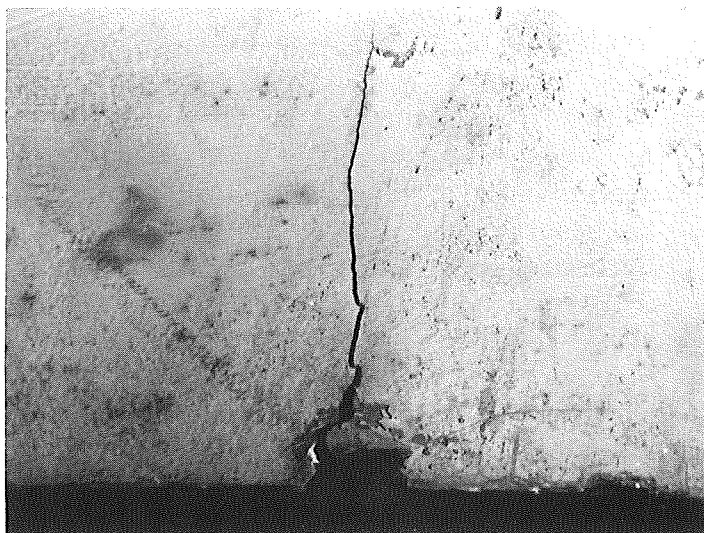
Figure 2b. Bottom side of the flange at the point of impact showing crack stopping before reaching far side of the flange.
