MICHIGAN
STATE HIGHWAY DEPARTMENT
LANSING 13

SUBJECT: Lincoln Stone as a Material for Bituminous Concrete Resurfacing.
Research Project 51 A-14. Report No. 179

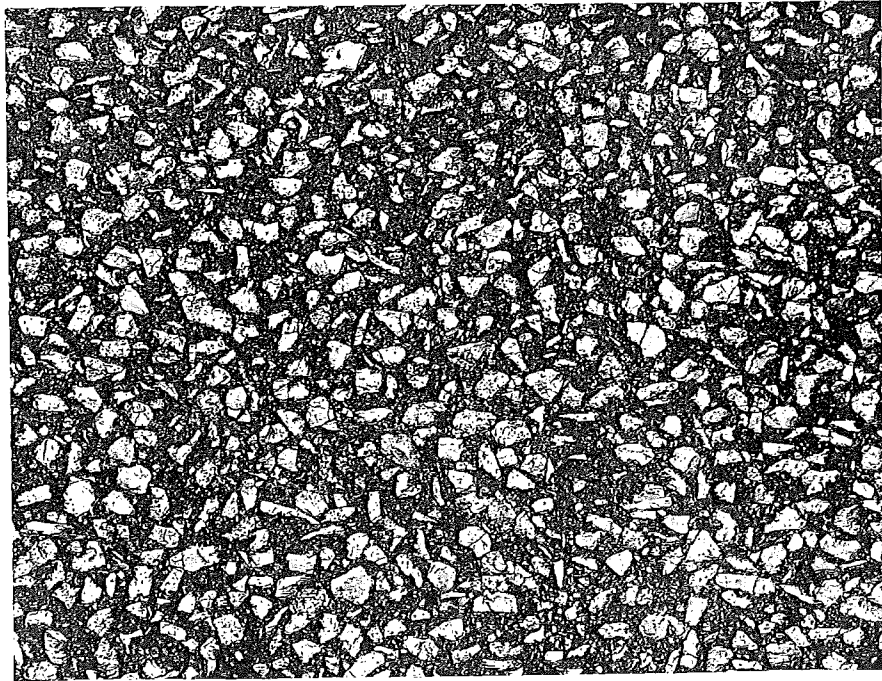
B. View of surface showing typical condition of aggregate.

Lincoln Stone 26A Mod. M 13-27, C14 - 1948
US-12 from Kalamazoo Co. line East 6-19-52

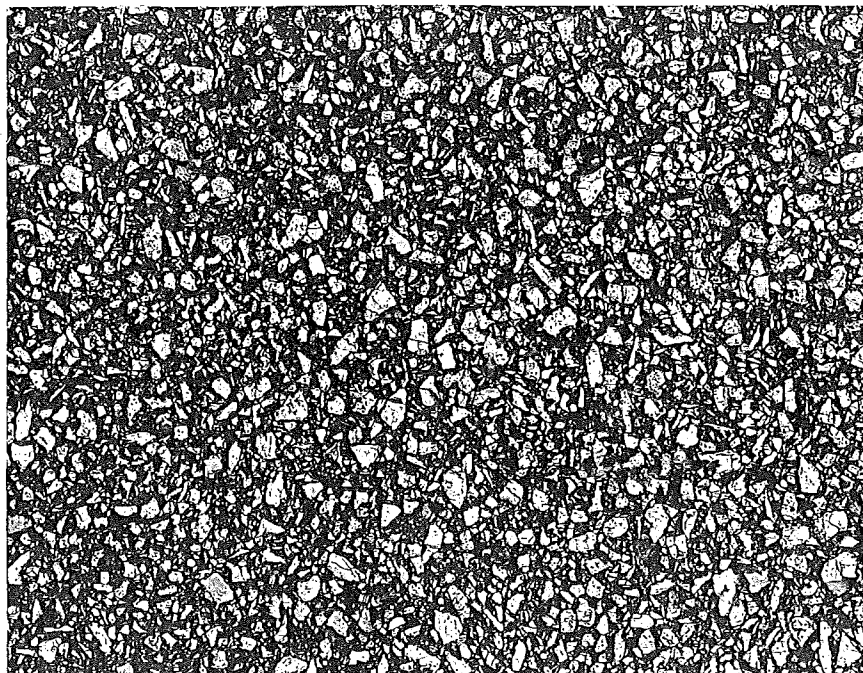
Fig. 7

B. View of area showing typical condition of aggregate.

Lincoln Stone 26A Mod. M 14-4,08 - 1948
M-60 South of Cassopolis 6-19-52

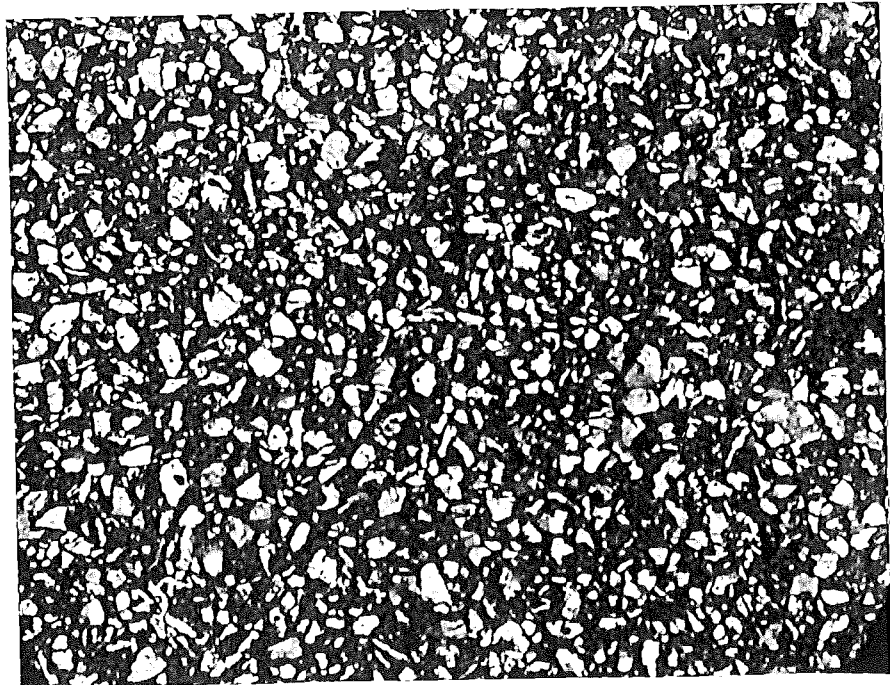
B. View of area showing condition of aggregate.

Lincoln Stone 26A Mod. M 14-15, C12 - 1948
US-112 east from Jct. M-119 6-20-52

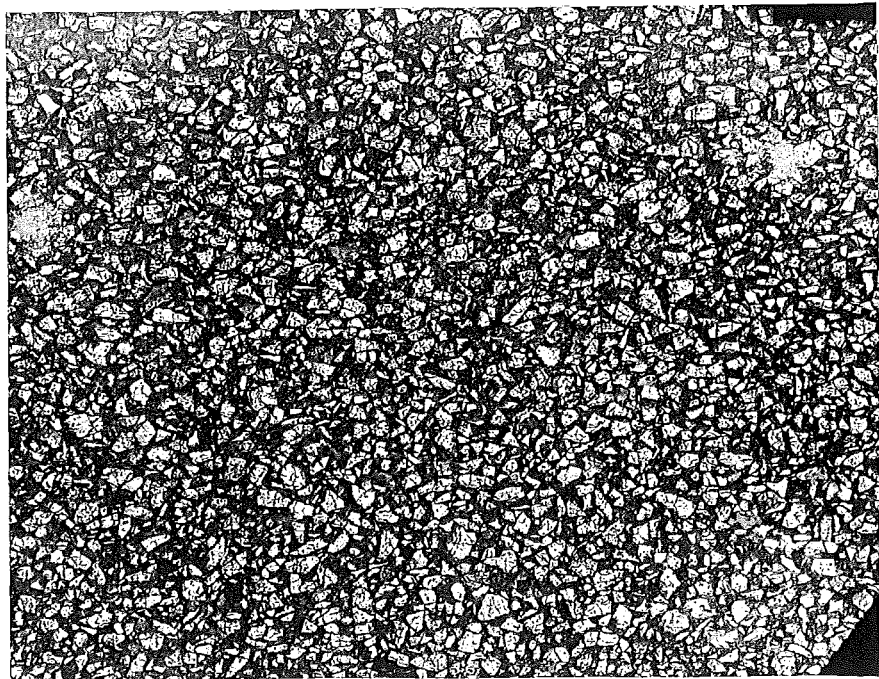
B. View showing condition of aggregate.

Lincoln Stone 26A Mod. M 39-30,C4 - 1948
US-12 in Kalamazoo near B1 of 39-7-2 6-19-52

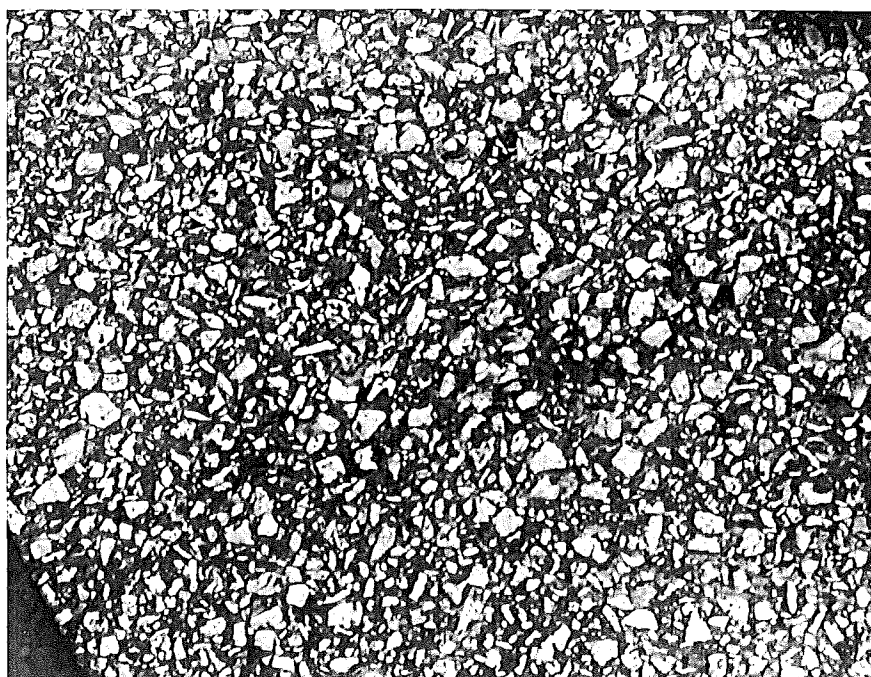
B. View showing character of surface and condition of aggregate.

Lincoln Stone 26A Mod. M 78-2,C6 - 1948
US-131 in Village of Constantine
on Canaris St. 6-20-52

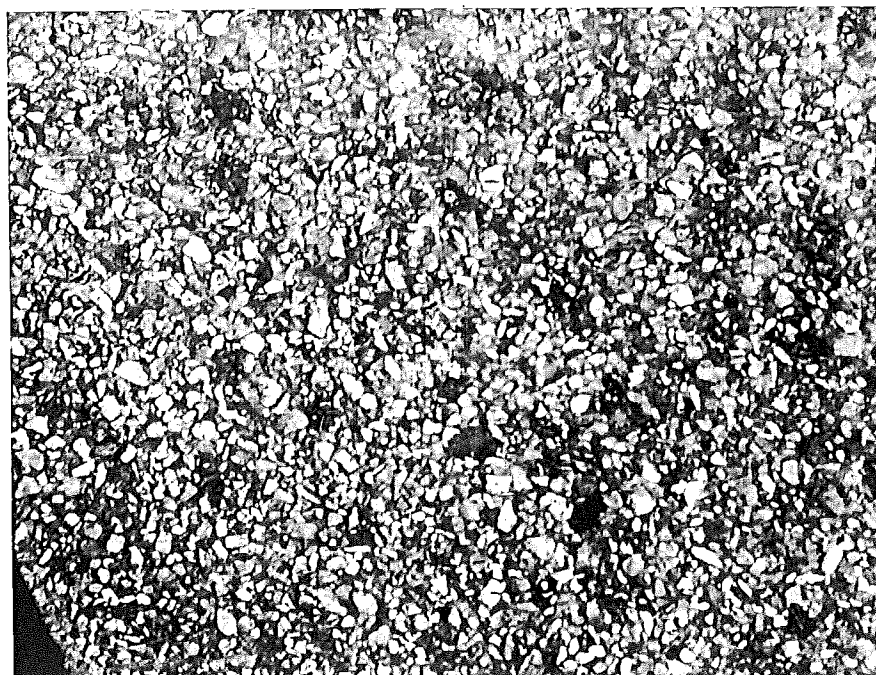
B. View showing texture of surface and aggregates.

Lincoln Stone 26A Mod. M 78-14,06 - 1948
US-112 Mottville to White Pigeon 6-20-52

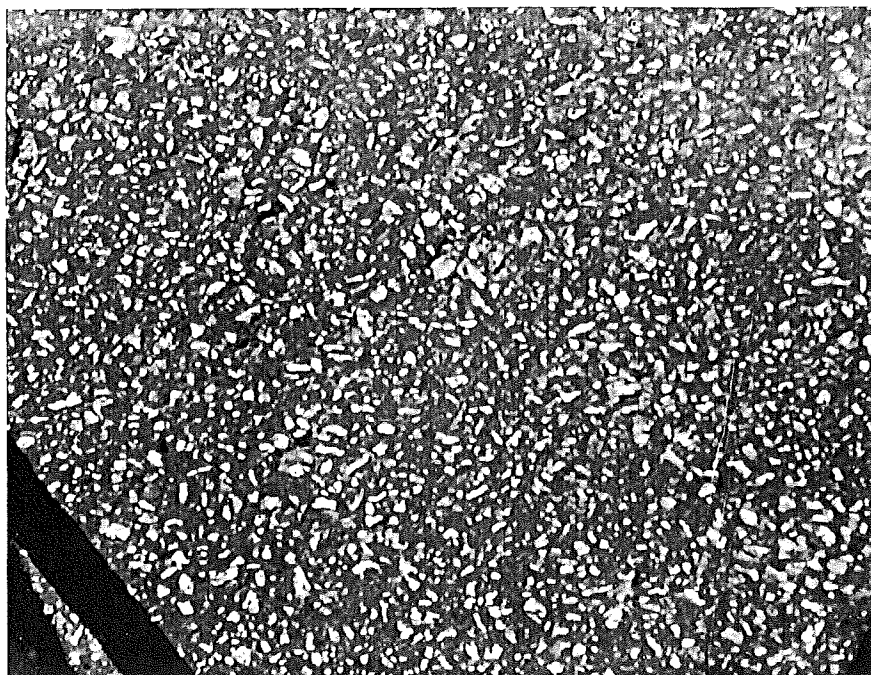
B. View showing character of surface.

Lincoln Stone 25A. 13-6,C2
US-127 So. edge of Marshall

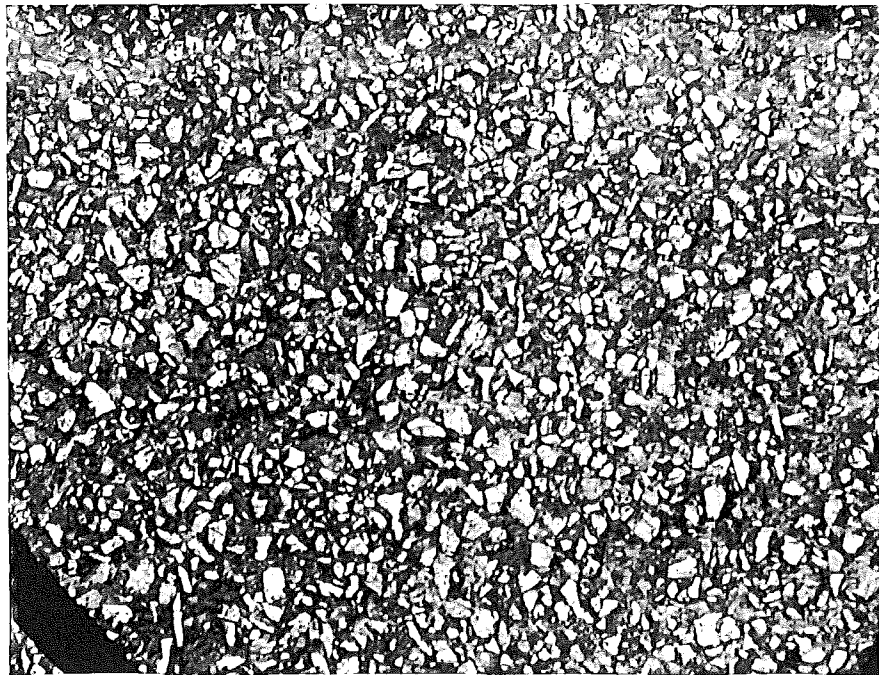
B. View showing texture of surface.

Lincoln Stone 25A Mod. 13-58, Cl - 1950
US-12 & M-96 Battle Creek 6-18-52

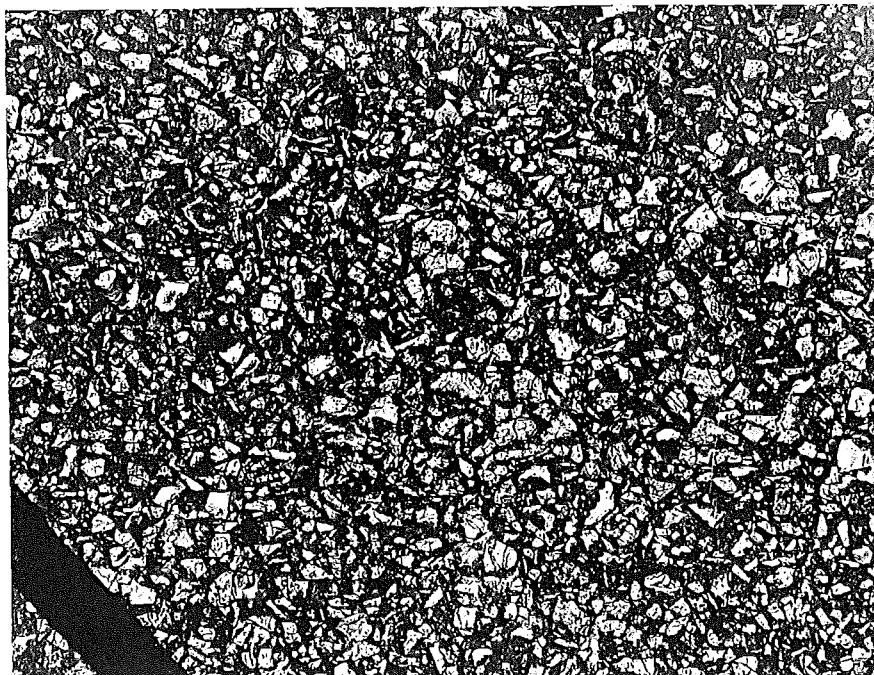
B. View showing typical condition of surface.

Lincoln Stone 25A. M 13-9,C3 - 1950
On M-78 leg of Jct. with M-66 6-19-52

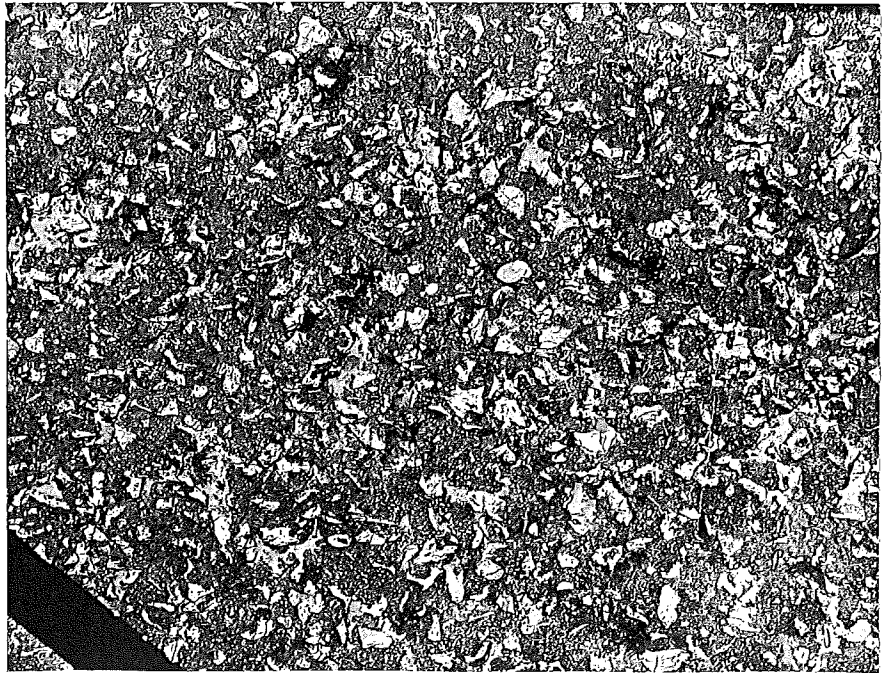
Fig. 17

B. View showing typical condition of surface.

Lincoln Stone 25A SS 80-20,04 - 1950
On M-94 in Paw Paw 6-19-52

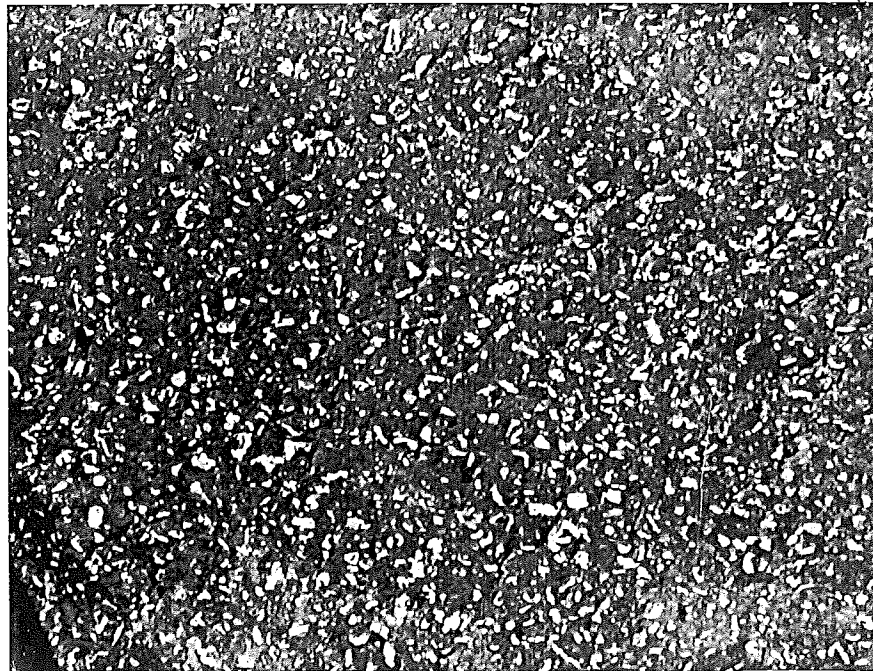
B. View showing character of surface.

Monon Stone 25A Mod. M 78-11, C4 - 1951 Constr.
M-60 east of Three Rivers toward
Mendon
