**Evaluation of Concrete Pavements
with Materials-Related Distress**

Final Report

1. Report No. RC-1533	2. Government Accession No.	3. MDOT Project Manager David Smiley	
4. Title and Subtitle Evaluation of Concrete Pavements with Materials-Related Distress		5. Report Date 3/02/2010

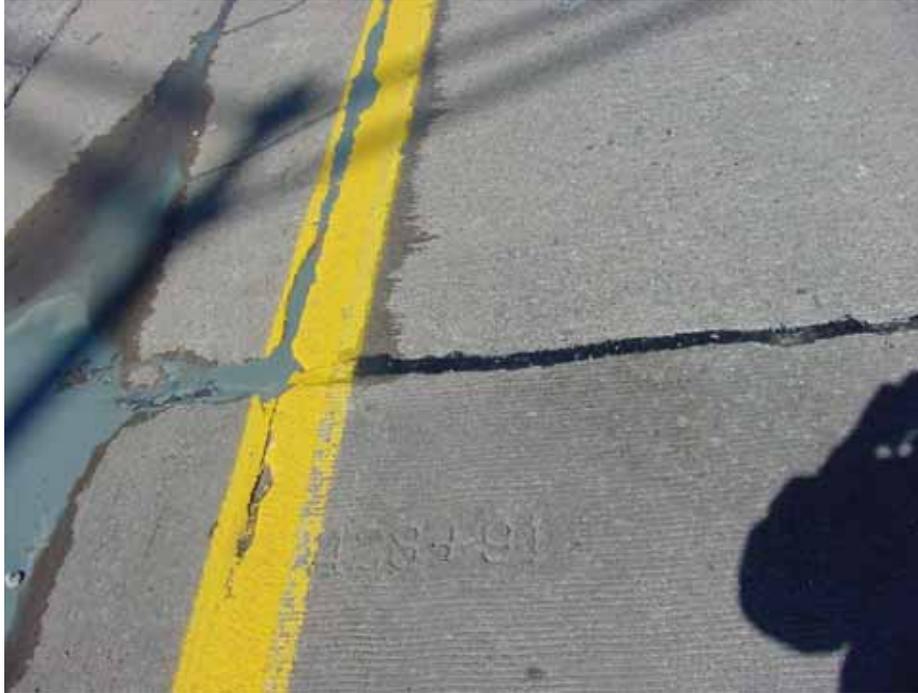
Figure 1: Photo of I-696 median lane, with no visible distress at pavement surface.

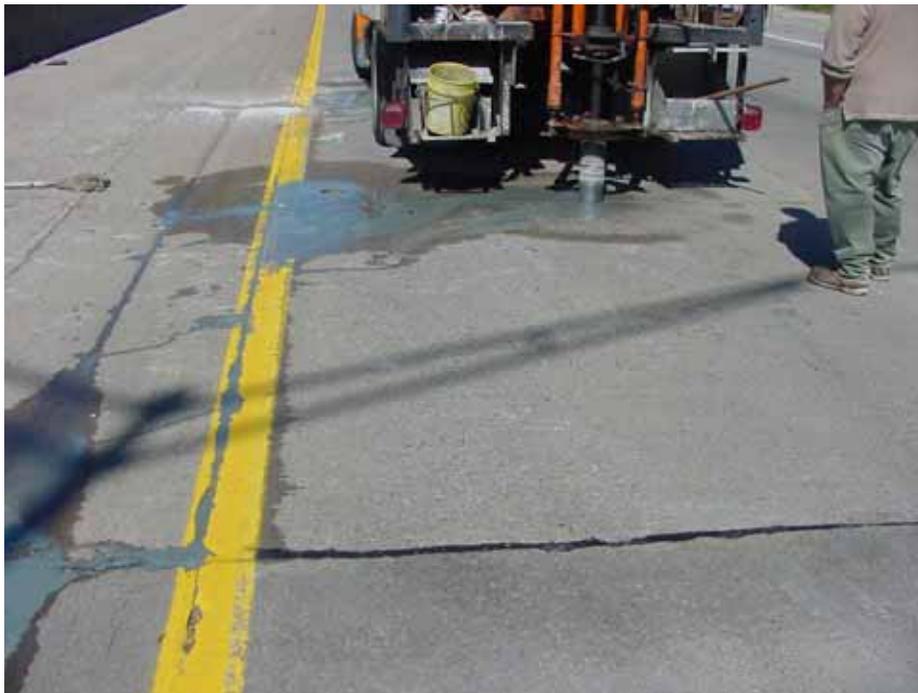
Figure 2: Photo of I-696 median lane, with no visible distress at pavement surface.

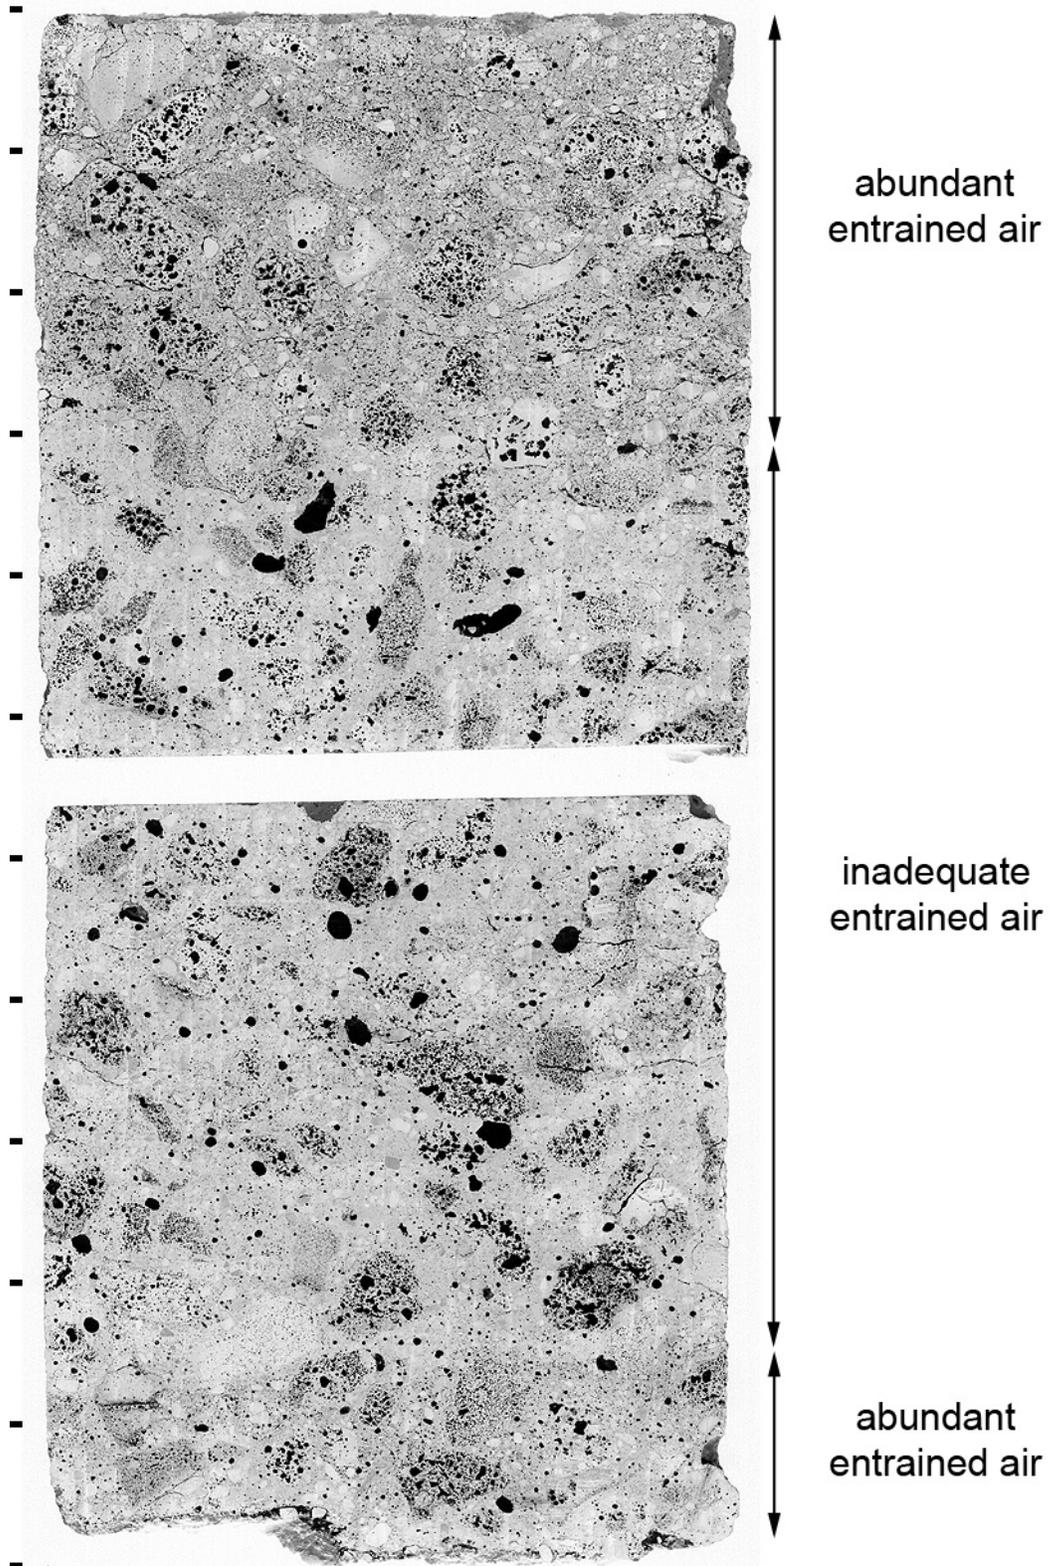
Figure 5: Slabs to represent cross section through core C, mid-panel, MTU ID 696-11, outside lane, WB I-696, after treatment to enhance air voids and cracks, tic marks every inch.

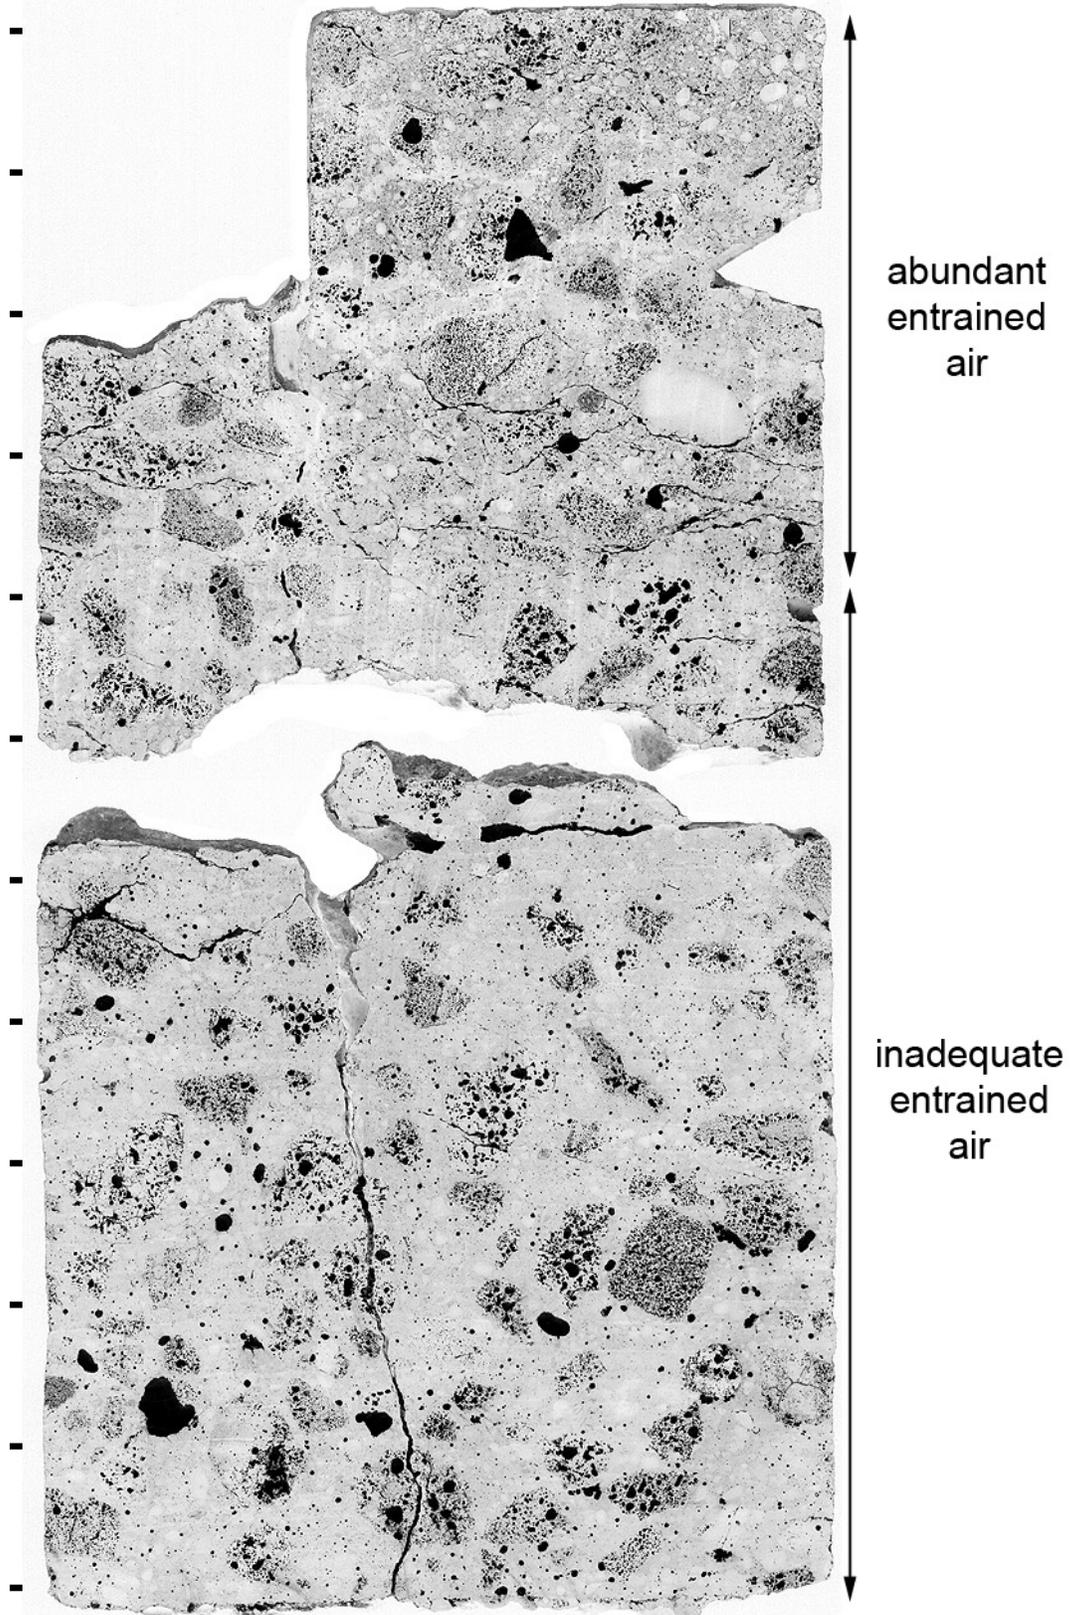
Figure 6: Slabs to represent cross section through core B, at joint, MTU ID 696-10, outside lane, WB I-696, after treatment to enhance air voids and cracks, tic marks every inch.

The key to ASR distress involves the formation of semi-permeable rims of rigid calcium-rich silica gels around the perimeters of reactive aggregate particles. Using chert as an example, silica gel formed at the surface of a chert sand particle is initially alkali-rich and fluid in nature. Over time, with continued contact with the pore solution, this fluid gel picks up calcium from the pore solution and becomes more rigid. This rigid membrane remains permeable, and allows pore solution to continue to pass into the chert particle. OH^- , K^+ , and Na^+ ions in the pore solution will continue to interact with remaining intact silicon-oxygen bonds within the chert, forming additional silica gel that can not escape the semi-permeable rigid membrane at the perimeter. In some cases, pressure builds within the chert sand particle until it cracks the surrounding concrete, as illustrated in Figures 10, 11, 14, 17, 19, 20, 22, 26-28, and 34. Figure 19 is especially interesting, as it shows two inert sand particles split in half by cracks emanating from surrounding reactive chert particles. Under the right conditions, when there is abundant reactive and expansive chert particles, cracks connect between chert particles, and disrupt the concrete with continuous crack planes, as shown in Figures 6, 7, 12, 13, and 21.

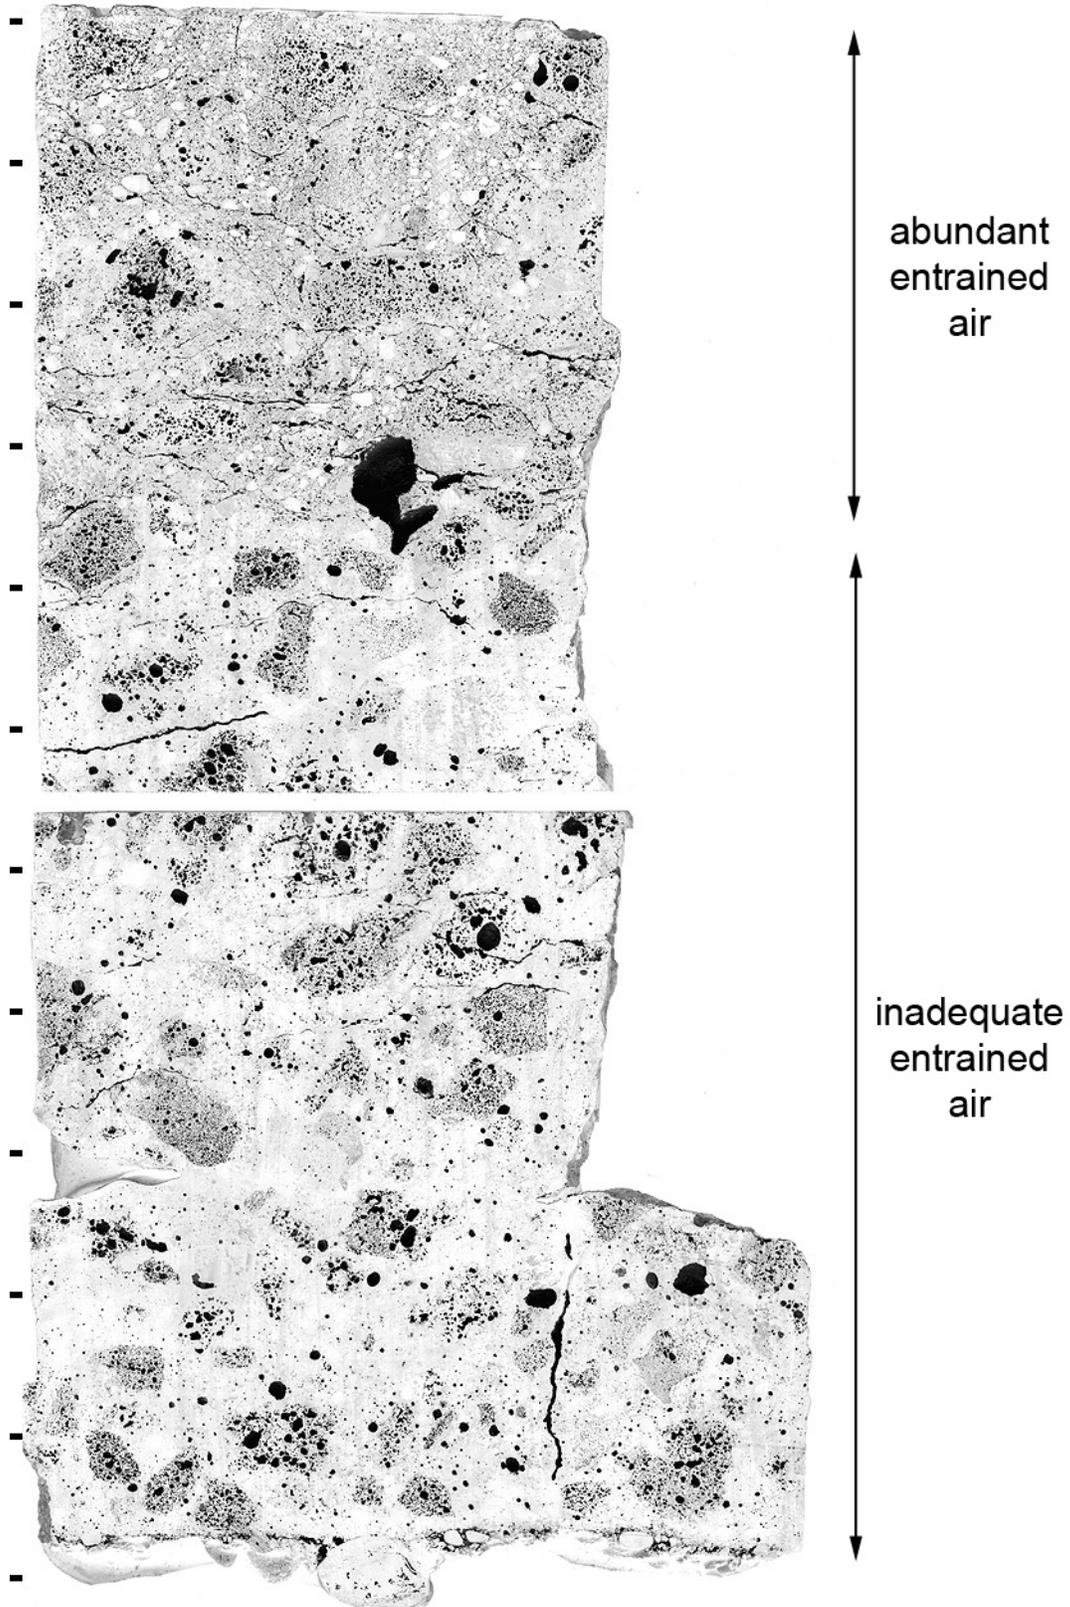
Figure 7: Slabs to represent cross section through core A, at joint, MTU ID 696-09, outside lane, WB I-696, after treatment to enhance air voids and cracks, tic marks every inch.

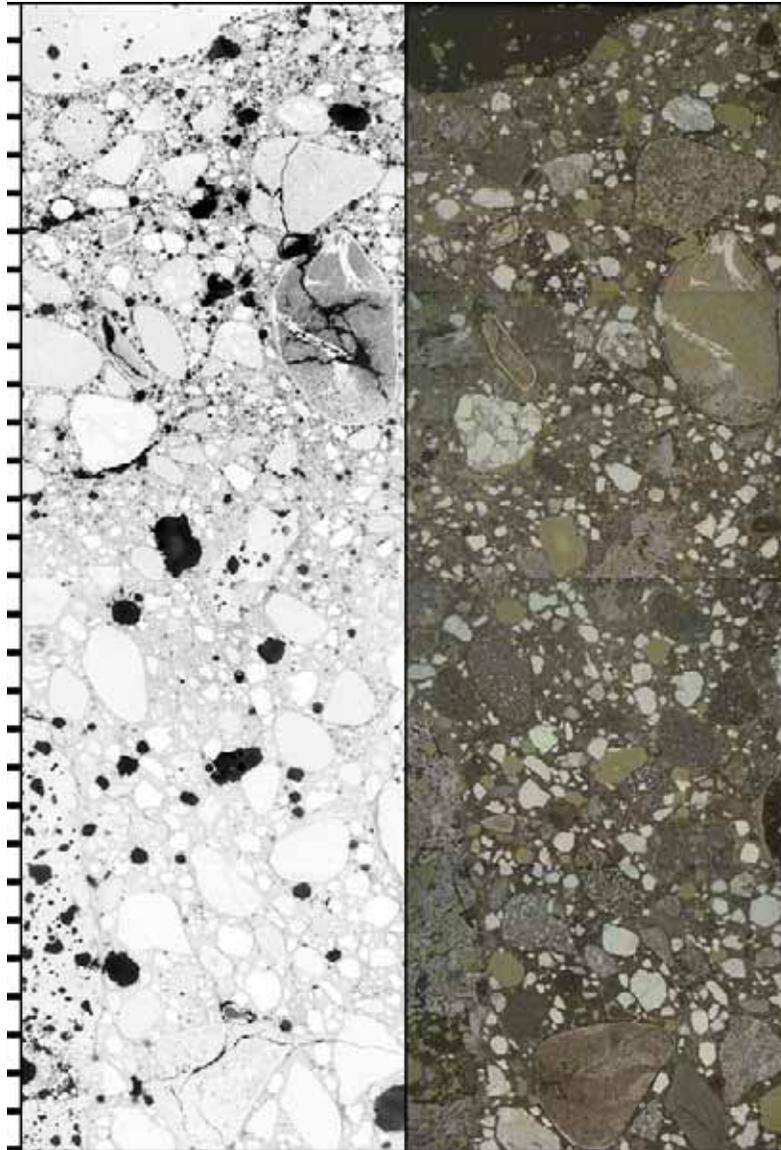
Figure 8: Epifluorescent mode (left) and transmitted light (right) images at transition between zone of abundant entrained air and zone without entrained air at a depth of approximately 3 inches (75 mm). Example from thin section prepared from core taken from I-696, outside lane, away from joint, MTU ID 696-03.

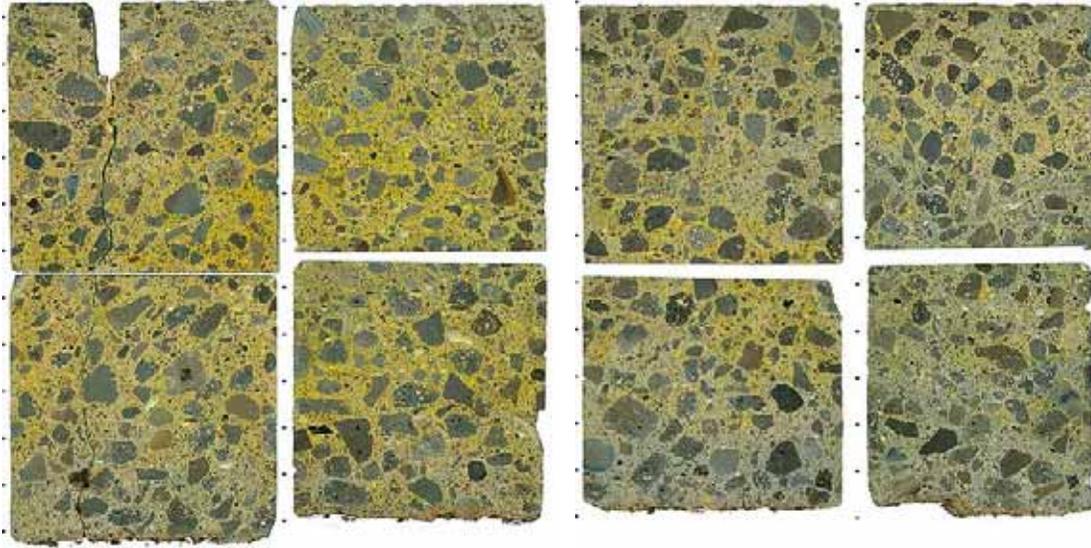
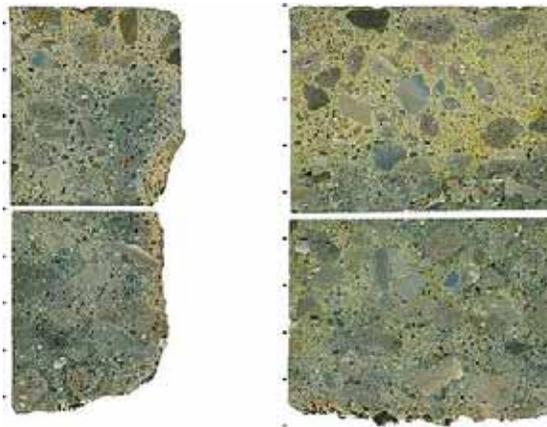
The primary distinction between the 1978 site and both of the 1995 sites was the degree of alkali silica reaction products associated with fine aggregate particles. Both pavements contained similar fine aggregate, but the reactive particles from the 1995 pavement exhibited abundant reaction products and crack networks, while the reactive particles from the 1978 pavement did not. The contrast in severity of the alkali-silica reaction was observable in the images from the scanned slabs after sodium cobaltinitrite staining, as shown in Figure 9. Figures 10 and 11 show example stereomicroscope images of reactive fine aggregate particles from the 1995 median lane pavement. Figures 12 and 13 show polished slabs from the 1995 median lane pavement after treatment to enhance the appearance of cracks and voids. Figure 14 shows a deleterious chert particle in thin section.

Figure 9: Overview of sodium cobaltinitrite stained slabs from I-696 sites. The slabs represent full cross-sections through the pavement, with tic marks along the left hand side at one inch intervals.

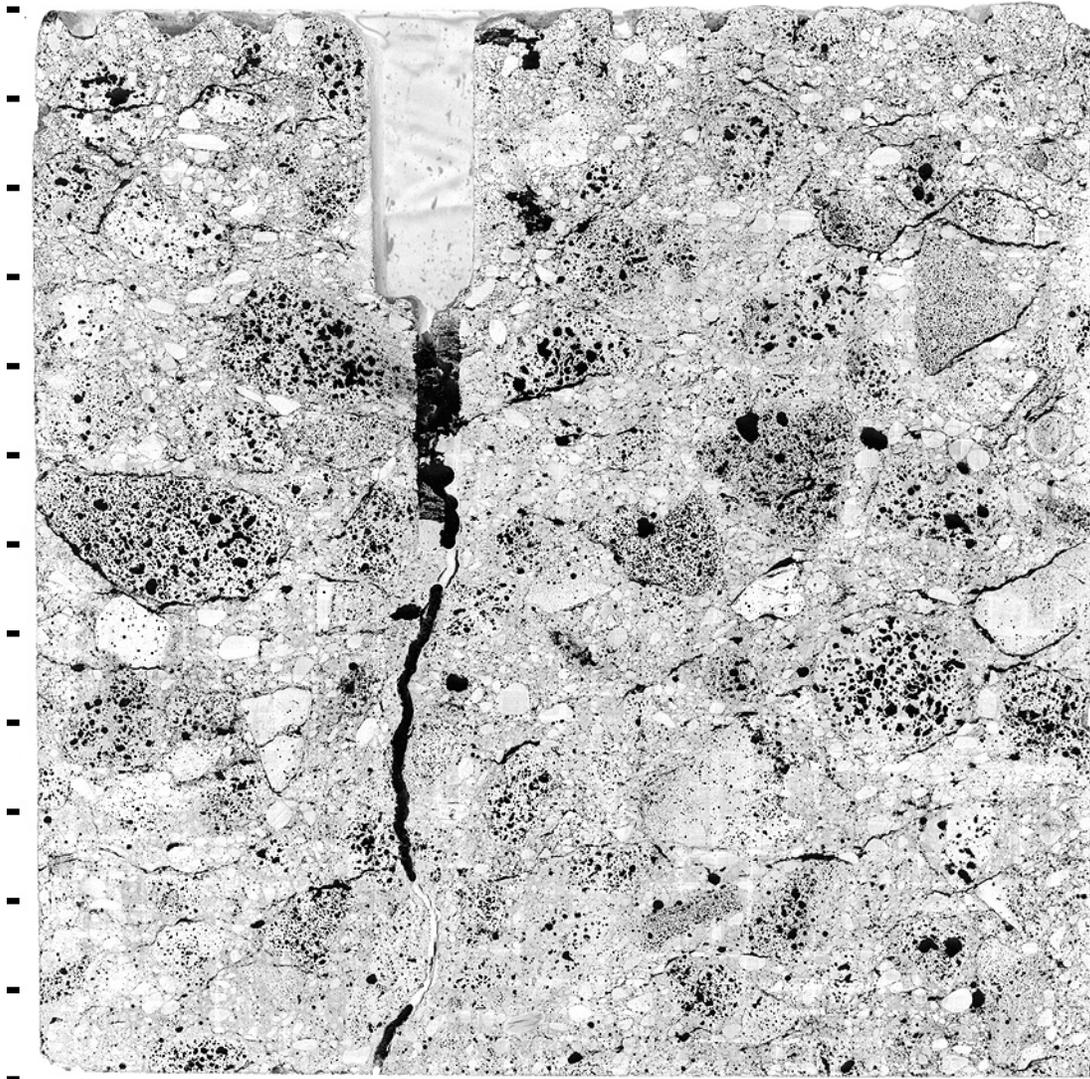
Figure 12: Slab representing cross section through top half of pavement, after treatment to enhance air voids and cracks, WB I-696, constructed in 1995, median lane, at transverse joint, core A, MTU ID 696-06, tic marks every half inch.

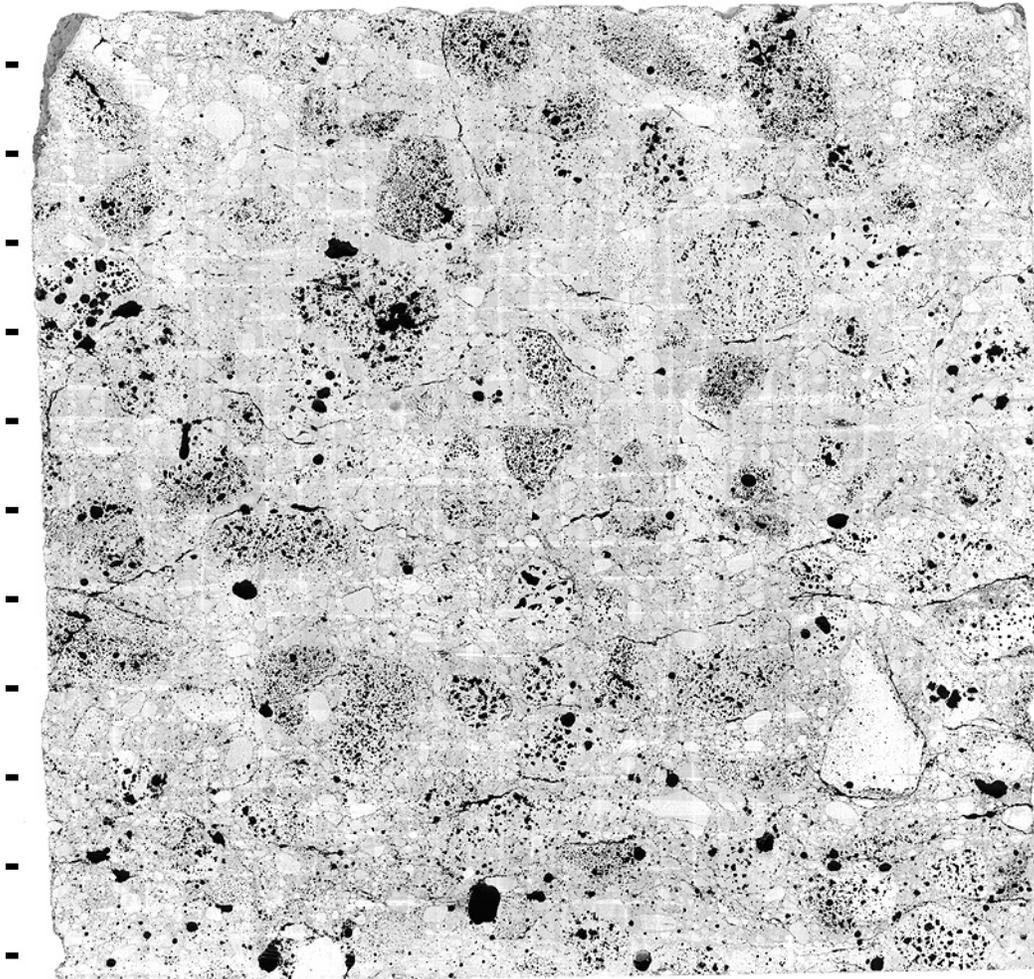
Figure 13: Slab representing cross section through top half of pavement, after treatment to enhance air voids and cracks, WB I-696, constructed in 1995, median lane, away from transverse joint, core D, MTU ID 696-03, tic marks every half inch.

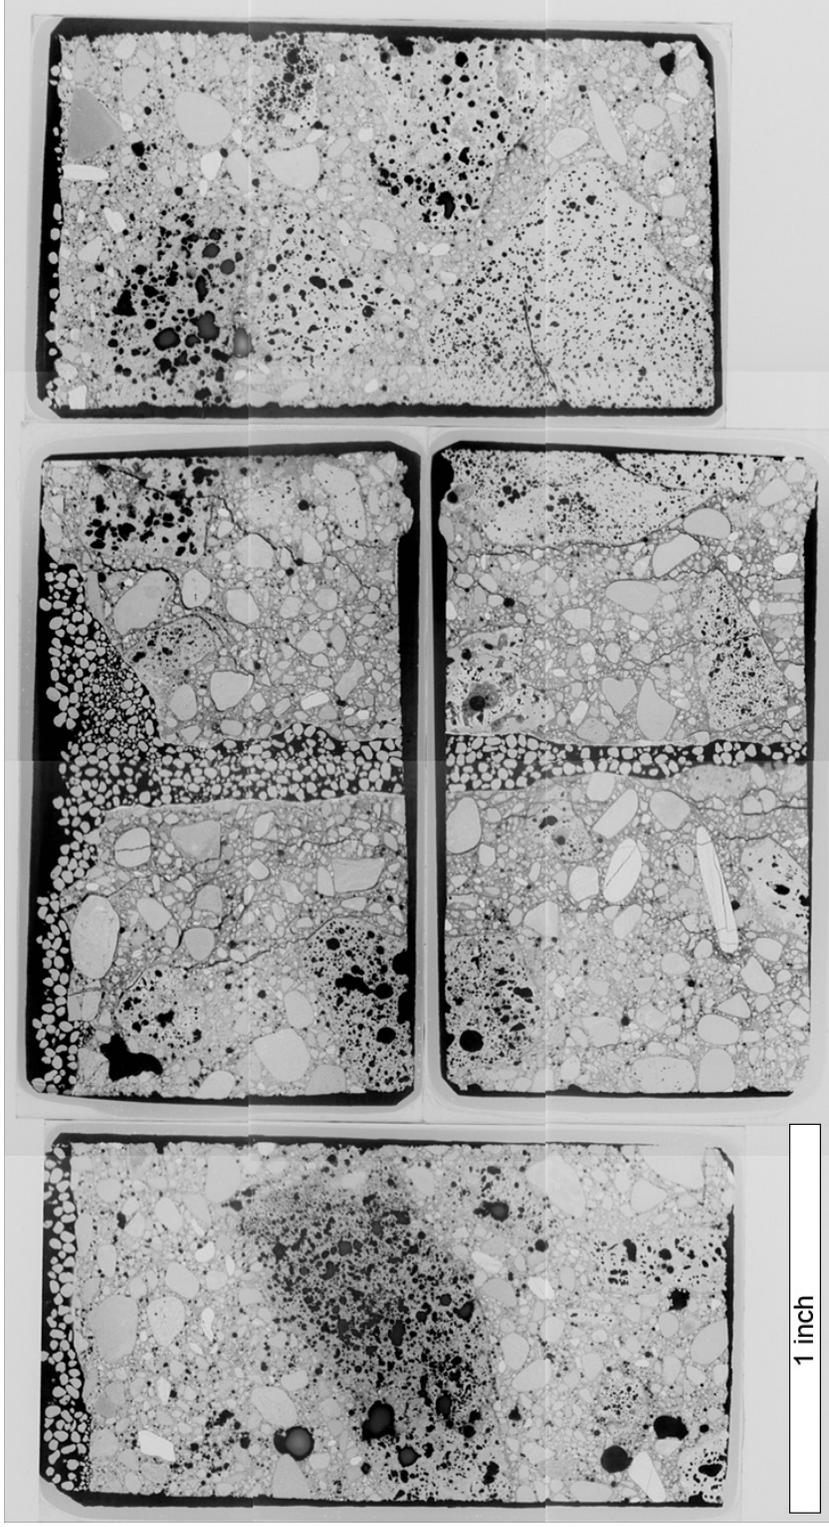
This site was divided into two categories: cores from an area showing visible distress, the outside lane, and cores from an area without signs of distress, the median lane (with one exception: a single core through the longitudinal joint between the outside and median lanes). The cores from this pavement appeared to be in good condition, except for the core from the longitudinal joint, which exhibited extensive cracking oriented parallel to the joint. As a result, this core was treated differently than the others. The top 2 ½" portion of the core was trimmed, vacuum impregnated with epoxy, and cut into slabs and billets for preparation in thin section to examine the longitudinal surface cracks in cross-section. The thin sections were taken in a plane perpendicular to the longitudinal joint to show the joint in cross-section. Figure 15 shows the thin sections arranged in their original spatial context as illuminated with UV light to enhance appearance of voids and cracks filled with the fluorescent epoxy. The cracks run sub-parallel to the joint, to a depth of about 2 inches, within a zone of one half of an inch on either side of the joint. The cement paste within this zone is heavily cracked, with some increase in porosity and decrease in Ca(OH)_2 .

Figure 15: Thin sections arranged in their original spatial context to show the longitudinal joint in cross-section. Voids and cracks in the inverted UV fluorescent image appear dark. Coarse sand particles observed at the pavement surface and filling the joint were blended with the epoxy to conserve epoxy during impregnation of the core segment.

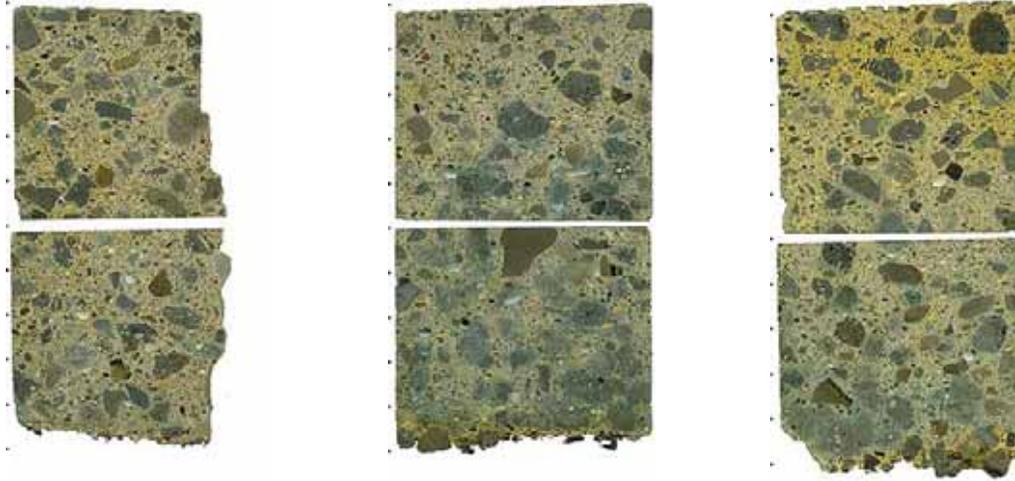
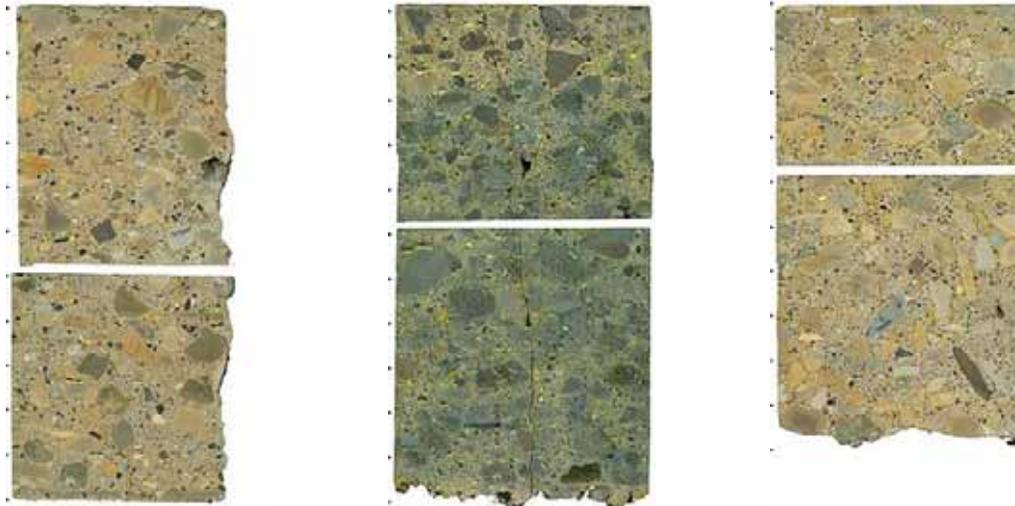
The other cores were slabbed, polished, stained, and examined as usual. The measured air-void parameters for both the median and outside lanes are summarized in Table 5 and were adequate for freeze-thaw protection. Results of equivalent w/c ratio measurements are included in Table 4. Figure 16 includes an overview of a polished slab after staining with sodium cobaltinitrite. Alkali-silica reactivity as observed by the staining method was limited, and only one instance of alkali-silica related cracking was observed near the pavement surface, as shown in detail in Figure 17. Figure 18 compares close-up petrographic microscope images of the cement paste in thin section from the median and outside lanes. One difference between the two sections is the concrete from median lane has fly ash, while concrete from the outside lane does not.

Figure 16: Overview of sodium cobaltinitrite stained slabs from all sites, excluding I-696. The slabs represent full cross-sections through the pavement, with tic marks along the left hand side at one inch intervals.

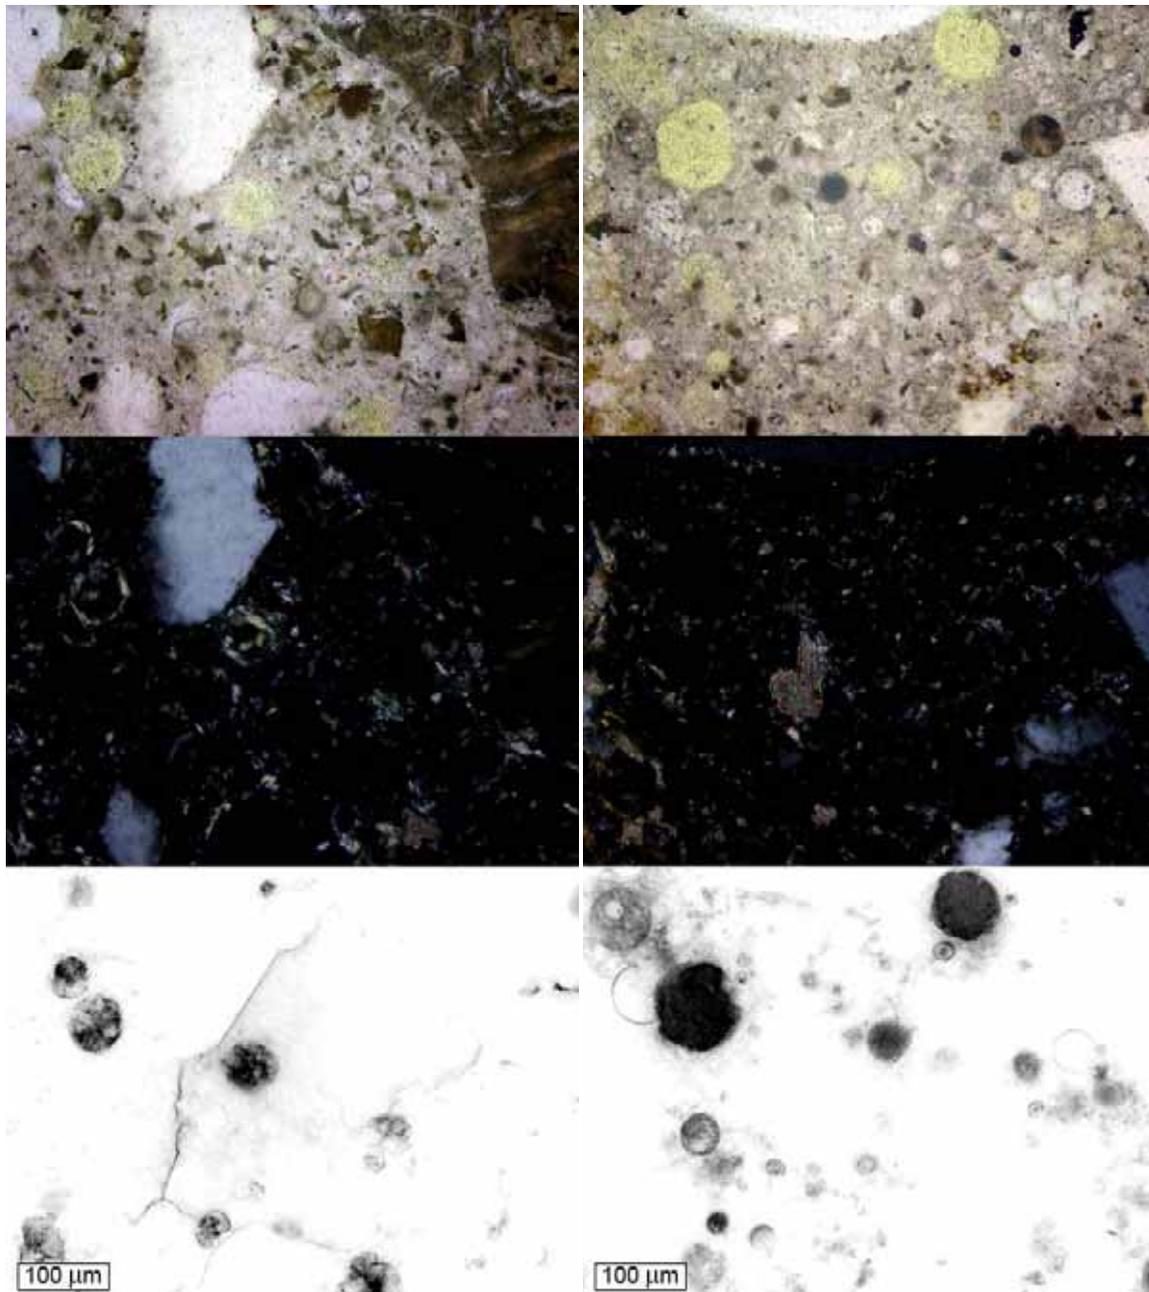
Figure 18: Examples of cement paste both without (left) and with (right) fly ash spheres. Left-hand side image from core M-5, outside lane, at transverse joint, MTU ID M5-05. Right-hand side image from core M-5, median lane, away from joint, MTU ID M5-02. From top to bottom: transmitted light, crossed-polars, and epifluorescent mode images.

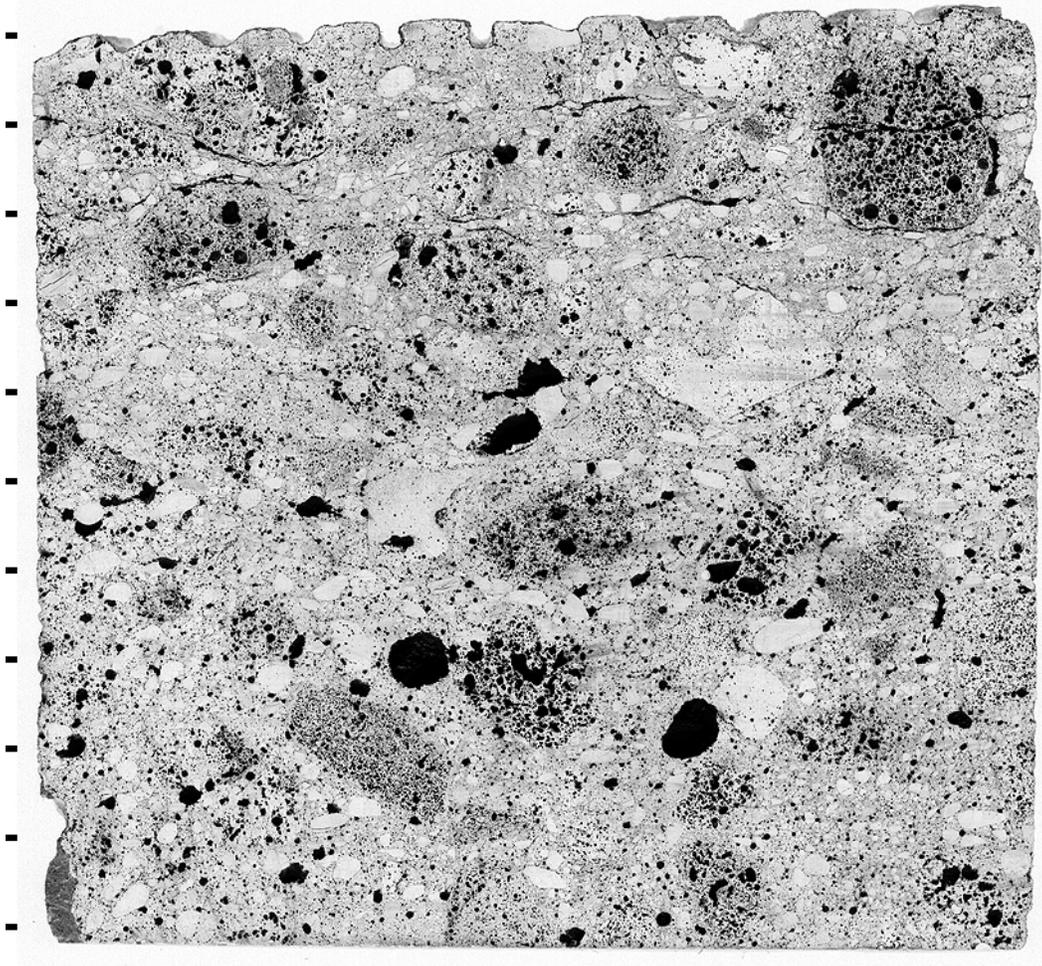
Figure 21: Slab representing cross section through top half of pavement, after treatment to enhance air voids and cracks, EB M-59, outside lane, away from transverse joint, core C, MTU ID M59-02, tic marks every half inch.

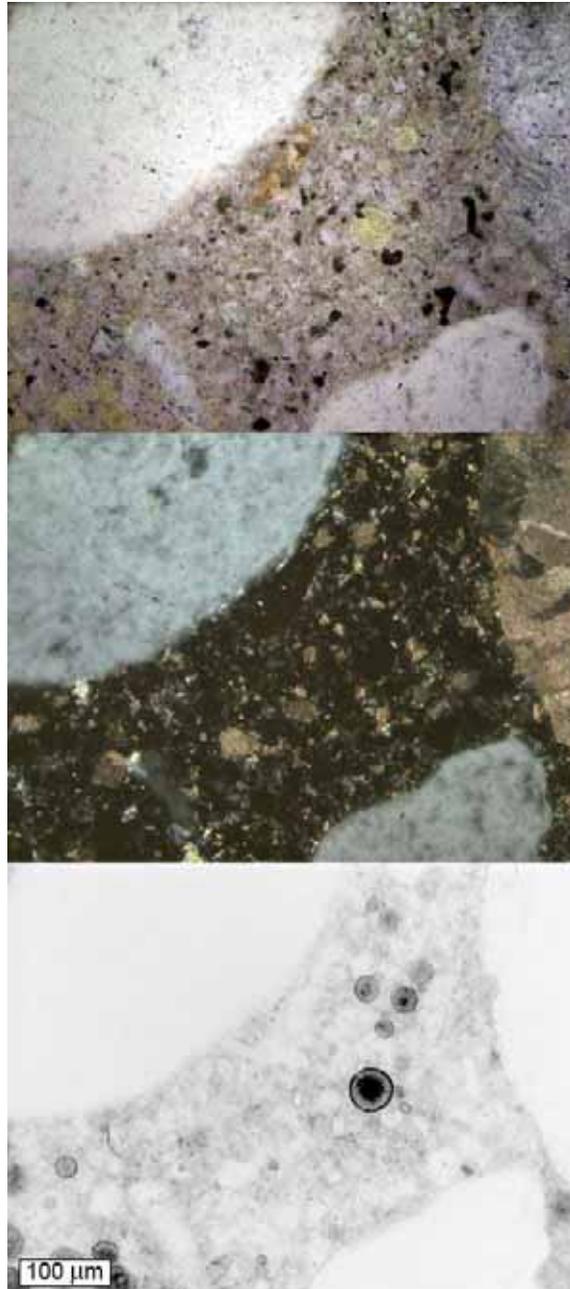
This site consisted of five cores, three cores taken at joints, and two cores taken away from joints. All of the cores appeared to be in good condition. Slight alkali-silica reactivity was observed by the staining method, but was limited to fine aggregate particles, without any associated cracking. An overview of the slab stained with sodium cobaltinitrite is included in Figure 16. Examples of reactive particles without any associated cracking are included in Figures 23 and 24. The air-void system parameters, summarized in Table 5 were not adequate for freeze-thaw protection as the spacing factor exceeded the generally recognized upper limit of 0.200 mm. Results of equivalent w/c ratio measurements are included in Table 4. Figure 25 shows the presence of carbonate dust dispersed throughout the hardened cement paste. The source of the carbonate dust likely occurred from the crushing process to produce the coarse aggregate, as opposed to limestone dust purposefully added to or interground with the portland cement.

Figure 25: Carbonate dust in cement paste fraction in thin section prepared from core from M-14, away from joint, MTU ID M14-03. From top to bottom: transmitted light, crossed-polars, and epifluorescent mode images.

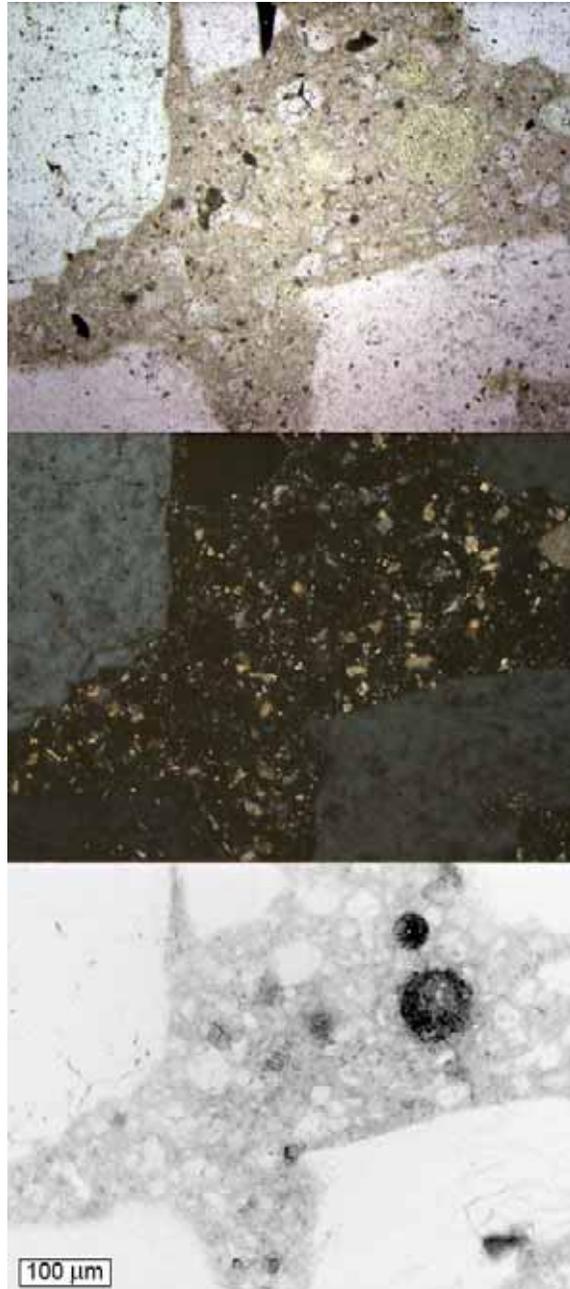
Figure 29: Carbonate dust in cement paste fraction in thin section prepared from core from US23, Section 19, away from joint, MTU ID US23-03. From top to bottom: transmitted light, crossed-polars, and epifluorescent mode images.

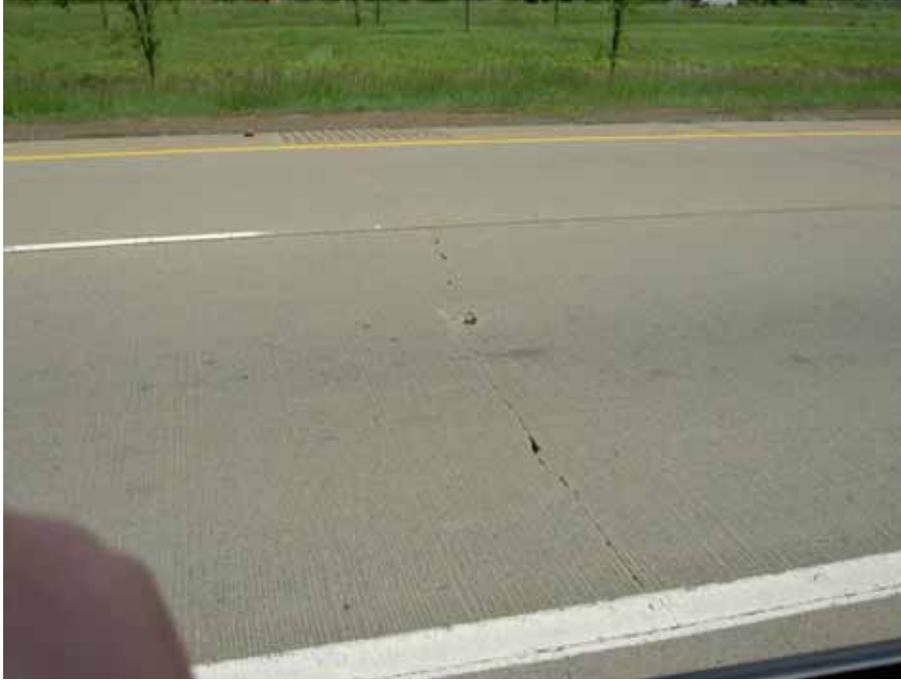
This site was selected because it did not exhibit MRD, and could be used as a basis for comparison with the newer JPCP sites that did exhibit MRD. Of particular interest was the condition of the ASR susceptible chert fraction of the fine aggregate. The site is pictured in Figures 30 and 31. Two core specimens were obtained, one core taken at a joint and another taken mid-panel. The sample from the joint was missing a portion of the core as shown in Figure 32. The core from mid-panel had a branched crack running through the entire depth of the core, as shown in Figure 33. Slight alkali-silica reactivity was observed by the staining method, and was limited to chert fine aggregate particles. Only a few of the reactive fine aggregate particles showed evidence of cracking, an example of which is shown in Figure 34. The isolated instances of ASR related cracks at this site were in contrast to the extensive inter-connected crack networks between chert particles observed in the other newer JPCP sites (M-59 and I-696). An overview of the slab stained with sodium cobaltinitrite is included in Figure 34. The air-void parameters, summarized in Table 5, were adequate for freeze-thaw protection. Results of equivalent w/c ratio measurements are included in Table 4. Figure 35 shows fly ash in a petrographic microscope image from the cement paste.

Figure 30: Overview of US-23, Section B test site.

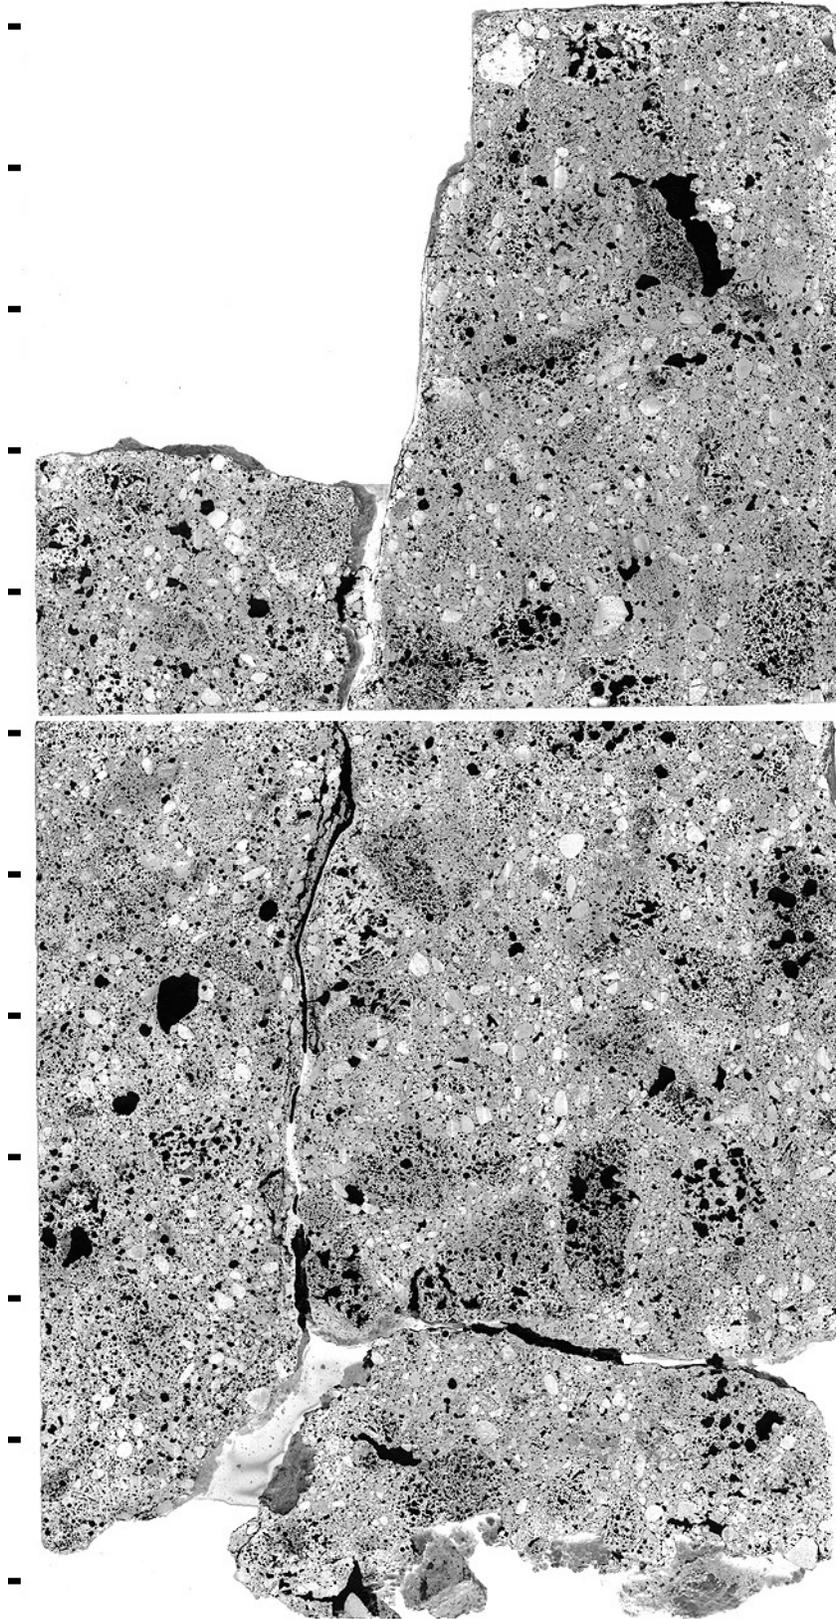
Figure 32: Polished slabs to represent cross-section through core MTU US23-07.

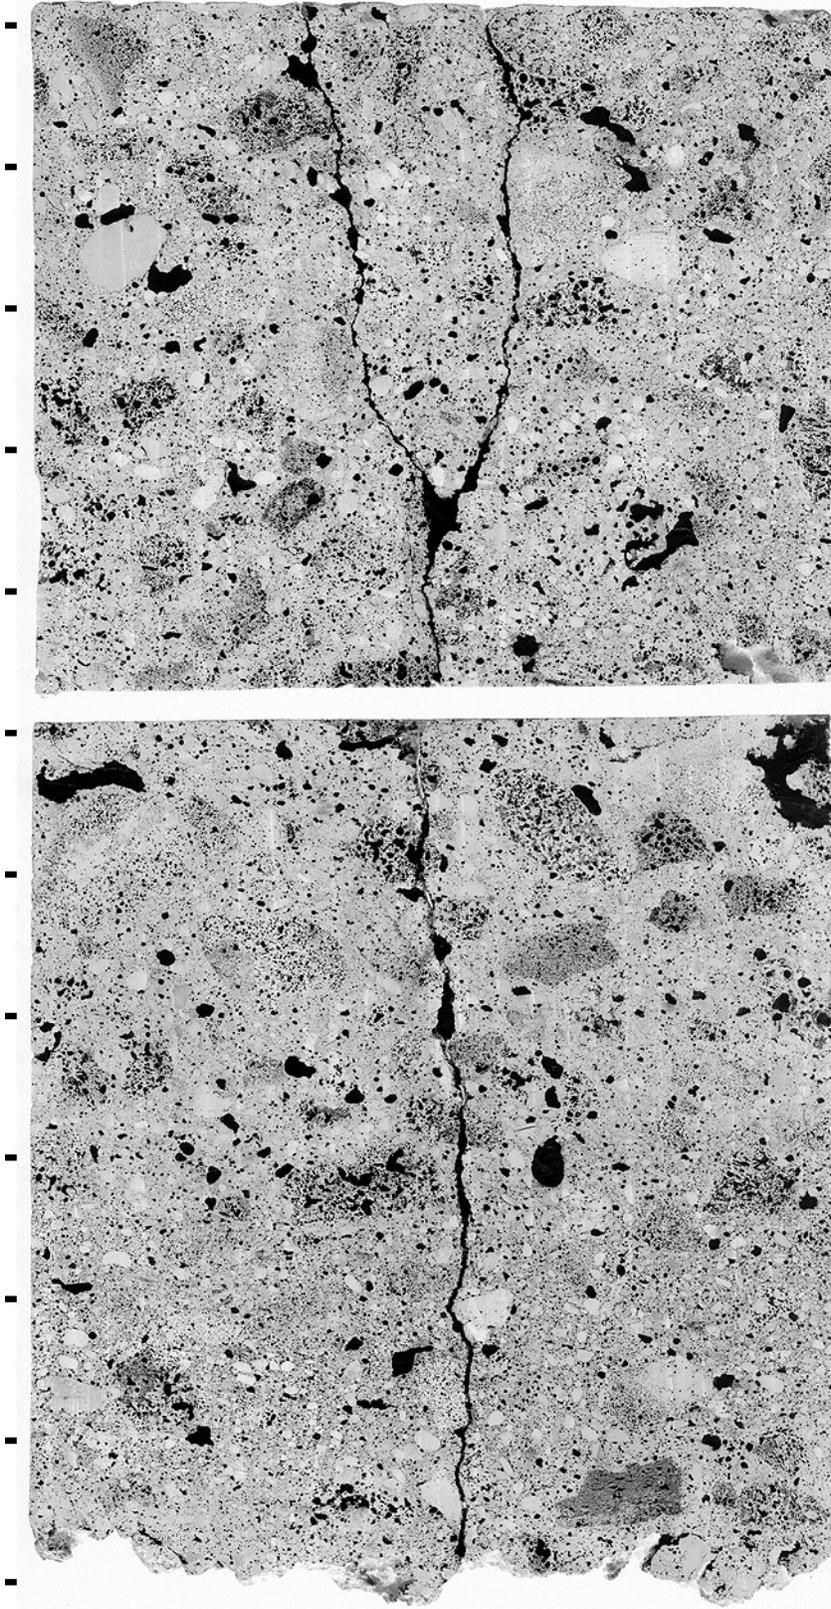
Figure 33: Polished slabs to represent cross-section through core MTU US23-06.
