**Evaluation of Concrete Pavements
with Materials-Related Distress**

Final Report

1. Report No. RC-1533	2. Government Accession No.	3. MDOT Project Manager David Smiley	
4. Title and Subtitle Evaluation of Concrete Pavements with Materials-Related Distress		5. Report Date 3/02/2010

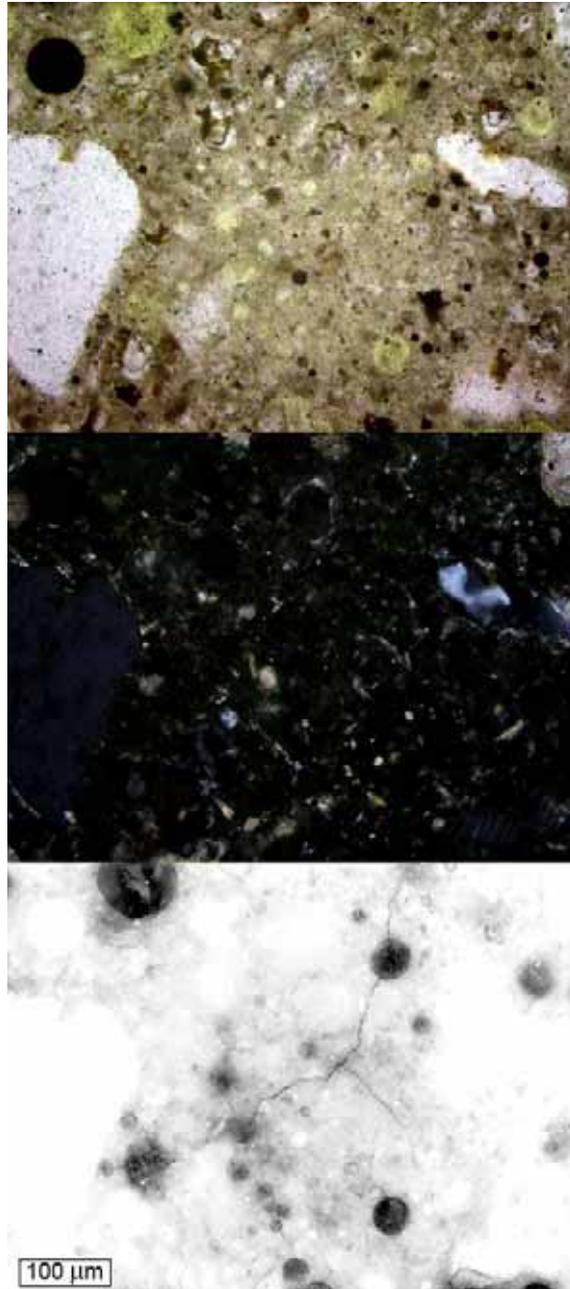
Figure 35: Fly ash in cement paste fraction in thin section prepared from core from US23, Section B at longitudinal joint, MTU ID US23-07. From top to bottom: transmitted light, crossed-polars, and epifluorescent mode images.
