DETERMINATION OF CONCRETE STRENGTH  
IN THE ARCH RIBS OF BRIDGE B01 of 22011  
(M 95 over Menominee River)

Research Laboratory Section  
Testing and Research Division  
Research Project 70 TI-12  
Research Report No. R-759

Michigan State Highway Commission  
Charles H. Hewitt, Chairman; Wallace D. Nunn, Vice-Chairman;  
Louis A. Fisher; Claude J. Tobin; Henrik E. Stafseth, Director  
Lansing, February 1971

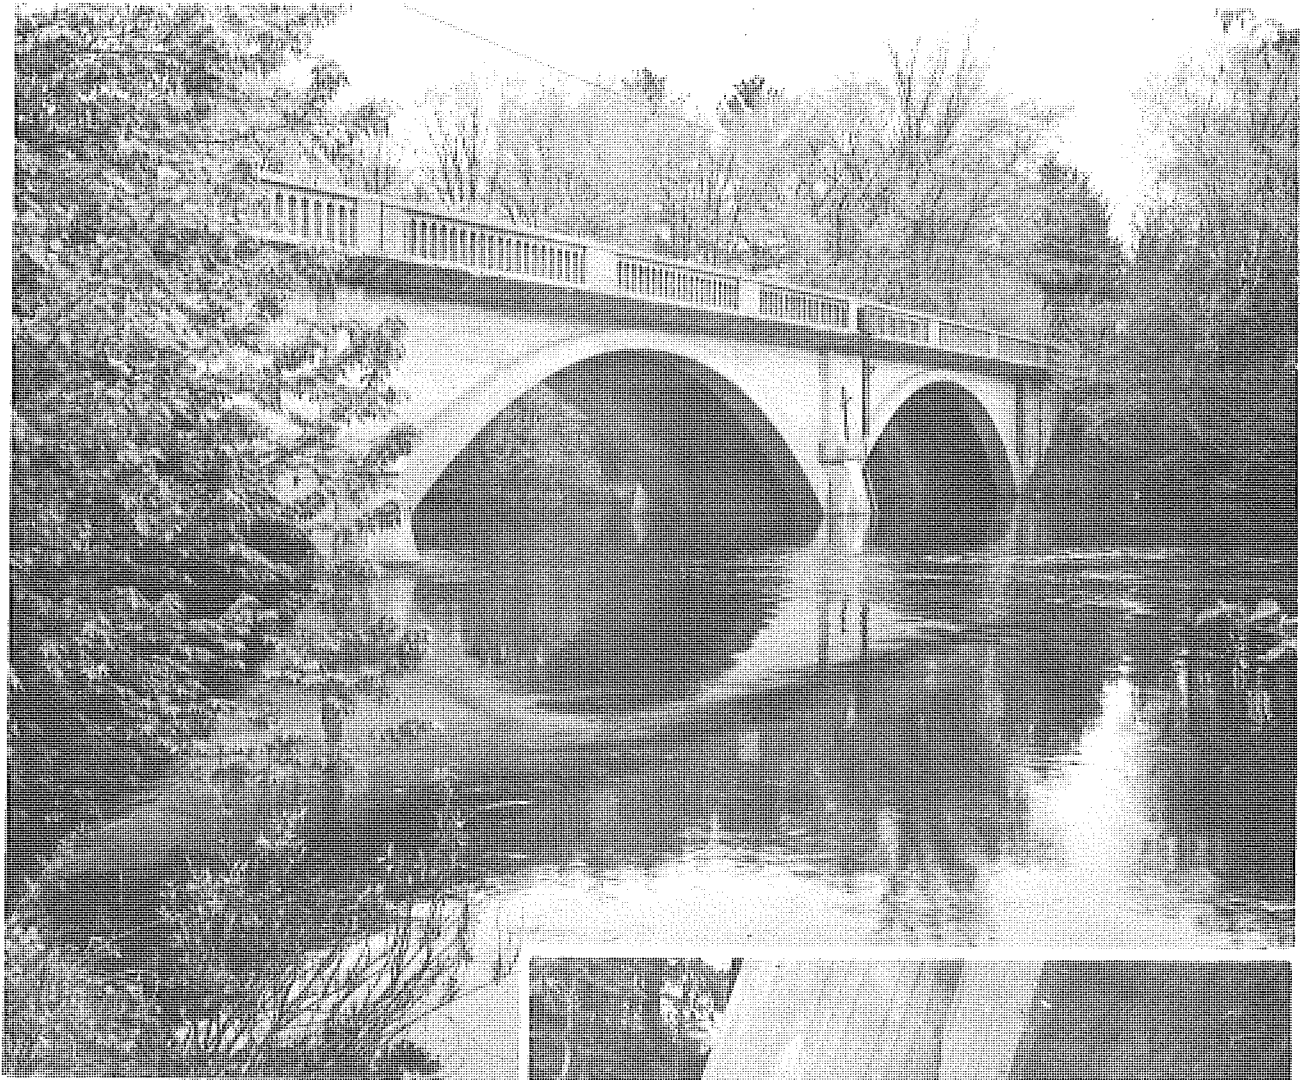
In May, an initial trip was made to the bridge site to generally assess the problem and obtain some initial cores and hammer readings. It was noted that water was entirely under all three spans with a swift current under the south span (Fig. 1). This limited the possible arch-rib working platforms to either a floating scaffold or one suspended from the bridge itself. Upon request, District 1 furnished chain, block and tackle, and a 20-ft painters scaffold. After manually lowering the scaffold over the side of the bridge and suspending it with block and tackle from the chains mounted to the parapet rail, it was discovered that the scaffold was unstable, dangerous to stand on, and too far removed from the arch rib to do any work. It was evident that more elaborate and specialized equipment would be required.

Figure 1. View of east side of bridge from the south (Wisconsin) bank.
