CONCRETE SPALLING ON PROJECTS 7-20, C6 AND
7-21, C2 ON US-41 IN UPPER PENINSULA

Research Project 51 B-26

Research Laboratory
Testing and Research Division
Report No. 208
April 16, 1954

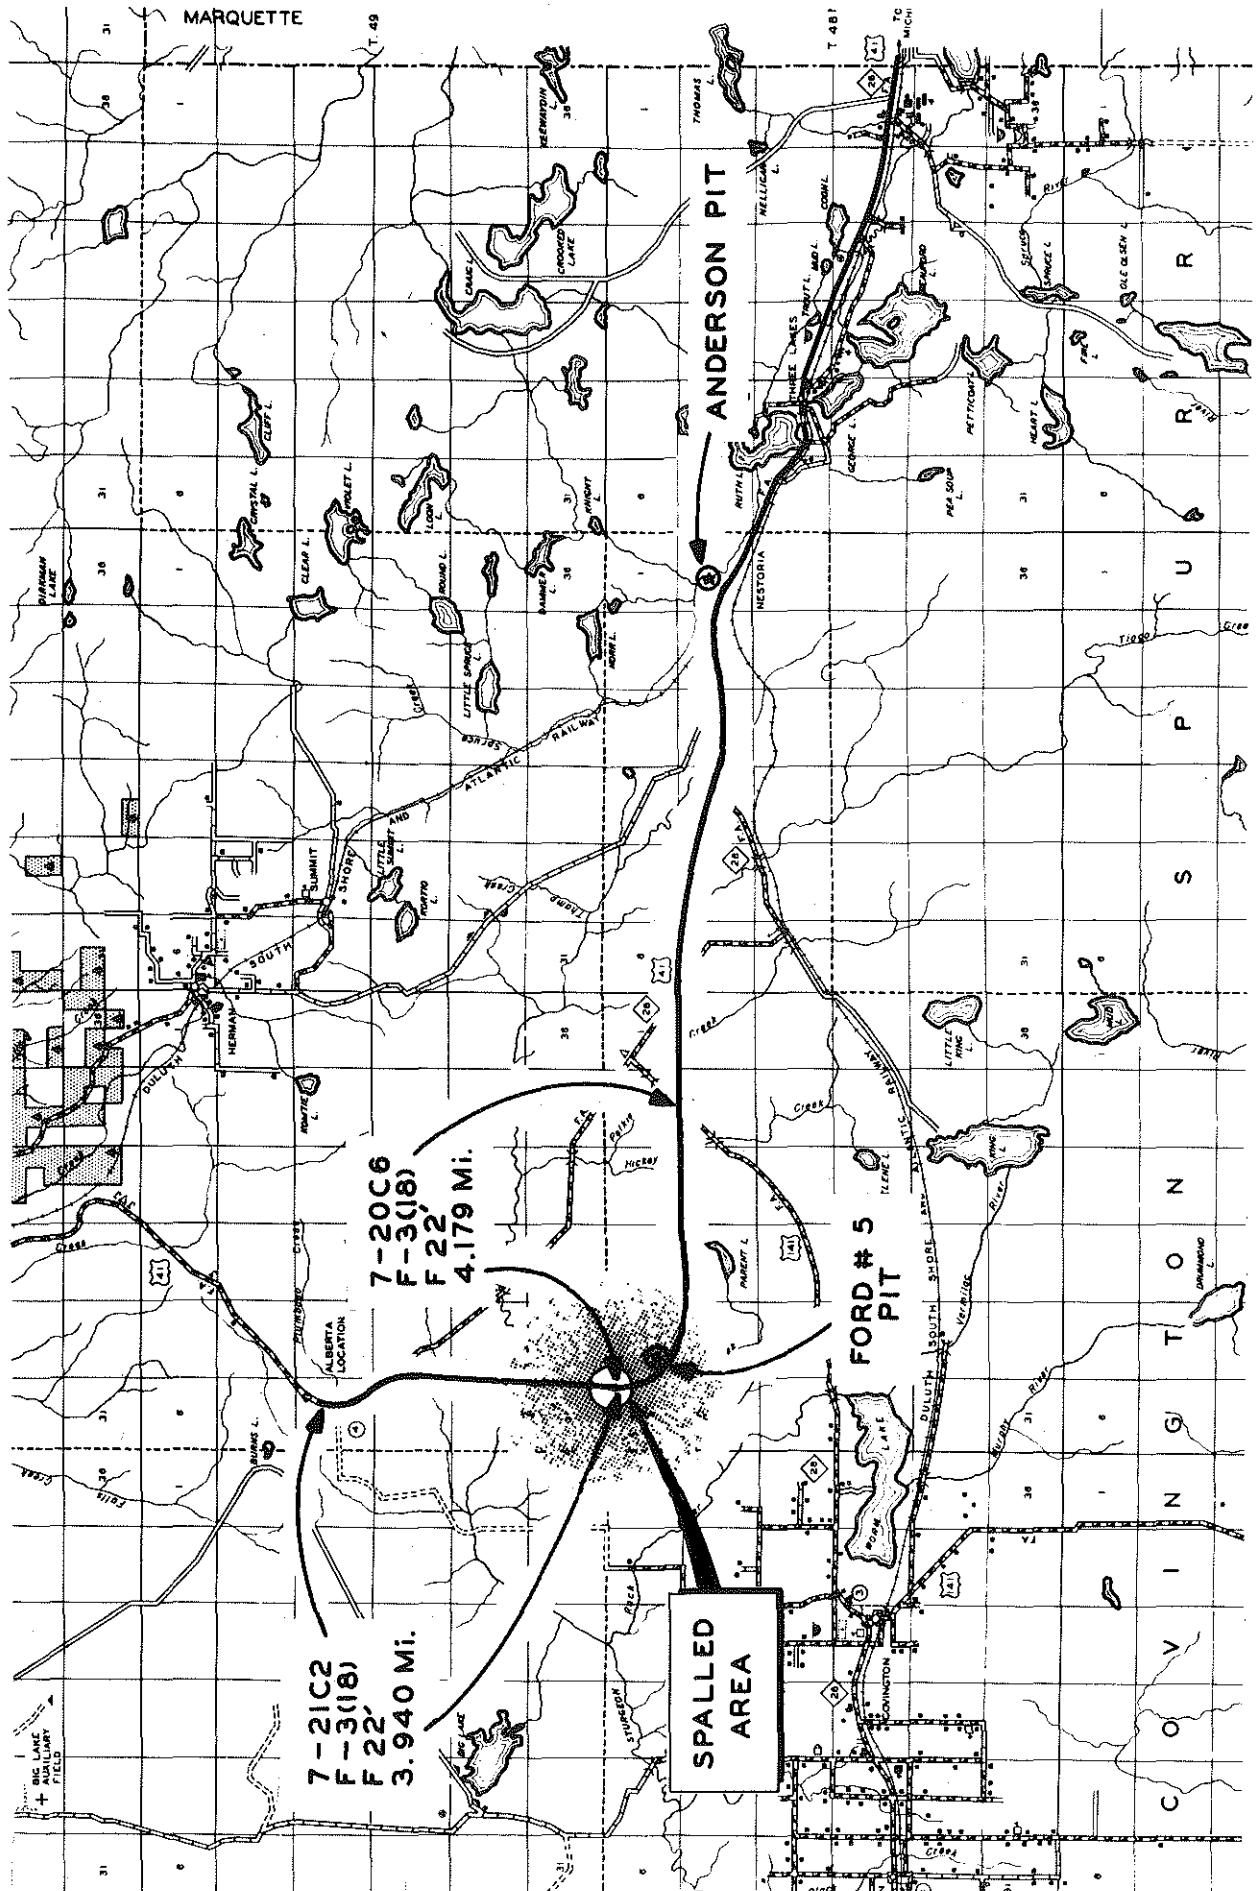
FIGURE I

On July 7, 1951, State Police reported considerable spalling of the concrete surface on US-41 between Alberta and Nestoria in Baraga County, Upper Peninsula. The spalling had occurred during the night of July 6, 1951. The pavement area associated with the spalling is located in projects 7-20, C6 and 7-21, C2 which adjoin each other. See Figure 1 for location of the two projects on US-41.

LOCATION OF SPALLED AREAS

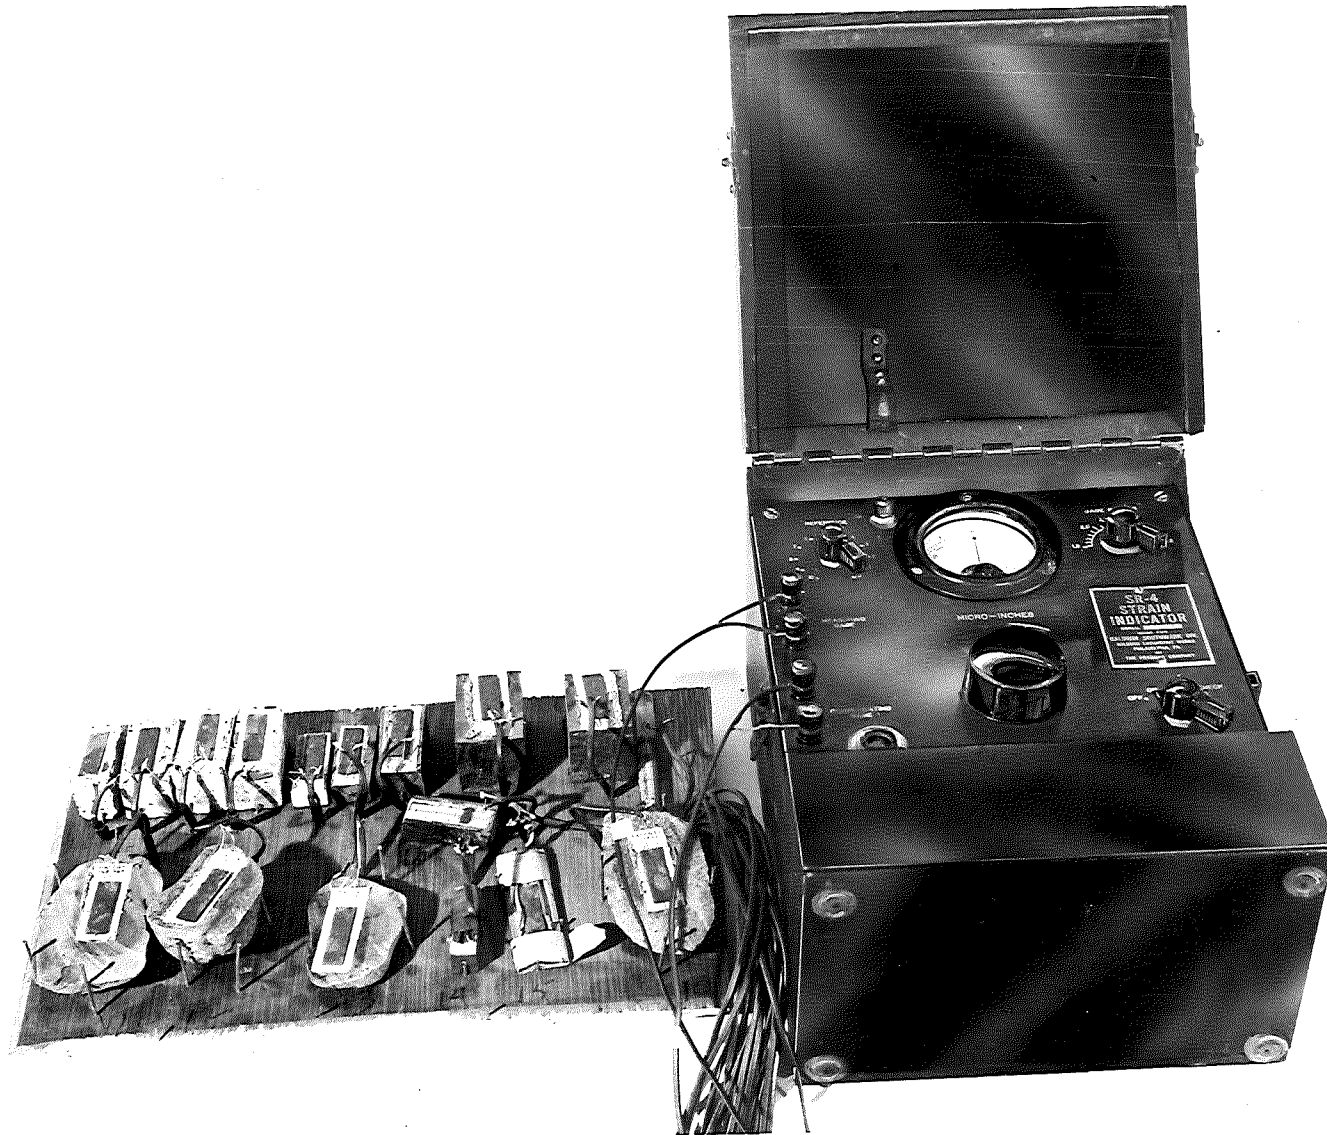
FIGURE 15

Table II contains thermal coefficient of expansion data for several rock types, including the slate. The values presented in Table II were determined by cementing SR-4 strain gages to the cut and polished rock face and recording the strain for a definite temperature range. (See Figure 15) Results from the strain gage method were considerably lower than those previously reported as determined by the dilatometer method. We now strongly suspect an error in the dilatometer work since the results from the use of strain gages seem more logical and they compare favorably with values reported in the literature. As expected, the slate was found to have a higher coefficient of expansion than the other rocks with the exception of smokey quartzite, which had a slightly higher value than the slate.

SR-4 STRAIN GAGE METHOD
FOR DETERMINING THERMAL COEFFICIENT OF EXPANSION
OF ROCK SPECIMENS.

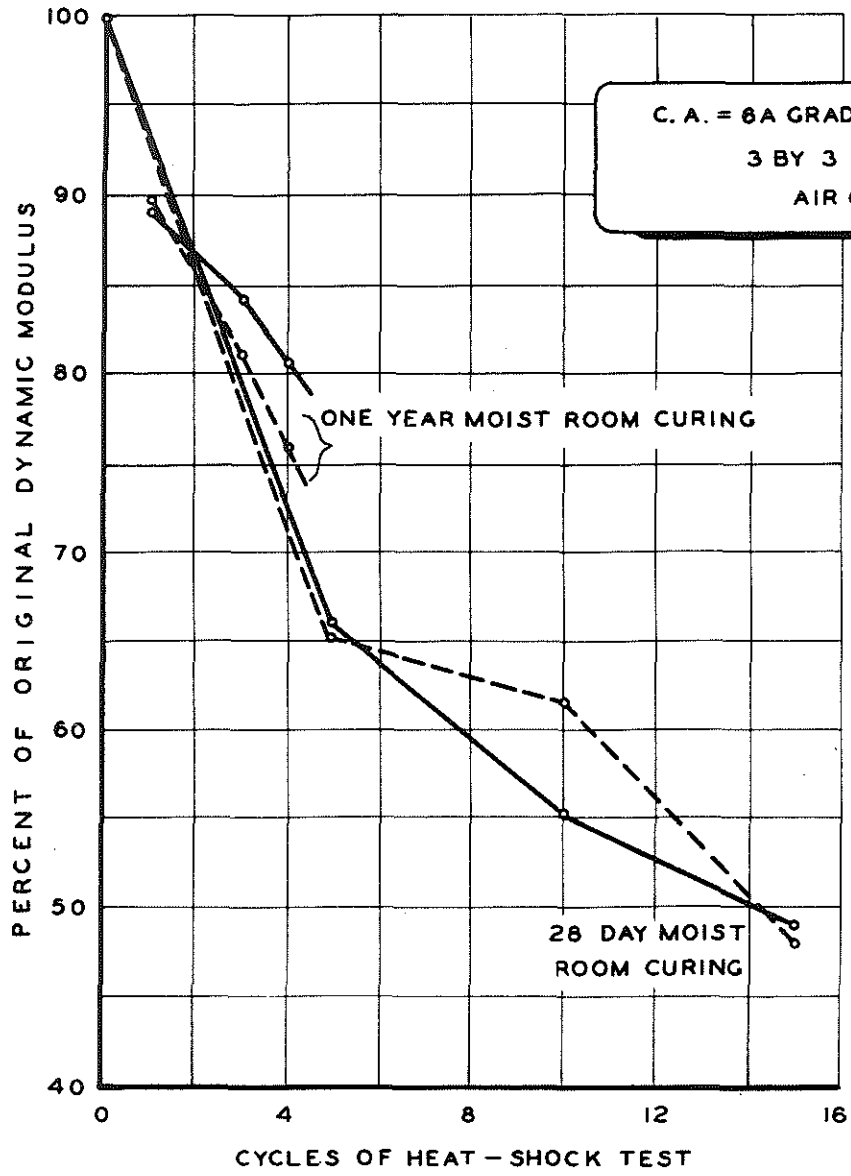
FIGURE 16

To check this belief, beams were prepared with and without the slate aggregate. The mix design and materials were the same as in the spalled projects. These beams were subjected to a heat shock cycle consisting of 8 hours in an oven at 145° F. and a cold cycle in water for 16 hours at 55° F. The data plotted in Figures 16 and 17 show no significant effect of the slate as compared to other rock types at the end of 16 cycles. Also, there is no indication that a major difference might have occurred had the test been continued beyond the 16-cycle period.

C. A. = 6A GRADING, ANDERSON PIT #7-22
 3 BY 3 BY 15 INCH BEAMS.
 AIR CONTENT = 5.0%

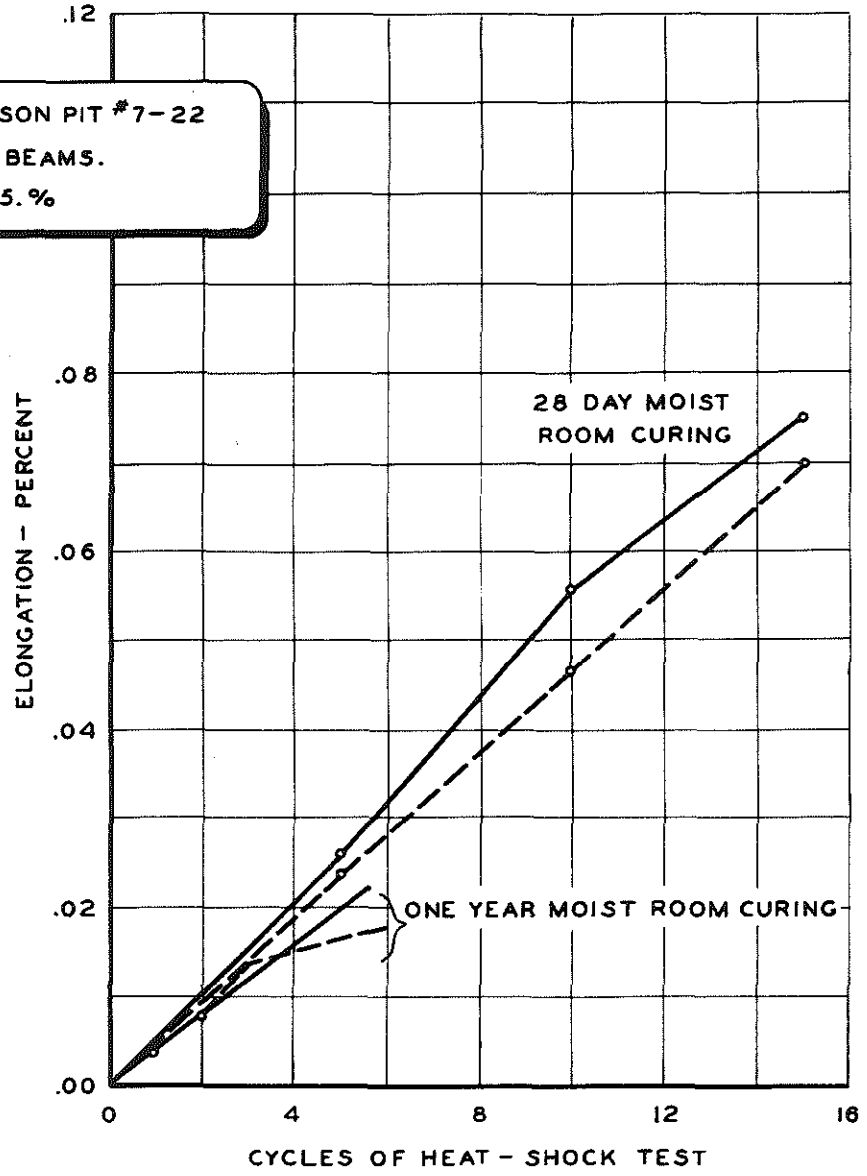
FIGURE 17

— BANK RUN GRAVEL
 - - - GRAVEL MINUS SLATE
