LIME TREATMENT OF A DETROIT SILTY CLAY
M 39 - Southfield Expressway at Oakwood Blvd. , Dearborn
(Project U 82192B, C21)

Research Laboratory Division
Office of Testing and Research
Research Project R-58 E-17
Research Report No. R-451

Michigan State Highway Department
John C. Mackie, Commissioner
Lansing, April 1964

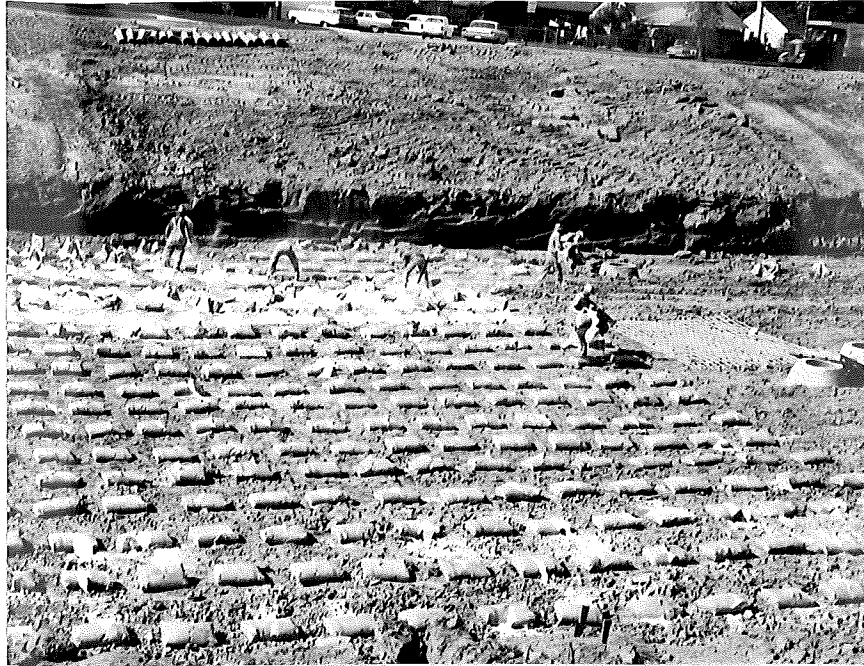
Bagged lime was spotted uniformly and spread over the dry surface by a crew of eight men, an operation requiring almost two days (Fig. 1). The piles of lime were then further spread by a bulldozer-drawn section of reinforcing mat. This procedure was fast and left a uniform layer of lime over the surface. The area was then lightly disced (Fig. 2) as an initial mixing and to reduce blowing of lime from the surface.

Figure 1. Spotting and spreading of bagged lime.

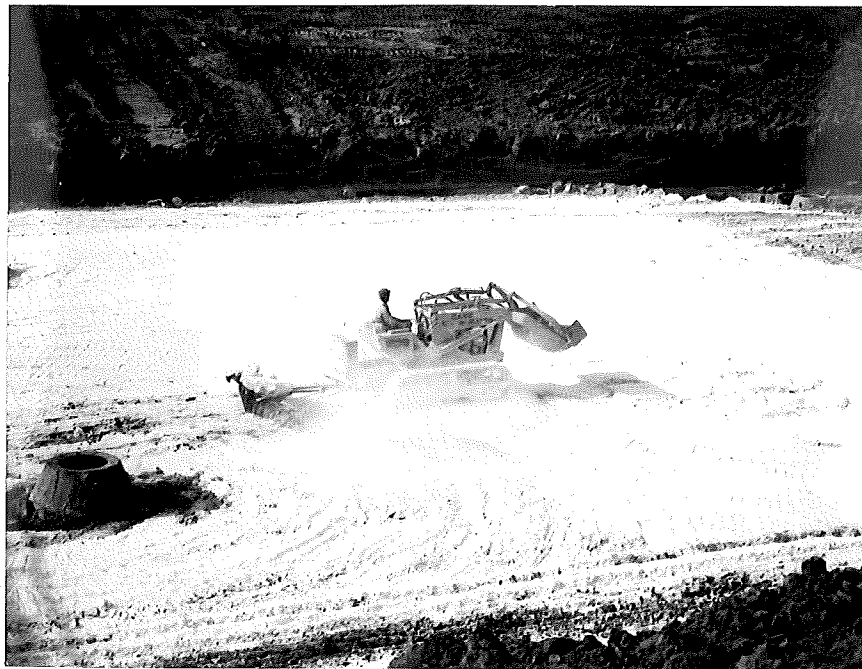
Figure 2. Initial mixing using disc.

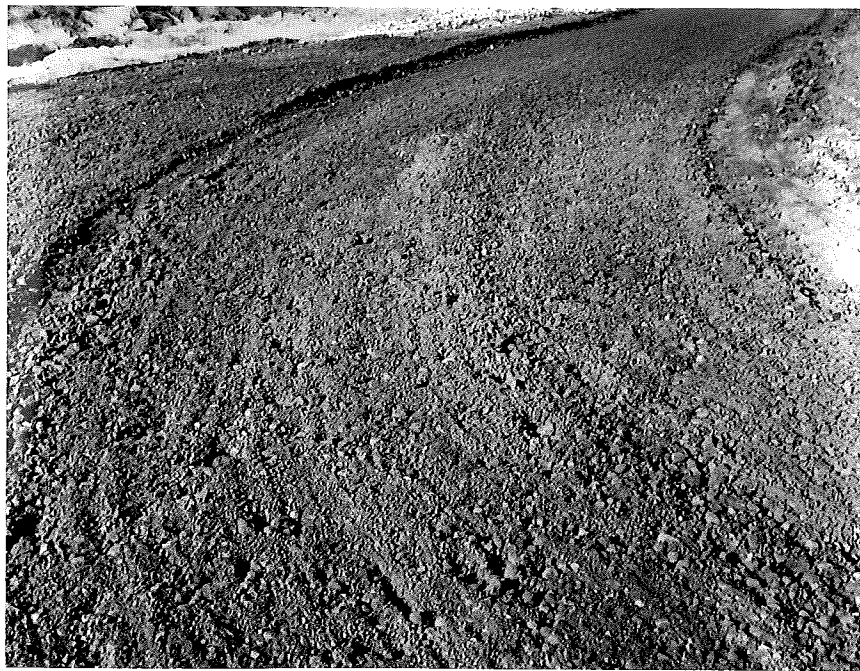
Based on improved mixing due to water addition, the entire job was watered during subsequent mixing with the Seaman. Water application, however, was uneven causing wet and dry areas which increased the mixing time required. Fig. 5 shows a general view of the job just prior to compaction, with a closeup of the soil-lime mix at this time in Fig. 6.

Figure 6. Close-up of mixture prior to compaction.
