EVALUATION OF VARIOUS BRIDGE
DECK JOINT SEALING SYSTEMS

Final Report

**Research Laboratory Section
Testing and Research Division
Research Project 72 F-128
Research Report No. R-1121**

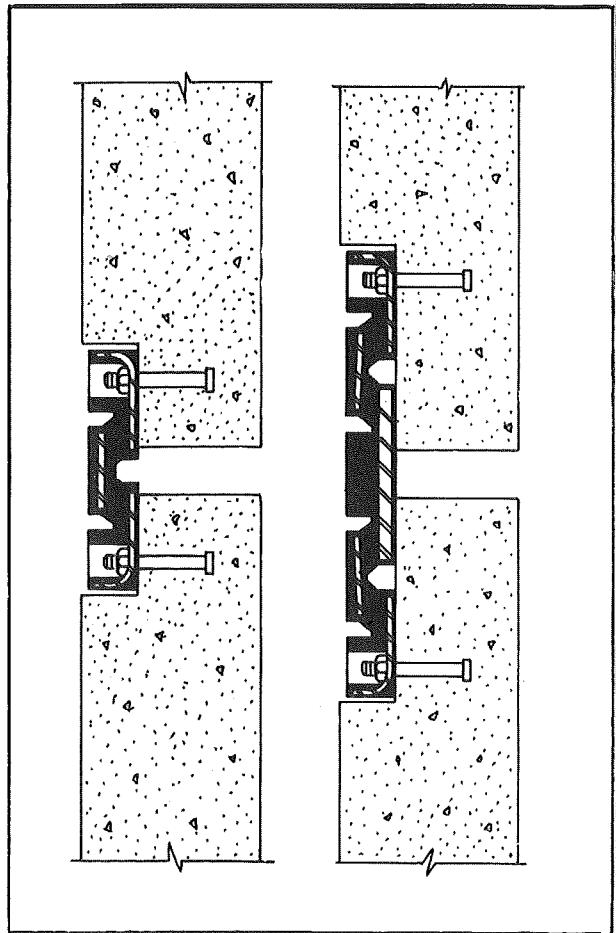
Figure 1. The drawing at left shows Transflex 200A and 250 (upper) and Transflex 400A and 650 (lower). Photos show (left to right) a Transflex 200A installation, a view of the sealed joint between two 200A pads, and the curb and sidewalk area of a Transflex 200A during installation.

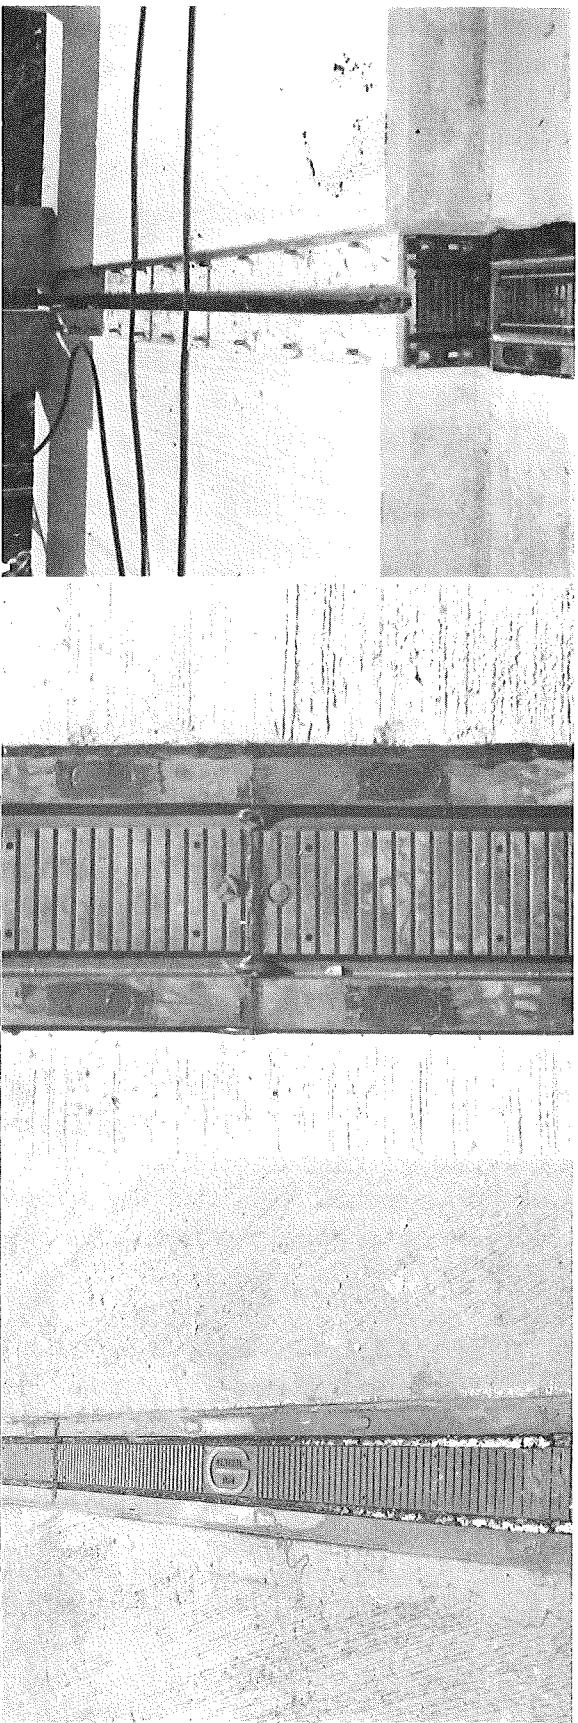
Most stud well plugs are lost when exposed to traffic use (Fig. 2). This allows corrosion of the studs and nuts which will eventually cause the pads to loosen. Our specifications have been changed to require that the stud wells be filled with a flexible epoxy.

Curb and gutter sections are also particularly vulnerable to damage and are frequently a source of leakage. Figure 2 also shows a curb and gutter installation that, though good in appearance, was found to be leaking. Factory prefabricated curb and gutter sections would be a major improvement.

Loss of stud well plugs and severe snow removal equipment damage, totally exposing steel.

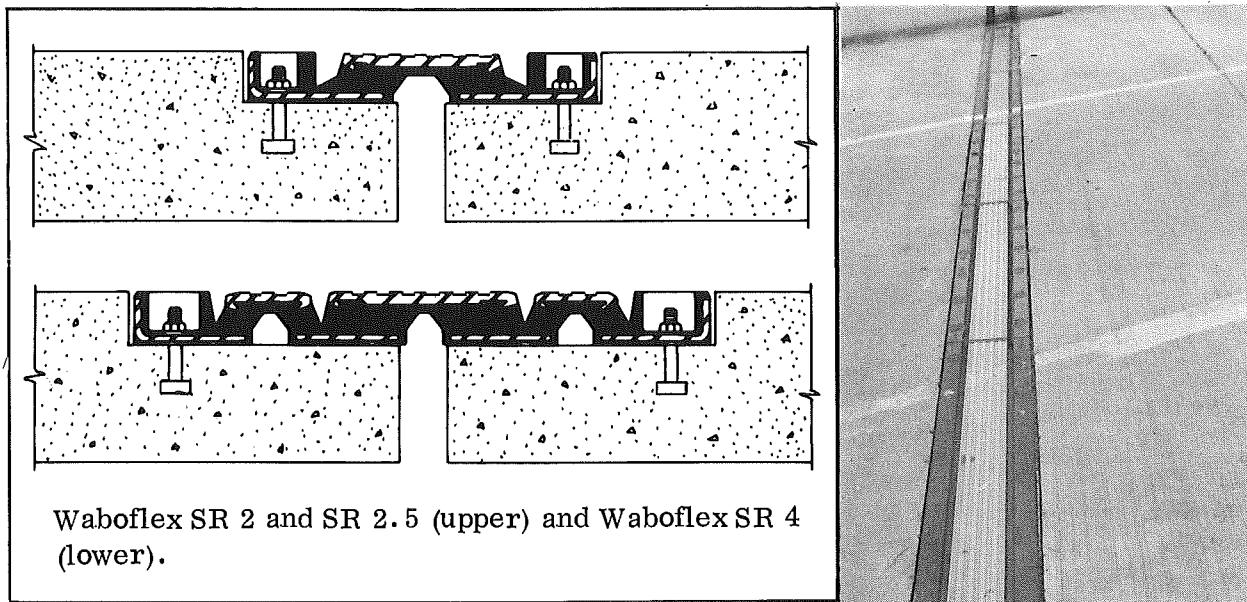
Figure 5. The drawing (above) depicts the Waboflex sealing systems; the photo at right shows a Waboflex SR 2 installation.

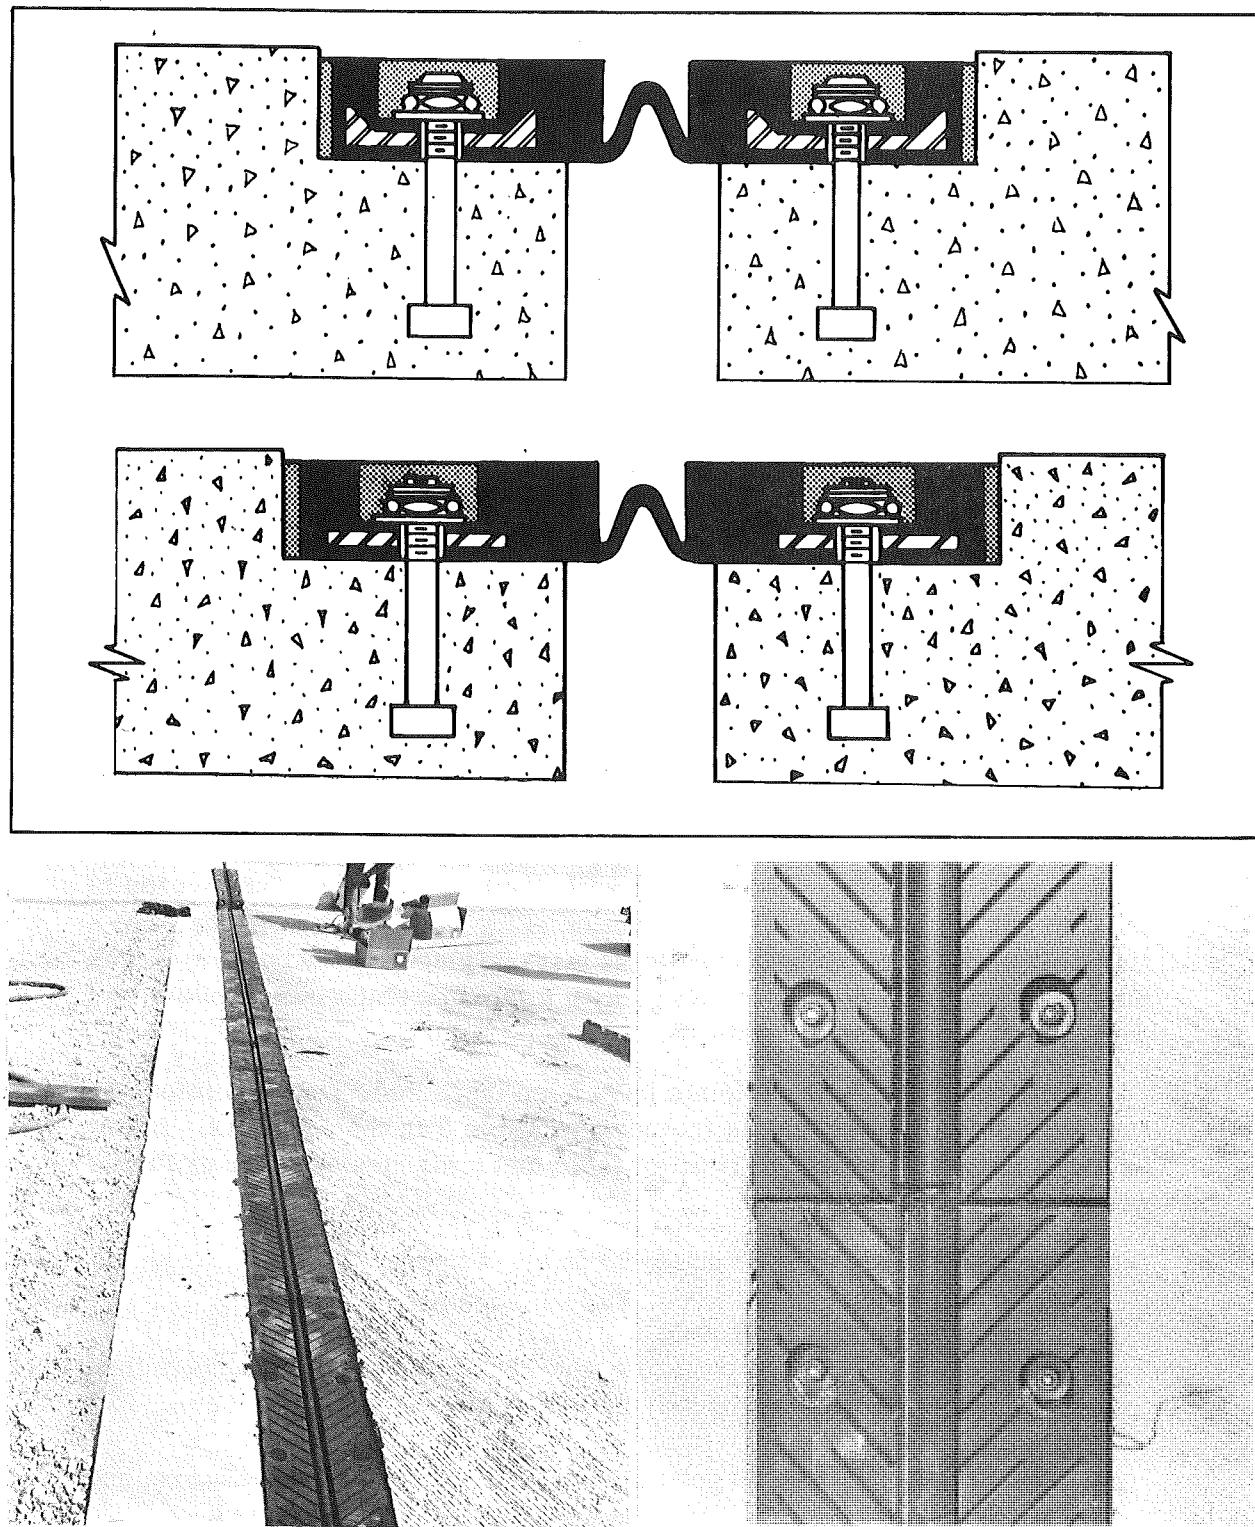
Figure 10. The drawing shows the Fel Span T20 (upper) and Fel Span T30 and T40 (lower). The left-hand photo shows the Fel Span T20 during installation; the right-hand photo shows a Fel Span T30 interconnect joint prior to filling side and stud wells with epoxy.

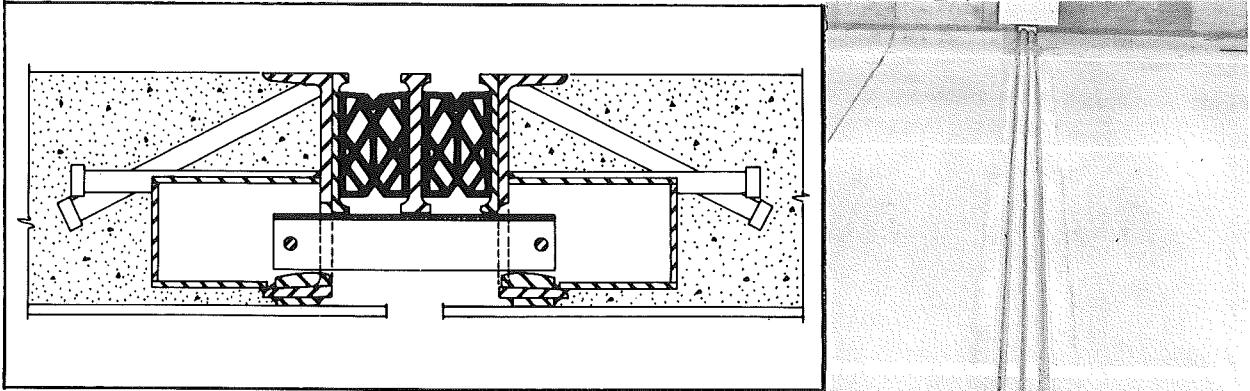
Figure 14. Cross-section of a double modular compression system (above) and an overall view of a triple modular system (right).

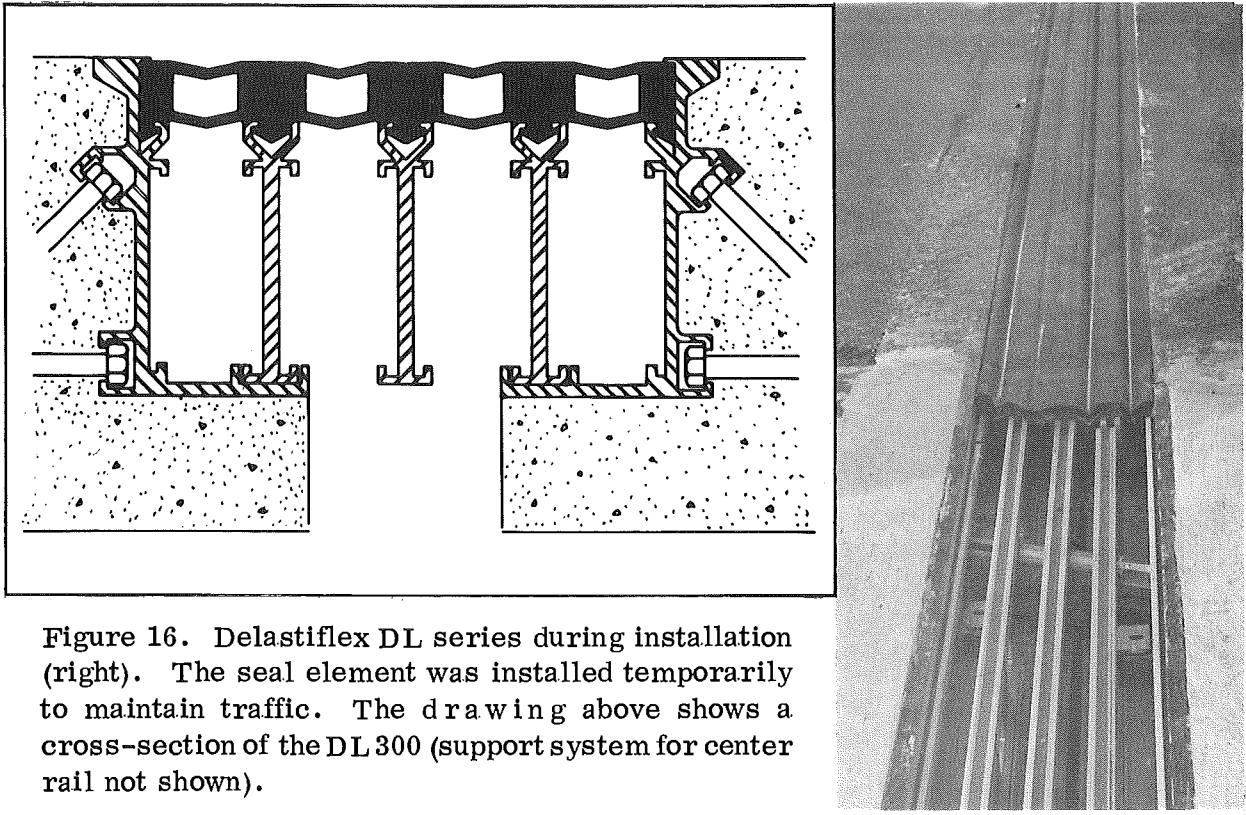
Figure 16. Delastiflex DL series during installation (right). The seal element was installed temporarily to maintain traffic. The drawing above shows a cross-section of the DL 300 (support system for center rail not shown).

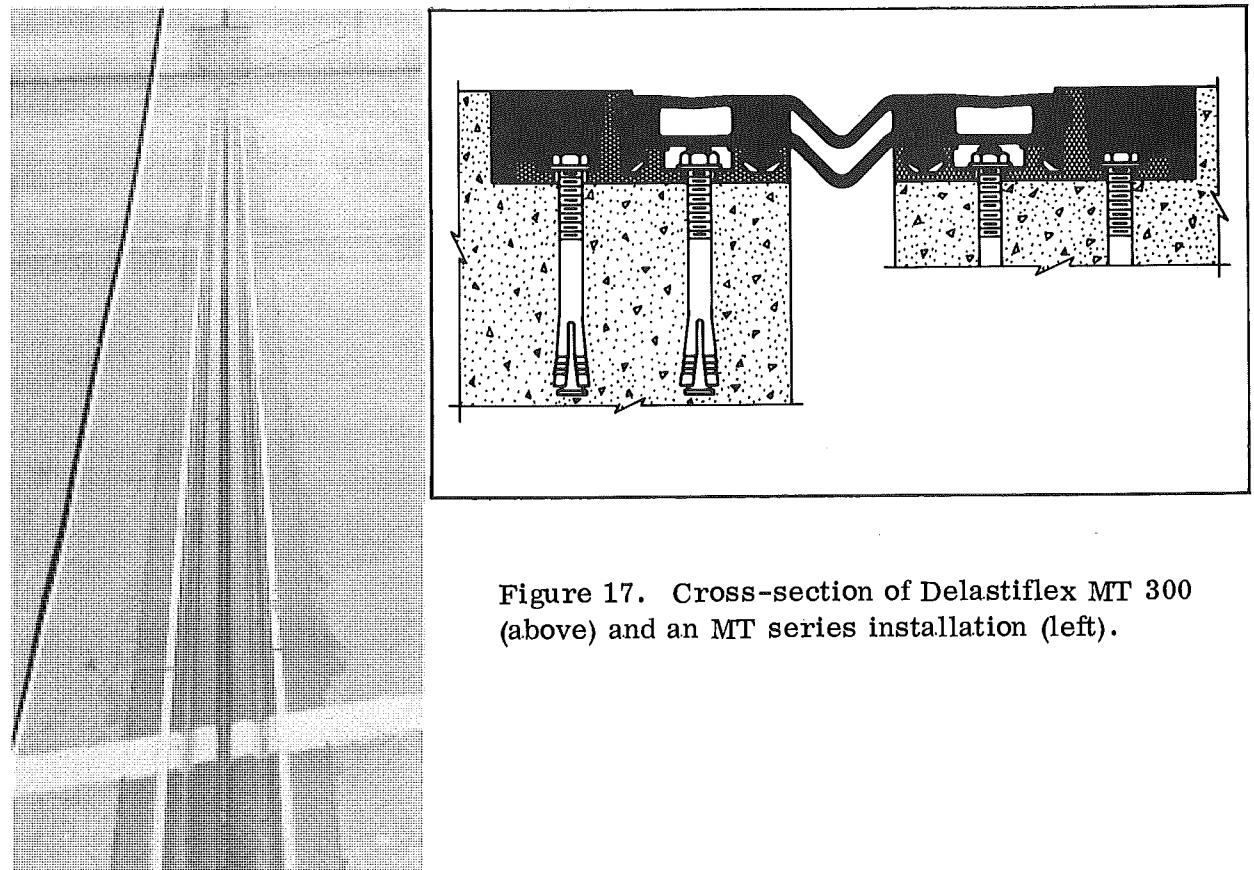
Figure 17. Cross-section of Delastiflex MT 300 (above) and an MT series installation (left).

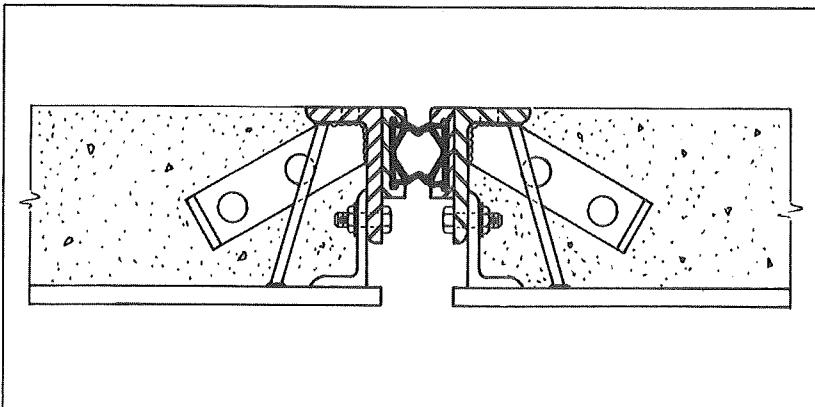
Figure 20. Cross-section (above) and typical installation (right) of the Type 190 Michigan Modified Wabo-Maurer seal.

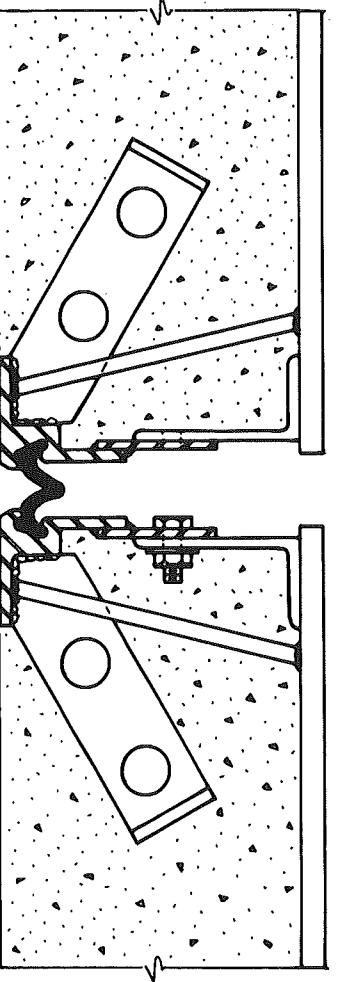
Figure 22. The drawing (above) shows the Wabo-Maurer strip seal; the photo (left) shows the system bolted in place and ready for the epoxy mortar to be placed above the studs.

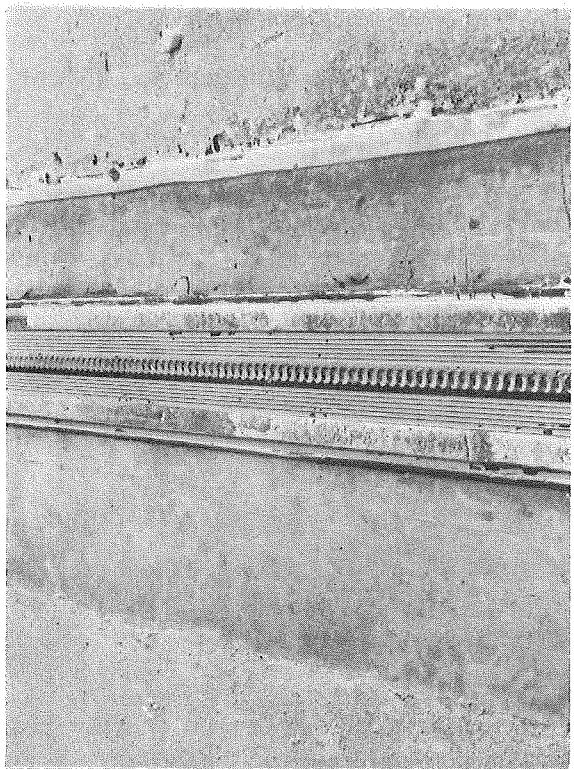
Figure 23. The drawing at the upper left shows the Onflex Maintenance Series installation; the lower drawing shows the Onflex Low Profile system. The photo above shows the Onflex Model 25 installed and in good condition at the time of inspection.
