FAILURE OF I 94 JOINT SEALANTS
Mt. Clemens to Marysville

Research Laboratory Division
Office of Testing and Research
Research Project R-64 G-133
Research Report No. 456

Michigan State Highway Department
John C. Mackie, Commissioner
Lansing, April 1964

THIRD INSPECTION OF FAILED JOINT SEALANTS

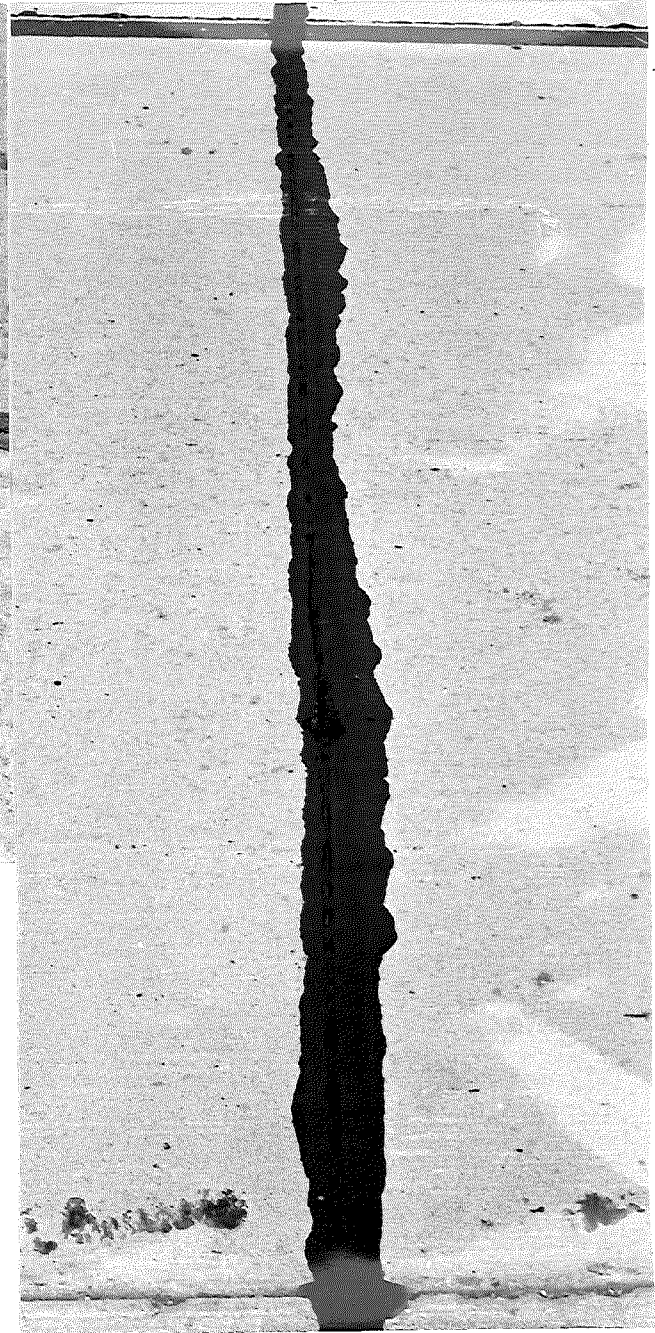
Figure 1. Joint sealant appearance in November 1963 (left), and June 1964 (right) showing exuded warm weather condition and healing of cohesion failure (Sta. 343+80 SB). Same joint shown in Fig. 2 of Research Report R-456.
