CONCRETE PAVEMENT PERFORMANCE  
PROBLEMS AND FOUNDATION  
INVESTIGATION OF I 75 FROM THE  
OHIO LINE NORTHERLY TO THE HURON RIVER

J. E. Simonsen  
E. C. Novak, Jr.

Research Laboratory Section  
Testing and Research Division  
Research Project 80 TI-669  
Research Report No. R-1171

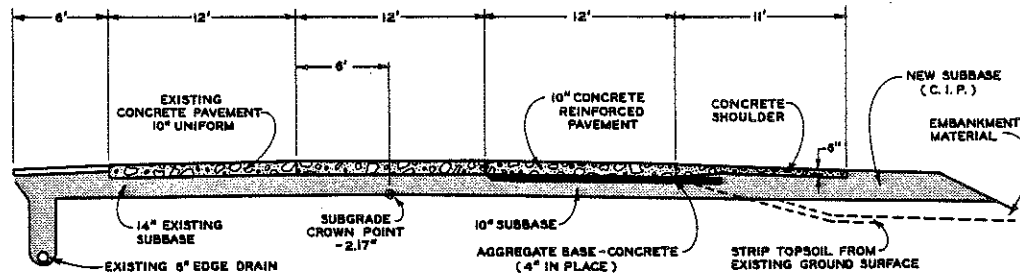
The section of I 75 studied has the typical cross-section shown in Figure 3. The subgrade and subbase materials are the same under all three

lanes. The only differences between lanes is that the outside or add-on lane has an approximately 3-in. thick crushed limestone aggregate base and a subbase which is thinner by 3 in. The original lanes are constructed directly on the subbase. Therefore, the total thickness of original subbase and new subbase plus base is the same.

Figure 3. I 75 pavement cross-section, as designed.

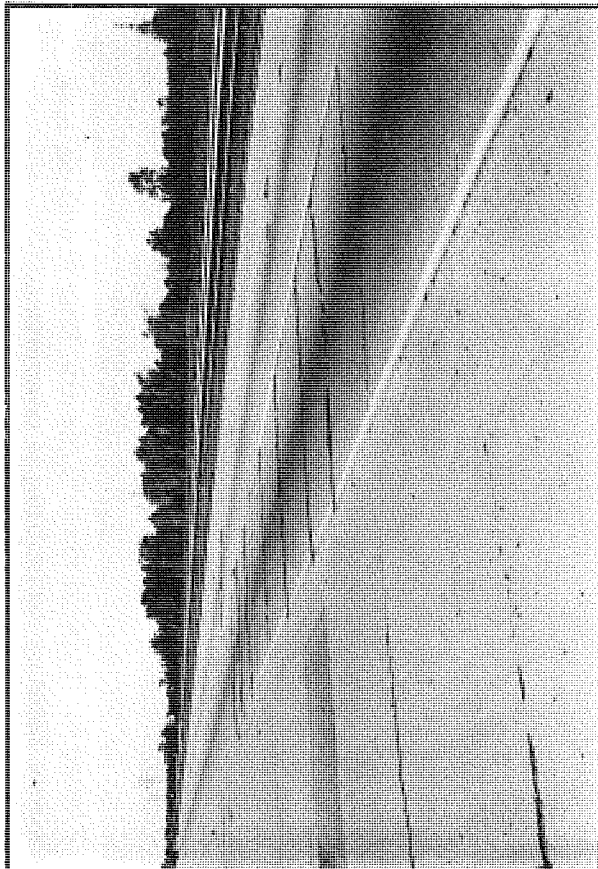
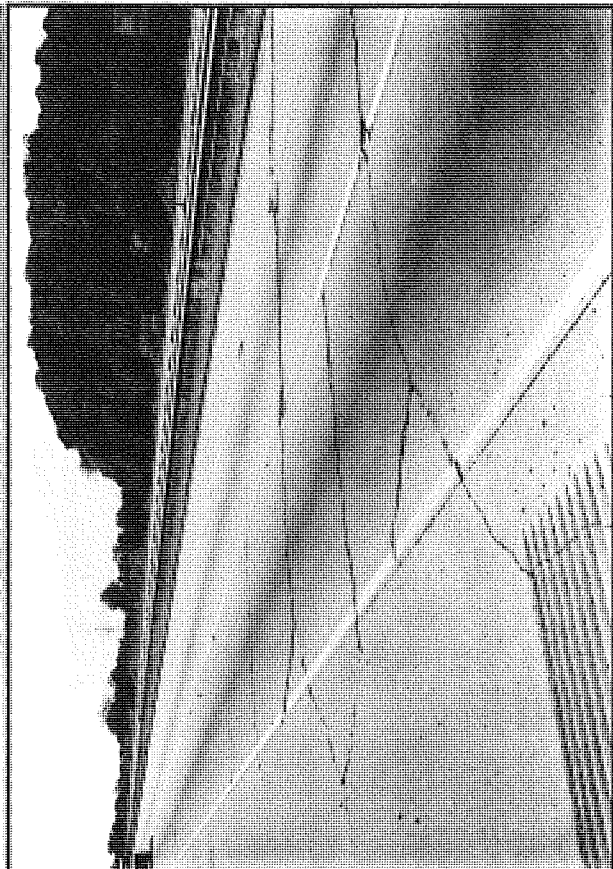
Figure 10. Severe cracking of the add-on lane indicating varying degrees of faulting and no associated depression of the surface of the add-on lane relative to the original pavement.

As stated in the pavement performance phase of this report, the general absence of faulting in the northern and southern ends of the pavement investigated, indicates that degradation of the base in these areas is not as rapid as it is in the central section. However, there appears to be no definite relationship between degradation and source of base material since all base material came from either France Stone (Pit 58-1) or France Stone (Monroe) (Fig. 15). While more data would be necessary in order to more accurately predict future pavement performance characteristics, indications are that all of the add-on lane between northbound exits 2 and 15 will be subject to premature failure of the type shown in Figures 10 and 11.

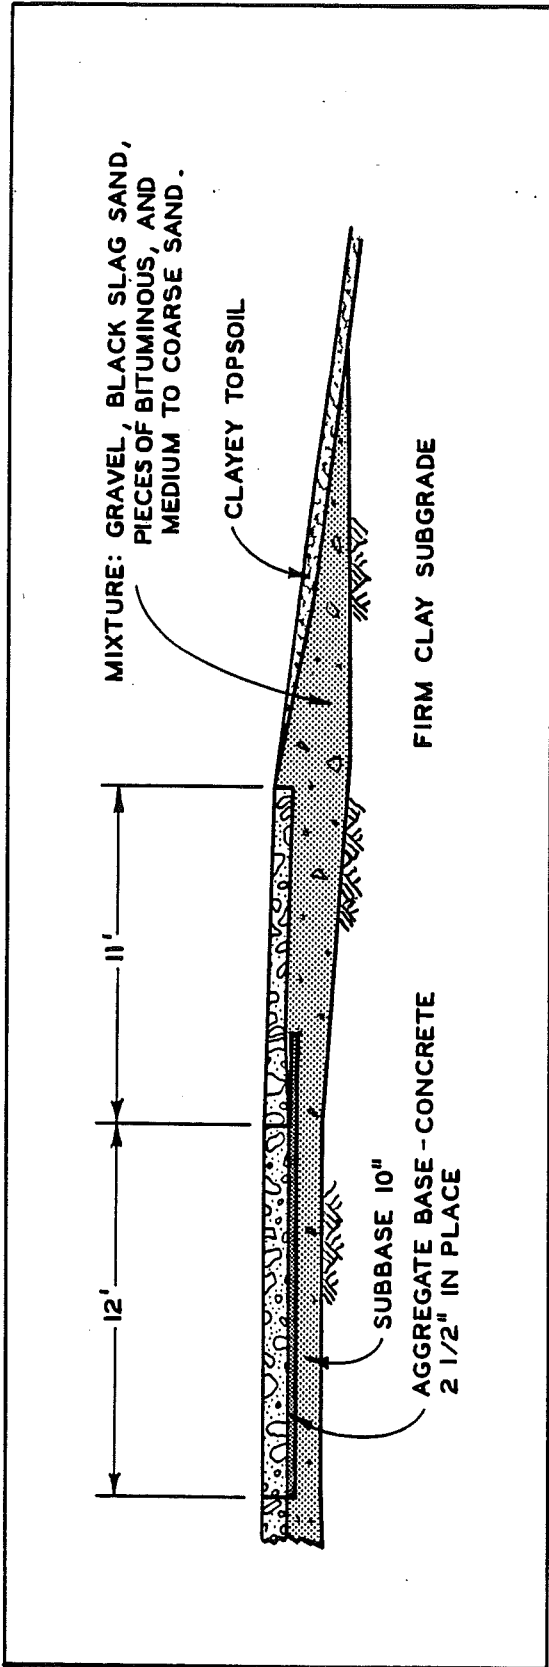
The as-built cross-sections from the outside lane to the ditch line of two sites selected for more detailed study are shown in Figures 12 and 13. Generally, the side slope area is covered with a thick layer of relatively impervious clayey soil. Thus, gravity water drainage is restricted at the side slope. It was beyond the scope of this study to classify foundation drainage conditions over all of the 13 miles of pavement investigated; however, differences do appear to exist in various sections of the project.

Figure 12. I 75 pavement cross-section at Station 320+25.

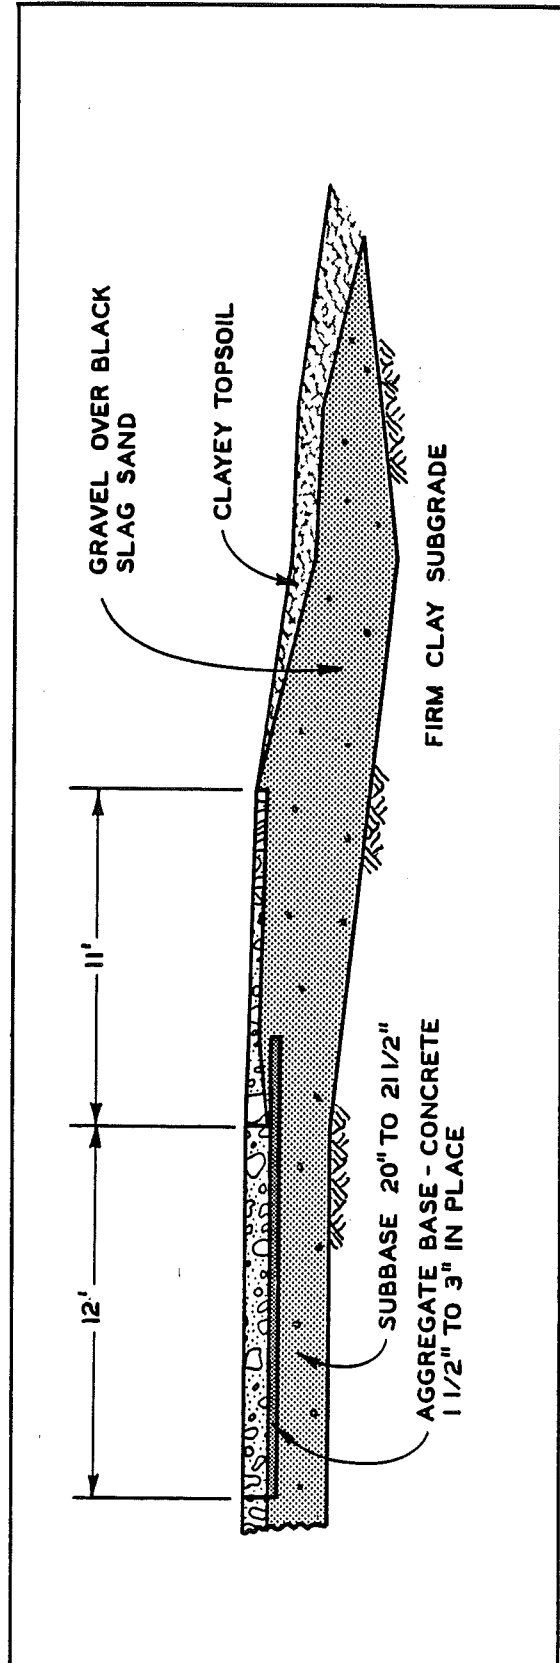
Figure 13. I 75 pavement cross-section at Station 512+15.

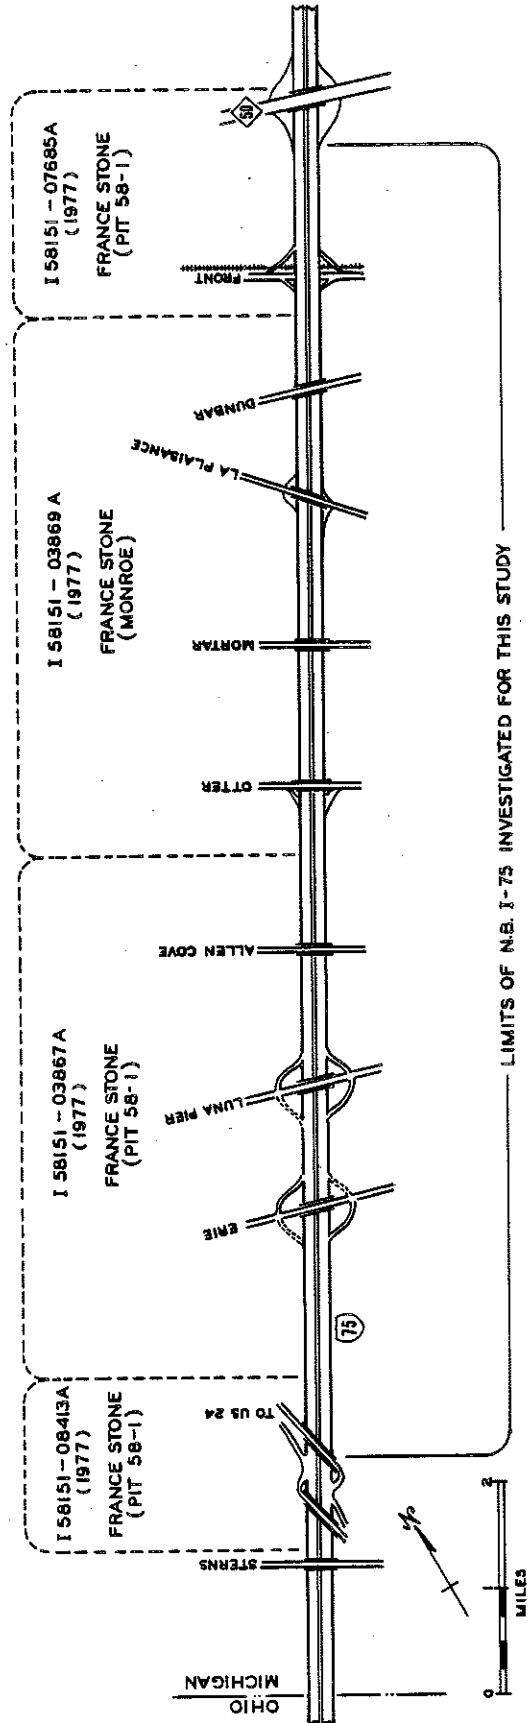
Figure 15. Aggregate base material sources for the control sections shown.
