CORROSION PERFORMANCE OF ALUMINUM CULVERTS
SECOND PROGRESS REPORT

Research Laboratory Section
Testing and Research Division
Research Project 60 NM-26
Research Report No. R-679

State of Michigan
Department of State Highways
Lansing, December 1968

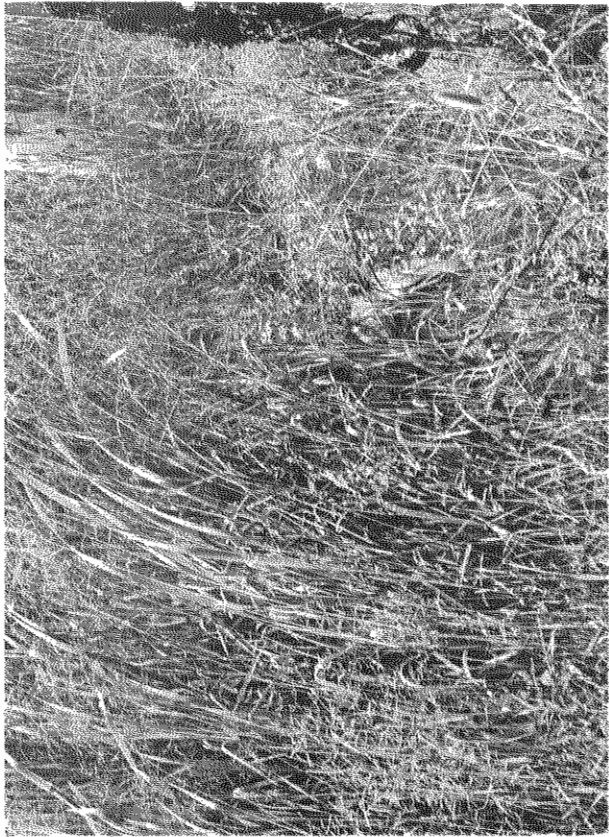
South end, Sta. 96+00.

Figure 1. Typical culvert site conditions.

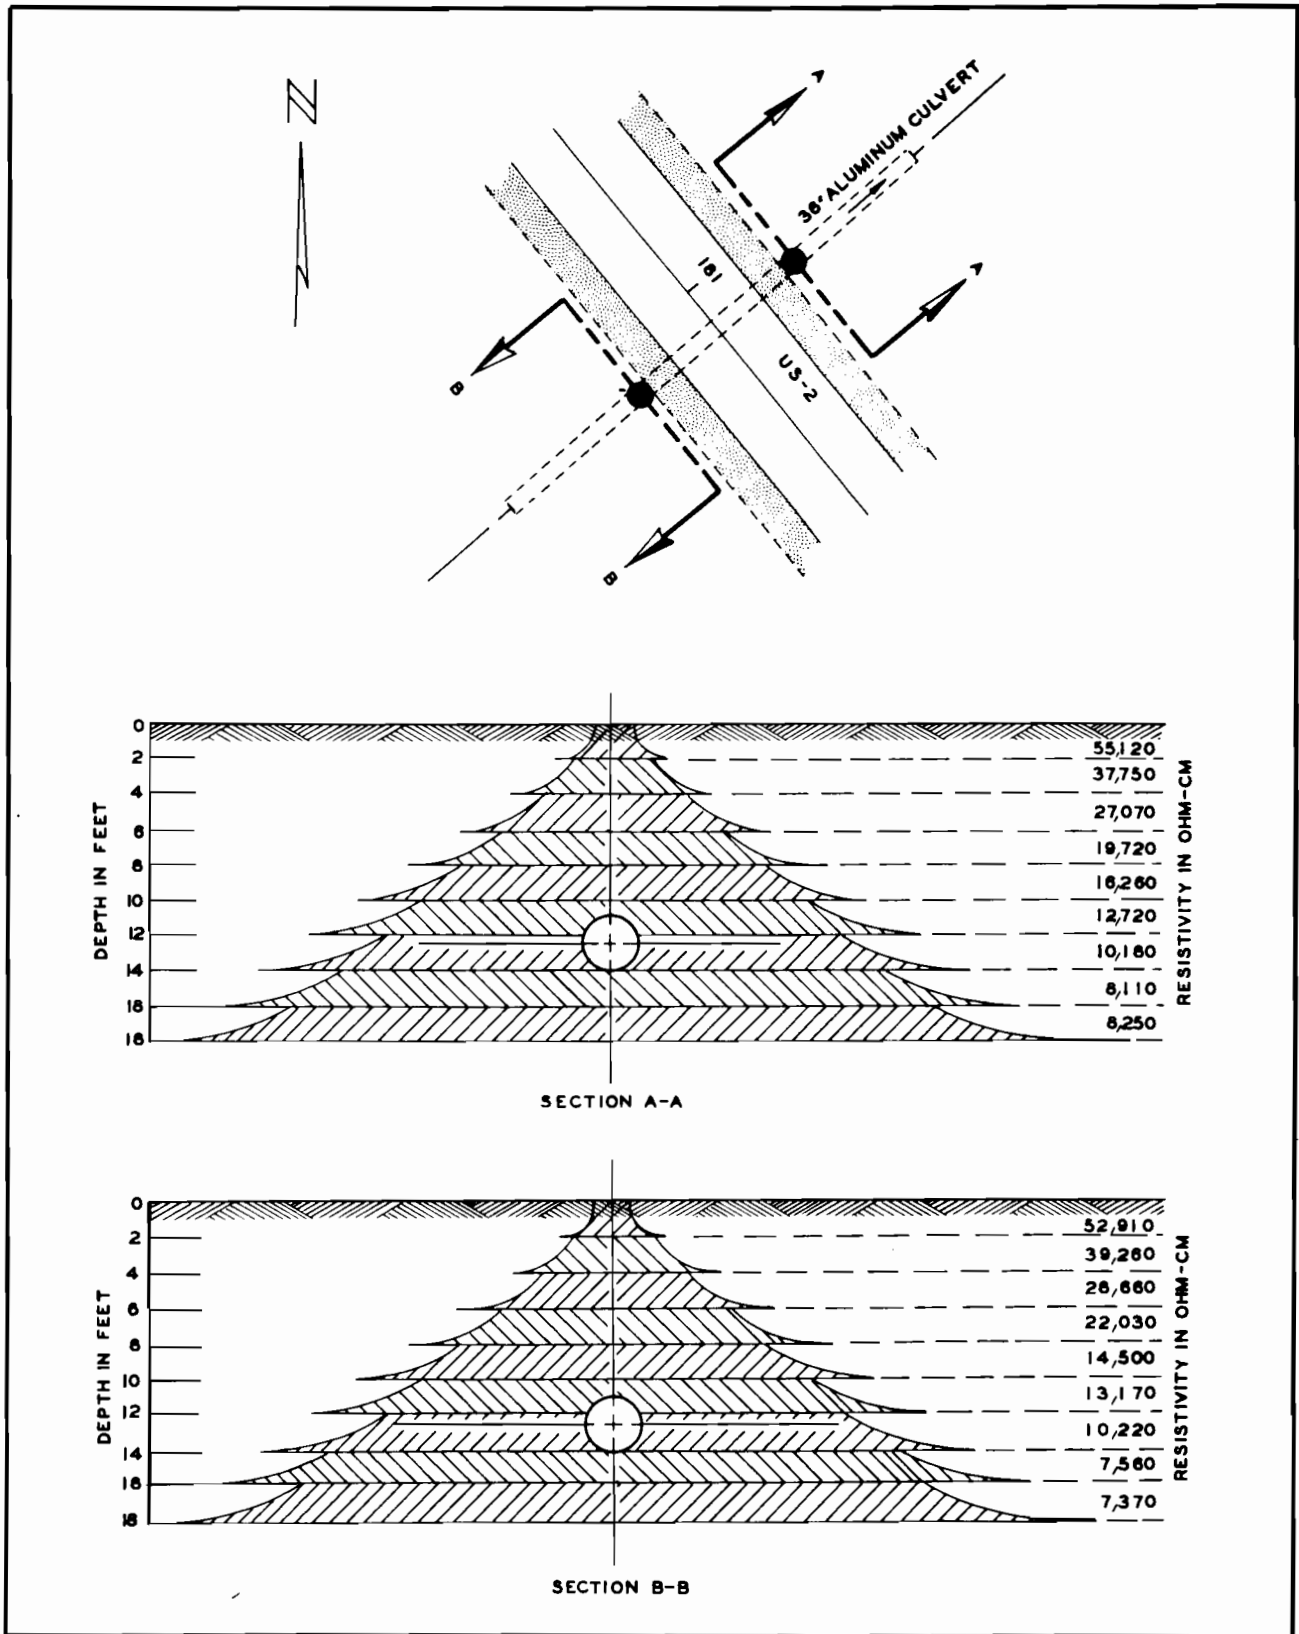
Figure 6. Aluminum culvert, Sta. 181+10. Plan shows typical relationship of the resistivity soundings to the roadway and the culvert.

The typical area plan shows, schematically, the general relationship of the soundings to the roadway and to the culverts (Fig. 6). The resistivity values obtained at each site are given in Table 3.

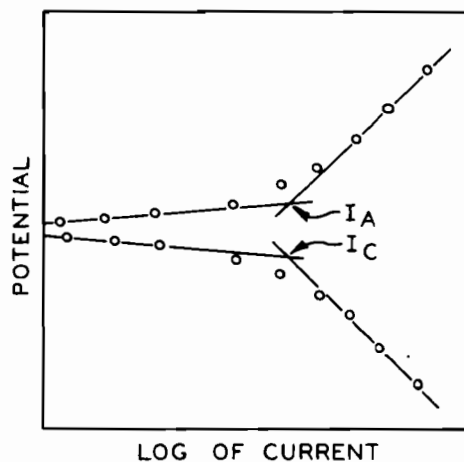
Figure 7. Typical polarization curve.

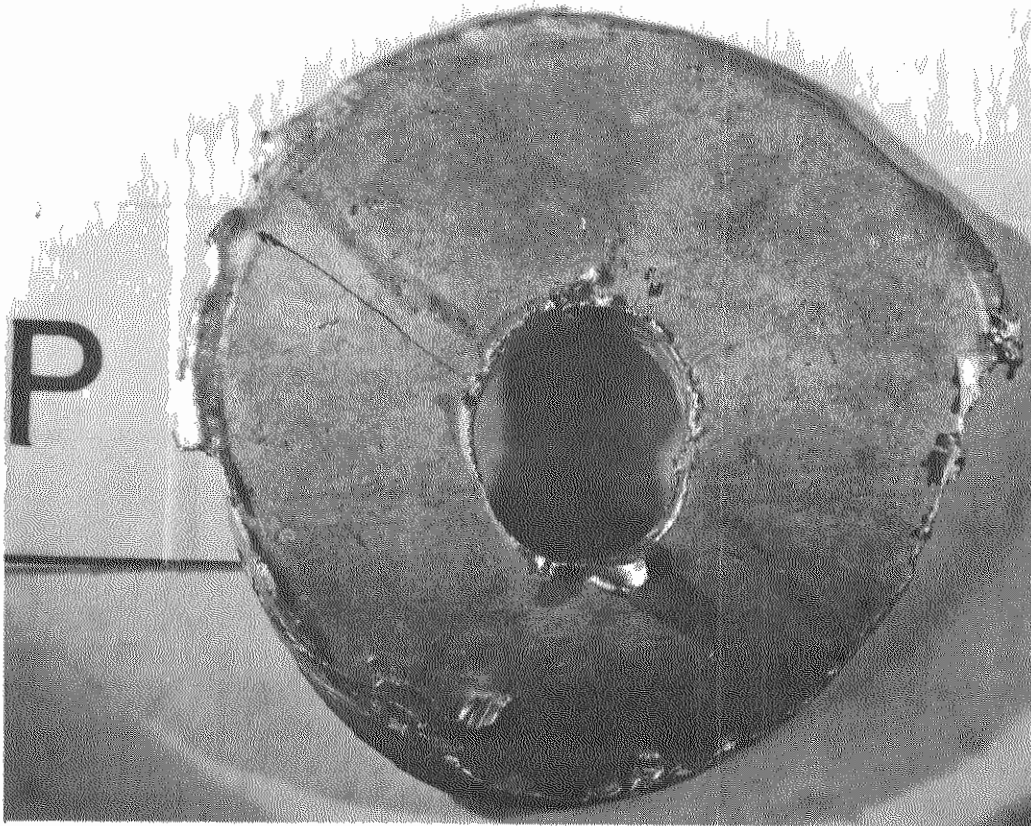
Figure 8. Typical 1-1/8 in. sample disc cut from culverts.

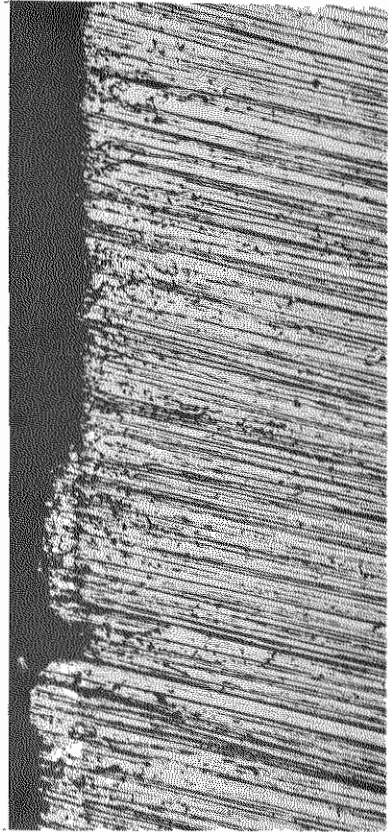
Figure 14. Photomicrograph (250X) of galvanized steel at Sta. 622+00. Corrosion has perforated galvanizing to the base metal in the white-rusted area in the upper part of the invert. Base metal appears unaffected.

US 2, Sta. 622+90 (galvanized steel). General condition fair. Several pits on the inside perforated the coating and exposed the base metal (Fig. 14). No damage to the base metal was observed.

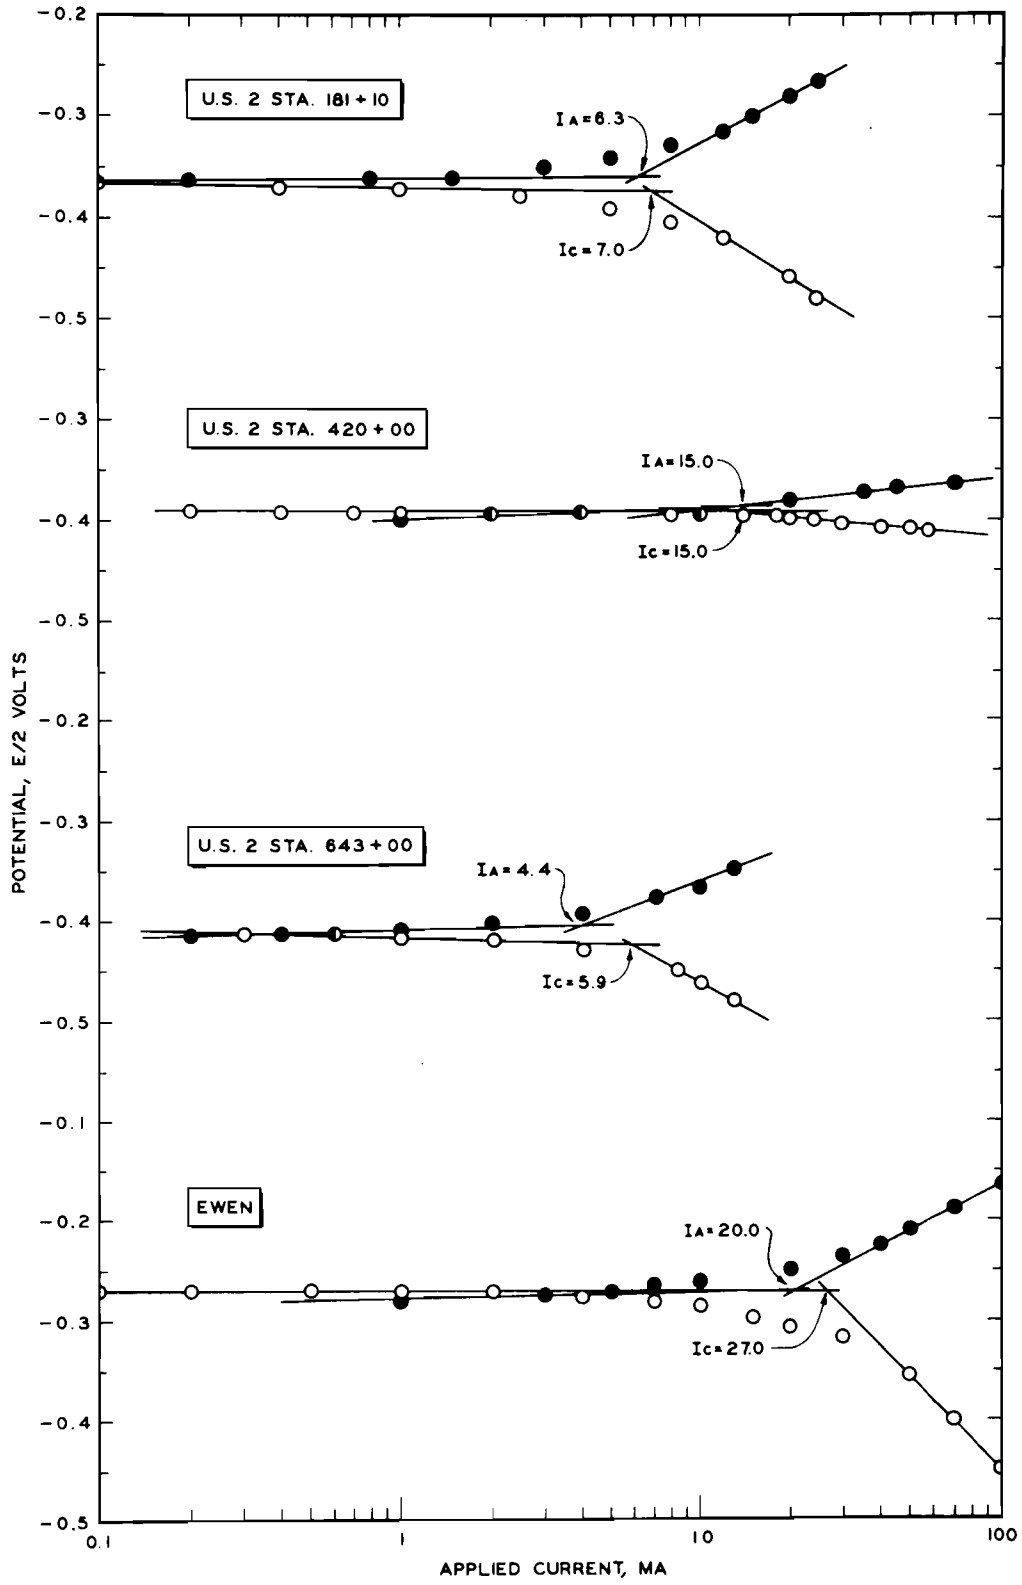
determined for each culvert (Fig. 17) as well as corrosion current I_{corr} and rate of metal loss, m . A sample calculation of I_{corr} and the weight loss per year for the aluminum culvert on US 2, Station 181+10 follows:

$$I_{corr} = \frac{I_a \times I_c}{I_a + I_c} = \frac{6.3 \times 7.0}{6.3 + 7.0} = 3.3 \text{ ma}$$

Using Faraday's Law $m = e I t$; where $t = 31.8 \times 10^6 \text{ sec/year}$, $e = 9.3 \times 10^{-5} \text{ gm/coulomb}$, $I = 3.3 \times 10^{-3} \text{ amp}$, then $m = (9.3 \times 10^{-5}) (3.3 \times 10^{-3}) (31.8 \times 10^6) = 9.8 \text{ gm/yr}$.

Figure 17. Polarization curves for culverts indicated.
